LOG # RF 45E

TARGET # C1080

DEBRIS FIELD Grass #1

Section of FUSELAGE MEASURES 5'7" x 4'3"

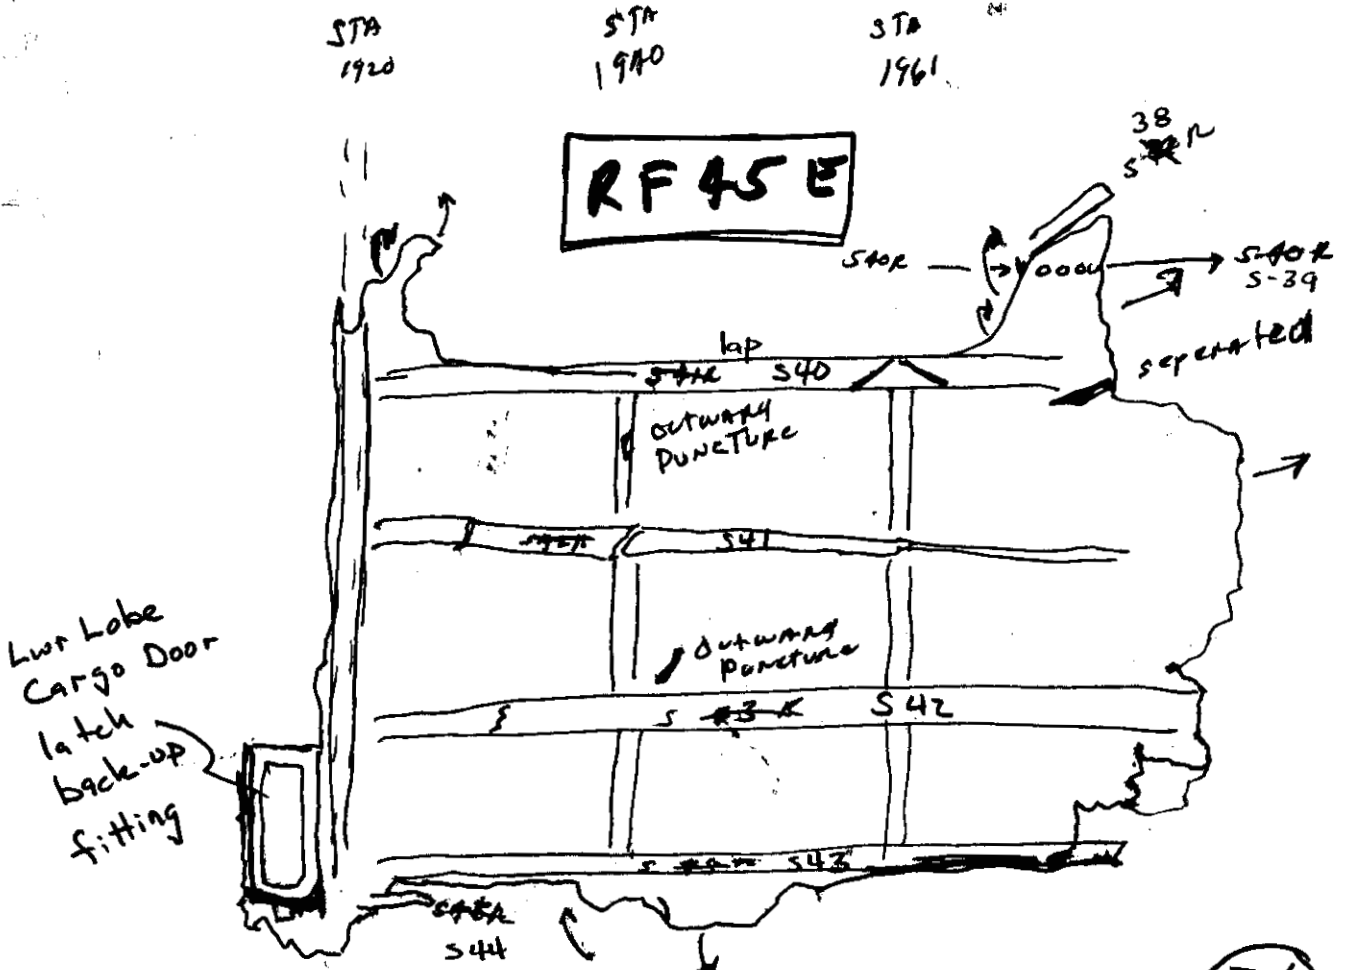
# RIGHT HAND

ENCOMPASSES STATION 1920-1940 & 1961 ALL THREE FRAMES MISSING FROM SKIN (Puncture outward @ STA 1940 4" in length 1/2" wide Between S41R & S42R)

STRINGERS S-39R TO S45R

S-39R 17 1/2" in length Severed at fwd edge & cracked, Pulled away from SKIN & curled outward & upward.

S-40R Lower section of stringer 1/2" attached to SKIN, 8" long Rest of stringer MISSING FROM SKIN

S-41R ATTACHED TO SKIN (Deformation of SKIN sections of stringer ARE CRACKED & MISSING AND Aft portion Pulled away From SKIN)

S-42R ATTACHED TO SKIN cracked & Bent FLAP Against SKIN Between S42R & S43R Puncture in SKIN 2" aft of STA 1940 2" x 1"

S-43R crack aft of STA 1920 ATTACHED TO SKIN

S-44R CRACKED CRUSHED & Flattened Against SKIN

S-45S small section ATTACHED TO SKIN at STA 1920 Fwd 11 1/2"

OVERALL There is Deformation of SKIN STATION FRAMES MISSING.

STRINGERS ARE CRACKED CRUSHED, Pulled away From SKIN & ALSO ATTACHED.

2 PUNCTURES 1- Between S-41R & S42R stat 1940 & another

Between S-42 & 43 sta 1940

Piece is curled inward & outward with jagged edges no sign of Burning or soot.

## FRAMES MISSING FROM SKIN 1920
