LOG # RF 53

B. HOCKING  
BOEING  
9/4/96

SEGMENT A - STA 1560 TO 1520,  
STG 34R TO 40R

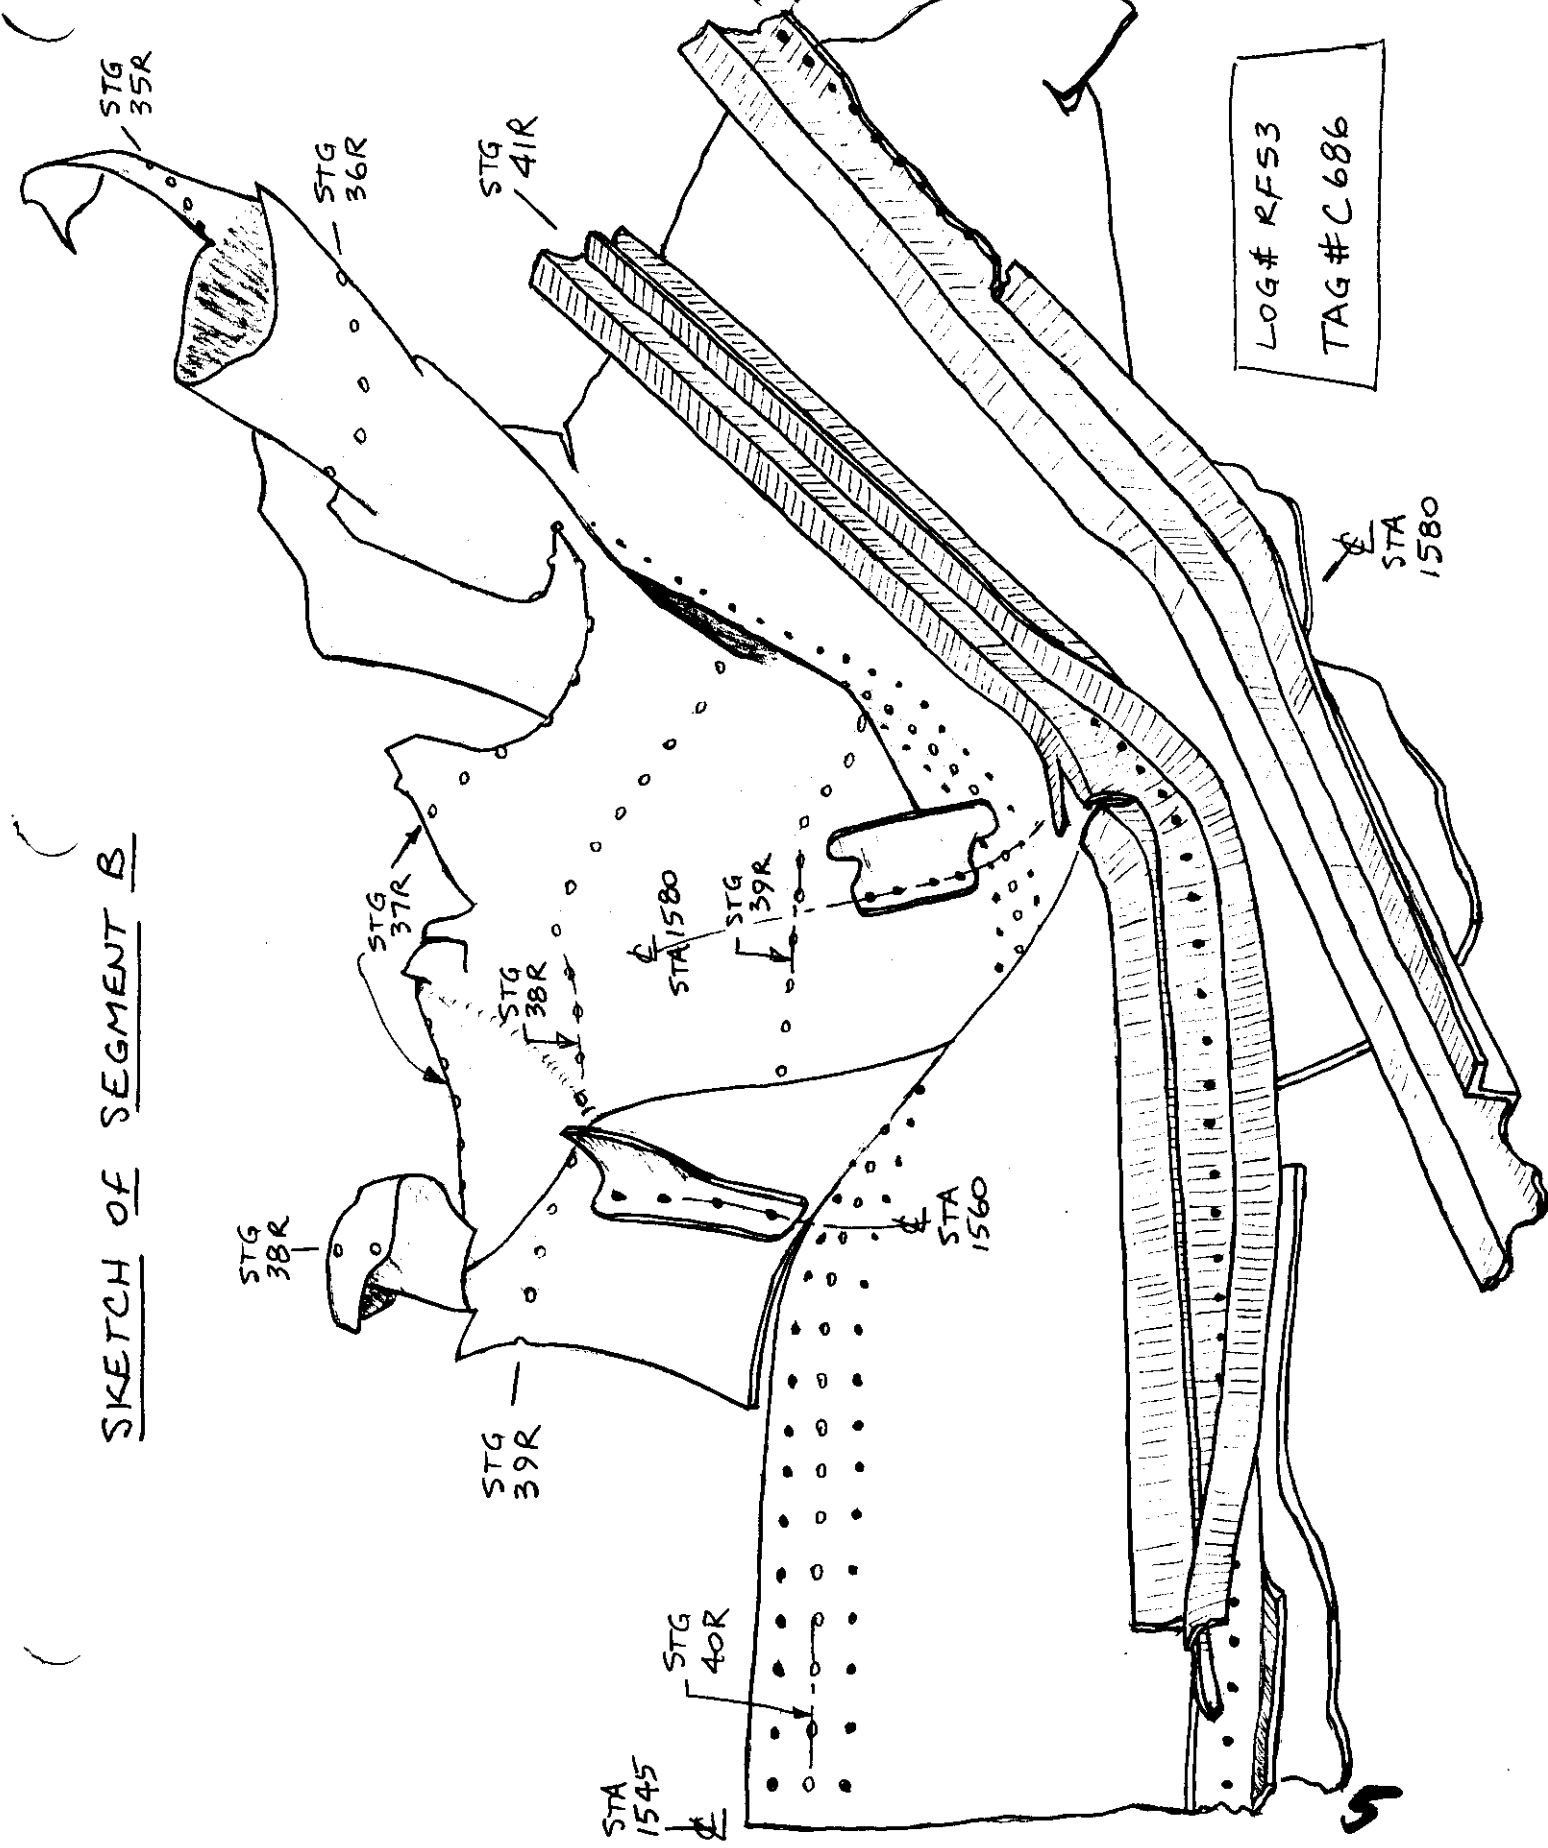
THE DEFORMATION OF SEGMENT B IS QUITE EXTREME AND IS THEREFORE SKETCHED ON THE FOLLOWING PAGE.

- 1) THIS SEGMENT IS NOTABLY DEFORMED WITH NUMEROUS CREASES, BENDS AND TEARS IN ALL DIRECTIONS.
- 2) THE SEGMENT THICKNESS RANGES FROM ABOUT 0.170 AT ITS FWD LOWER CORNER TO ABOUT 0.080 INCH AT ITS AFT UPPER CORNER.

- 6) DEFORMATIONS OF THIS PANEL IS CHARACTERISTIC OF MANY OTHER PANELS ALL AROUND IT. BESIDES TEARS AND BENDS, IS RIPPLED AND CREASED, FOLDING BACK UPON ITSELF A NUMBER OF TIMES. SEE THE SKETCH OF SEGMENT B FOR AN EXAMPLE.
