LOG # RF6 R3A-C
9-30-96

TARGET # 2 (P/L
of 5)

RF6A

This section of ~~of~~ RIGHT FUSELAGE SKIN AND FRAMES (which includes 5 1/2 MAIN DECK PAX WINDOWS AND ENCOMPASSES STATION 620 TO STA 641, AND STRINGERS S20R TO S26R. WITHIN AN AREA 10'x4'

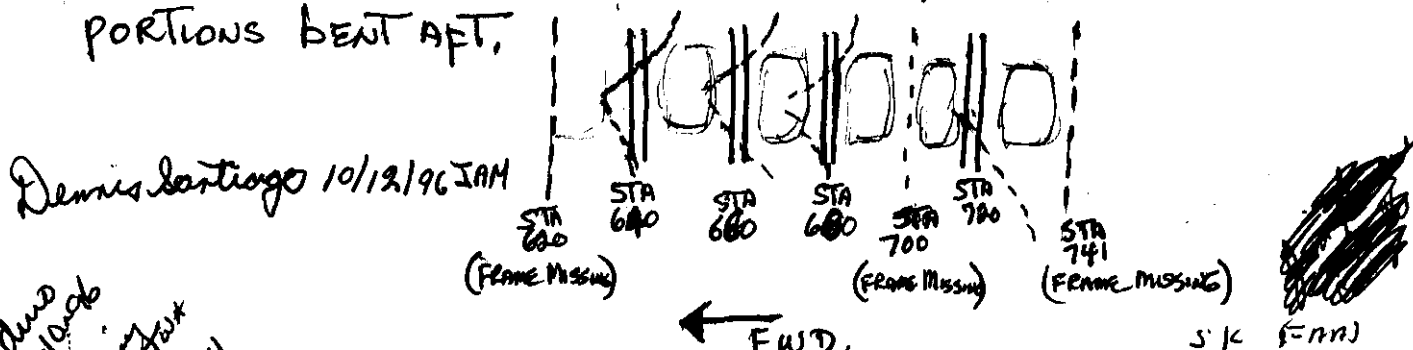
FUSELAGE SKIN SHEARED AND JAGGERED ALONG TOP STRINGER R20R RIVET HOLES FROM STA 620 TO STA 720.

VERTICALLY AT STA 741 (SHEAR TIE) METAL TIE IS SHEARED + JAGGERED

FUSELAGE SKIN BELOW S22R (WINDOW STRINGER) JAGGERED, BENT, AND FOLLOWS OUTLINE OF EACH INDIVIDUAL WINDOW REINFORCEMENT PANEL FROM STA. 640 TO STA 720, AT WHICH POINT FUSELAGE SKIN APPEARS AND CONTINUES AFT TO STA 741 (LENGTH OF SKIN IS APPROX 30", BUT IS WRINKLED AND ROLLED OVER - THIS SKIN ALSO INCLUDES SECTION OF FLOOR TO SIDEWALL ATTACH ANGLE BETWEEN STRINGERS S25R + S26R)

1) FUSELAGE FRAMES 620, 640, 680, AND 720

FRACTURED AND BENT FORWARD AT MIDPOINT AND REMAINING PORTIONS BENT AFT.

2) NO EVIDENCE OF FIRE OR SMOKE DAMAGE

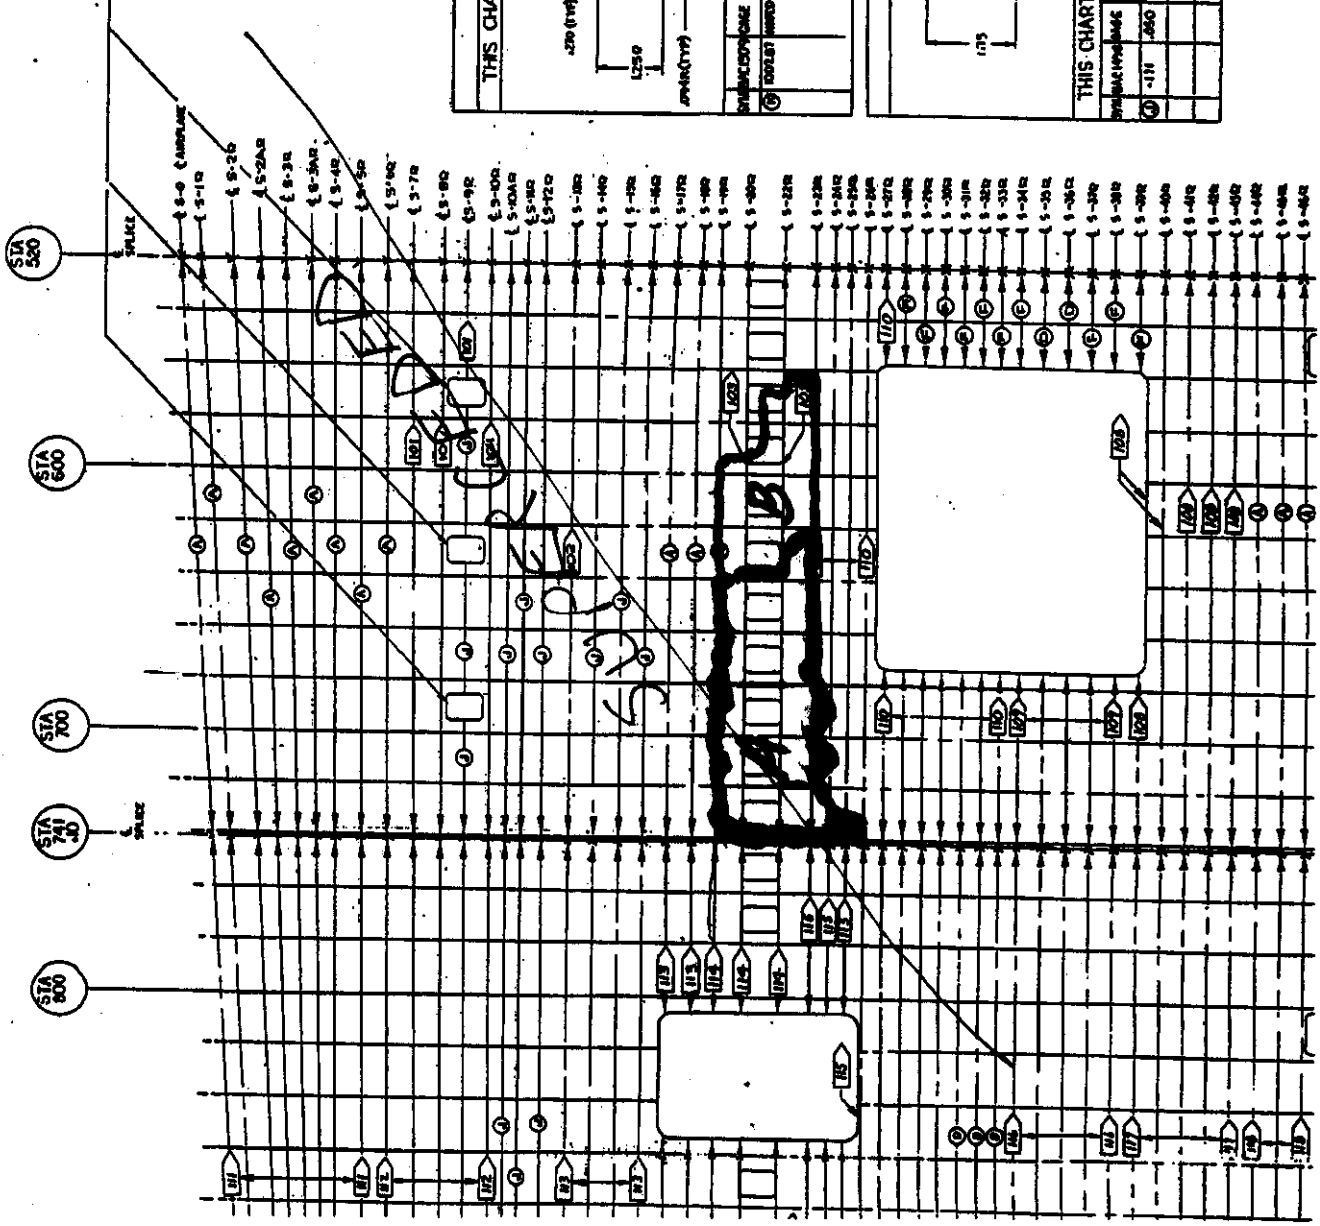
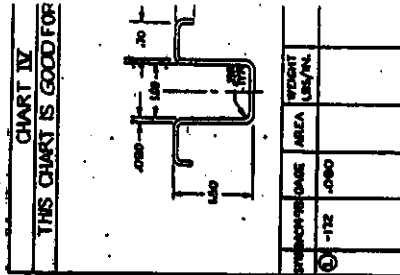
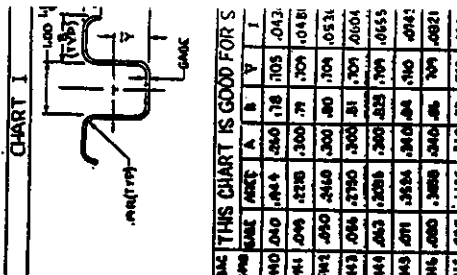
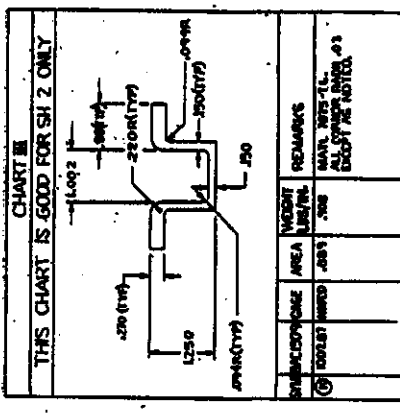
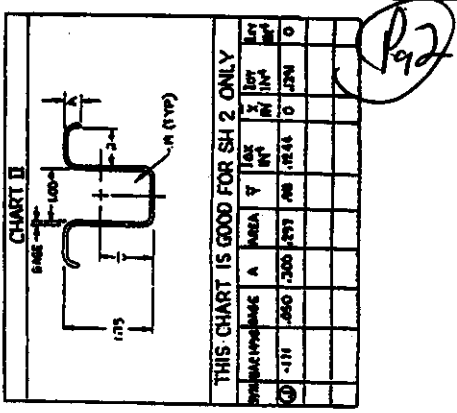
RF6C

THIS PIECE IS A SHORT SEGMENT OF WINDOW BELT RUNNING FROM STA 570 TO STA 600, MID-WINDOW HEIGHT DOWN TO STG 23R (RIGHT SIDE). THE UPPER EDGE CUTS THRU BOTH SIDES OF THE WINDOW FORGING CENTERED AT STA 590 AND THRU THE AFT SIDE OF THE WINDOW FORGING CENTERED AT STA 570. THE ~~FOR~~ FORWARD BOUNDARY CUTS THRU THE BOTTOM SIDE OF THE FRAME CENTERED AT STATION 570. ALSO, THE FRAME CENTERED AT STA 590 IS CRACKED ~~THRU~~ PARTWAY THRU THE LOWER SIDE, AND THE CRACK THEN RUNS FWD & JUST ABOVE STG 22R AND RUNS TO THE EDGE OF THE FRAME.

ON THE INBOARD SURFACE AT ~~EB~~ EACH FRAME STATION (580 & 600), THE ~~SKIN~~ SKIN TO FRAME SHEAR TIES' ATTACH LEGS REMAIN ~~BE~~ ATTACHED - THE FRAME ATTACH LEGS ARE MISSING.

THE IS NO APPARENT SOOTING OF THE SEGMENT. THE FRACTURE SURFACES APPEAR TO BE DUCTILE FAILURE

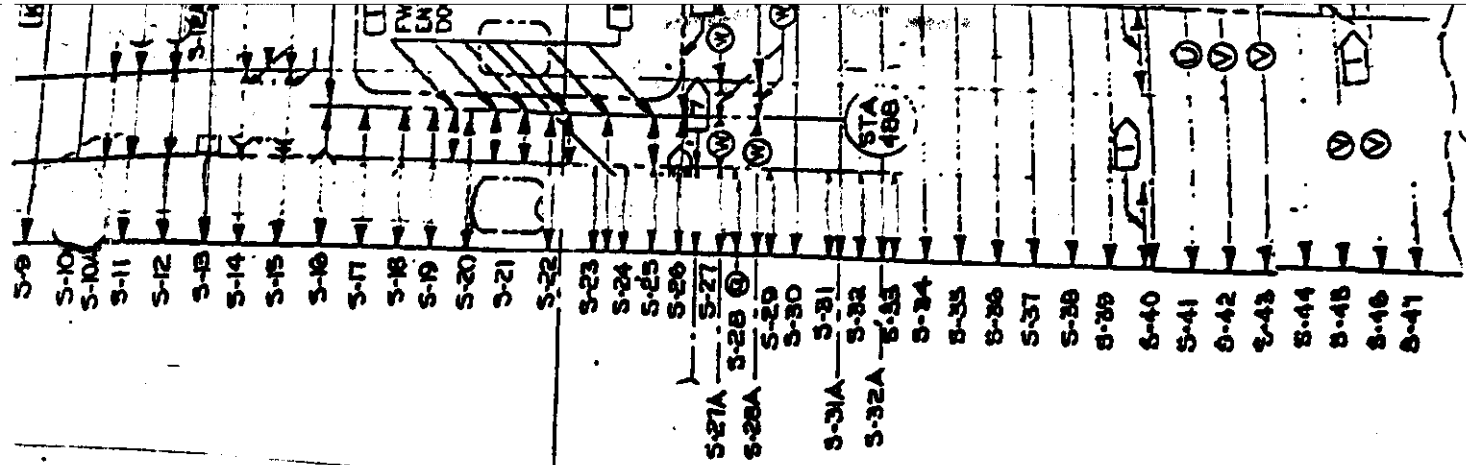
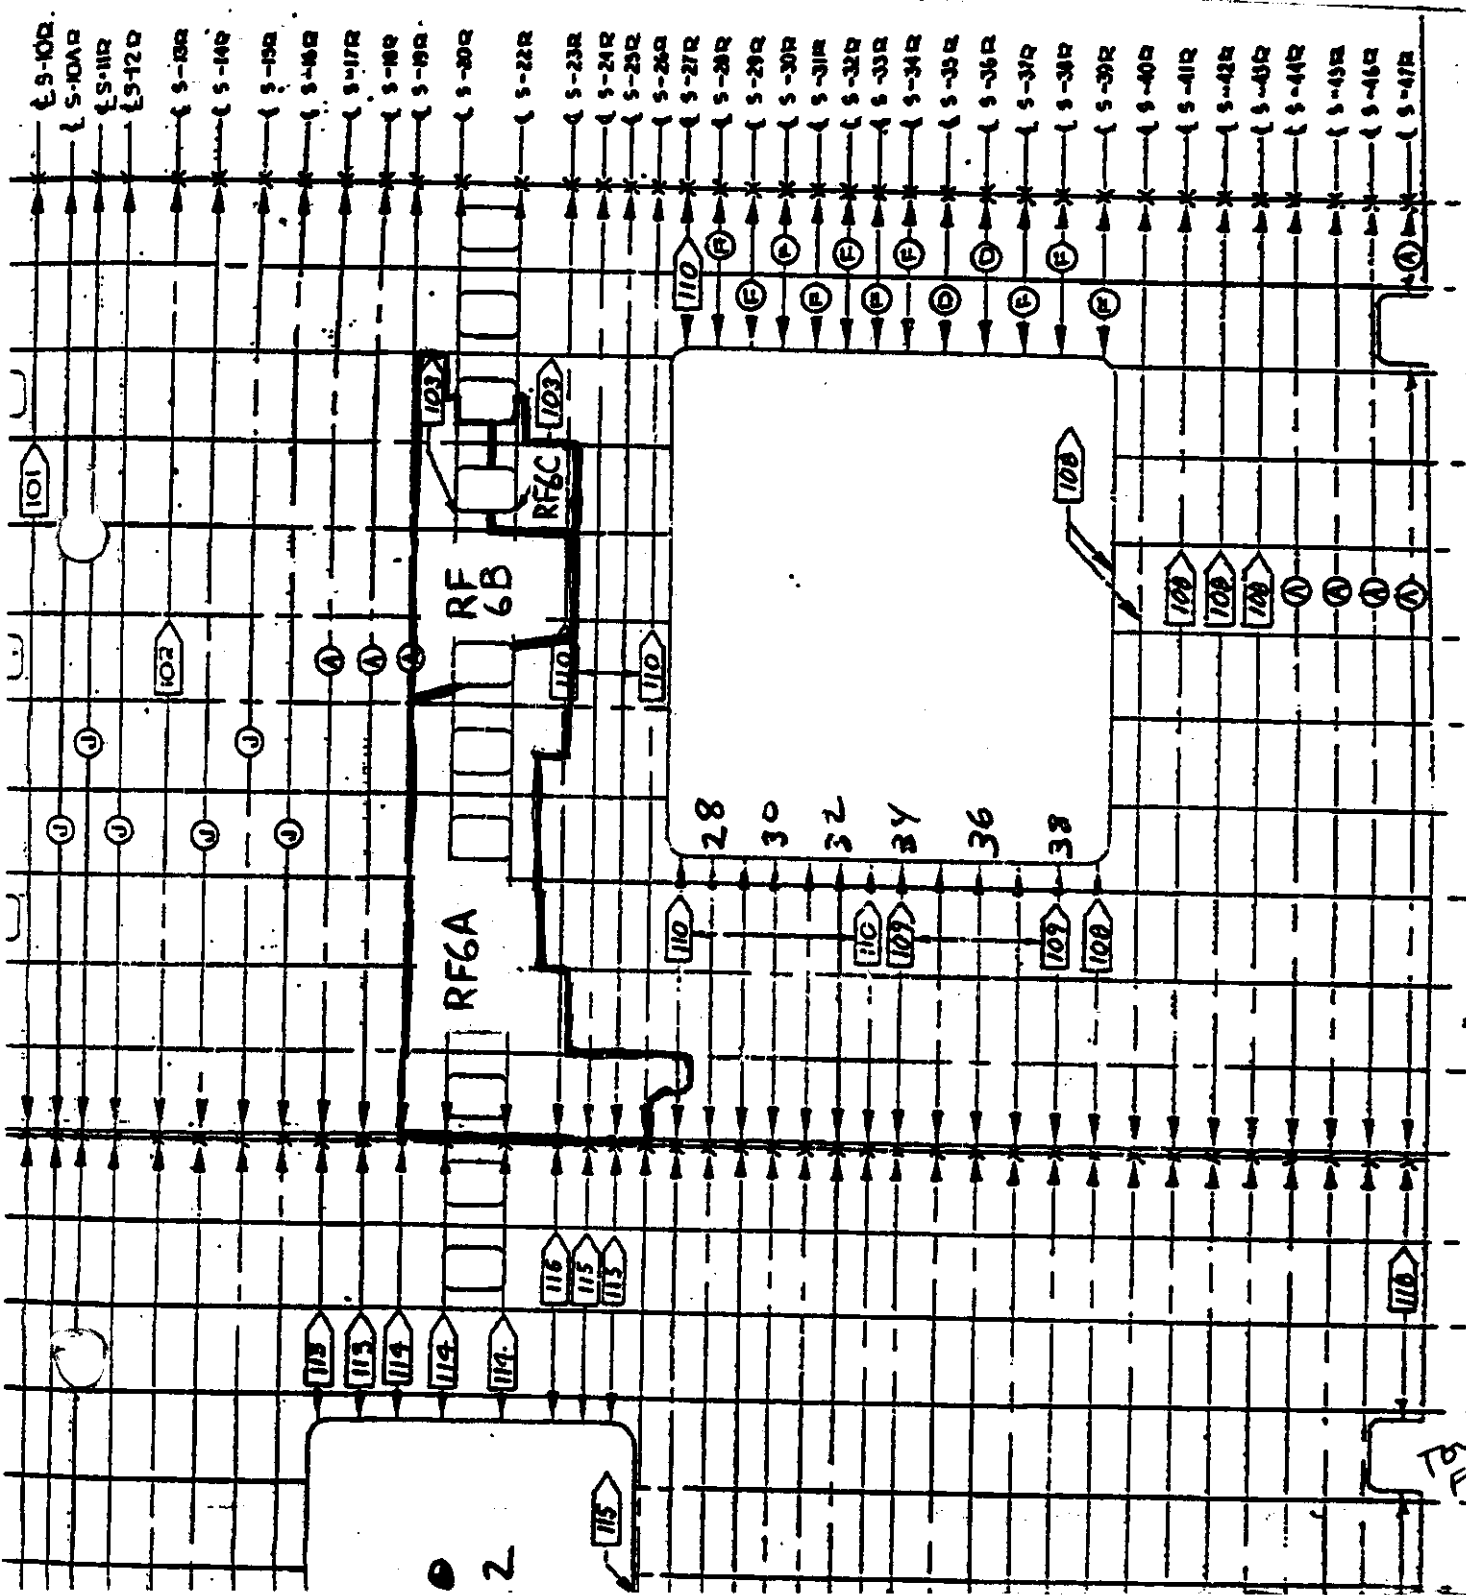
BF6B Tag # B240

Similar to BF6A. Upper skin ~~exhibits tension~~ ^{FRACTURED} failure along rivet line. Lower skin from FS 600 to FS 620 exhibits lap joint which with rivet holes showing tension pull through. Former segment at FS 620 bent aft.
