LOG # RF62

TAG # C2337

SKIN SEGMENT, STA 1920 TO
STA 1940, STG 34R TO 40R

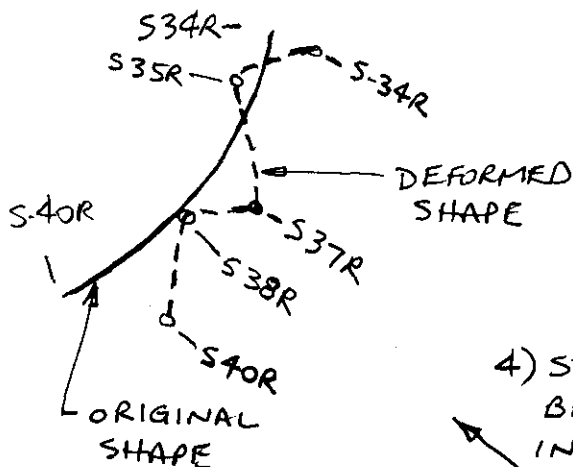
VIEW A-A

SKIN SEGMENT IS CRUMPLED CIRCUMFERENTIALLY AND IS BENT AS DESCRIBED IN SKETCH BELOW:

1) STR 34R IS BADLY CRUSHED BUT REMAINS ATTACHED. A CARGO DOOR STOP INTERCOSTAL WEB REMAINS ATTACHED TO THE I/C BUT IS BADLY TORN.

2) STG 35R IS MISSING. ATTACHMENT HOLES ARE ENLARGED BY PULL-THRU.

3) STG 36R NOT TOO BADLY CRUSHED AND REMAINS ATTACHED.

4) STG 37R REMAINS ATTACHED BUT IS BADLY CRUSHED SINCE IT IS LOCATED IN THE MIDDLE OF A SKIN BEND (SEE SKETCH). A CARGO DOOR STOP INTERCOSTAL WEB REMAINS ATTACHED TO THE I/C.

5) STG 38R IS MISSING BUT A PIECE OF THE STRINGER "HAT" TOP IS STILL ATTACHED. A FEW PULLED-THRU FASTENERS EXIST WITH THE CHARACTERISTIC ENLARGED HOLES.

6) STG 39R IS MISSING.

7) THE WEB IS TORN OFF AT THE FIRST ROW OF FASTENERS AT THE WEB SPLICE AT STRINGER 40R. NO STRINGER IS ATTACHED.

AS NOTED ABOVE IN #1) & 4), DOOR STOP INTERCOSTAL WEBS REMAIN ATTACHED AT STRINGERS 34R & 37R. ALSO, AN APPARENT PIECE OF INTERCOSTAL WEB AND ITS ATTACHMENT LEG ARE STILL ATTACHED TO THE SKIN BETWEEN STRINGERS 39R & 40R.

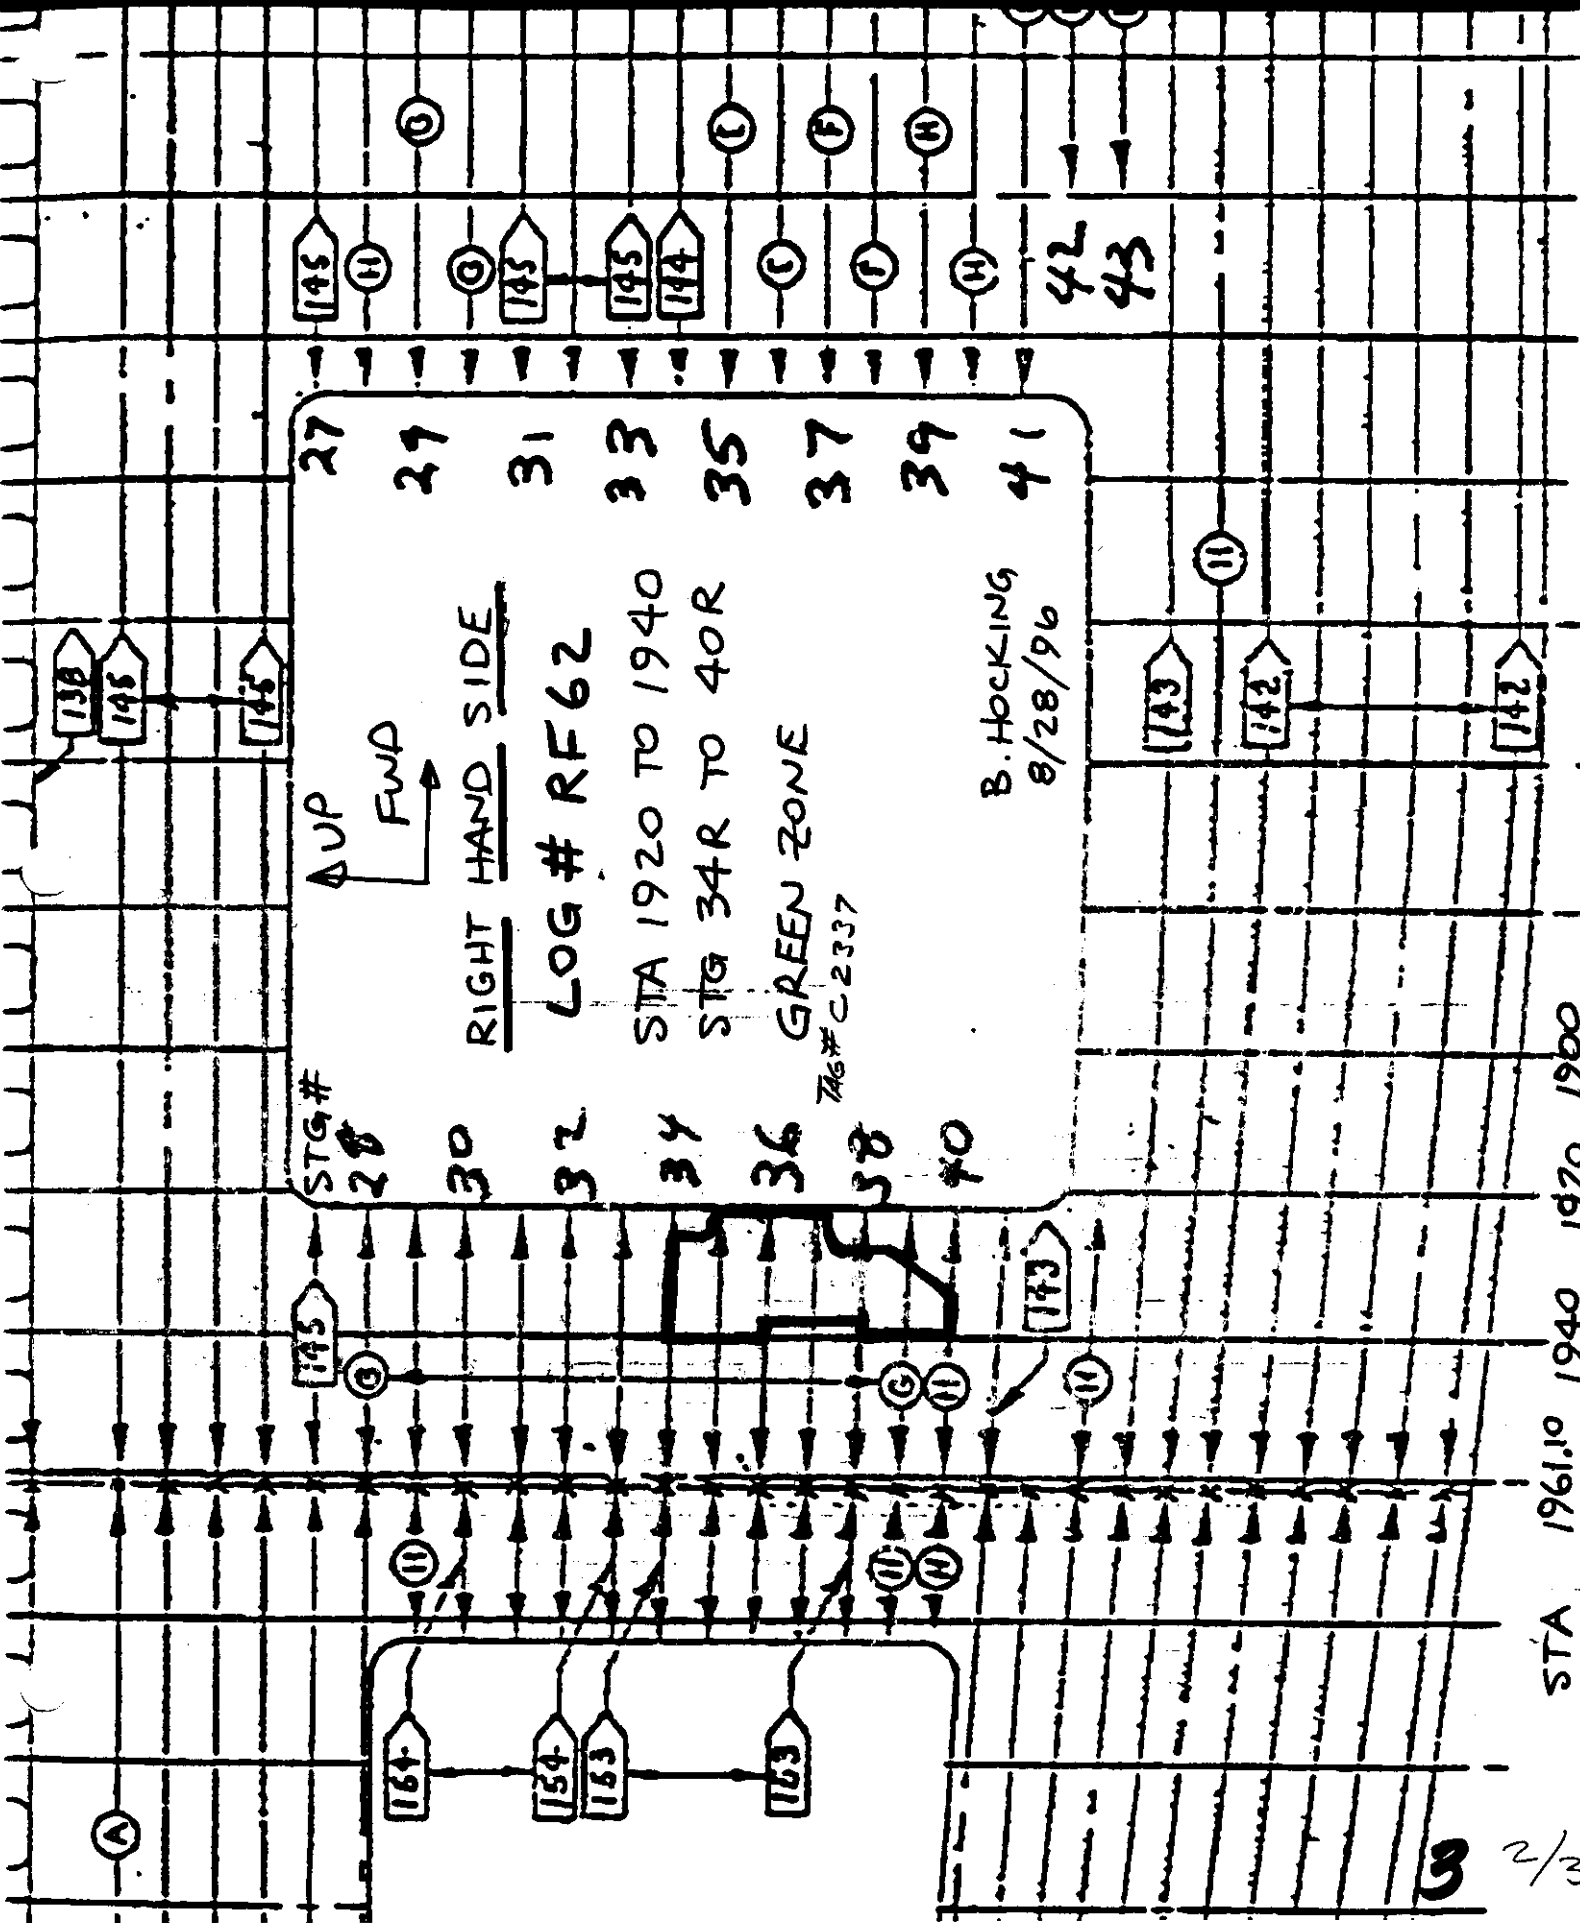
RIGHT HAND SIDE
 LOG # RF62
 STA 1920 TO 1940
 STG 34R TO 40R
 GREEN ZONE
 746# C-2337

FRAME-TO-SKIN SHEAR TIE LEGS, ONLY, REMAIN ATTACHED TO THE SKIN BETWEEN STGS 35R AND 36R, BETWEEN 38R AND 39R AND BETWEEN 39R AND 40R.

A PORTION OF THE SUBJECT CHORD REMAINS ATTACHED AT THE FORWARD EDGE OF THE PANEL BETWEEN STG 34½R AND 37R. IN ADDITION, A SMALL AMOUNT OF FRAME WEB IS ATTACHED BETWEEN STG 35R AND 36R.

A LENGTH OF THE SUBJECT STRAP IS PRESENT BETWEEN STG 34½R AND 37R.

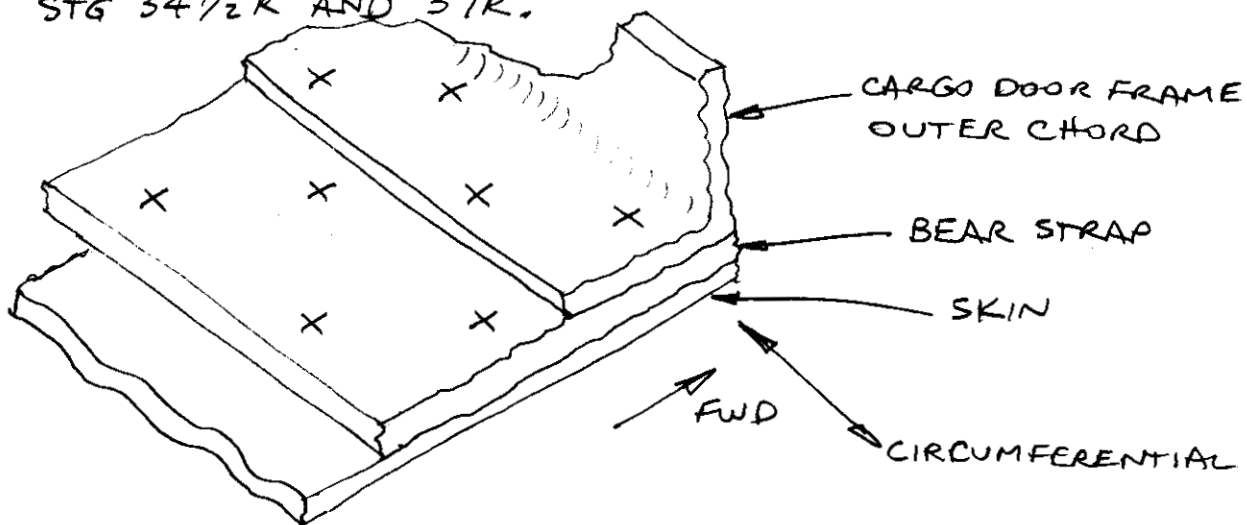
OTHER OBSERVATIONS: NO APPARENT CHARRING OF ITEM. FRACTURE SURFACES APPEAR TO BE DUCTILE FAILURES - NOT FATIGUE.
