LOG # RF 63
TARGET # C1081
COORD: LAT _____
LONG _____
DEBRIS FIELD _____

STA 1480 TO 1570, STG 36R TO STG 45 1/2 R

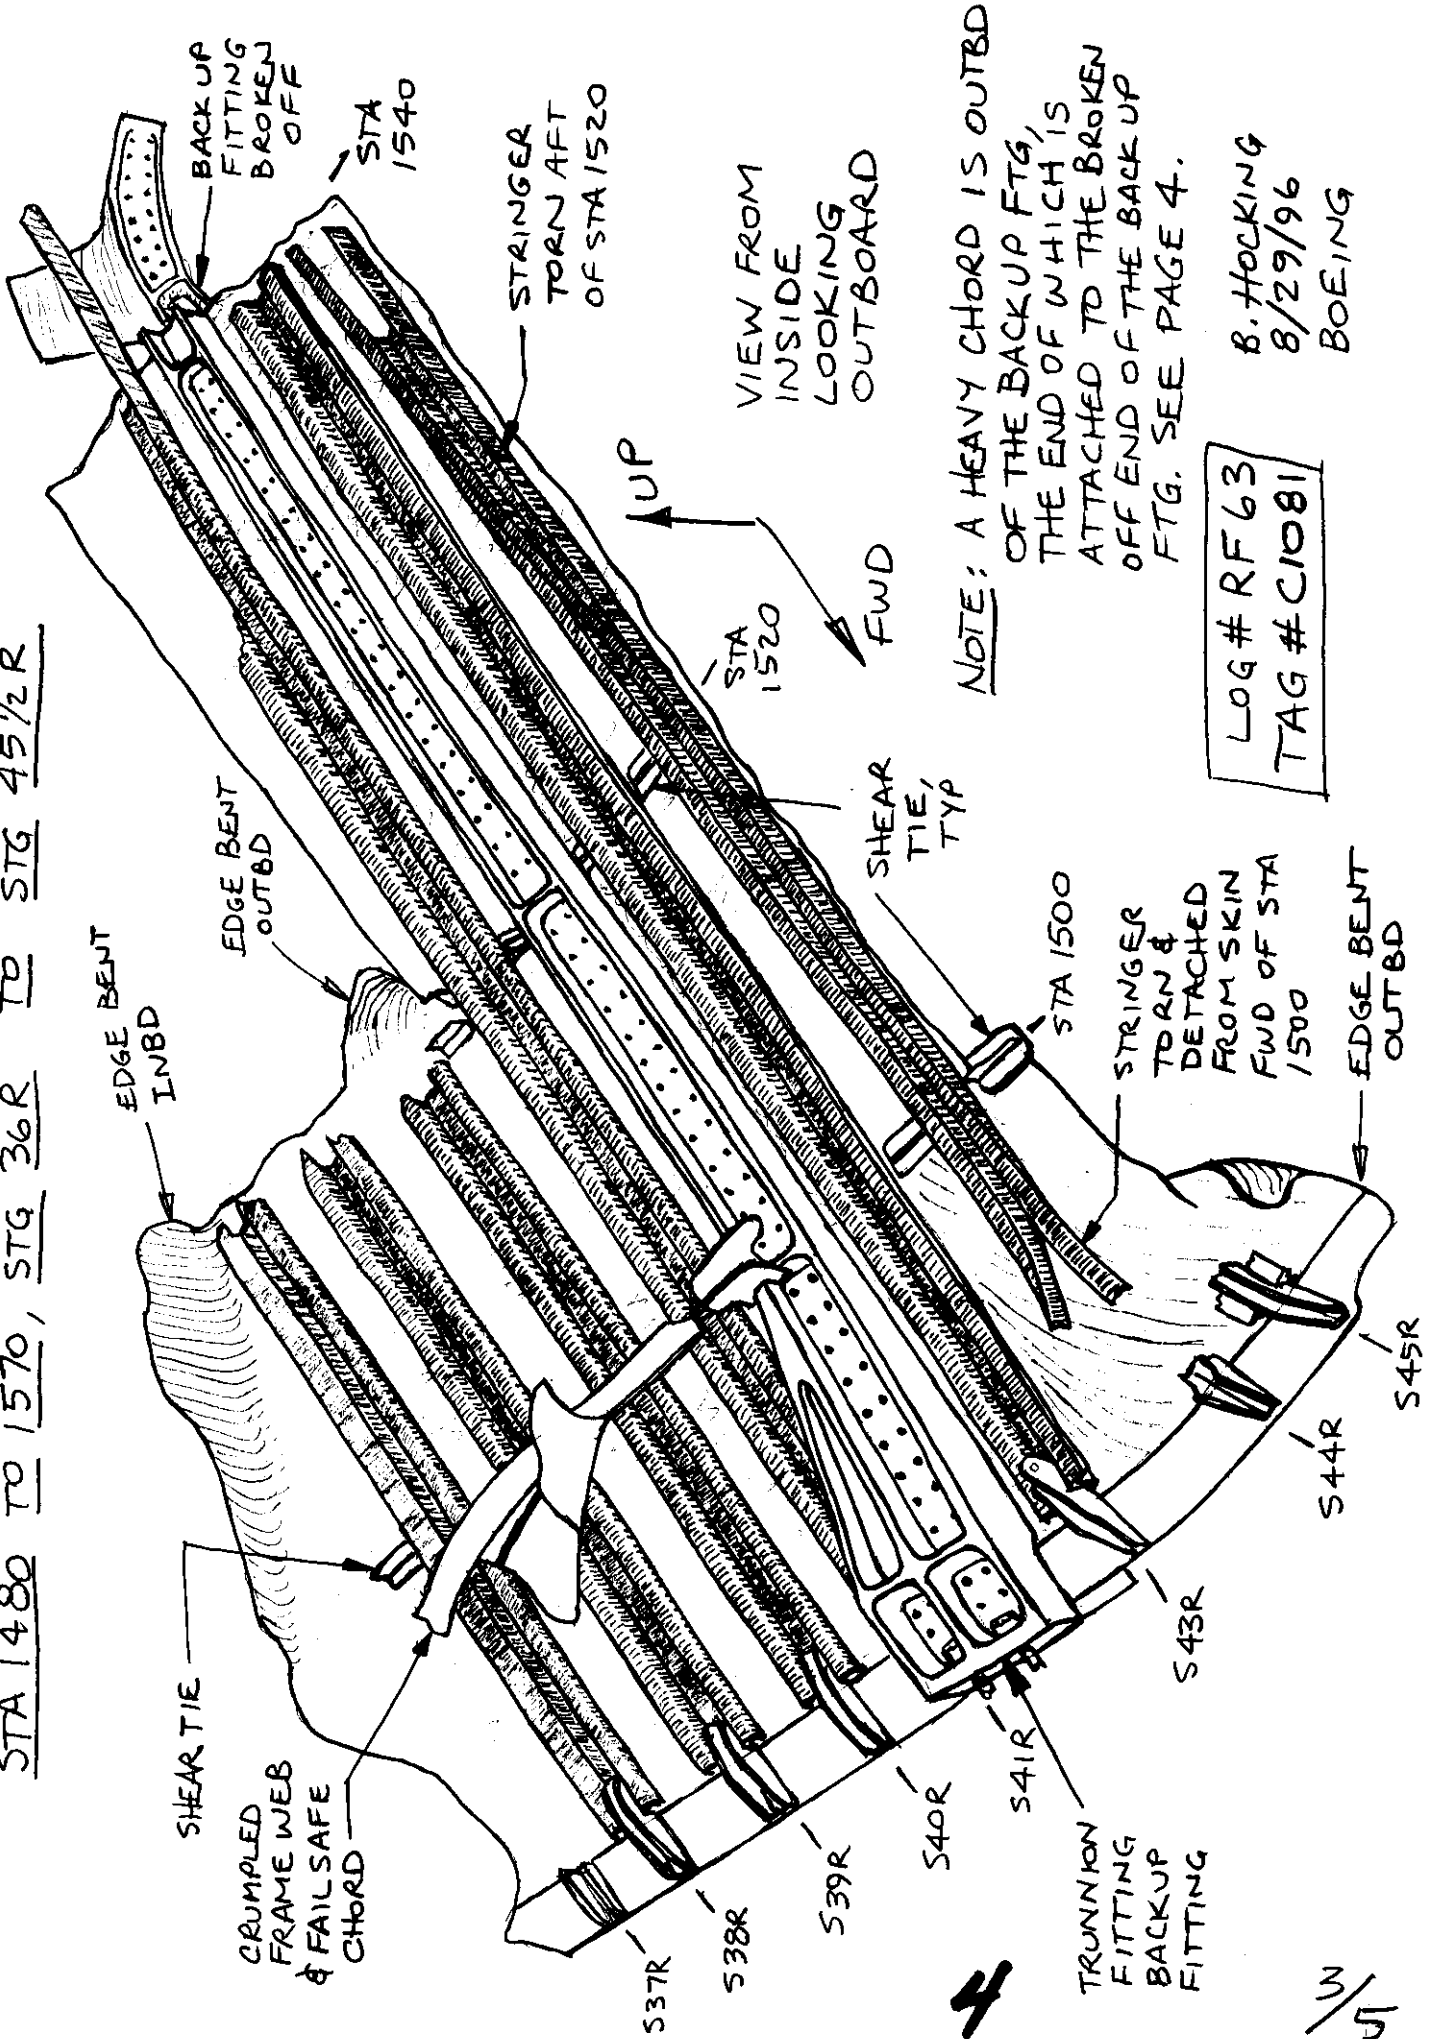
SEGMENT IS FROM STA 1480 TO STA 1570, STG 36R TO STG 45 1/2 R. SEGMENT OF SKIN HAS THE BODY LANDING GEAR (BLG) TRUNNION FITTING BACK UP FITTING ATTACHED TO IT ON THE INBOARD SURFACE AND AN OUTER CHORD ATTACHED ALONG THE OUTBOARD SURFACE. A PIECE OF THE STA 1500 BODY FRAME WEB AND FAIL SAFE CHORD ARE STILL ATTACHED TO THE SKIN VIA SHEARTIES.

NO SOOTING IS PRESENT ON THE INBOARD SIDE OF THE PANEL. THE OUTBOARD SIDE HAS A SMALL AMOUNT OF SOOTING BUT MAY HAVE RESULTED FROM CONTACT WITH OTHER CHARRED STRUCTURE; THE SOOTING HAS "RUB LINES". FRACTURE SURFACES APPEAR TO BE DUCTILE FAILURE.

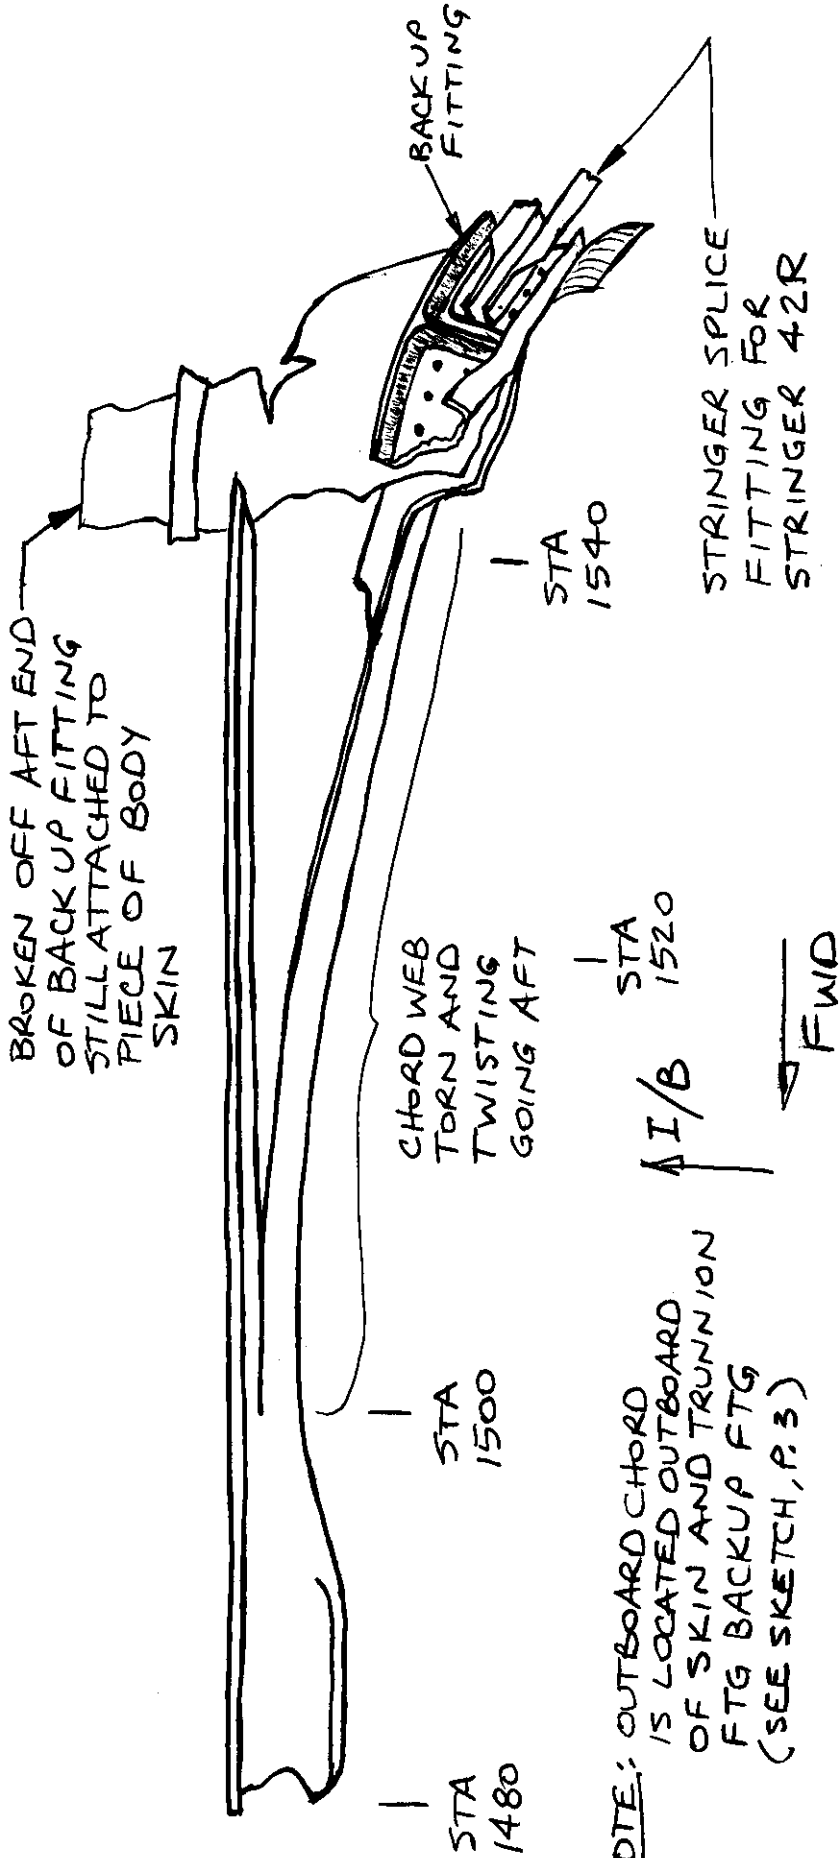
TRUNNION FTG BACKUP FTG OUTBOARD CHORD

NOTE: OUTBOARD CHORD IS LOCATED OUTBOARD OF SKIN AND TRUNNION FTG BACKUP FTG (SEE SKETCH, P. 3)

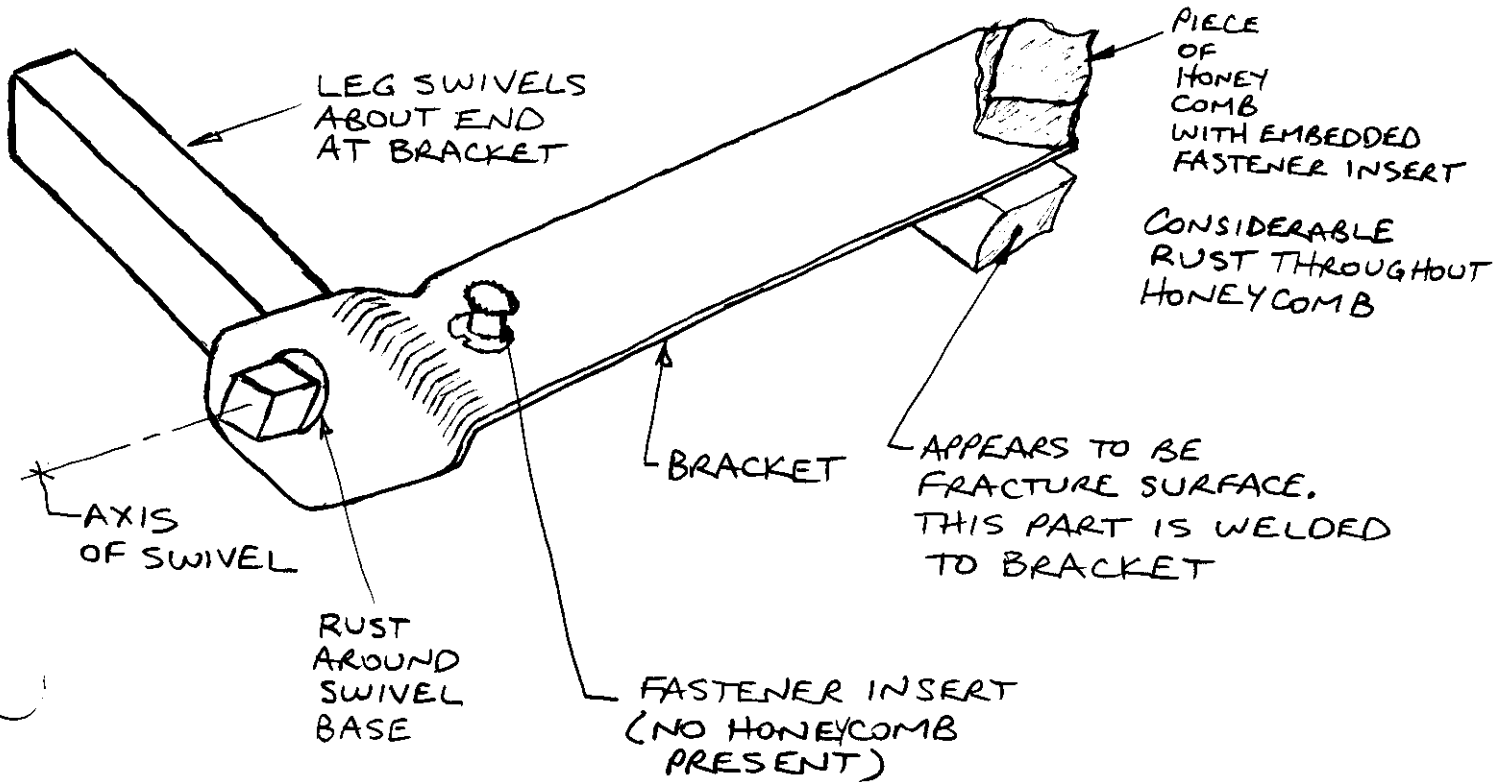
PART FOUND CAPTURED BETWEEN
STRINGER # 38R AND SKIN

PART WAS FOUND "CAPTURED" UNDER
STRINGER ATTACHED TO SKIN PANEL
DOCUMENTED IN LOG # RF63.

APPROXIMATE POSITION STA 1510, RIGHT
HAND SIDE STRINGER 38
