RF 2146

LOG # RF 65
 TARGET # C1661 GREEN
 COORD: LAT _____
 LONG _____

REFER FIRE AND EXPLOSION GROUP NOTES FOR FIRE DAMAGE

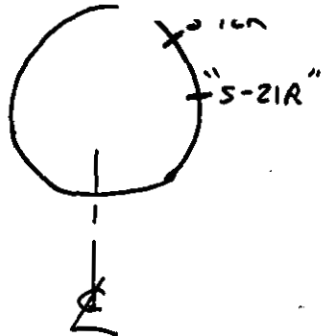
VIEW A-A

SEGMENT OF SKIN RUNS FROM STA 1500 TO STA 1600, STG 12R TO "STG 21R" (WINDOW BELT)

SEGMENT HAS ONLY TWO SHORT PIECES OF STRINGER STILL ATTACHED. ONE IS A PIECE OF STG 14R FROM STA ~ 1550 TO 1560. THE OTHER IS

A PIECE OF S-19R FROM STA ~ 1572 TO STA ~ 1592. THE LACK OF STRINGERS AND FRAME SHEAR TIE ATTACHMENT TO SKIN APPEAR TO INDICATE OVERPRESSURIZATION CONDITION.

A PIECE OF WINDOW FORGING IS PRESENT BETWEEN STA 1580 AND 1600 RUNNING FROM ABOUT 11 O'CLOCK TO 3 O'CLOCK (VIEWING WINDOW FROM OUTSIDE).

AFT END OF PANEL IS BENT SLIGHTLY OUTBOARD WITH BEND LINE AT ABOUT STA 1570 TO 1575 (BENDLINE RUNNING CIRCUMFERENTIALLY). THE FWD LOWER CORNER IS BENT SLIGHTLY INBOARD WITH A BENDLINE RUNNING ABOUT FROM STA 1500, STG 17R TO STA 1530, STG 19R. THE FWD EDGE, UPPER, IS BENT OUTBOARD WITH BENDLINE RUNNING FROM STA 1520, STG 13R TO STA 1535, STG 12R.

AN ELLIPTICAL CUTOUT LOCATED AT STA ~~1554~~ ¹⁵⁵⁴ TO STA ~~1554~~ ¹⁵⁵⁴, STG 13 1/2 R IS MISSING THE EQUIPMENT WHICH NORMALLY IS INSTALLED THERE. THE INBOARD SURFACE HAS NO APPARENT SOOTING. THE OUTBOARD SURFACE, HOWEVER, DOES EXHIBIT LIGHT SOOTING OVER THE ENTIRE AREA. FRACTURE SURFACES APPEAR TO BE DUCTILE FAILURE.
