LOG # RF 66

TARGET # C2156 GREEN

SKIN SEGMENT IS LOCATED FROM STA ~1536 TO STA ~1620, FROM STG. 42R DOWN TO 49 1/2R.

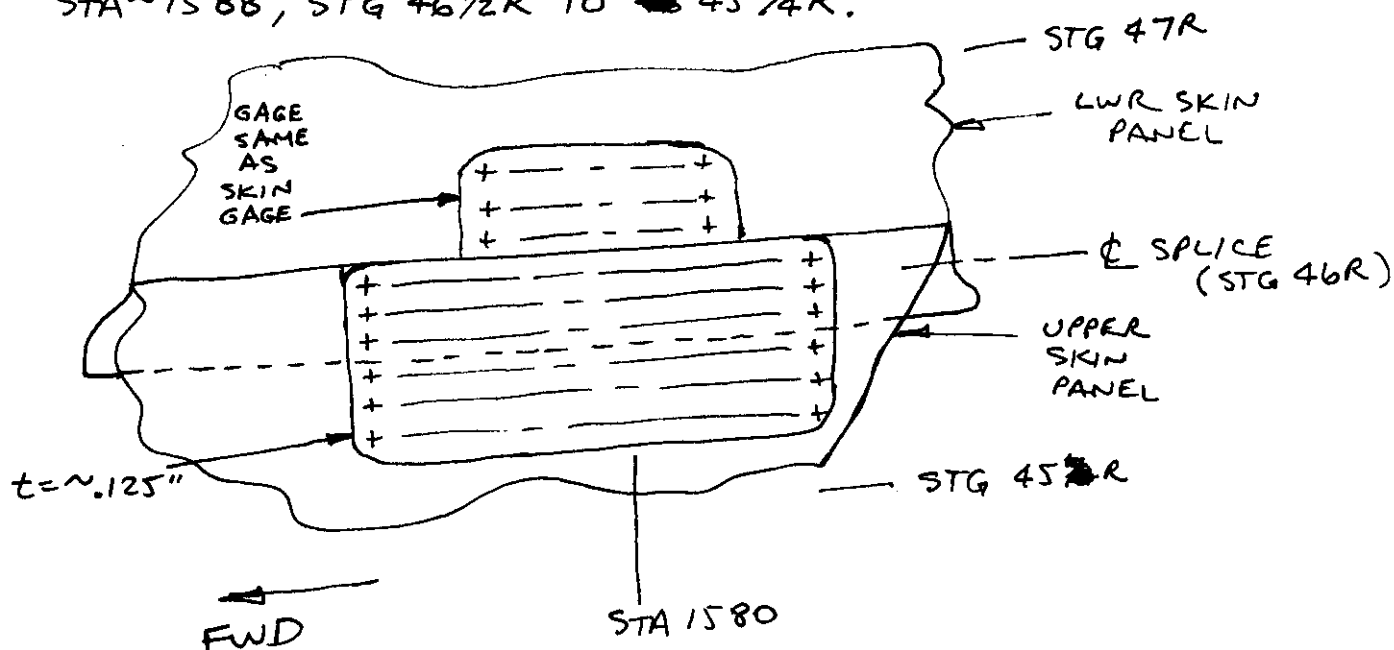
- 1) AN EXTERNAL SKIN REPAIR EXISTS BETWEEN STA~1570 TO STA~1588, STG 46 1/2 R TO 45 1/4 R.

- 2) THERE APPEARS TO BE SOME SLIGHT SOOTING OF THE OUTER SURFACE. THE FWD CORNER OF THE LARGE DOUBLER PICTURED ABOVE AT STG 46R HAS DARK SOOTING ABOUT 1 1/2 INCH BY 3 INCH.
- 3) THE INBOARD SURFACE APPEARS TO BE SOOTED MORE EXTENSIVELY. GRIME IN THE LOWER BILGE REGION SEEMS TO BE DARKER THAN THE STRINGER FLANGES. ALSO, THE AFT REGION OF THE PANEL WHICH IS BENT INBOARD AND FWD IS MORE SIGNIFICANTLY SOOTED ON THE INBOARD SURFACE.
- 4) SOME OF THE FRACTURE SURFACES SHOW SOOTING, AS WELL, PARTICULARLY IN THE AFT REGION BENT I/B & FWD.

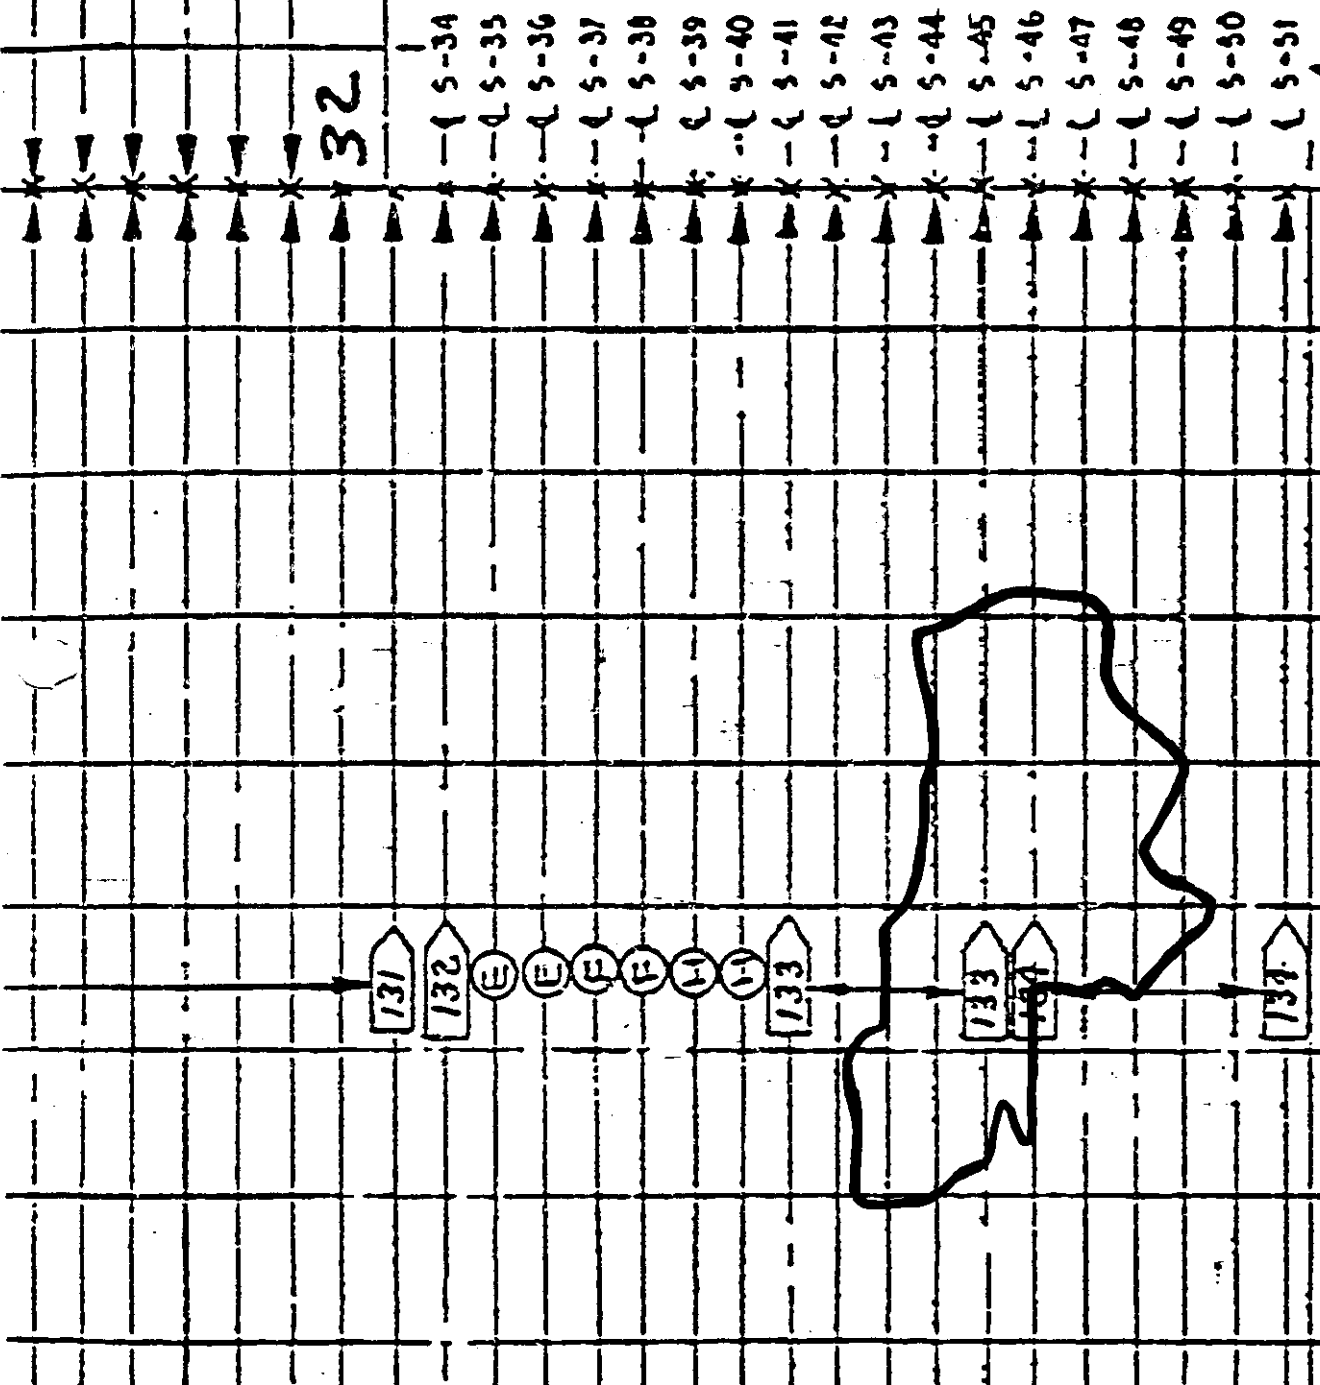
LOG# R F 66
TAG# C 2156
GREEN

- 1) THE HEAVY GAGE ALUMINUM IS CONSIDERABLY BENT ALL ACROSS THE SEGMENT.
- 2) THE AFTMOST PIECE OF THE SEGMENT IS ALMOST SEVERED FROM THE MAIN REGION WITH THE FRACTURE RUNNING FROM ABOUT STA 1593, STR S-43 1/3R TO ABOUT STA 1659, STG 46R. THIS AFT PORTION REMAINS ATTACHED BY A WIDTH OF PANEL OF ONLY 1 1/2 INCH.

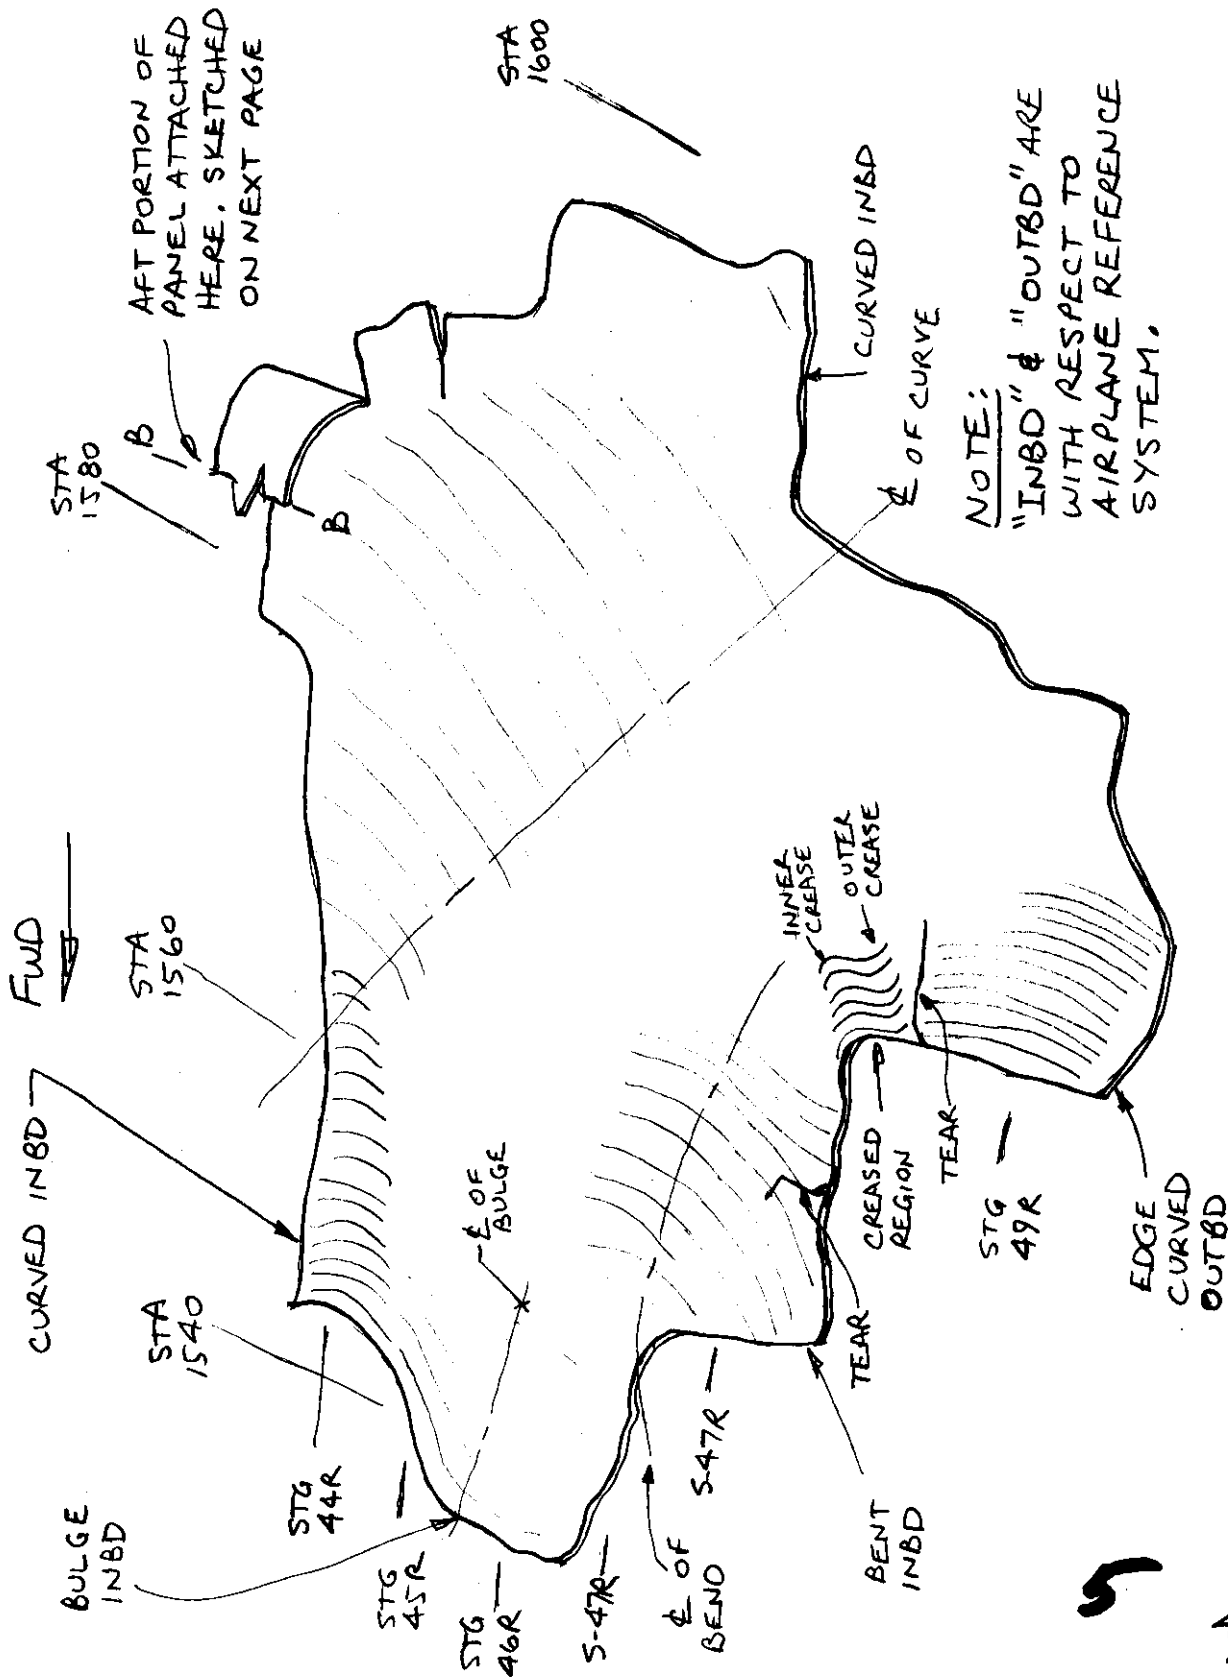
SKETCH OF SKIN BENDING

VIEW FROM INSIDE LOOKING OUT

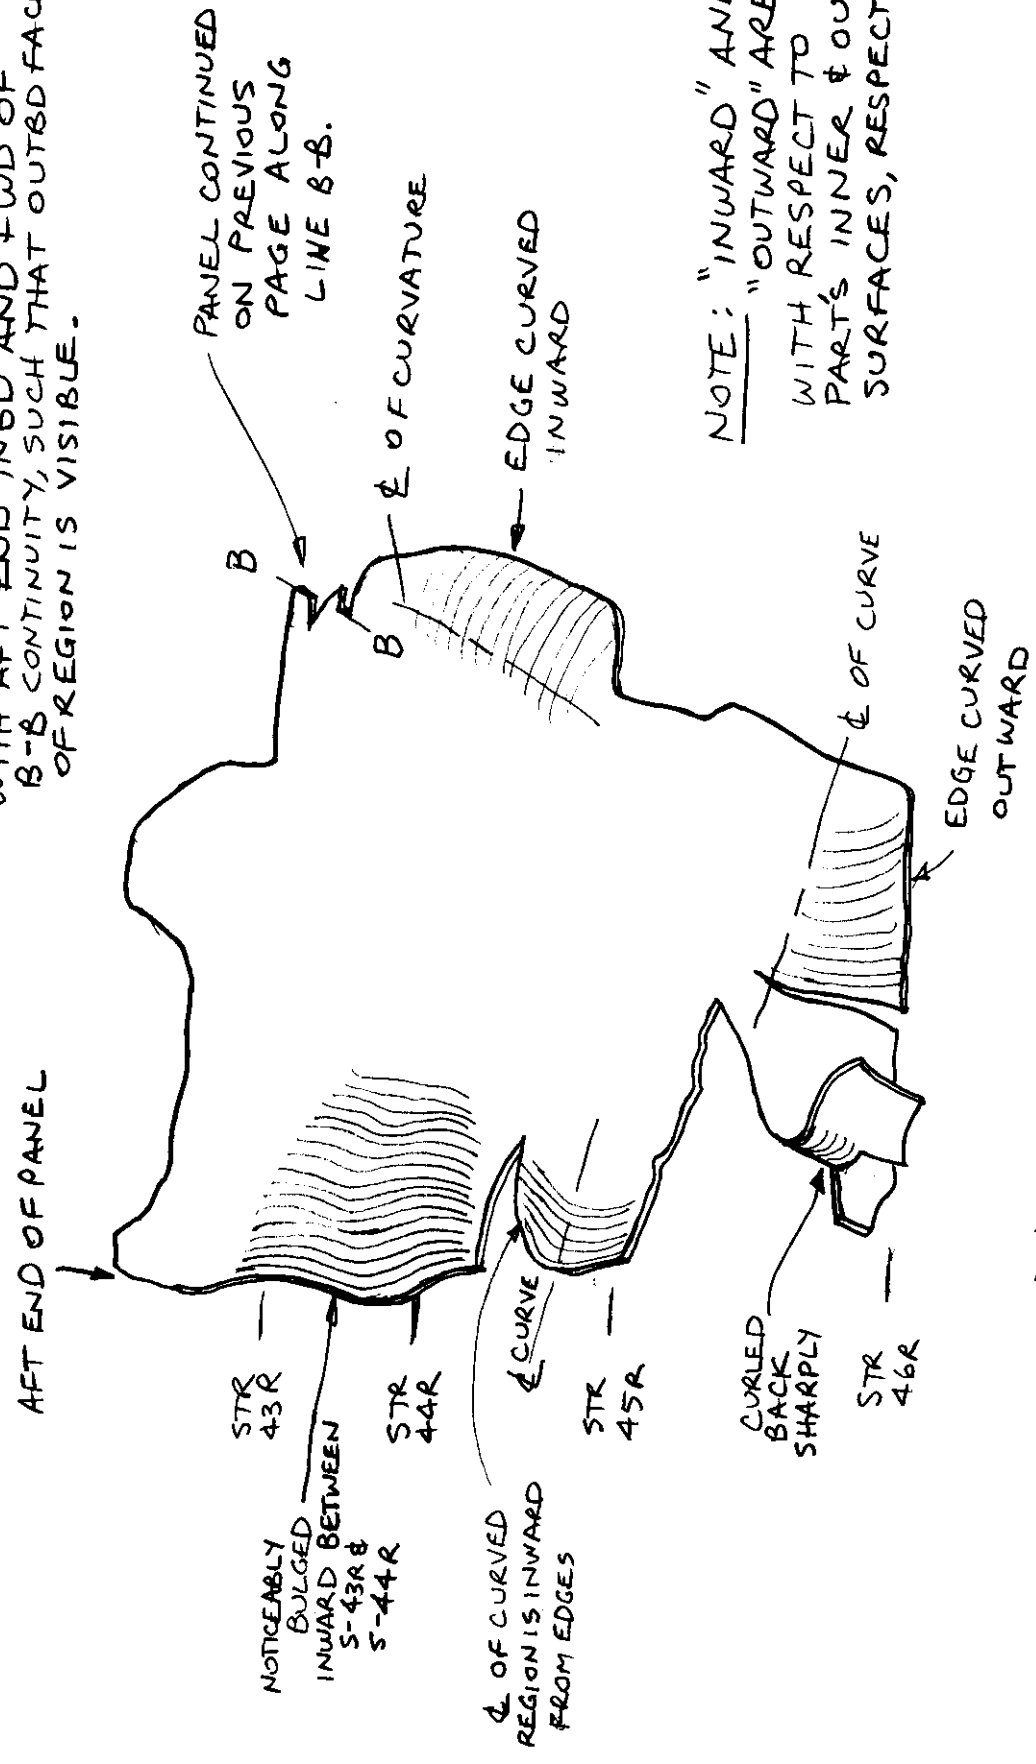
SKETCH OF SKIN BENDING (CONT.)

VIEW FROM INSIDE LOOKING OUT
REGION SHOWN HERE IS BENT ABOUT B-B
WITH AFT END INBD AND FWD OF
B-B CONTINUITY, SUCH THAT OUTSD FACE
OF REGION IS VISIBLE.
