LOG # RF 67 *RF 20219*

TAG # C 1696

RF 67  
PAGE 1

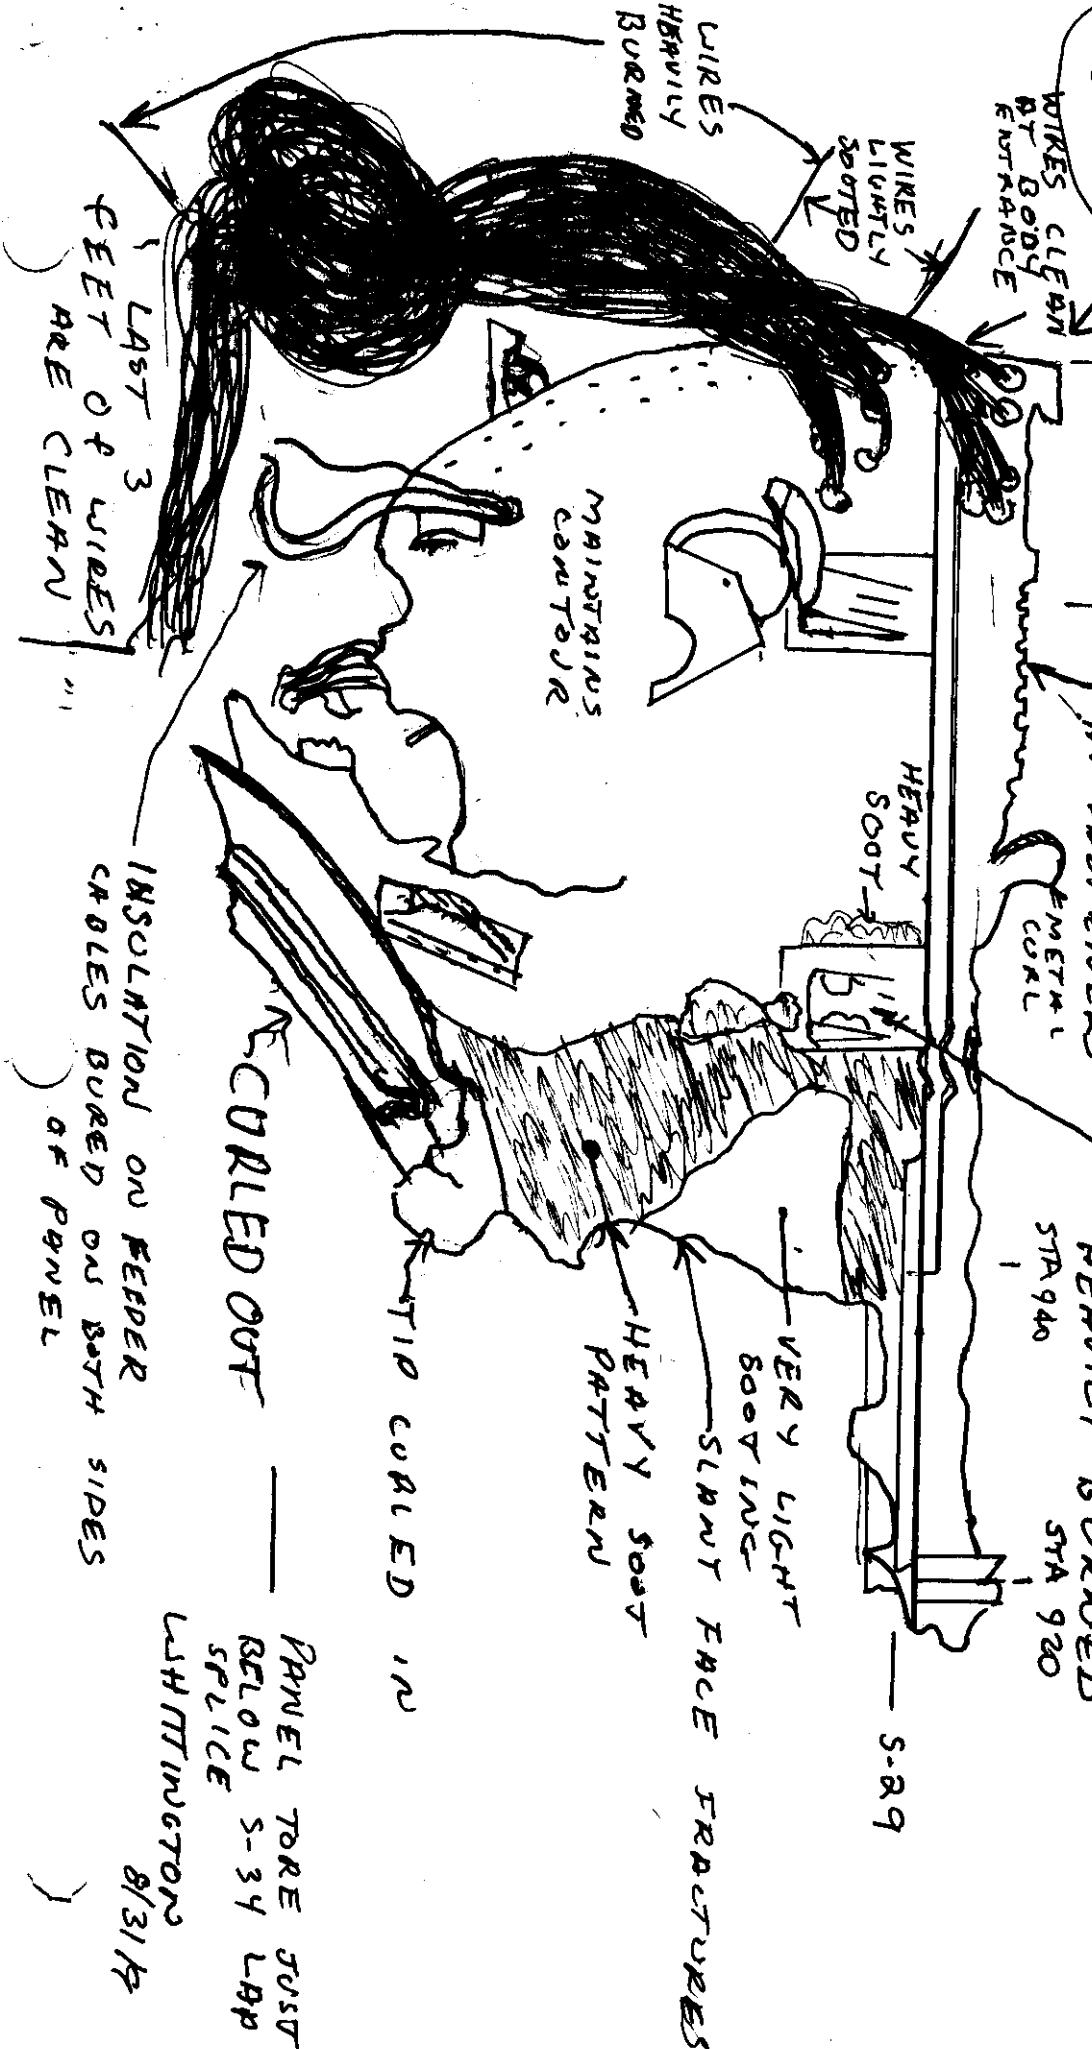
BACK OF PANEL  
VERY CLEAN

BRACKET  
HEAVILY BURNED  
STA 940

PANEL UNZIPPED  
AT FASTENERS

HEAVY  
SOOT

VERY LIGHT  
BOILING  
SLANT FACE FRACTURES

HEAVY SOOT  
PATTERN

TIP COILED IN

PANEL TORE JUST  
BELOW S-34 LAP  
SPICE  
WHITTINGTON  
8/31/73

INSULATION ON FEEDER  
CABLES BURED ON BOTH SIDES  
OF PANEL

LAST 3  
FEET OF WIRES  
ARE CLEAN

WIRES CLEAN  
AT BODY  
ENTRANCE

WIRES  
LIGHTLY  
SPOTTED

WIRES  
HEAVILY  
BURNED
