LOG # RF69 RIS 10-21-96
 TARGET # UNKNOWN
 COORD: LAT _____
 LONG _____
 DEBRIS FIELD _____

SKIN SEGMENT STA 300 TO 340,
 STG "21"R TO 26R

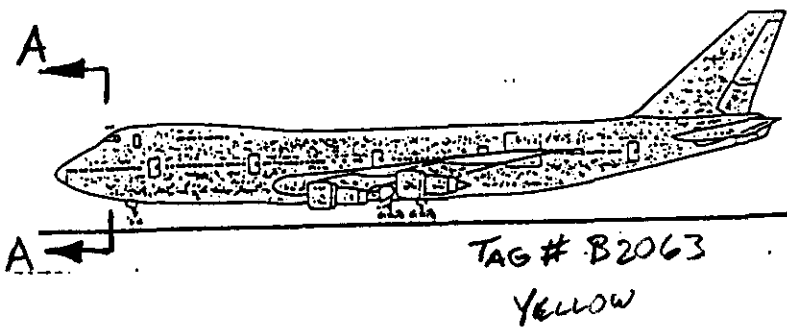
VIEW A-A

- 1) SKIN SEGMENT IS TORN AND BENT SIGNIFICANTLY. A FWD PORTION OF THE SEGMENT IS BENT AFTWARD, BACK UPON ITSELF.
- 2) THE SEGMENT INCLUDES A PORTION OF WINDOW CUTOUT REINFORCEMENT AT THE BOTTOM OF THE WINDOW BELT.

- 1) THE LEG OF STG 22R WHICH IS SANDWICHED BETWEEN THE WINDOW FORGINGS AND THE WINDOW DOUBLER REMAINS ATTACHED BETWEEN STA 300 AND 340.
- 2) STG 23R REMAINS ATTACHED FROM STA 300 TO 340, HOWEVER THE ZEE SHAPE HAS BEEN ~~FA~~ FLATTENED BACK AGAINST THE SKIN.
- 3) STG 24AR REMAINS ATTACHED FROM STA 300 TO 318. THE ZEE SHAPE HAS NOT FOLDED OVER BUT INSTEAD HAS BEEN CRUSHED OUTBOARD TO THE SKIN.
- 4) THE ATTACHMENT LEG OF STG 26R REMAINS ATTACHED TO THE SEGMENT FROM STA 300 TO 317.

- 1) CONCERNING THE WINDOW FORGING BETWEEN STA 300 AND 320, THE CENTRAL RING PORTION OF THE FORGING IS MISSING, LEAVING ONLY THE ATTACHMENT FLANGE BOLTED TO THE SKIN.
- 2) THE WINDOW FORGING BETWEEN STA 320 AND 340 HAS ITS CENTRAL RING PARTIALLY SEVERED. THE RING REMAINS ATTACHED FROM THE 9 O'CLOCK POSITION DOWN TO THE 7 O'CLOCK POSITION ONLY (LOOKING FROM INSIDE, OUTWARD).
- 3) THERE APPEARS TO BE NO SOOTING OF THE SEGMENT.
- 4) THE FRACTURE SURFACES APPEAR TO BE DUCTILE FAILURE.

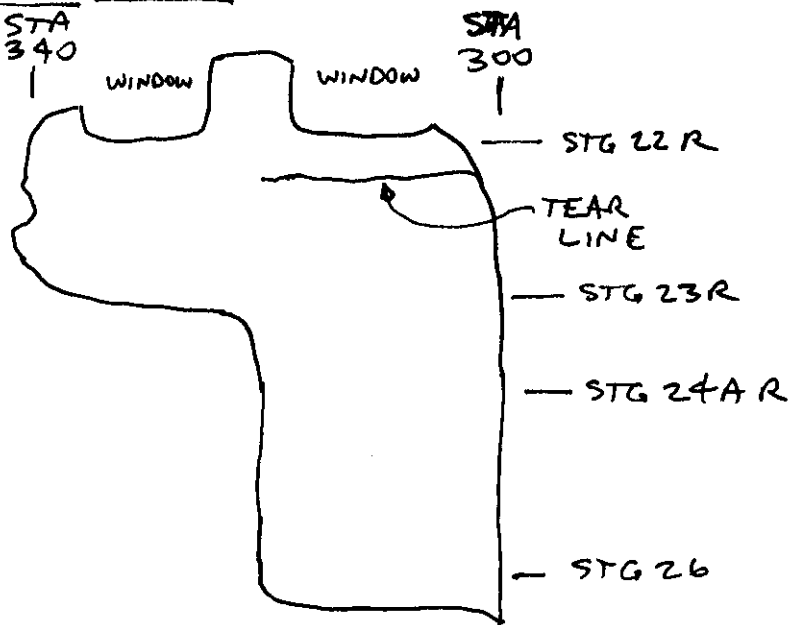
ORIGINAL SHAPE :

THE DEFORMED SHAPE OF THE SEGMENT IS SHOWN SIMPLISTICALLY BELOW:
