LOG # RF 7 ^{SDG} ^{PTS} ₉₋₃₀₋₉₆

TARGET # 2

DEBRIS FIELD RED A033
(near field #3)

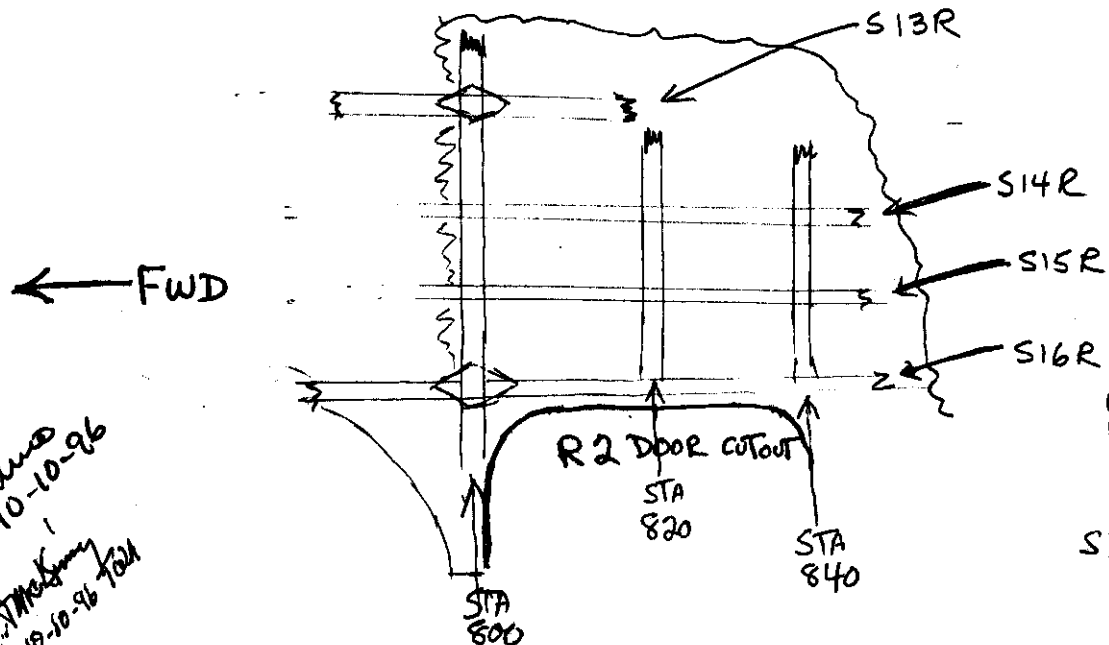
This section of RIGHT FUSELAGE SKIN AND FRAMES (which includes top of R2 DOOR CUTOUT) ENCOMPASSES STATIONS 800 TO 840, AND STRINGERS S13R TO S16R WITH AN AREA 6' X 5'.

FUSELAGE SKIN ~~SHEARED~~ ^{FRACTURED} AND JAGGERED ALONG TOP STRINGER S13R FROM STA 800 AND BEYOND STA 840 AND CONTINUES DIAGONALLY DOWN AND AFT TO S16R

STRINGERS S13R FRACTURED AND MISSING APT OF STATION 820 AND PROTRUDES FWD OF STA 800 APPROX 1'

- STATION 800 FRACTURED AND MISSING ABOVE S13R
- STATION 820 " " " ABOVE S14R
- STATION 840 " " " " S14R

NO EVIDENCE OF FIRE OR SMOKE DAMAGE

- INTERCOSTAL
1) THE ~~ADDITIONAL SUPPORT~~ ATTACHED TO
S15R AND FRAME 820+840 IS
BROKEN AWAY FROM 820+840 AND
BENT TOWARDS TOP OF AIRCRAFT COMING
TO REST AT A 45° ANGLE RELATIVE TO THE
OUTER SKIN.
