LOG # RF 74 AS 10/24/96
 TAG # C1668
 COORD: LAT _____
 LONG _____

DEBRIS FIELD GREEN

RF 74

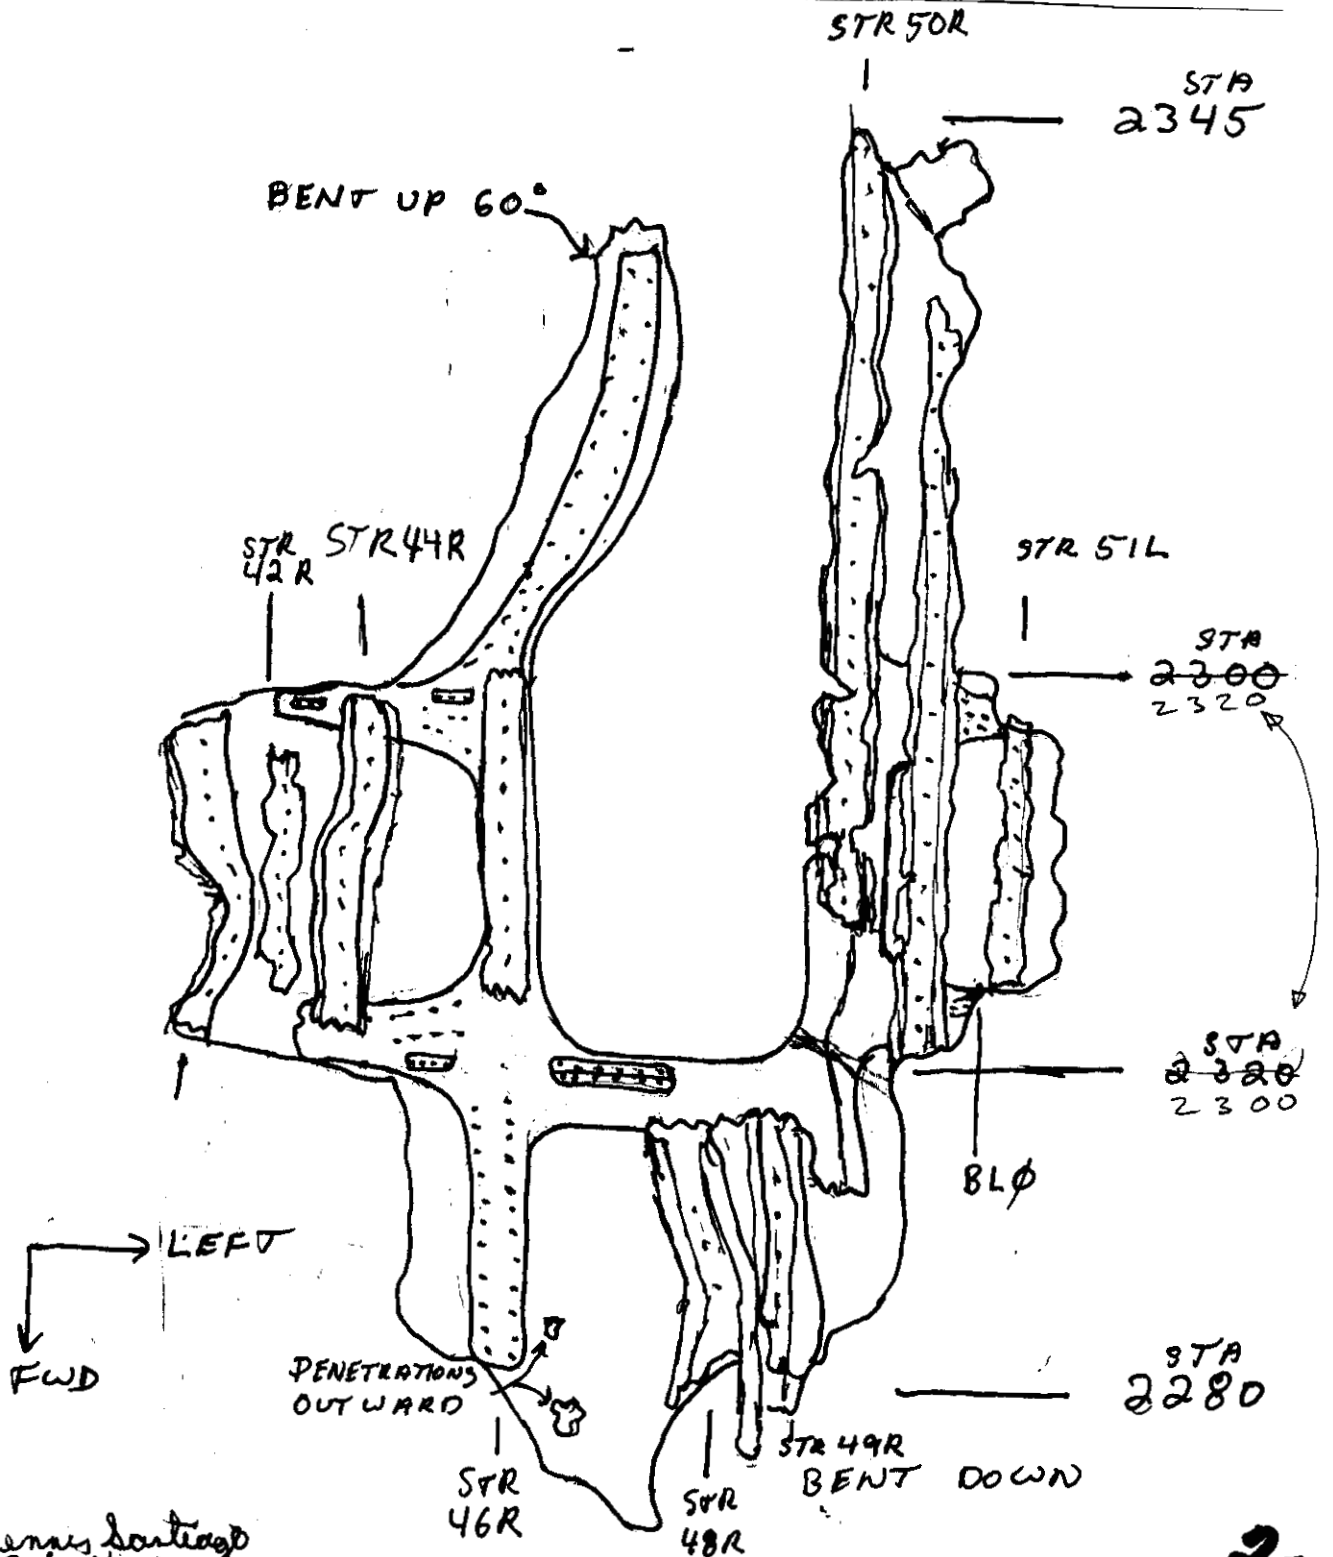
SKIN PANEL FROM STA 2280 TO STA 2345 BETWEEN STRINGERS 41R AND 51L. PANEL IS HEAVILY DAMAGED BY INWARD PRESSURE AND IS BENT DOWN AROUND THE EDGES. THE STRINGERS ARE FLATTENED AGAINST THE PANEL. NO FRAMES ARE ATTACHED AND MOST SHEAR TIES REMAIN ON PANEL, SKIN AND STRINGERS DIRECTLY BEHIND CUTOUT ARE MISSING. NO EVIDENCE OF FATIGUE. NO SMOKE OR FIRE DAMAGE.
