LOG # RF75

TARGET # C2082 GREEN

SEGMENT OF WINDOW BELT,
STA 1847 TO 1877, S-20R TO S-23R

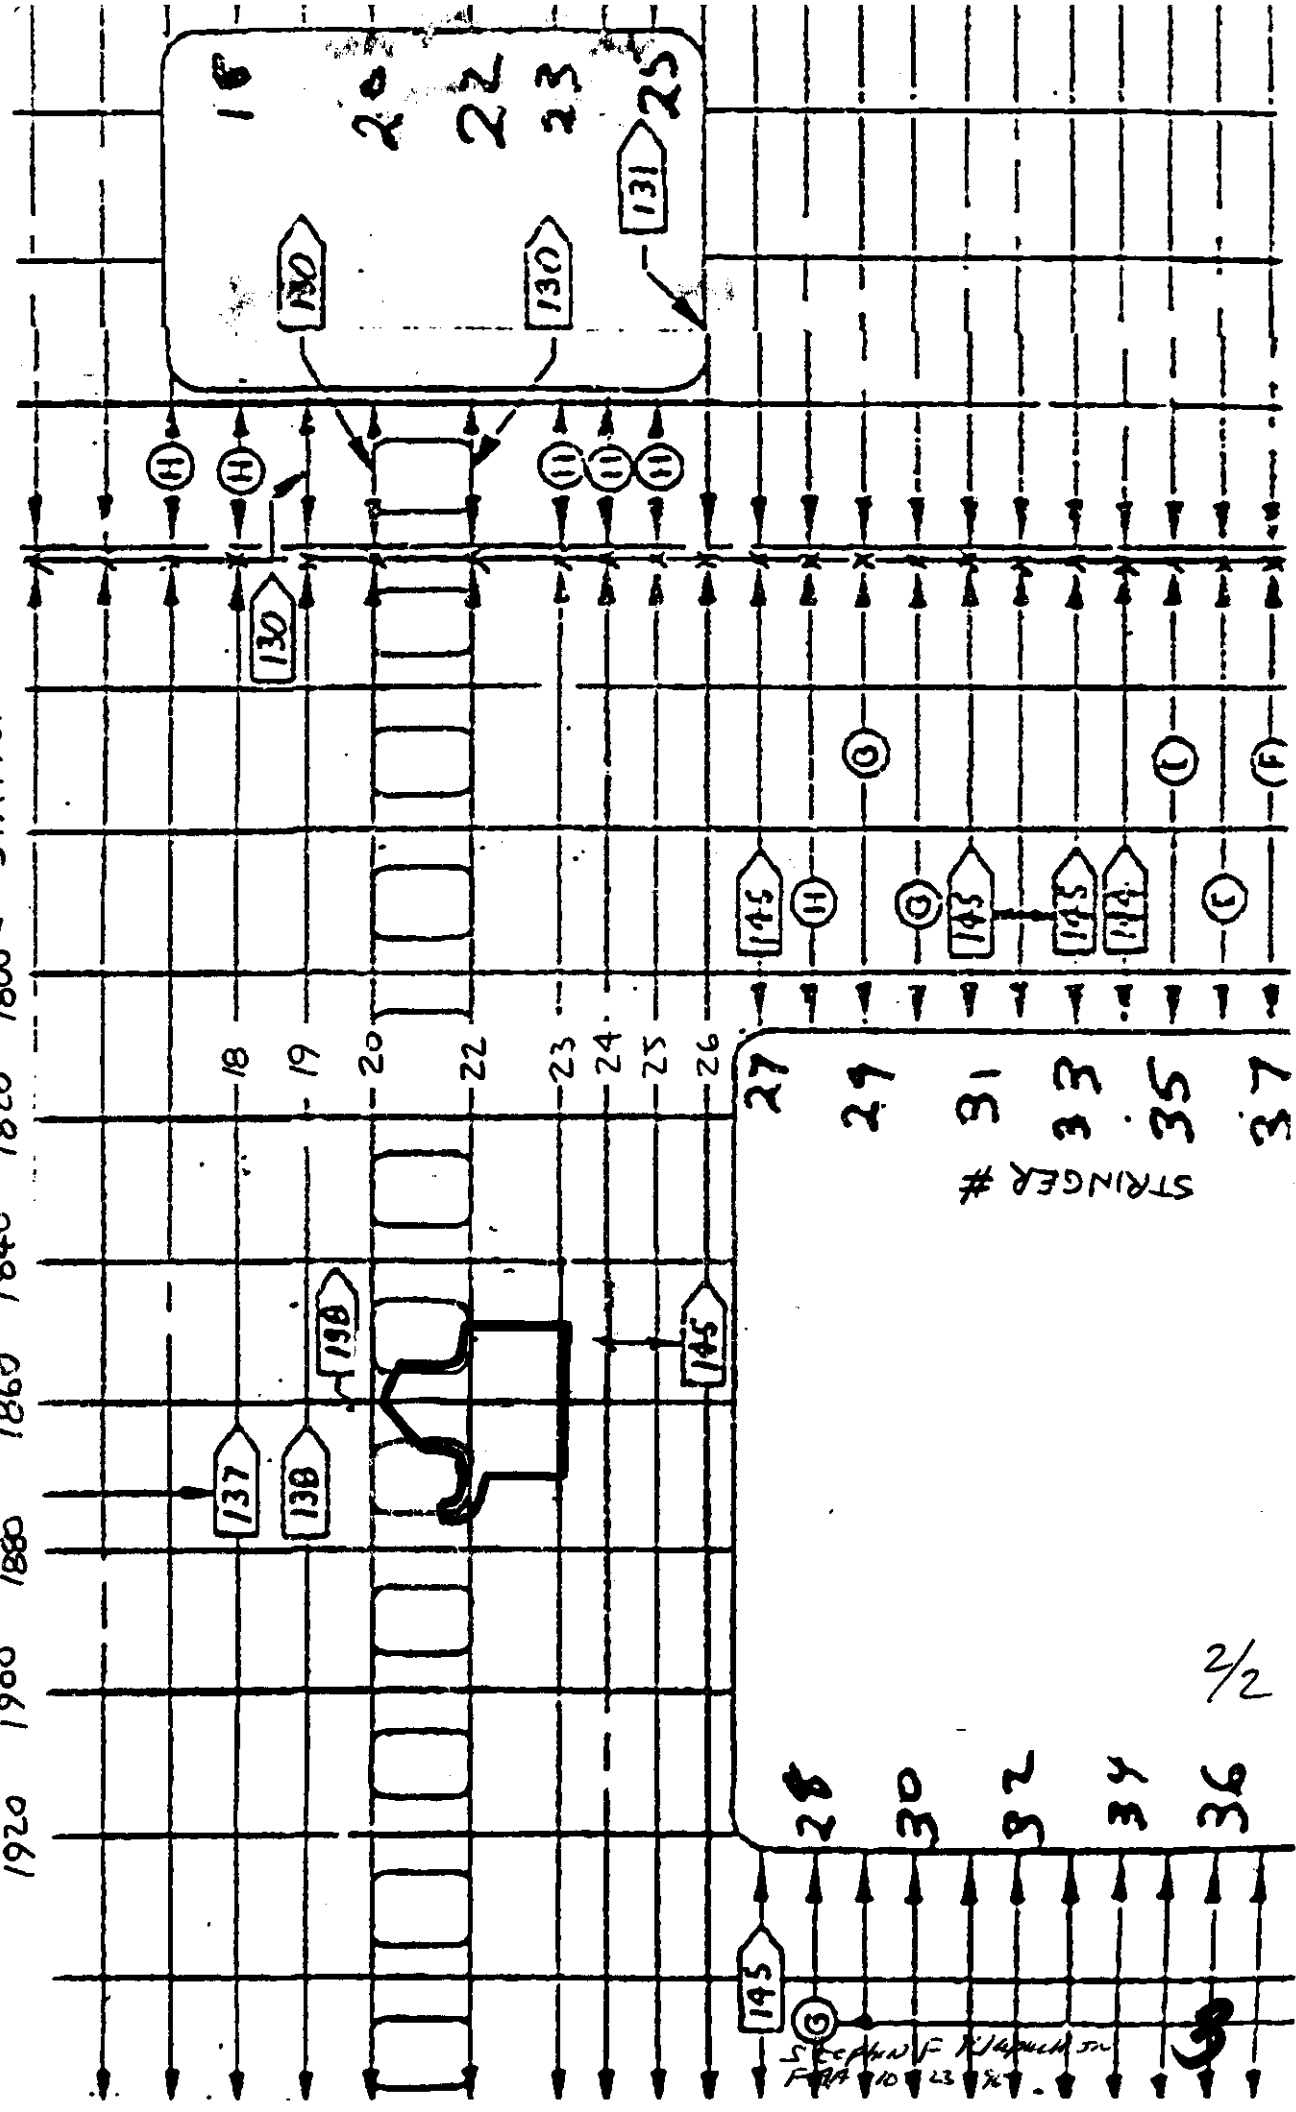
VIEW A-A

- 1) THE FORWARD WINDOW FORGING IS COMPRISED OF A PORTION FROM 2 O'CLOCK TO 7 O'CLOCK (FROM INSIDE LOOKING OUT). IN ADDITION, IT IS BROKEN AT THE 3 TO 4 O'CLOCK POSITION.
- 2) THE AFT WINDOW FORGING IS COMPRISED OF A PORTION FROM 4 O'CLOCK TO 10 O'CLOCK (INSIDE LOOKING OUT). IN ADDITION, IT IS BROKEN AT THE 8 TO 9 O'CLOCK POSITION.

- 1) S-22R REMAINS ATTACHED FROM STA 1848 TO STA 1871.

- 1) SKIN TO FRAME SHEAR TIES REMAIN ATTACHED TO THE SKIN AT STA 1860 BETWEEN S-20R TO S-22R AND BETWEEN S-22R AND S-23R. THE LEG WHICH ATTACHES TO THE FRAME FOR EACH SHEAR TIE IS MISSING.
- 2) THE WINDOW BELT DOUBLER IS DISBONDED FROM THE SKIN ALONG ITS LOWER EDGE.
- 3) THERE IS NO APPARENT SOOTING OF THE PART
- 4) FRACTURE SURFACES APPEAR TO BE DUCTILE FAILURE.
