LOG # RFB 506  
TARGET # \_\_\_\_\_  
COORD: LAT \_\_\_\_\_  
LONG \_\_\_\_\_

DEBRIS FIELD #2  
yellow (middle)

RHS Fwd upper section 41 skin Assy's.

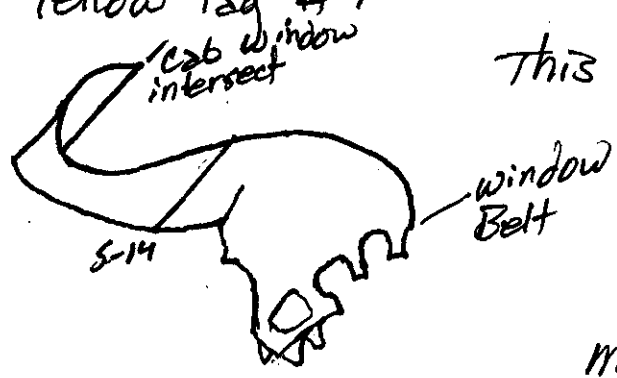
This panel is very curved. No frames remain attached and there are no stringers above 5-17. Fastener holes are mainly open and appear to have failed with rivet tension (skin puckers inbd).

Stringers that do remain are bent but not flattened.

Bent similar to ①. Again, no frames remain on panel. The ~~att~~ upper end of the panel curled outbd 360°. All holes aft of STA 260 are open, all holes fwd of STA 260 are filled. Most stringer segments fwd of 260 remain.

forward. The fwd window belt area is also bent inbd. The STA 134 ring and STA 140 B/khd are detached. Almost all stringers remain. The STA 160 frame is attached for 3 bays above the window belt, STA 180 frame is attached for 6 bays, and STA 200 attached for 12 bays. The STA 220 frame is gone.

✓ (D) Yellow Tag # B068  
This small piece is very twisted and deformed. The stringers are flattened and there are no frames.

✓ (E) Yellow Tag # B268  
Panel is twisted and ripped. All internal structure is flattened.

✓ (F) Yellow Tag # B248  
Panel is curled similar to adjacent panel (A)

No panels show any obvious signs of smoke or fire damage.

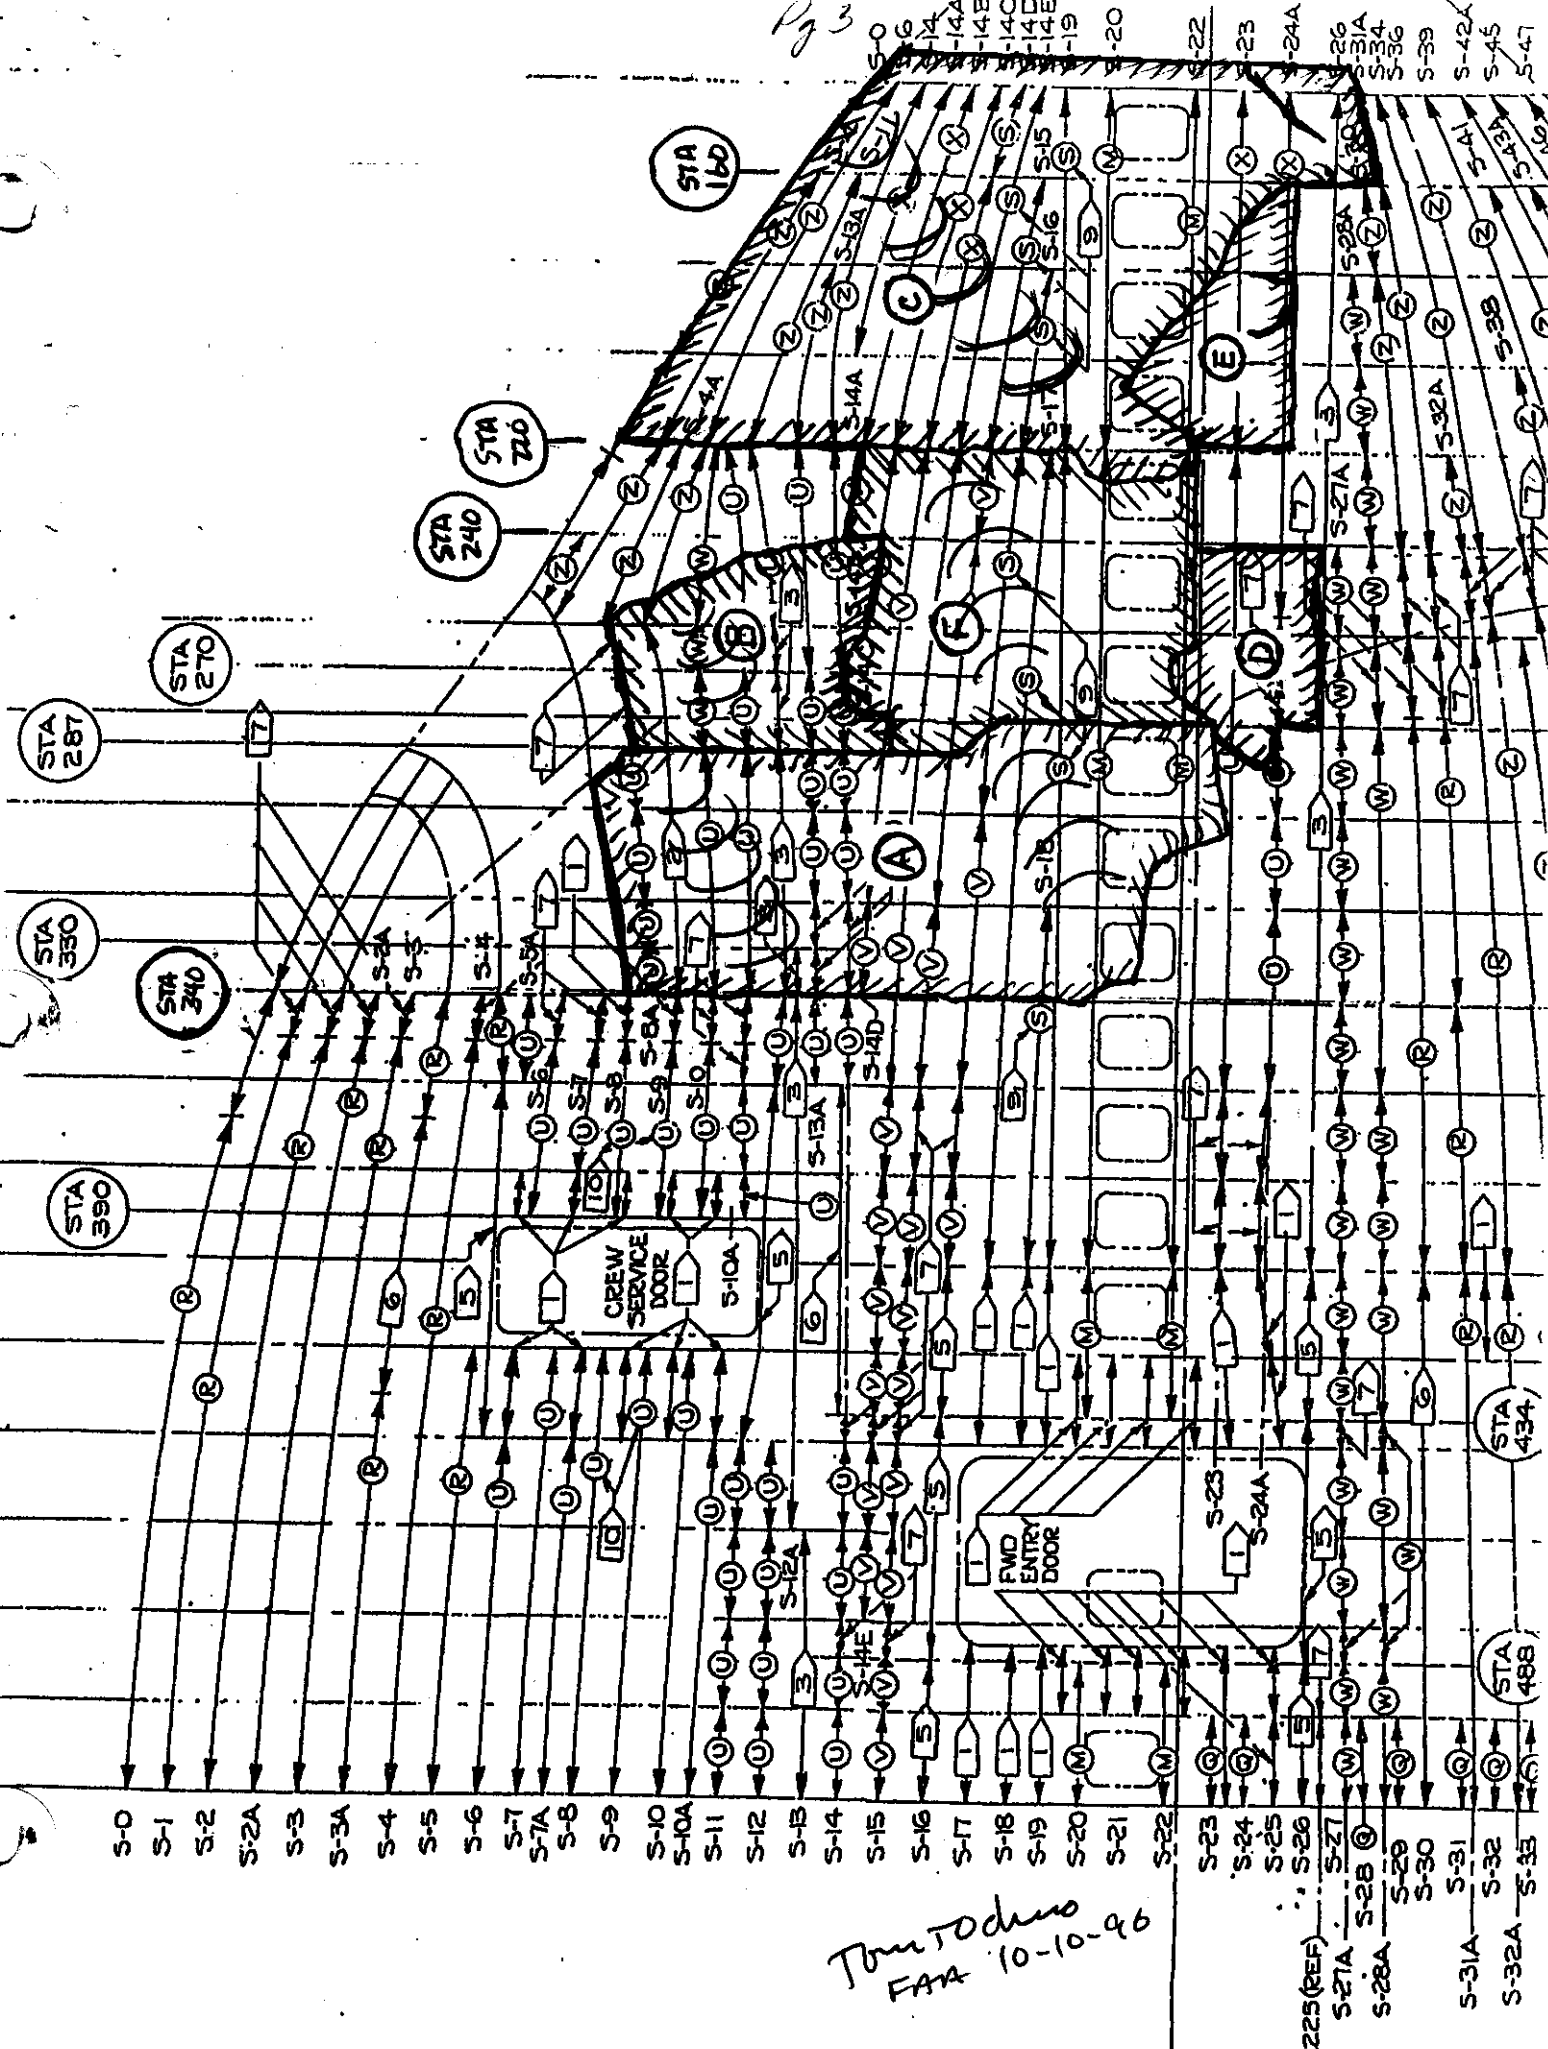
1) RES A STATEMENT "... APPEAR TO HAVE FAILED WITH RIVET TENSION," IS ANALYSIS, PREFER TO INDICATE SKIN IS DEFORMED INWARD AROUND RIVET HEADS. (OR SOMETHING TO THAT EFFECT.)
