LOG # RF9 ^{RTS A-C} ₉₋₂₀₋₉₆

DEBRIS FIELD _____ Pg 14B

This Report contains:

RF9A
RF9B
RF9C

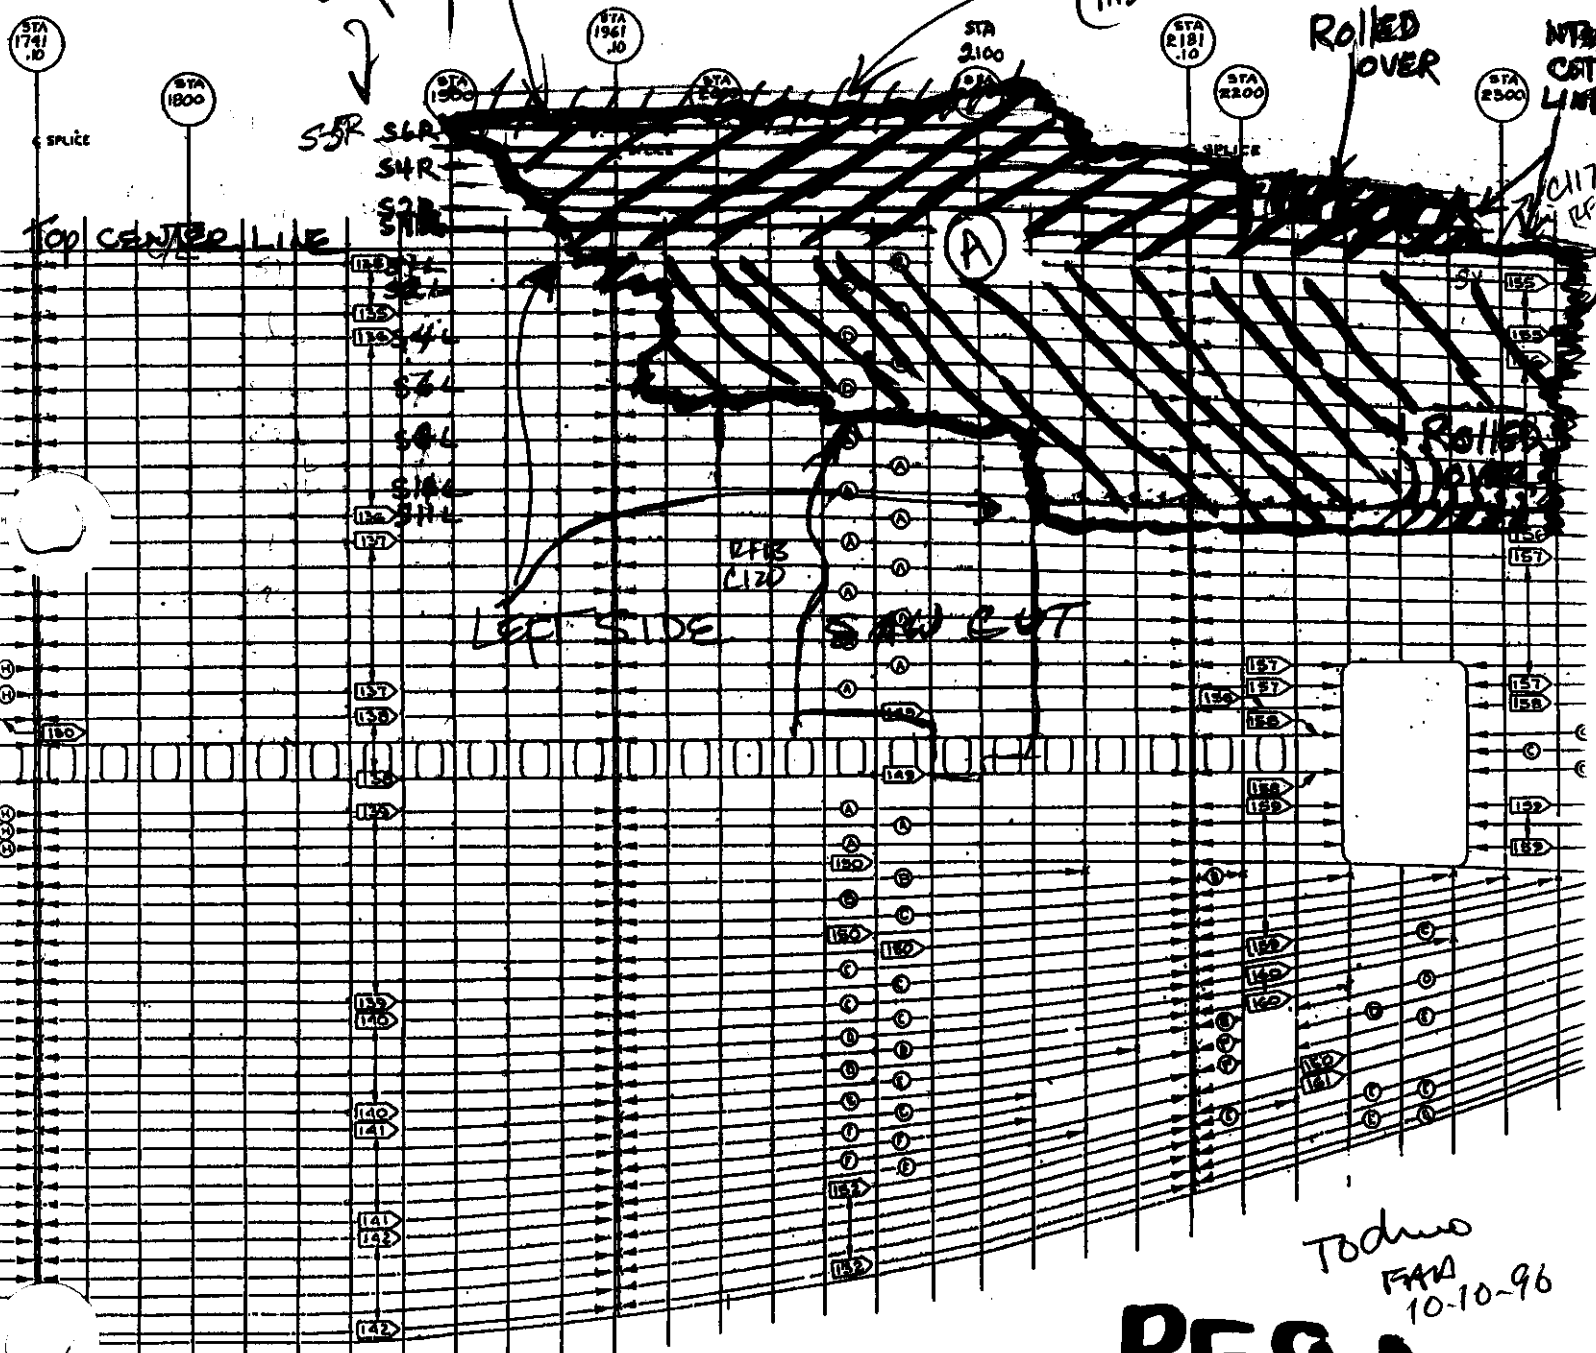
RF9A

- ① LOG # RF9 (A) CONTAINS FUSELAGE SKIN AND STRUCTURE APPROX 35' X 11.5'.
- ② ENCOMPASSES STATION 1900 THROUGH 2320, STRINGERS LEFT SIDE S10L THROUGH S1L, CONTINUING OVER THE TOP OF THE FUSELAGE RIGHT SIDE, S1R THROUGH S6R.
- ③ FRAMES FRACTURED, MISSING, NO EVIDENCE OF TWISTING FORE AND AFT. NO EVIDENCE OF FIRE.

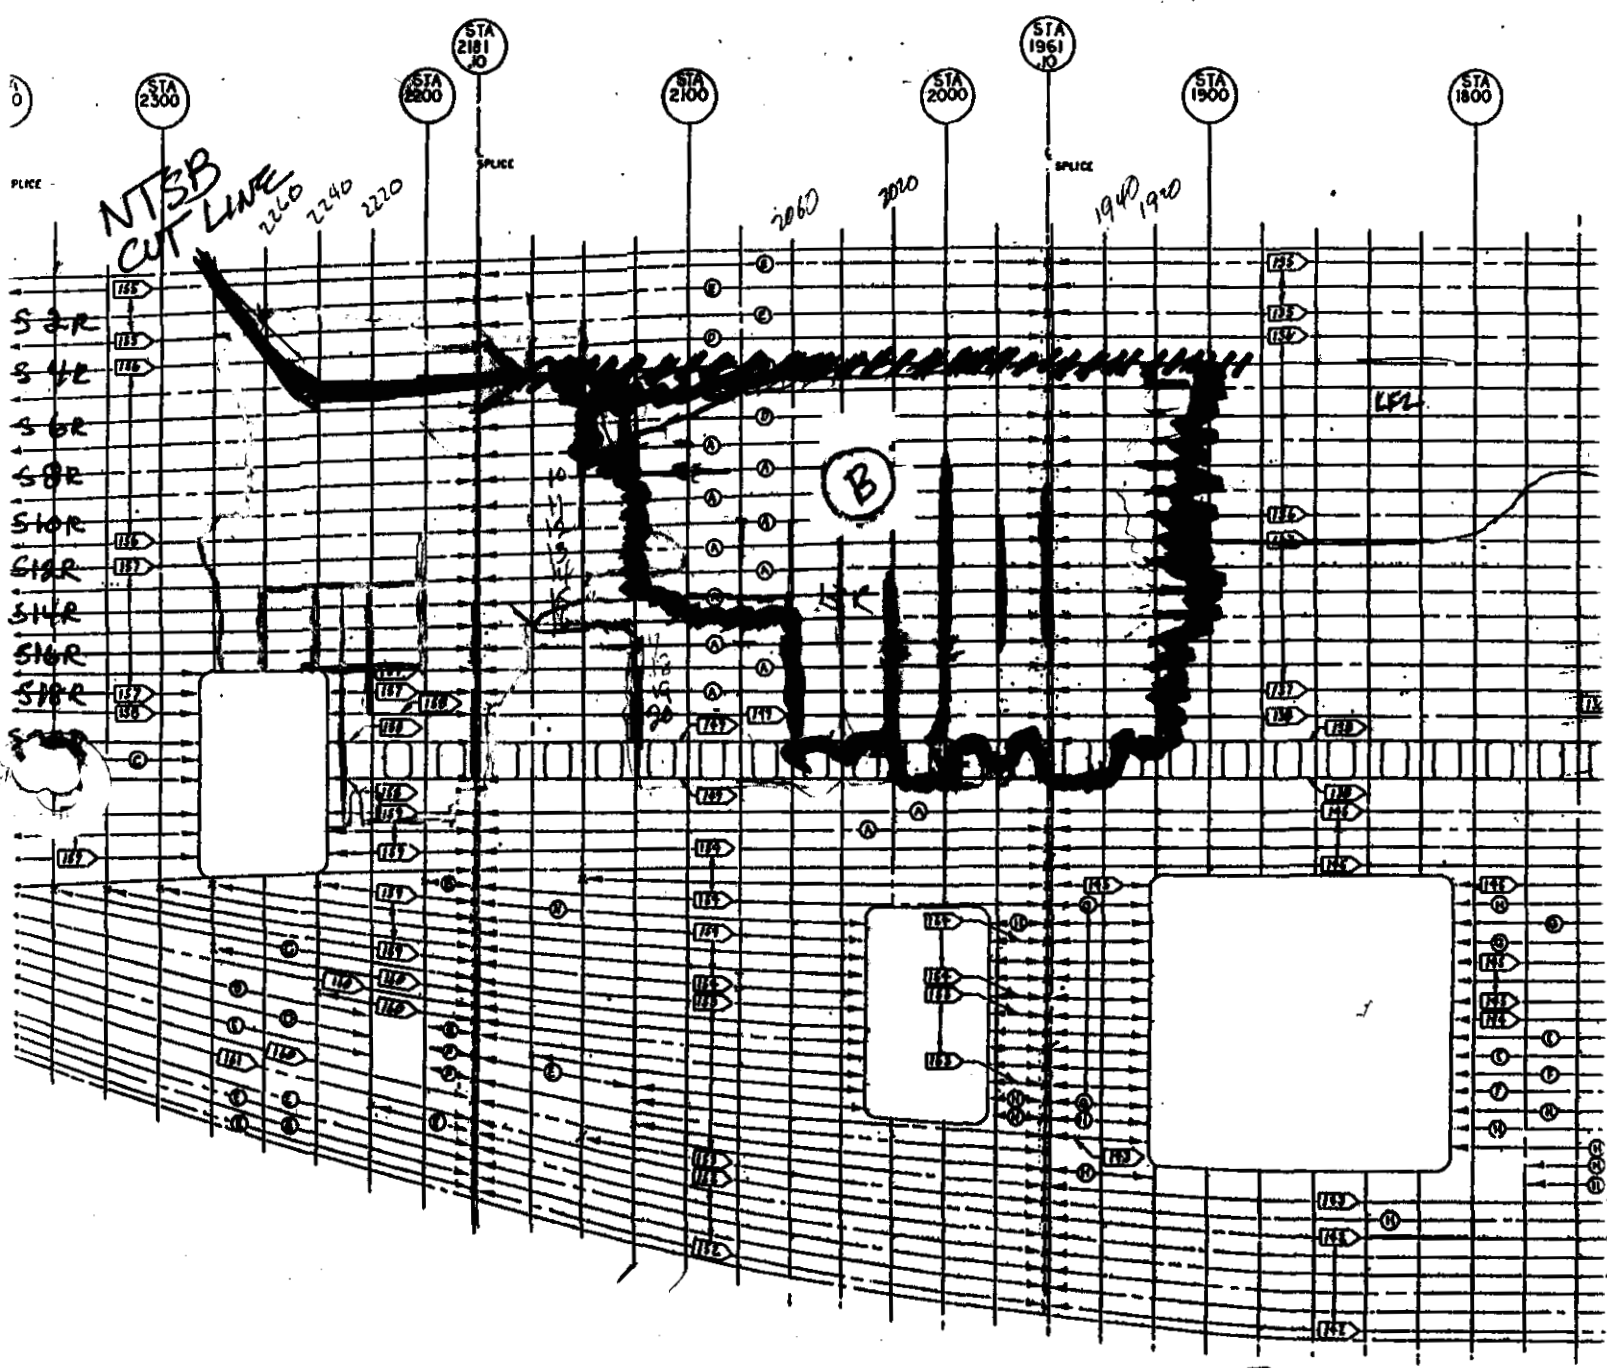
R9(B)

RIGHT
 THIS SECTION OF FUSELAGE MEASURES APPROXIMATELY 20' X 15', AND ENCOMPASSES STA. 1900 THRU STA. 2140, AND FUSELAGE SKIN FROM MAIN DECK PAX WINDOWS UPWARDS TO NTSB CUT LINE, (STRINGERS S22R TO S6R.)

WITH THE EXCEPTION OF THE NTSB CUT LINE (WHICH SEPARATED LOG # RF9; INTO RF9A + RF9B, WHICH WAS NECESSARY DUE TO ITS ORIGINAL HIGH SIZE), THE REMAINING FUSELAGE SKIN IS FRACTURED SHEARED AND JAGGERED AND CONTAINS PORTIONS OF MAIN CABIN PAX WINDOWS.

MANY OF THE ^{omit. str. b/w 10/9/96} STRINGERS AND FRAMES ARE MISSING, AND THE FEW REMAINING MEMBERS ARE FRACTURED AND BENT APT. AND TOM TODDING FAA-10-10-96

THE FUSELAGE SKIN AND STRUCTURE SHOWS NO EVIDENCE OF SMOKE OR FIRE DAMAGE

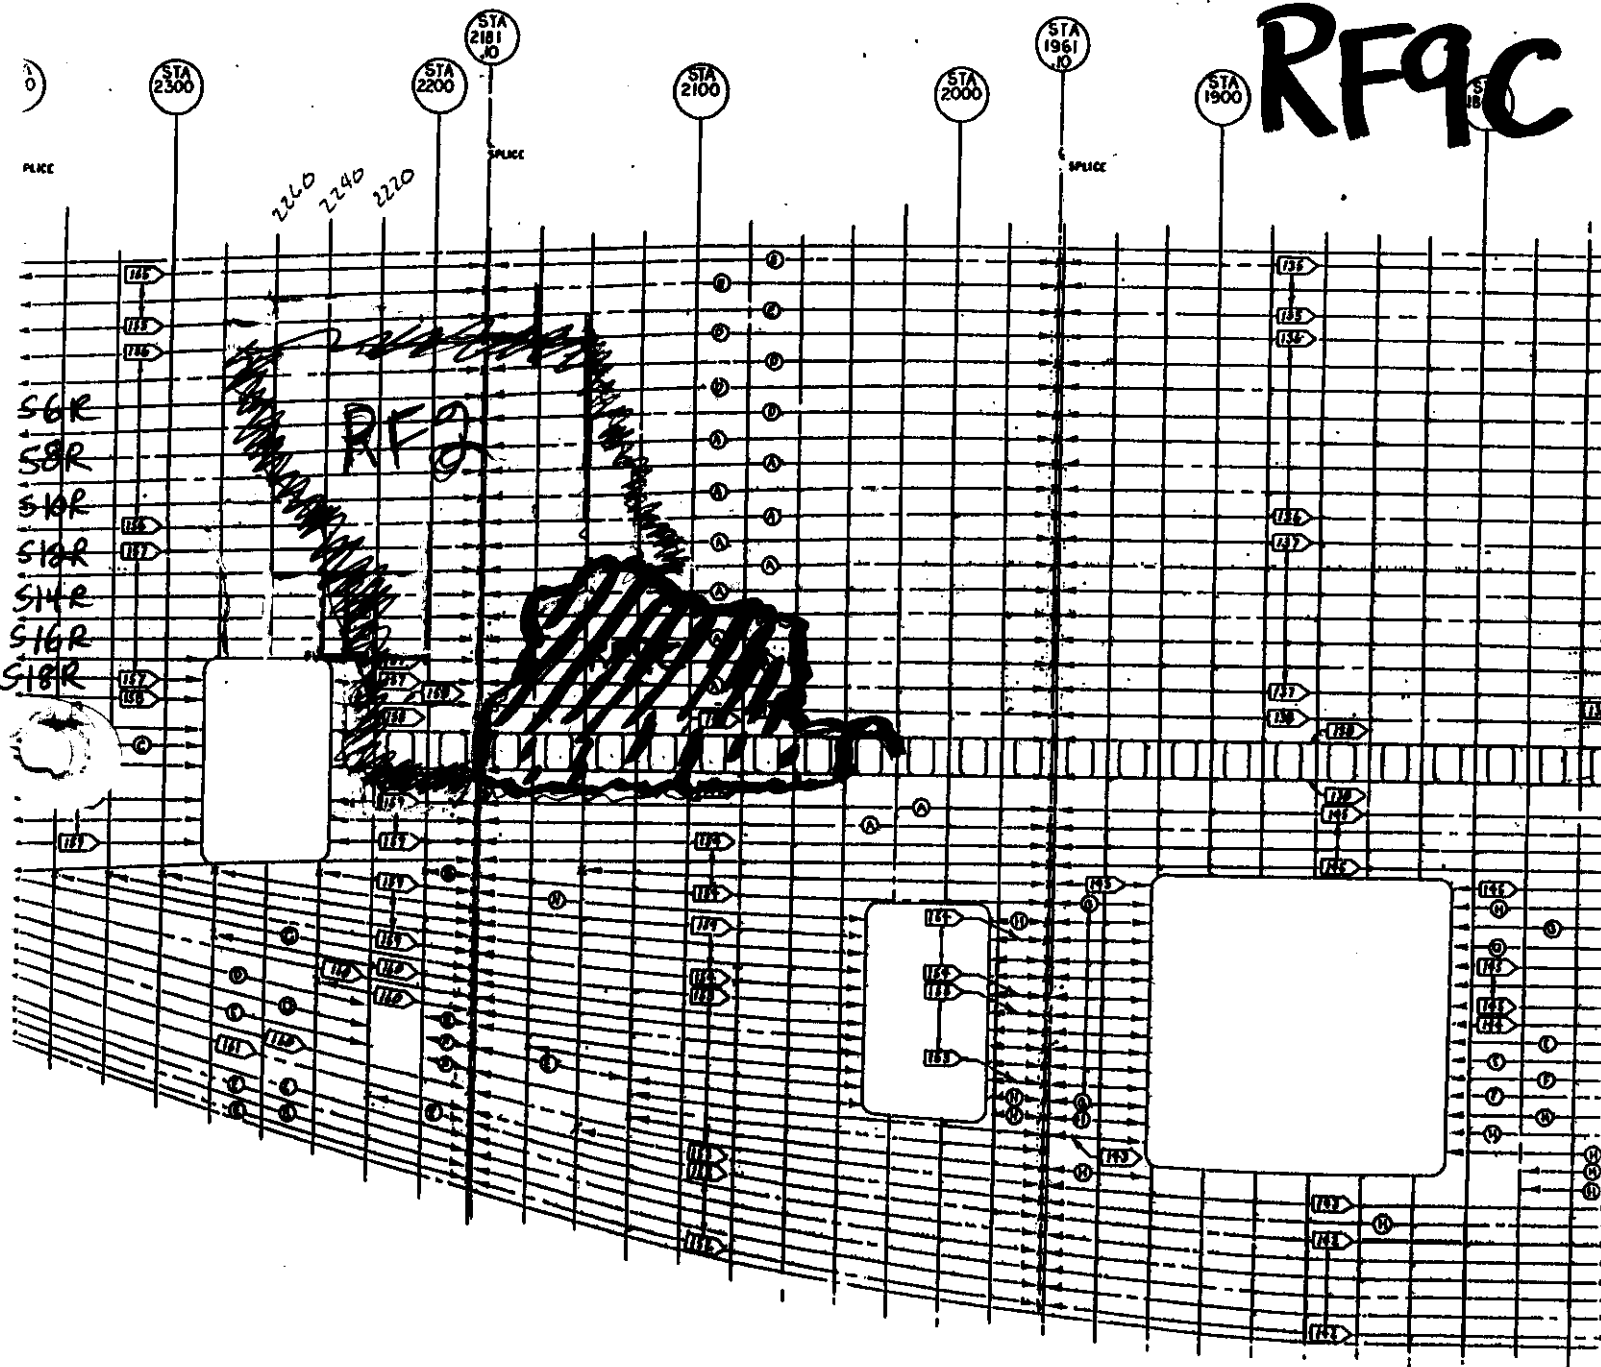
RFQC

THIS SECTION OF RIGHT FUSELAGE MEASURES APPROX 10' X 7' AND ENCOMPASSES STA 2060 THRU 2180 AND STRINGERS S18R THRU S13R THRU S22R.

ALL FRAMES MISSING (EXCEPT SMALL FRACTURED PORTION OF FRAME BETWEEN S18R + S16R. EDGES OF FUSELAGE SKIN FRACTURED SHEARED AND JAGGERED. ALL STRINGER RUPTURED BETWEEN STA 2080 + 2100 NO EVIDENCE OF SMOKE OR FIRE DAMAGE. SECTION HAS 7 PAX WINDOWS

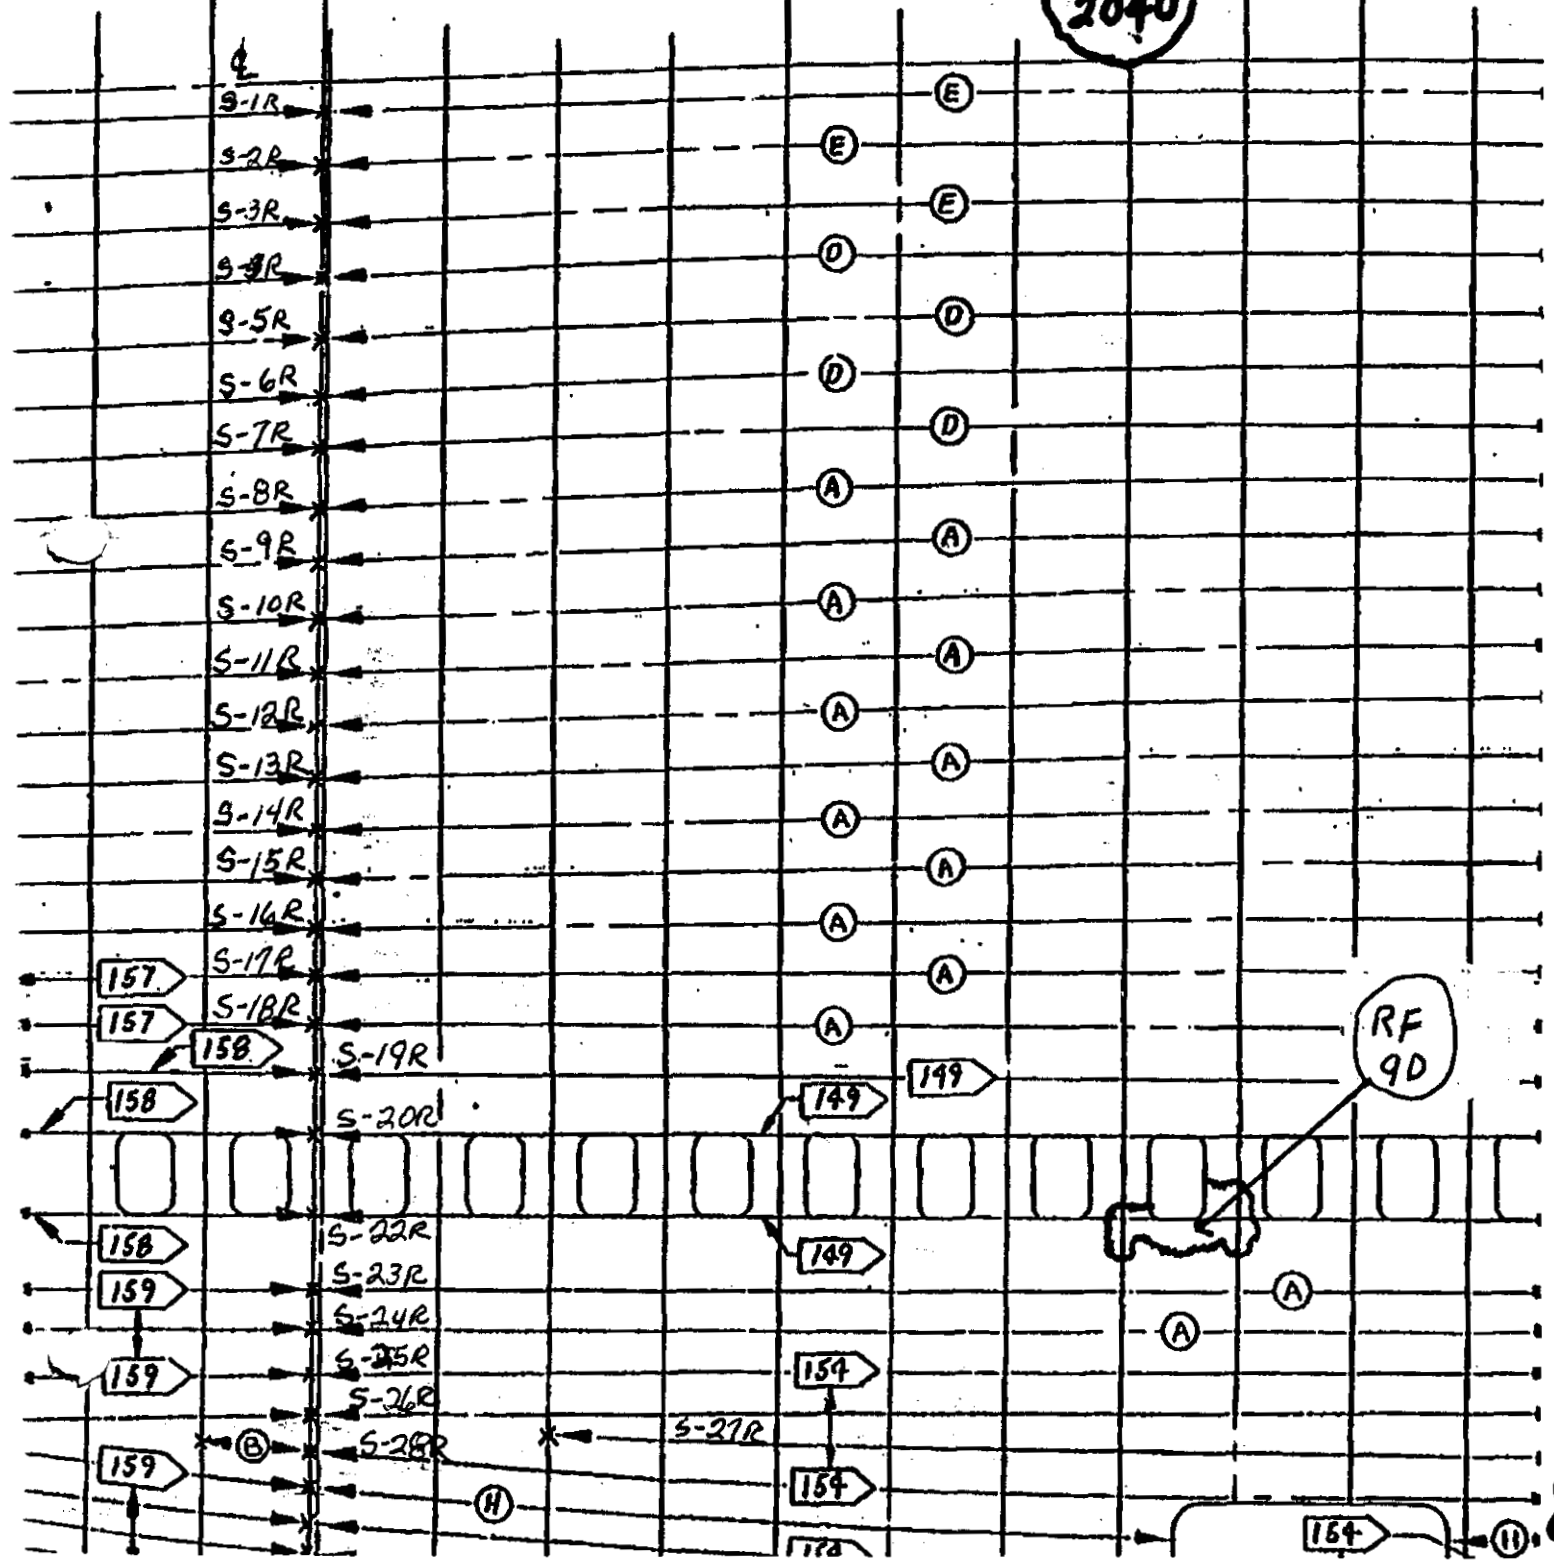
RF 9D
 C1697

FRAGMENT OF SKIN, LWR. WINDOW BELT.
FS 2018-2040. 10" X 24" LOWER 1/3 OF
WINDOW FRAME. RF9D PART MATCHES
RF9B & RF9C. WINDOW FRAME AND SKIN
FRACTURES, SOME DIS BONDING BETWEEN
FUS. SKIN AND WINDOW DOUBLER AT FWD
LOWER CORNER.
