# RIGHT WING RW-24

LOG # RW-24  
 TARGET # \_\_\_\_\_  
 10/07-5 (10/7/96)

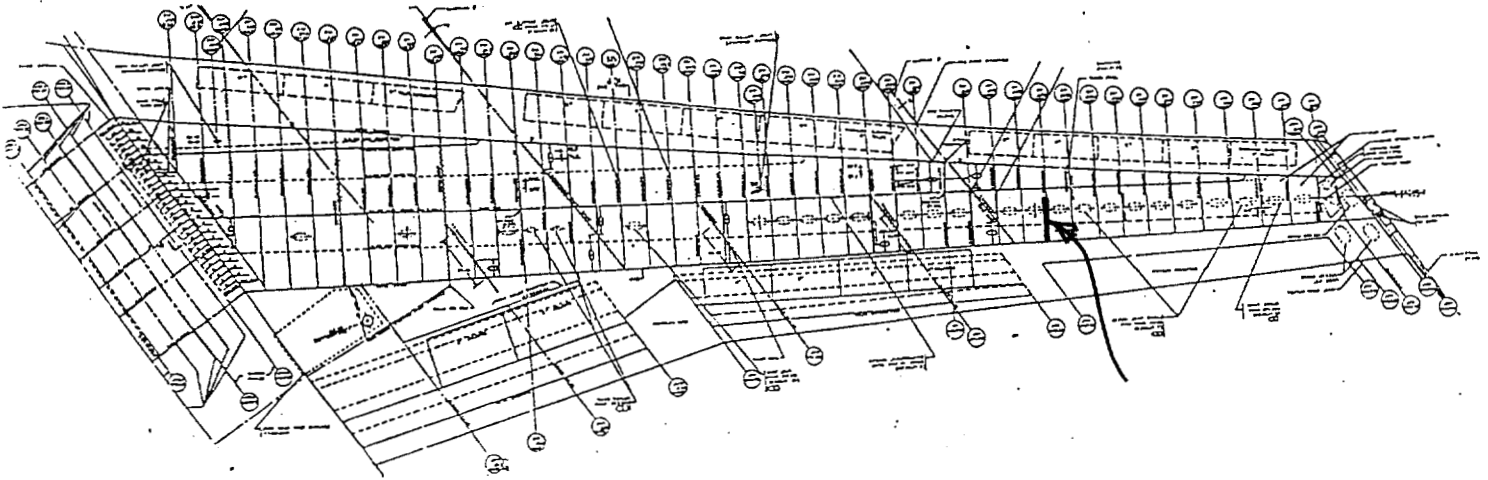
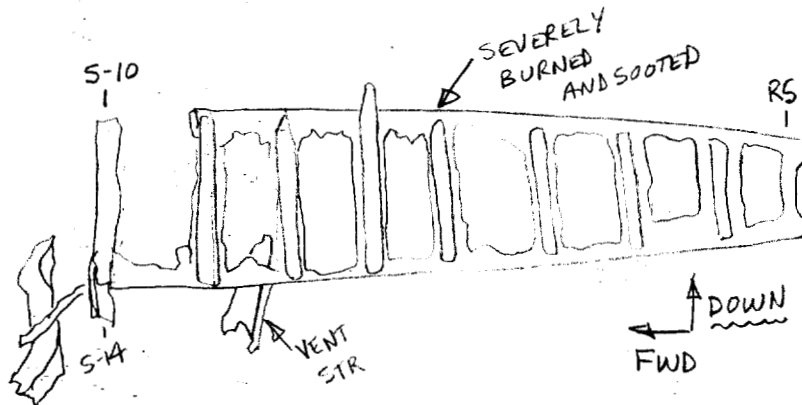
RIGHT HAND WING STATION 1252 RIB. FRACTURED AT STR-14 UPPER AND STR-10 LWR. FWD SECTION MISSING. SEGMENTS OF STR-14 UPR AND VENT STRINGER (LOC STR 12) STILL ATTACHED. (NOTE: THESE STRINGERS MATE WITH FRACTURE FACES ON CORRESPONDING STRINGERS ON PANEL RW-1 JUST OUTBD OF THIS RIB) (ALSO NOTE THAT THESE SEGMENTS ARE SOOTED EVEN ON FRACTURE FACES, WHILE MATING PIECES ON RW-1 ARE CLEAN) WEB IS BURNED THRU ALL BAYS BETWEEN RIB STIFFENERS.
