RW-3

C-185 GREEN TAG

LOWER SURFACE RIGHT WING SKIN PANEL, EXTENDING FROM
RBL 75 IN THE CENTER TANK TO JUST PAST ENGINE #4

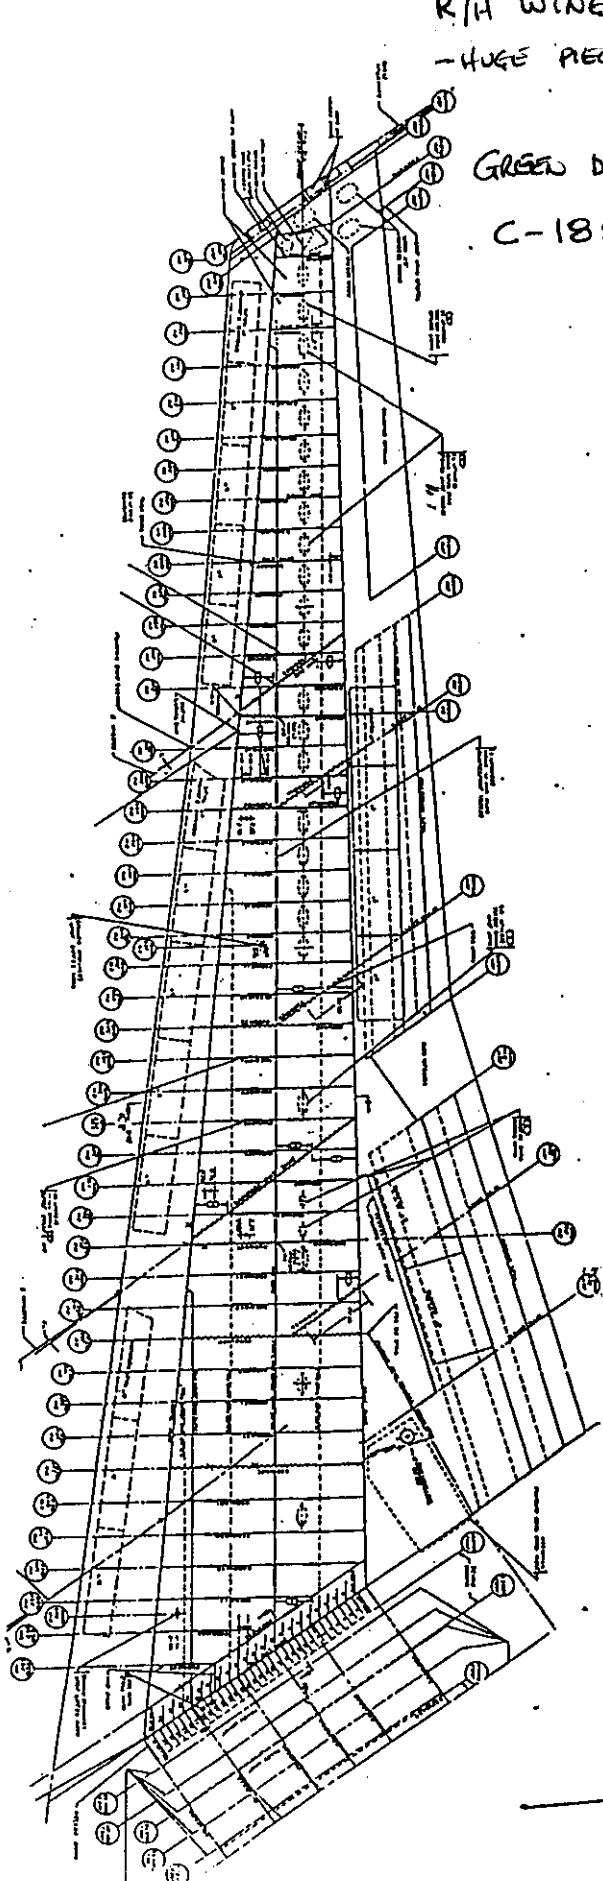
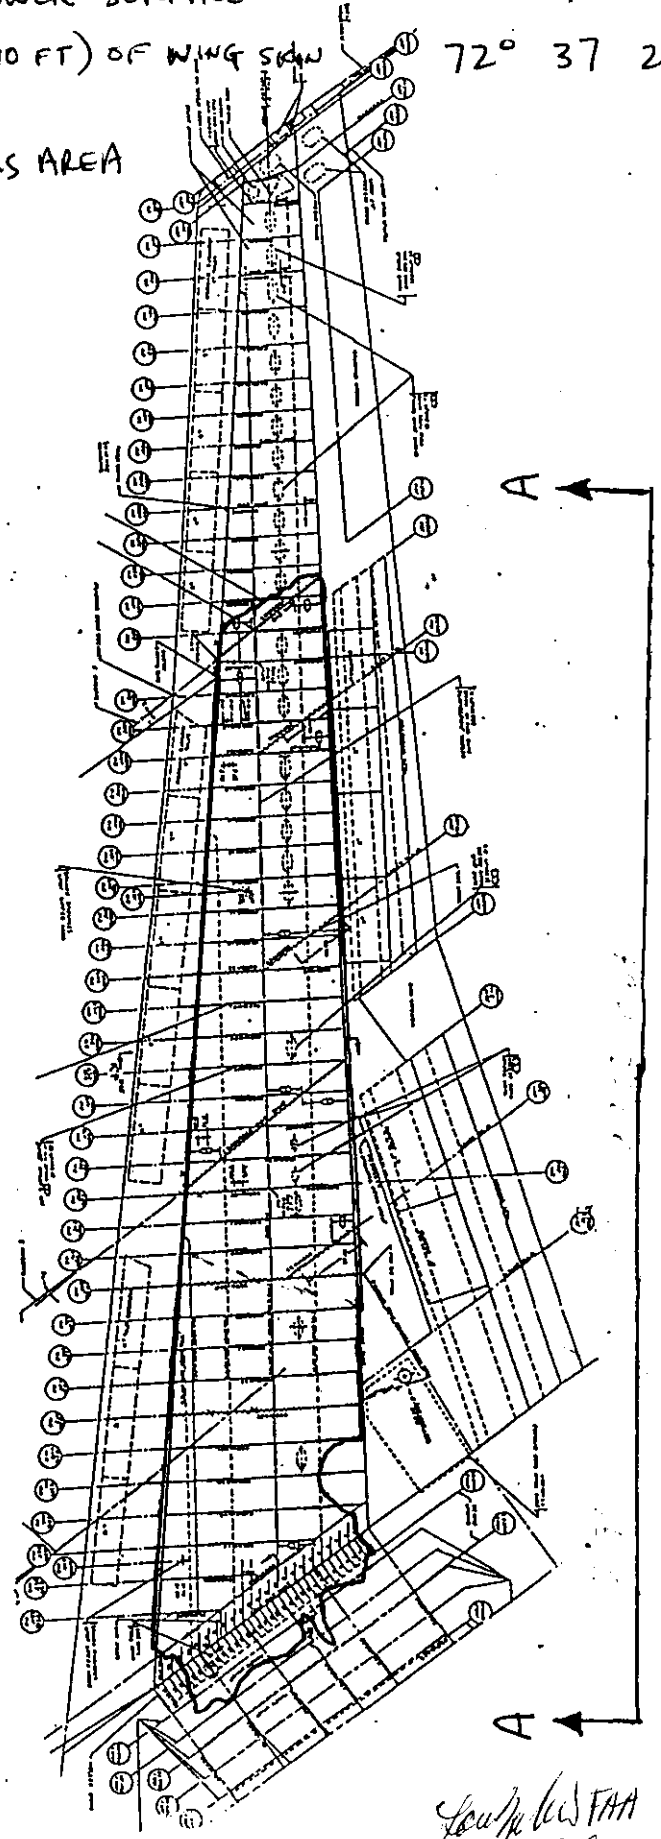
RW-3

- HUGE PIECE (90 FT) OF WING SKIN

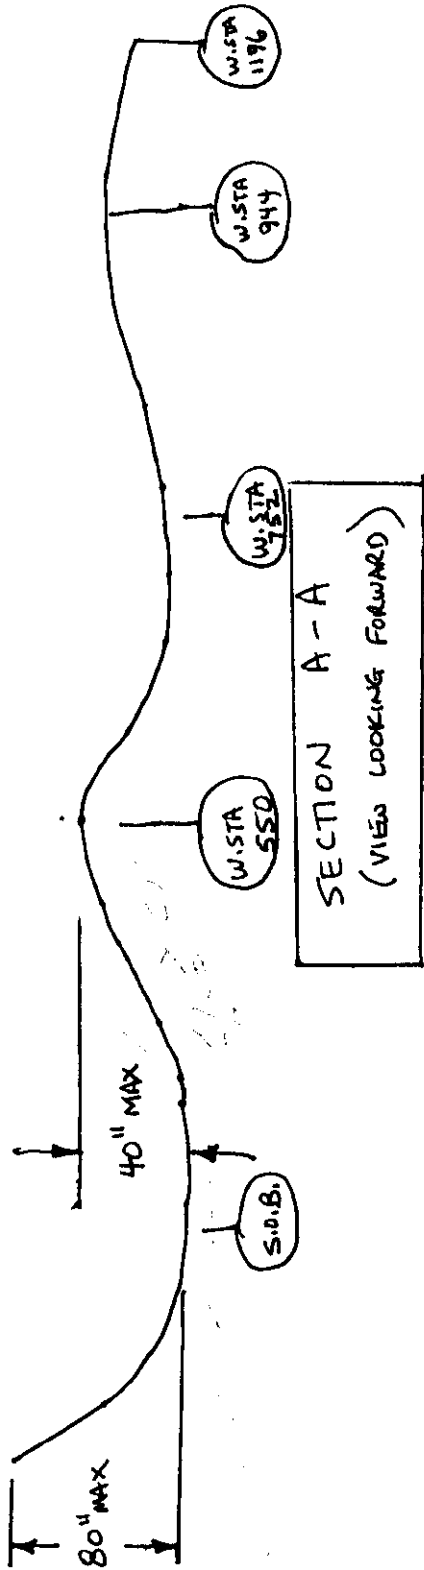
RW 3

THIS SECTION OF LOWER WING SKIN HAS A SPANWISE WAVY FEATURE AS SHOWN. THIS IS TYPICAL OF BOTH SKIN AND STRINGERS. CHORDWISE THE PANEL IS RELATIVELY FLAT. IT IS IMPORTANT TO NOTE THAT THE UPPER AND

LOWER SKIN/STRINGER ASSEMBLIES ARE SEPARATE. ALL SPARS AND RIBS HAVE FAILED AND SEPARATED, IN NO TYPICAL FASHION. ~~THIS IS ATTRIBUTED TO~~ THE U.S.S. GLIMP NEEDS TO SPLIT THE RH FUSELAGE/WING RECOVERED SECTION INTO SMALLER PIECES, IN THE INTEREST OF SAFETY. THERE FORG, AN INITIALLY HUGE PIECE BECAME 4 PIECES (RW-3 INBOARD AND OUTBOARD) AND OUTBOARD (OUTBOARD & OUTBOARD)

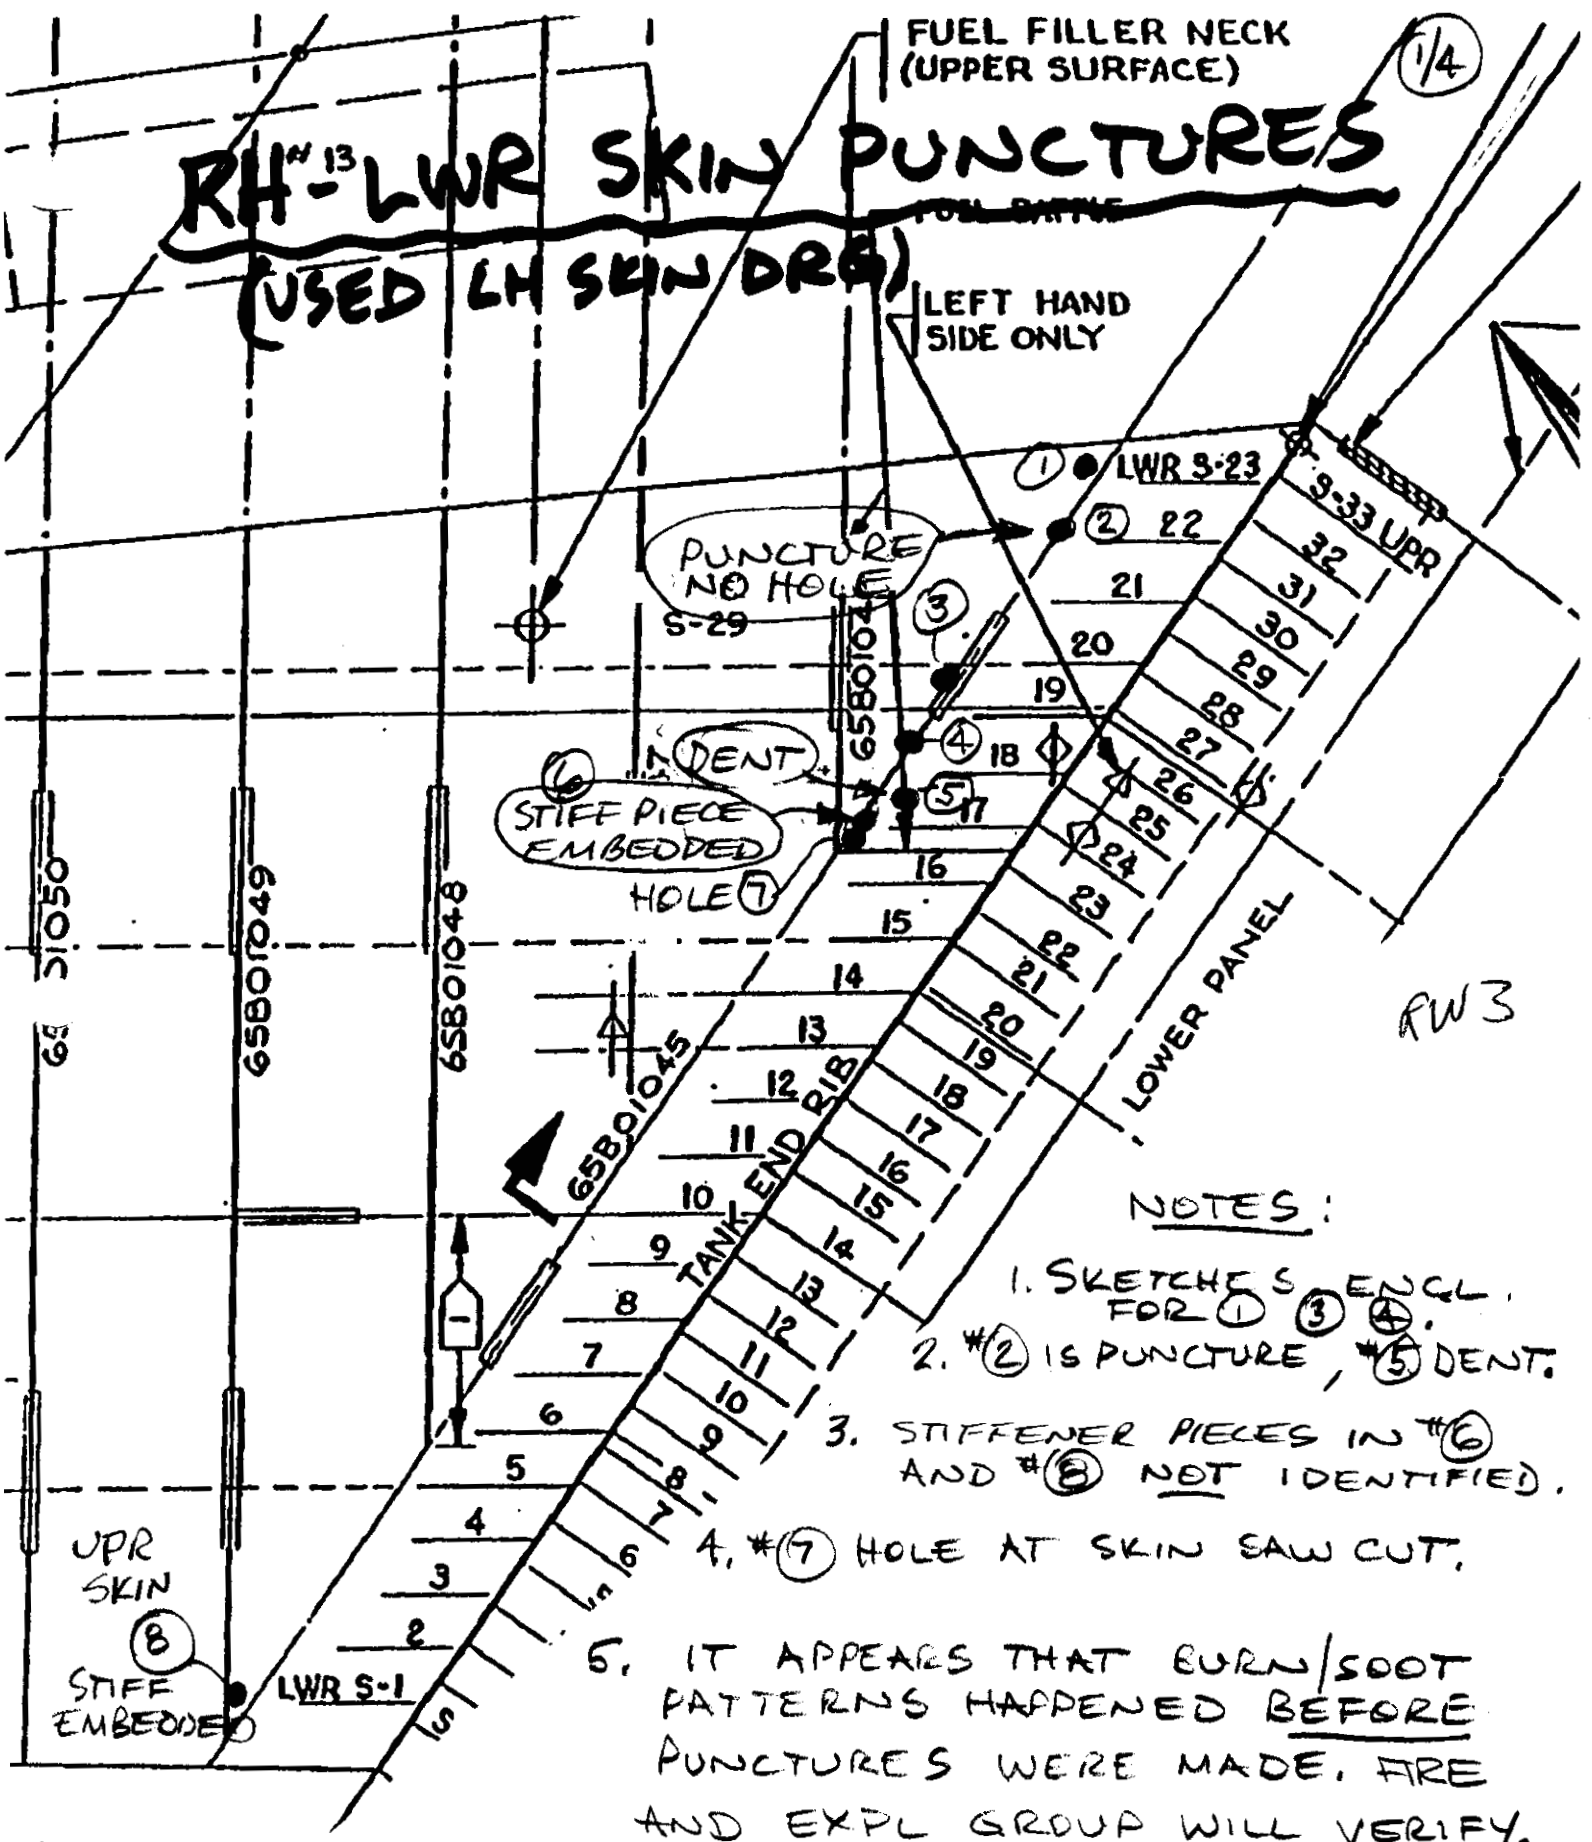
RH^{#13} LWR SKIN PUNCTURES

AN ADDITIONAL FEATURE OF THIS PANEL IS PUNCTURE HOLES NOTED AT APPROXIMATELY WBL 150. THE HOLES WERE NOTED AT APPROXIMATELY STRINGER 23, 22, 20, 19, 18, 17, AND 1 LOCATIONS. OF THE TWO HOLES NOTED AT STR-17, ONE APPEARS TO HAVE A PIECE OF A SIDE-OF-BODY RIB STIFFENER IMBEDDED IN THE HOLE. BURN/SOOT PATTERNS ON THE LOWER, EXTERNAL SURFACE OF THE PANEL DO NOT CONTINUE ON THE FRACTURE FACES OF THE HOLES OR ON THE INSIDE/UPPER SURFACE OF THE PANEL AROUND THE HOLES. (NOTE THAT SOME OF THESE HOLES ARE ON THE INBOARD SIDE OF THE CUT NEAR THE S-O-B.)

1. SKETCHES ENCL. FOR ① ③ ④.
2. #② IS PUNCTURE, #⑤ DENT.
3. STIFFENER PIECES IN #⑥ AND #⑧ NOT IDENTIFIED.
4. #⑦ HOLE AT SKIN SAW CUT.
5. IT APPEARS THAT BURN/SOOT PATTERNS HAPPENED BEFORE PUNCTURES WERE MADE. FIRE AND EXPL GROUP WILL VERIFY.

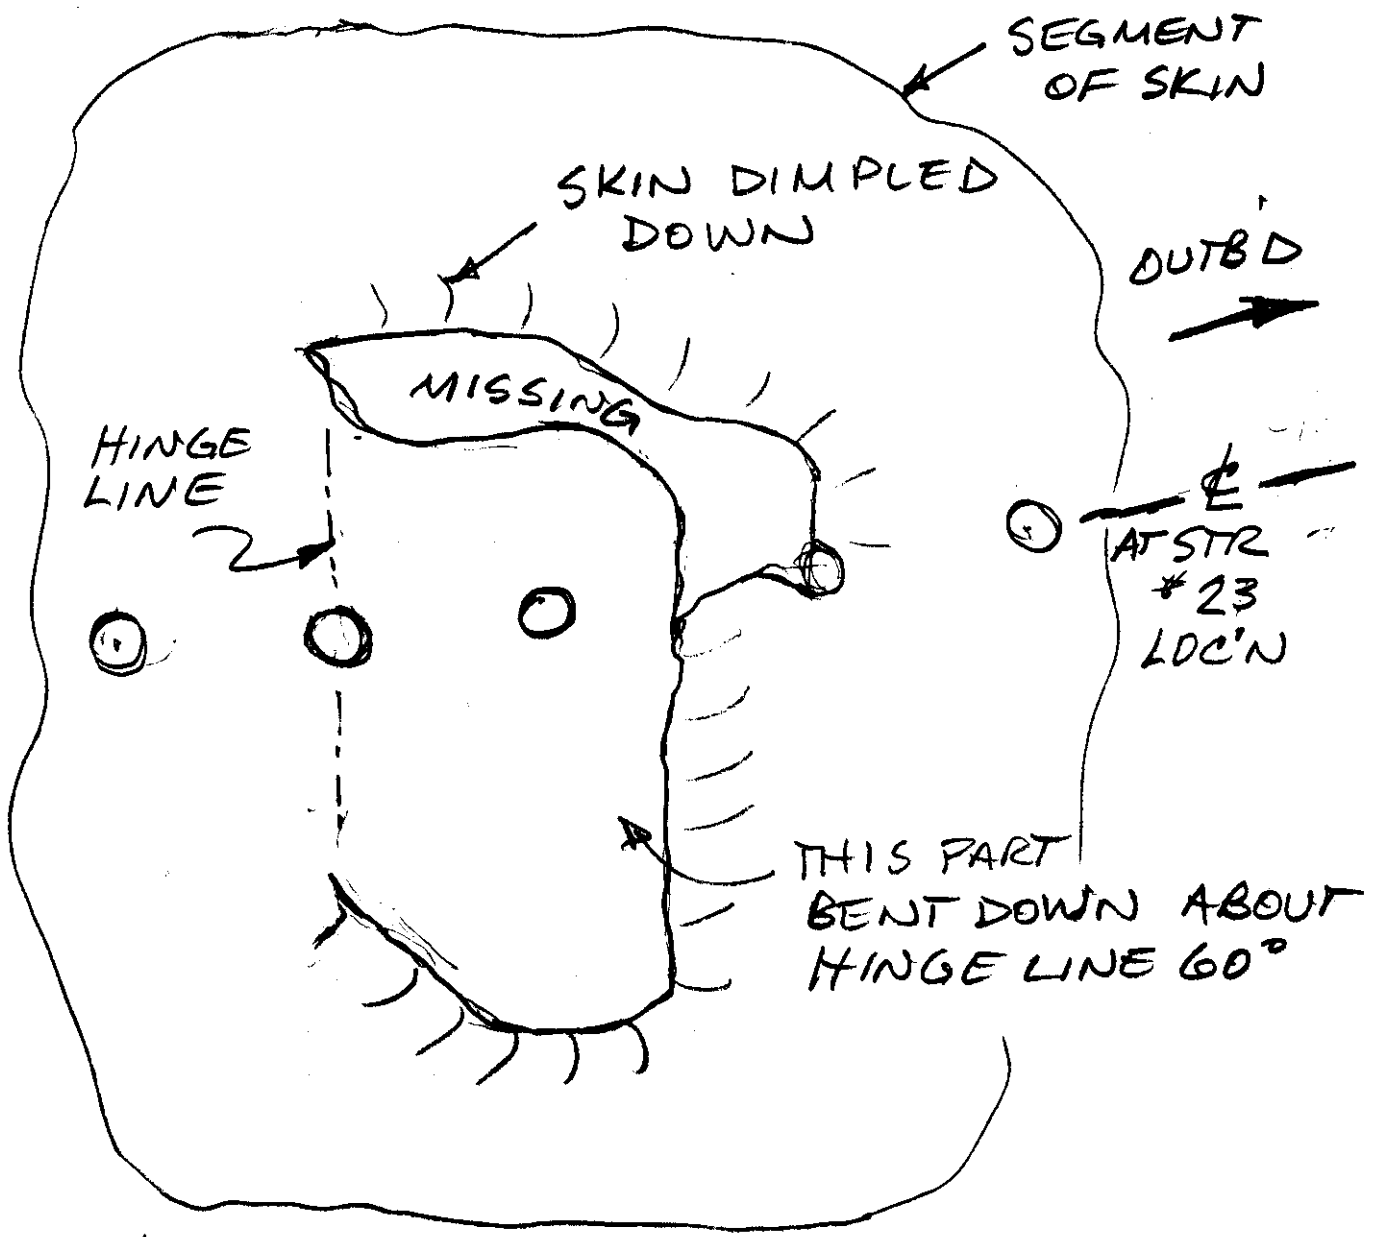
HOLE # (1)

RH LOWER SKIN PUNCTURE

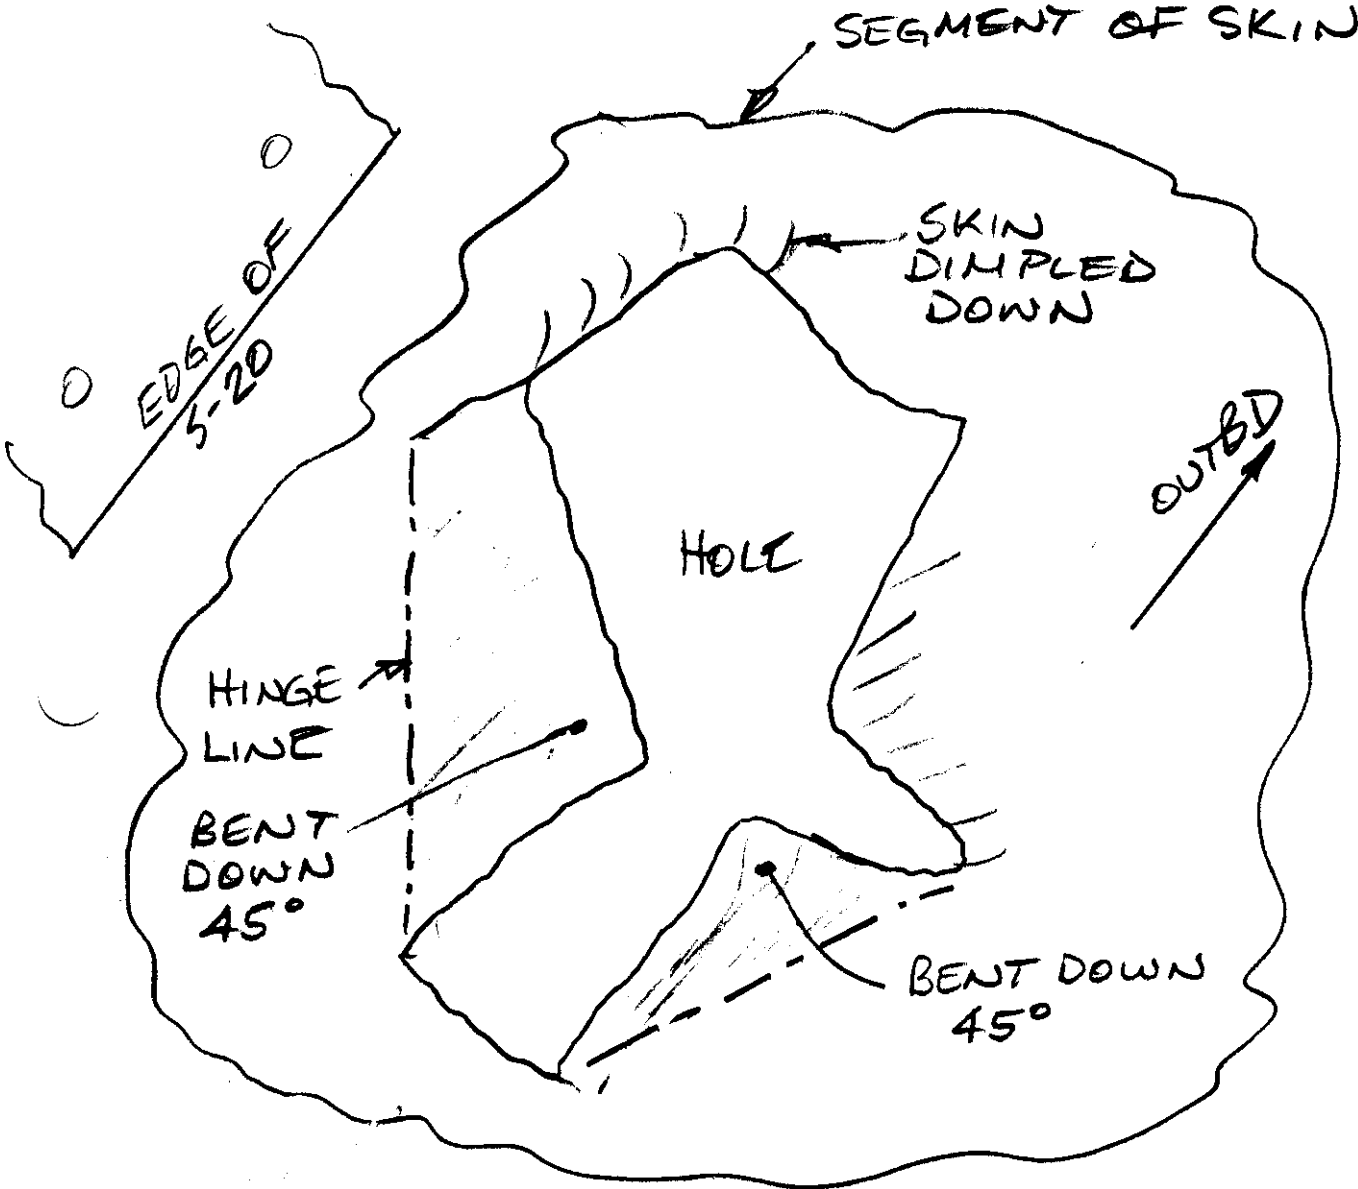
HOLE #3

RH LOWER SKIN PUNCTURE

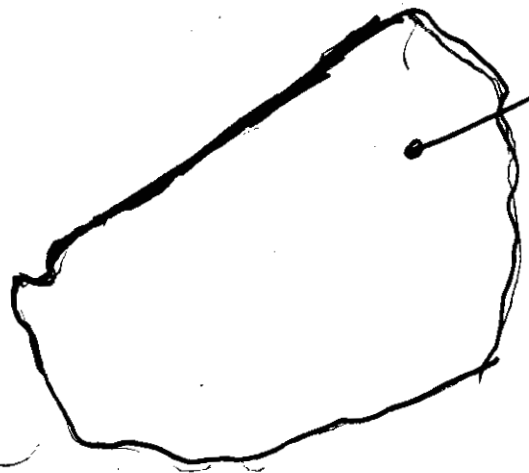
HOLE # 4

RH LOWER SKIN PUNCTURE

HOLE,
NO
FOLD
