11-8-96-1

# RIGHT WING RW37

ORANGE W2003  
 LOG # C 6592-134  
 TARGET # -

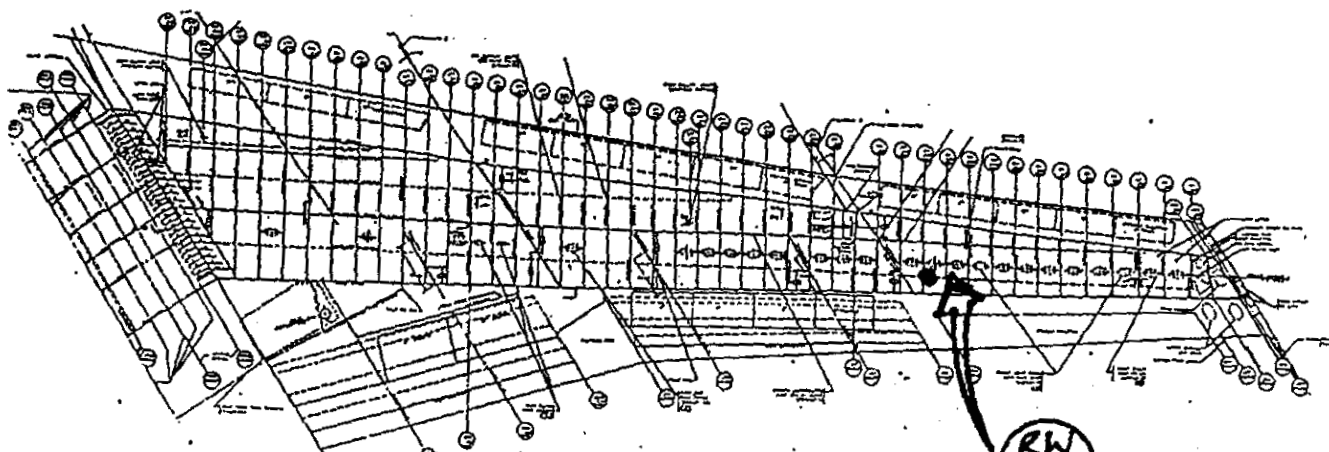
RIGHT WING UPPER SKIN PANEL LOCATED JUST OUTBOARD OF THE NO 4 NAAGLE RIB. THE 3' X 4' SECTION EXTENDS FROM WS 1196 TO WS 1252 AND ENCOMPASSES STRINGER REMAINT'S 5 THRU 9, INCLUDING A SECTION OF REAR SPAR CHORD FLANGE. A SECTION OF FIXED TRAINING GOUGE UPPER FIBER GLASS PANEL EDGE REMAINS ATTACHED AND EXTENDS ALONG THE AFT SKIN EDGE. THE PANEL SKIN SECTION SEPARATED IN A DUCTILE MANNER WITH STRINGER NO'S 5 THRU 9 AND THE REAR SPAR CHORD FLANGE, SEPARATING ALONG THE JUNCTION RADIUS OF EACH STRINGER ELEMENT STEM AT THE FLANGE TO SKIN AS INDICATED IN SECTION A-A.

THE PANEL FINISH IS PRIMARILY INTACT WITH NO DEGRADATION OR OBVIOUS ANOMALY, EXCEPT FOR SOME SALT WATER CORROSION ALONG THE EXTERNAL SURFACE BETWEEN STRINGERS 5 AND 7 COVERING APPROX 5" X 10". THE PANEL SHOWED NO SIGNS OF SCOTCH, FIRE OR IMPACT DAMAGE, AND THE SKIN IS RELATIVELY FLAT EXCEPT FOR SOME SLIGHT OUT OF PLANE DEFORMATION ALONG THE INBOARD EDGE INDICATIVE OF PANEL BENDING.
