# RIGHT WING RW-38

LOG # RW-38  
TARGET # C242

OUTBOARD PORTION OF #22 VC FLAP (BELOW UPR SKIN SEGMENT RW11)

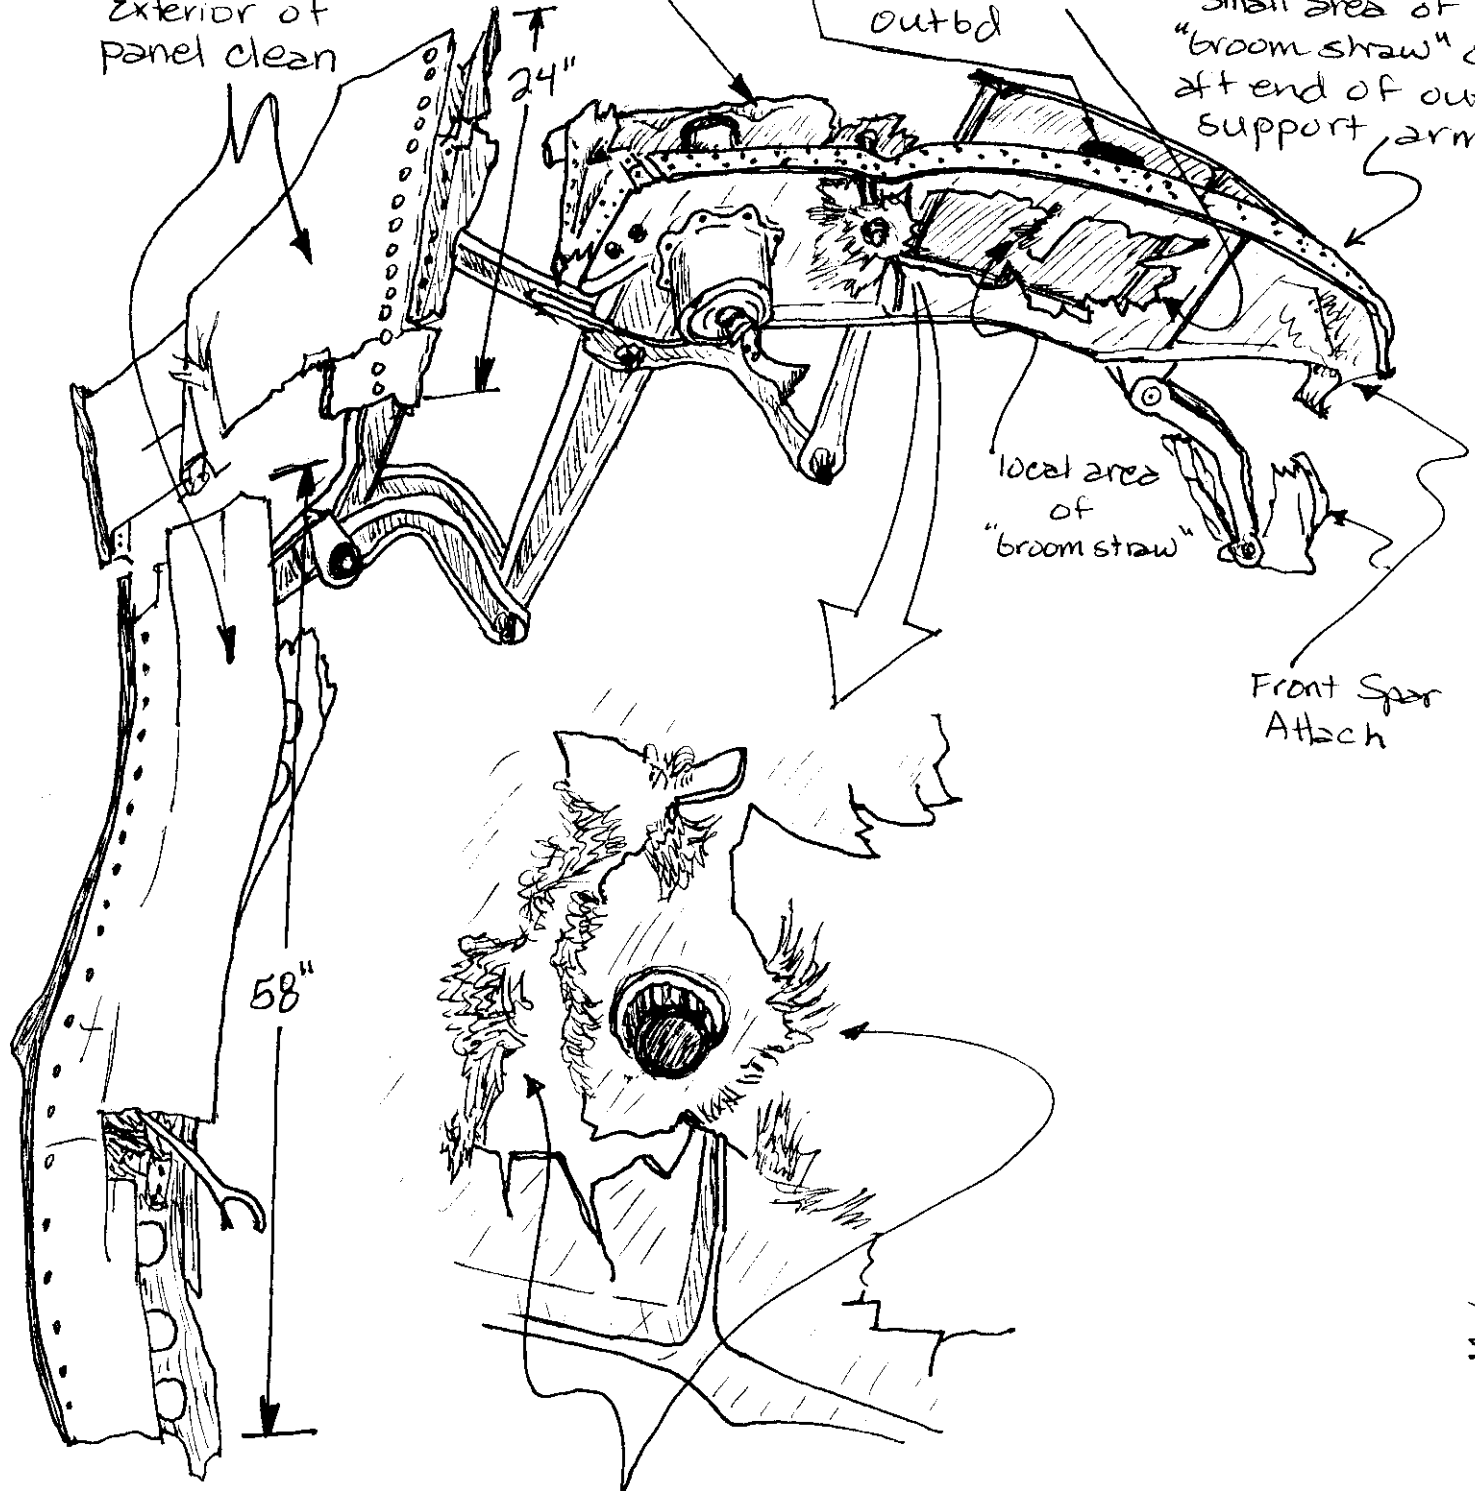
RW-38

web edge is curled inbd  $\approx 300^\circ$  locally

Hole in outbd web

Web bent outbd

Small area of "broom straw" on aft end of outbd support arm

Exterior of panel clean

local area of "broom straw"

"Broom straw"

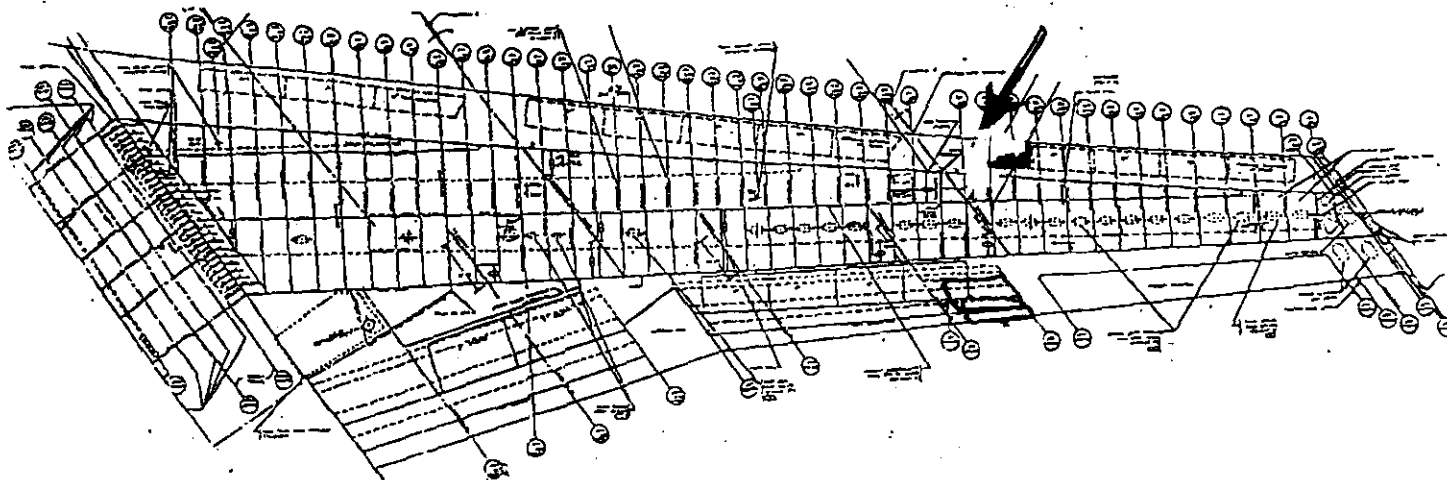
ATTACHES TO WING FRONT SPAR AT BREAK IN WING IMMEDIATELY OUTBD OF ENGINE #4. FIXED PORTION (UPPER) PANEL IS GONE. EXTERIOR (PAINTED) SURFACE OF REMAINING PANEL IS CLEAN, INTERIOR IS HEAVILY SOOTED (OUTBD) TO LIGHT SOOT (INBD).

OUTBD FLAP SUPPORT IS COMPRISED OF 2 ARMS THAT ATTACH TO F/S AND SUPPORT AN ACTUATOR AND LINKAGES. SUPPORT ARMS FRACTURED FROM FRONT SPAR (F/S) AT BASE. THE INBOARD MOST ARM HAS MAJORITY OF WEB MISSING WITH "BROOM STRAWING" JUST AFT OF ACTUATOR (NEAR FWD END OF ARM). THE OUTBOARD MOST ARM HAS LOCAL AREA OF "BROOM STRAWING" NEAR LOWER AFT END.
