RW-4 (ATTACHED TO RW-1 TOP SKIN)

LIGHT HAND MARK TIP TWA 800

RW-4 Additional Comments

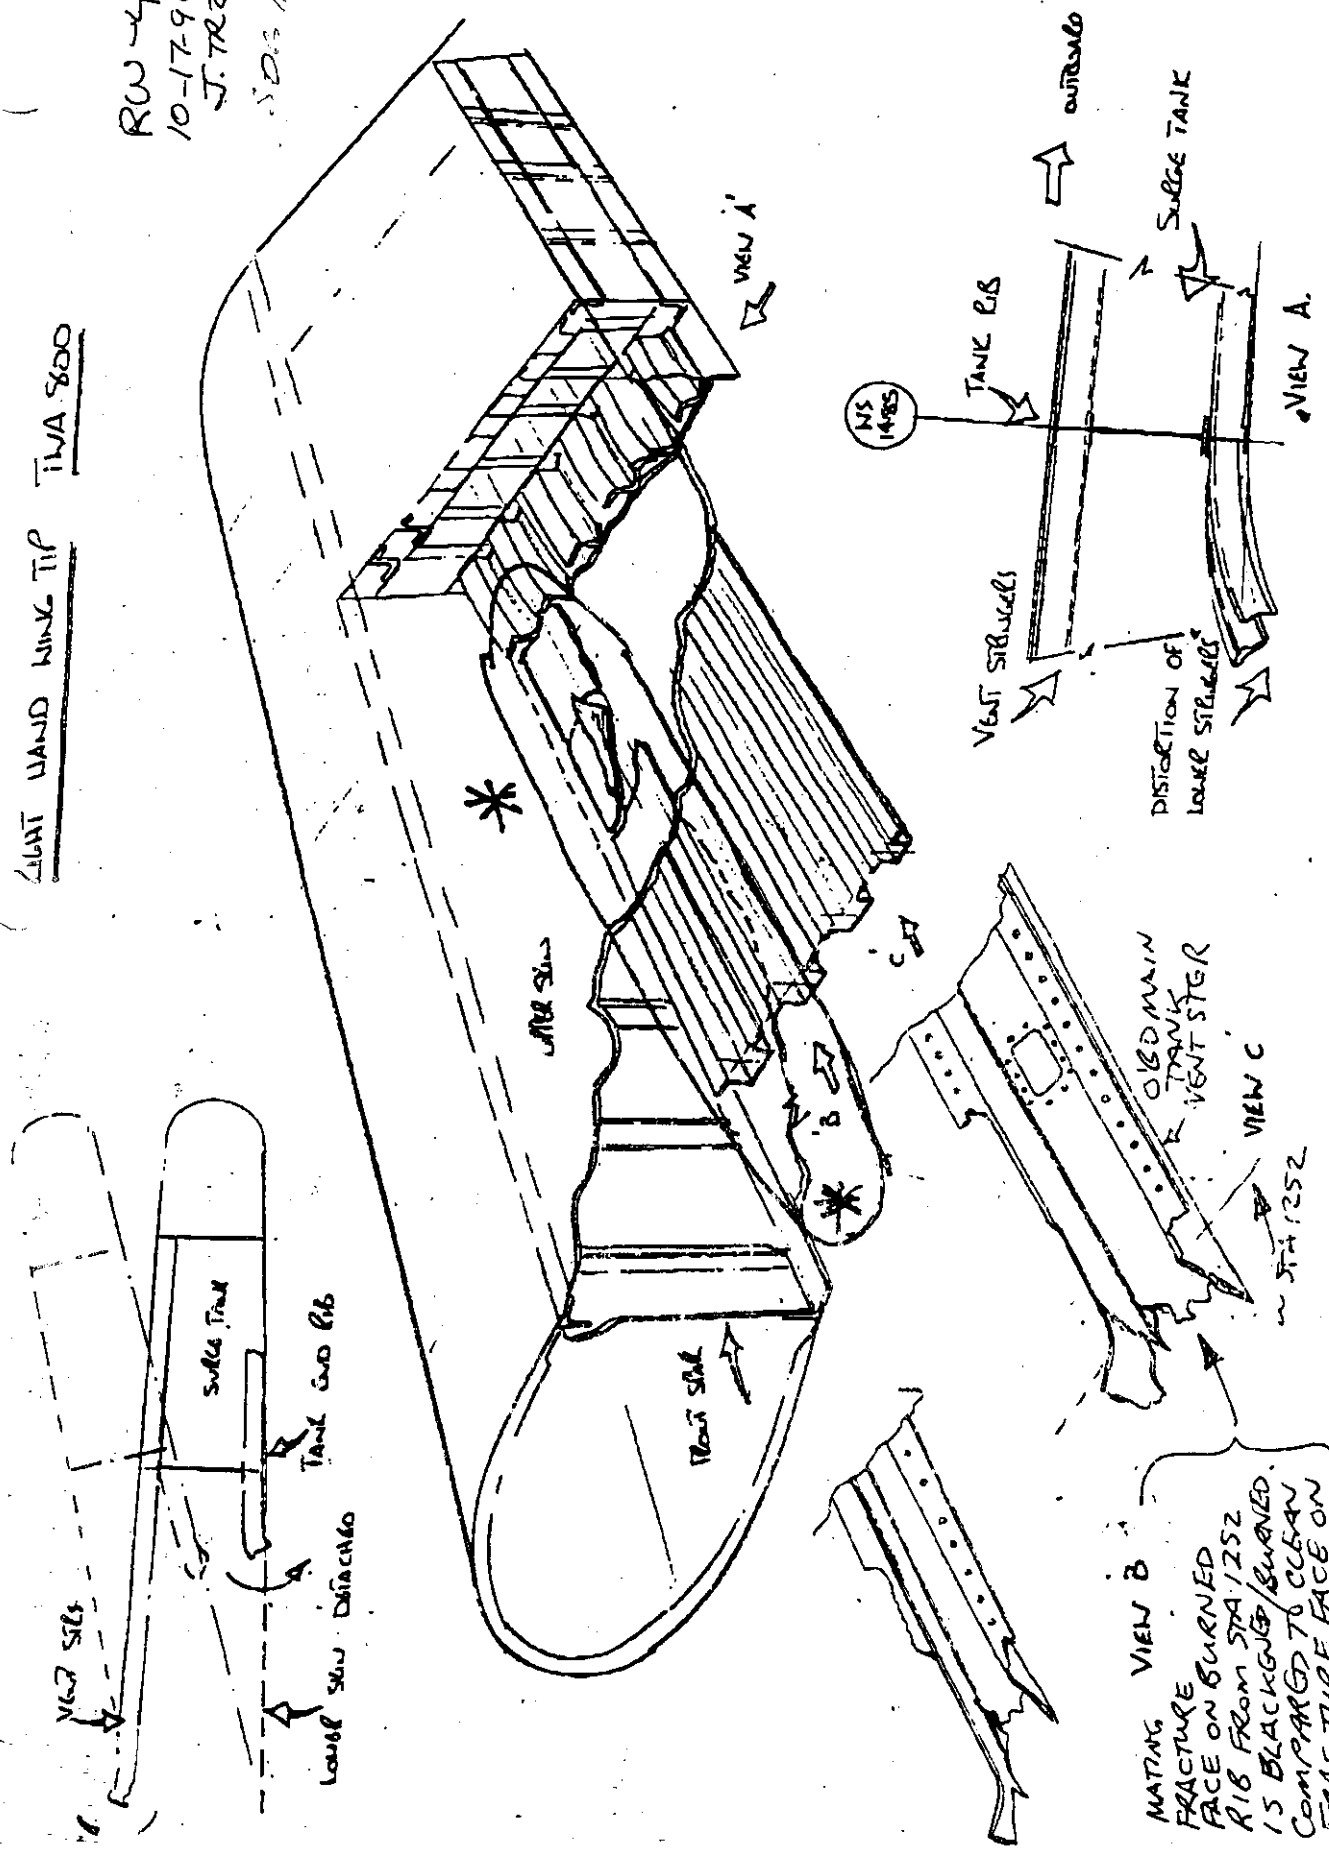
ANGEL FRACTURE FACE OF
 SEPARATION OF LOWER SKIN C/T STRINGER SPICE
 JUST AFT OF FRONT SPAR.

MATING VIEW B
 FRACTURE
 FACE ON BURNED
 RIB FROM STA 1252
 IS BLACKENED/BURNED.
 COMPARED TO CLEAN
 FRACTURE FACE ON
 RW4/RW1 VENT STRG.

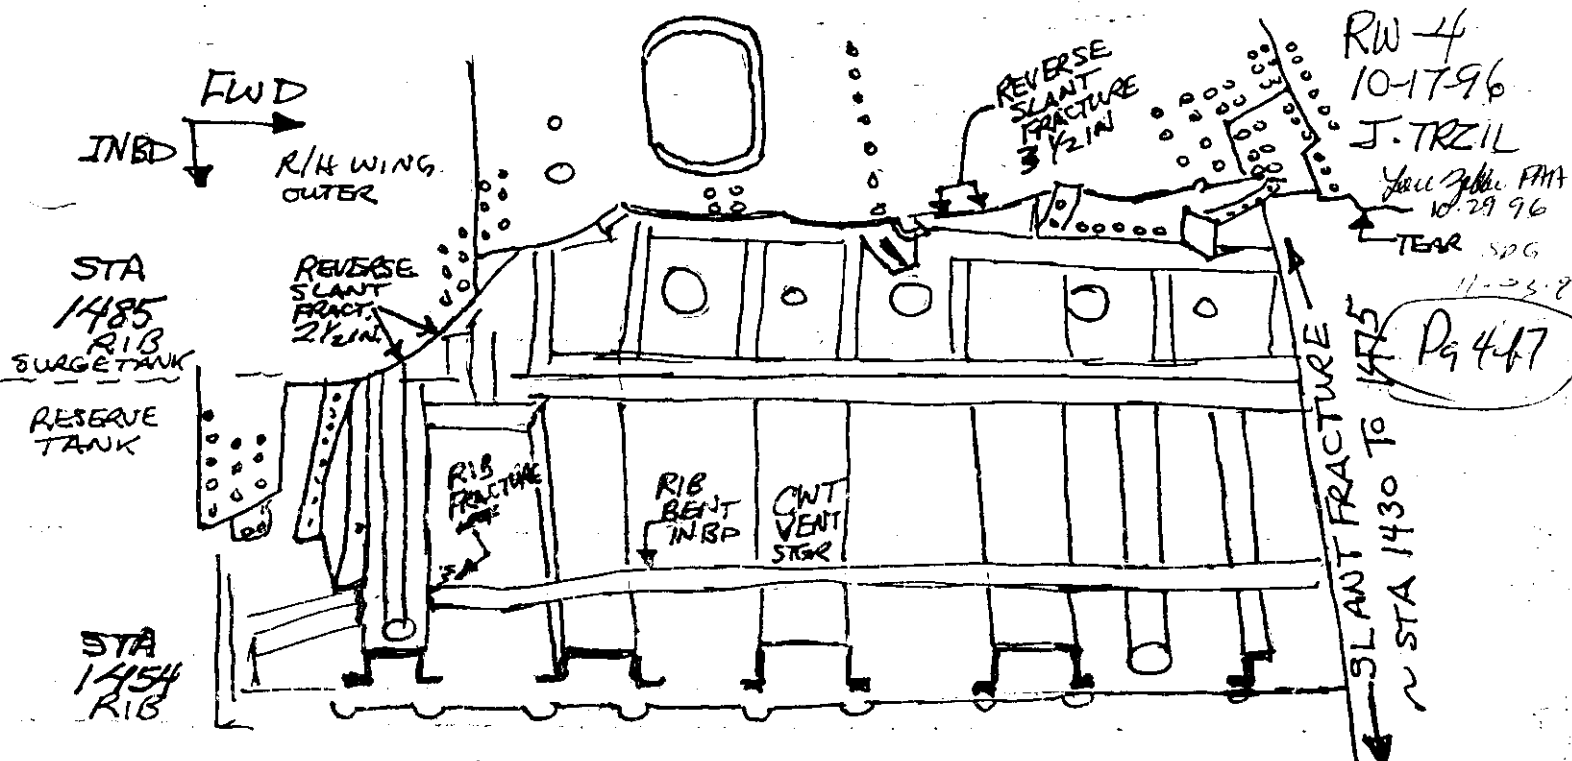
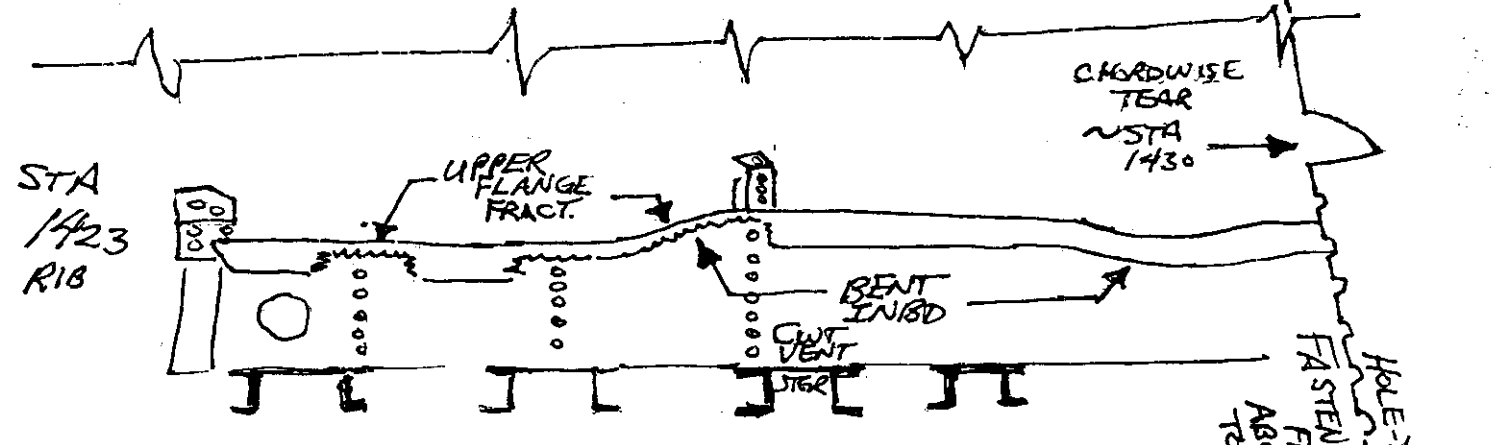
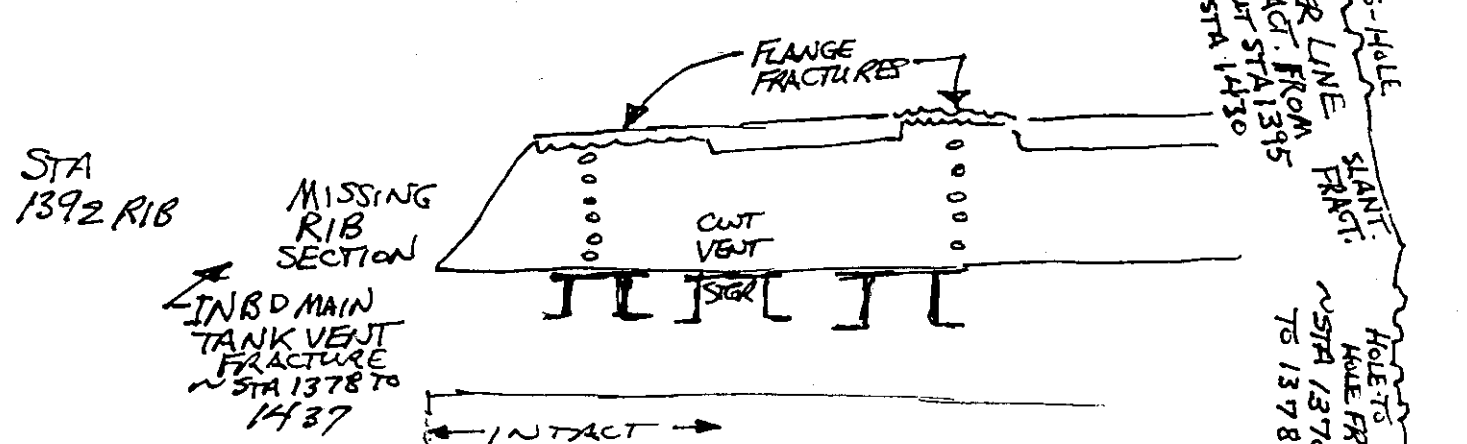
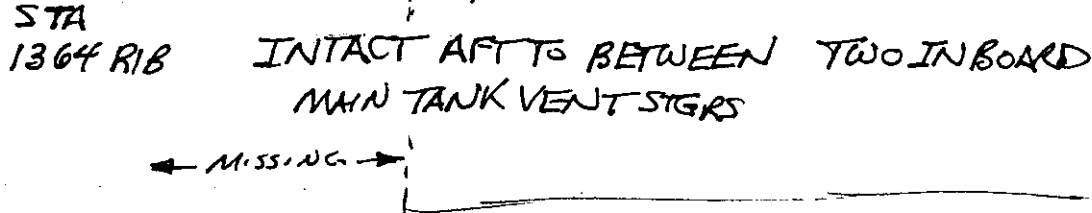
RIGHT WING OUTBOARD MAIN TANK VENT STR
AND CENTER TANK VENT STR VIRTUALLY
CLEAN OF SCOTING* ON ^{EXTRUSION} INSIDE SURFACES ^{AND TANK INSIDE} AT SURFACES
STA 1280 TO 1252 [OF LENGTH INTACT WITH
{RW-1} O'BD MAIN FRACTURE IS JUST O'BD OF
W.S. 1252 AND CWT VENT STR FRACTURE ~1255*
IS ABOUT W.S. 1260

NOTE: * FWD VERTICAL FLANGE
EXTENDING INBOARD OF STA 1252
IS CLEAN ON RW-4/RW-1

MID SPAR AT STA 1210 RW-1/RW-4 FRACTURE
FACE IS CLEAN. [SEE RW-8 SCOTED FRACTURE FACE
MATING TO THIS]
