RW-7

BOOY (GREEN) TAG # C2151

DBL PLUS CHORD - R/H FORWARD

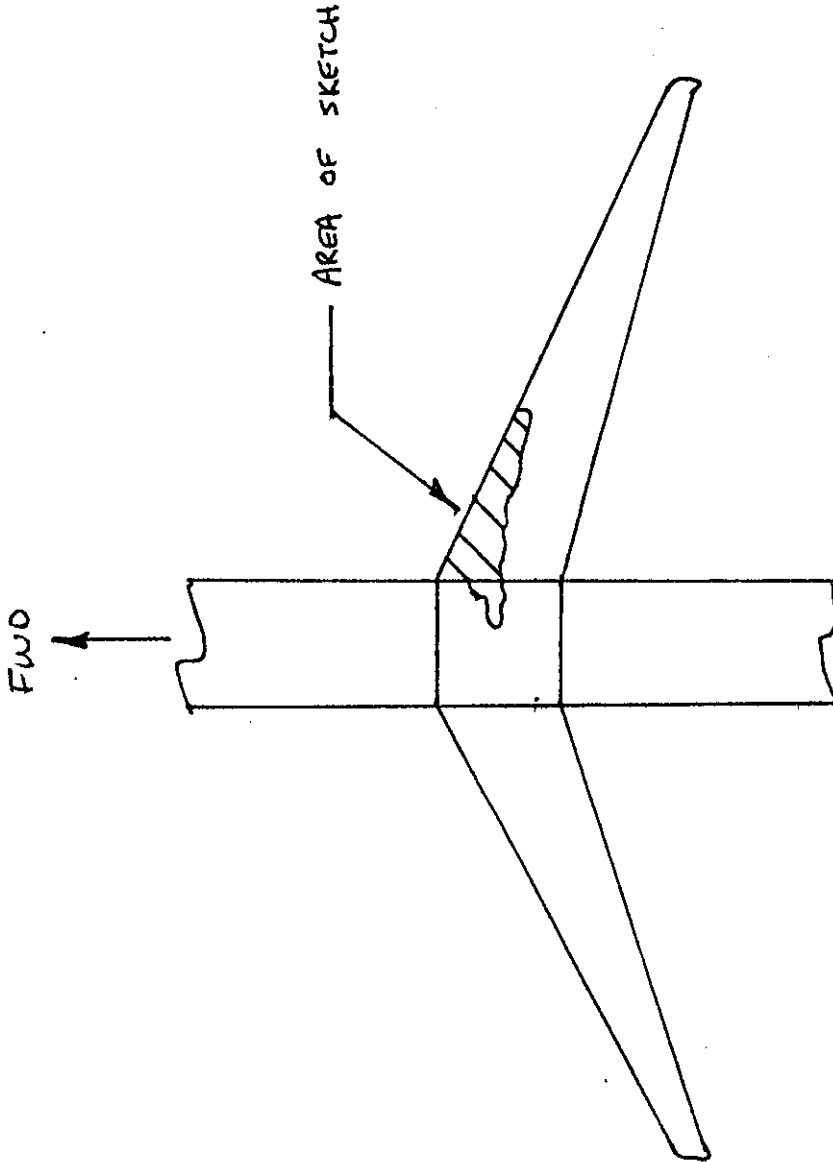
REFER FIRE AND EXPLOSION GROUP NOTES FOR FIRE DAMAGE

- OUTBOARD WING SKIN SCOTED ON TOP, CLEAN ON BOTTOM
- CENTER WING SKIN SCOTED TOP & BOTTOM
- INBOARD FACE OF S.O.B. UPPER PLUS CHORD CLEAN
- UPPER SKIN/STRINGERS FAILED IN COMPRESSION
- SECTION IS APPROXIMATELY 29' INBD/OUTBY BY 7' FWD/AFT

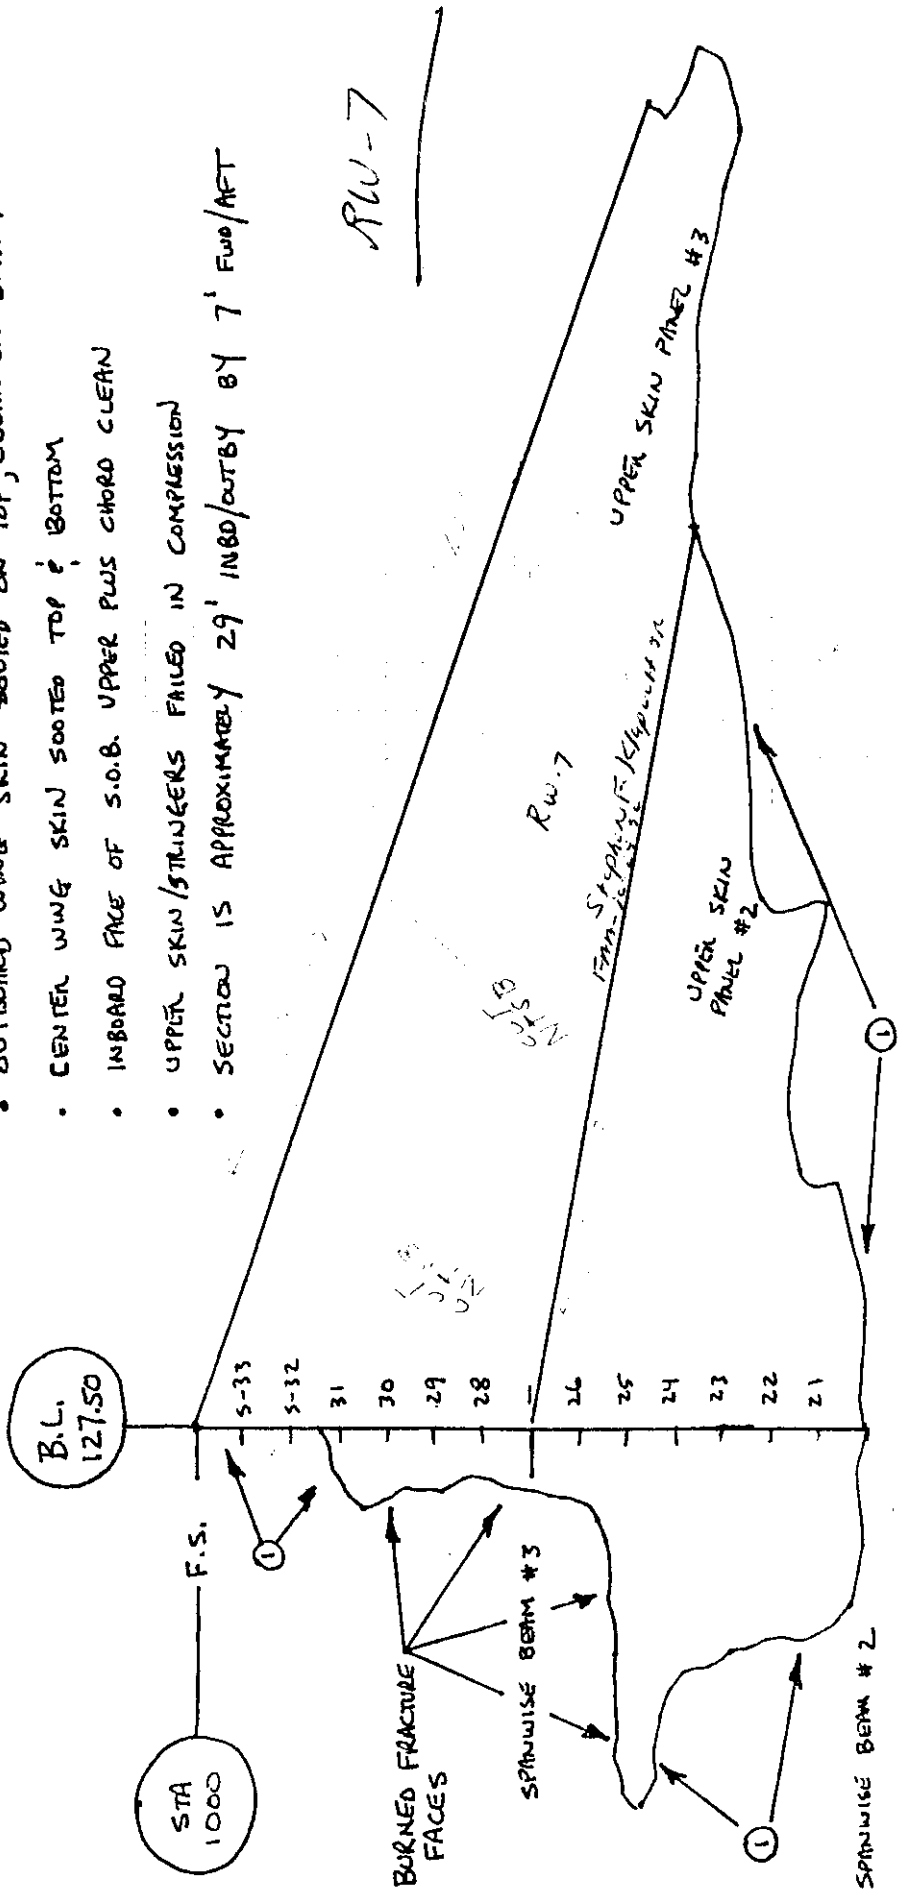
VIEW OF RH WING UPPER SURFACE

① CLEAN FRACTURE FACES

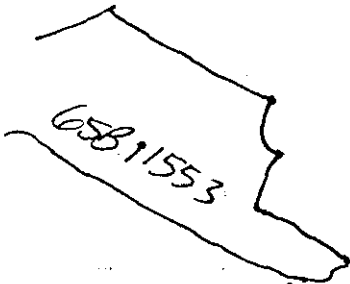
SPANWISE BEAM  
NO. 3 ATTACHED  
@ STGR 28  
& SHOWS  
CLEAN FRACTURE  
AT THAT PT. &  
IS OTHERWISE  
BENT FWD  
(WEB REMNANT)

END BENT  
O'BD/UP  
FAIRLY  
STRAIGHT

HOLES  
DEFORMED  
UPWARDS

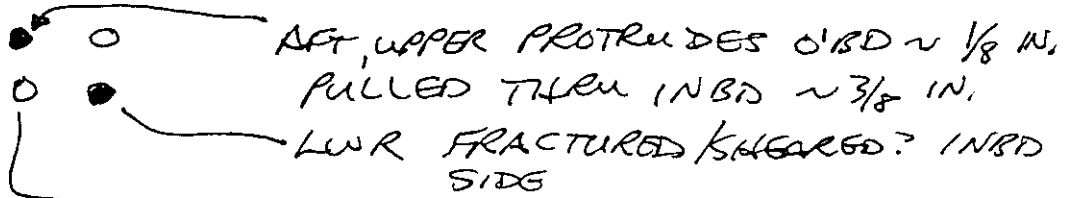
2 ~~ST~~ FSTNRS @ STIFFENER BELOW STR 33

ELONGATED FWD ABOUT 4 O'CLOCK

UPR HOLE, FWD ELONGATED 10 O'CLOCK TO 4 O'CLOCK
