RW-8

UPPER SURFACE RIGHT HAND WING PANEL, FROM SIDE-OF-BODY TO ENGINE #4

RIGHT HAND WING UPPER SKIN

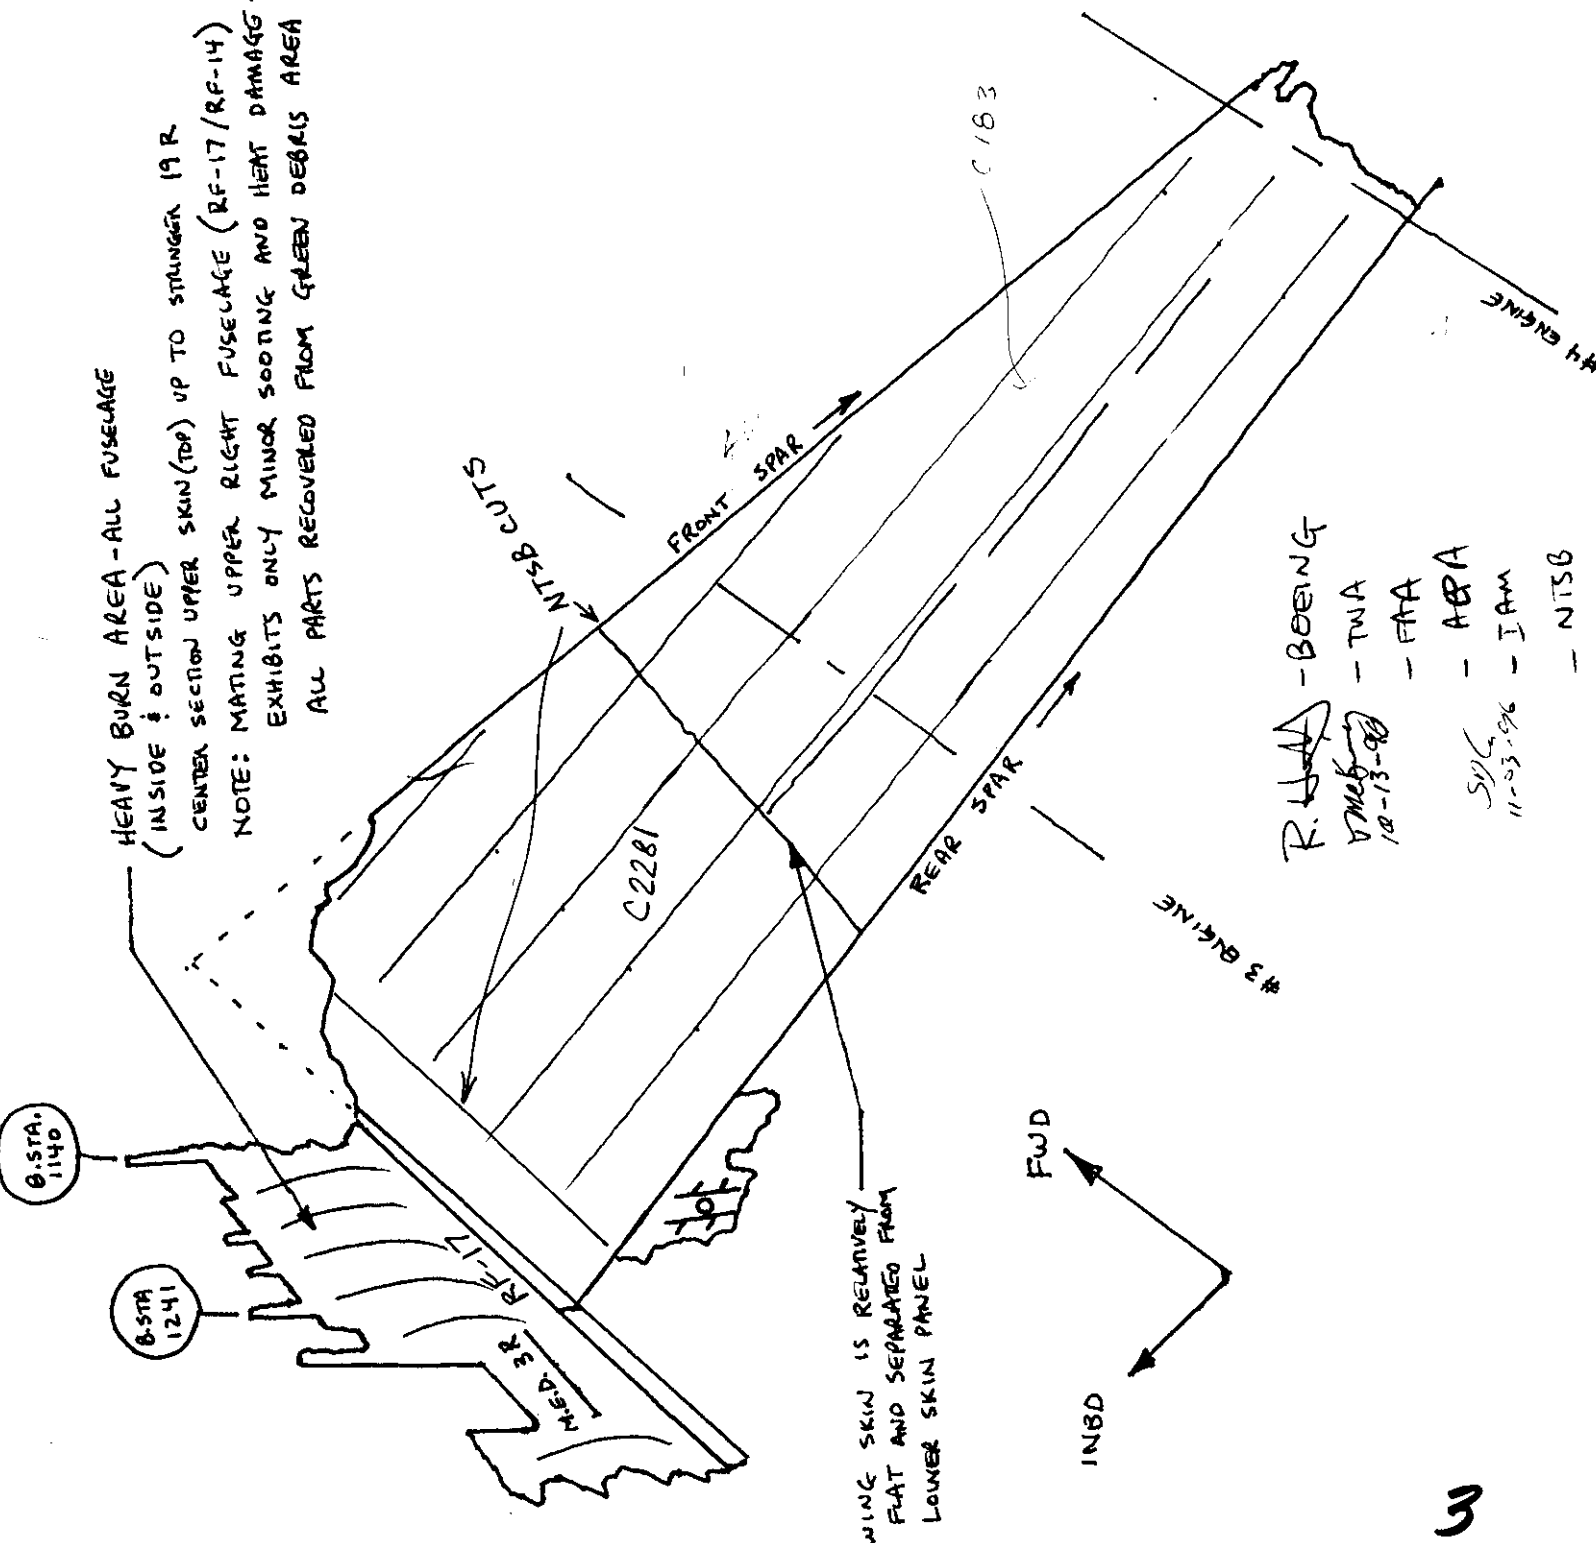
HEAVY BURN AREA - ALL FUSELAGE  
(INSIDE & OUTSIDE)  
CENTER SECTION UPPER SKIN (TOP) UP TO STRINGER 19 R  
NOTE: MATING UPPER RIGHT FUSELAGE (RF-17/RF-14)  
EXHIBITS ONLY MINOR SOOTING AND HEAT DAMAGE -  
ALL PARTS RECOVERED FROM GREEN DEBRIS AREA

APPEARANCE OF  
EXCESSIVE  
HEAT DAMAGE  
ON FRAMES

EXTERNAL SURFACE HEAT DAMAGE

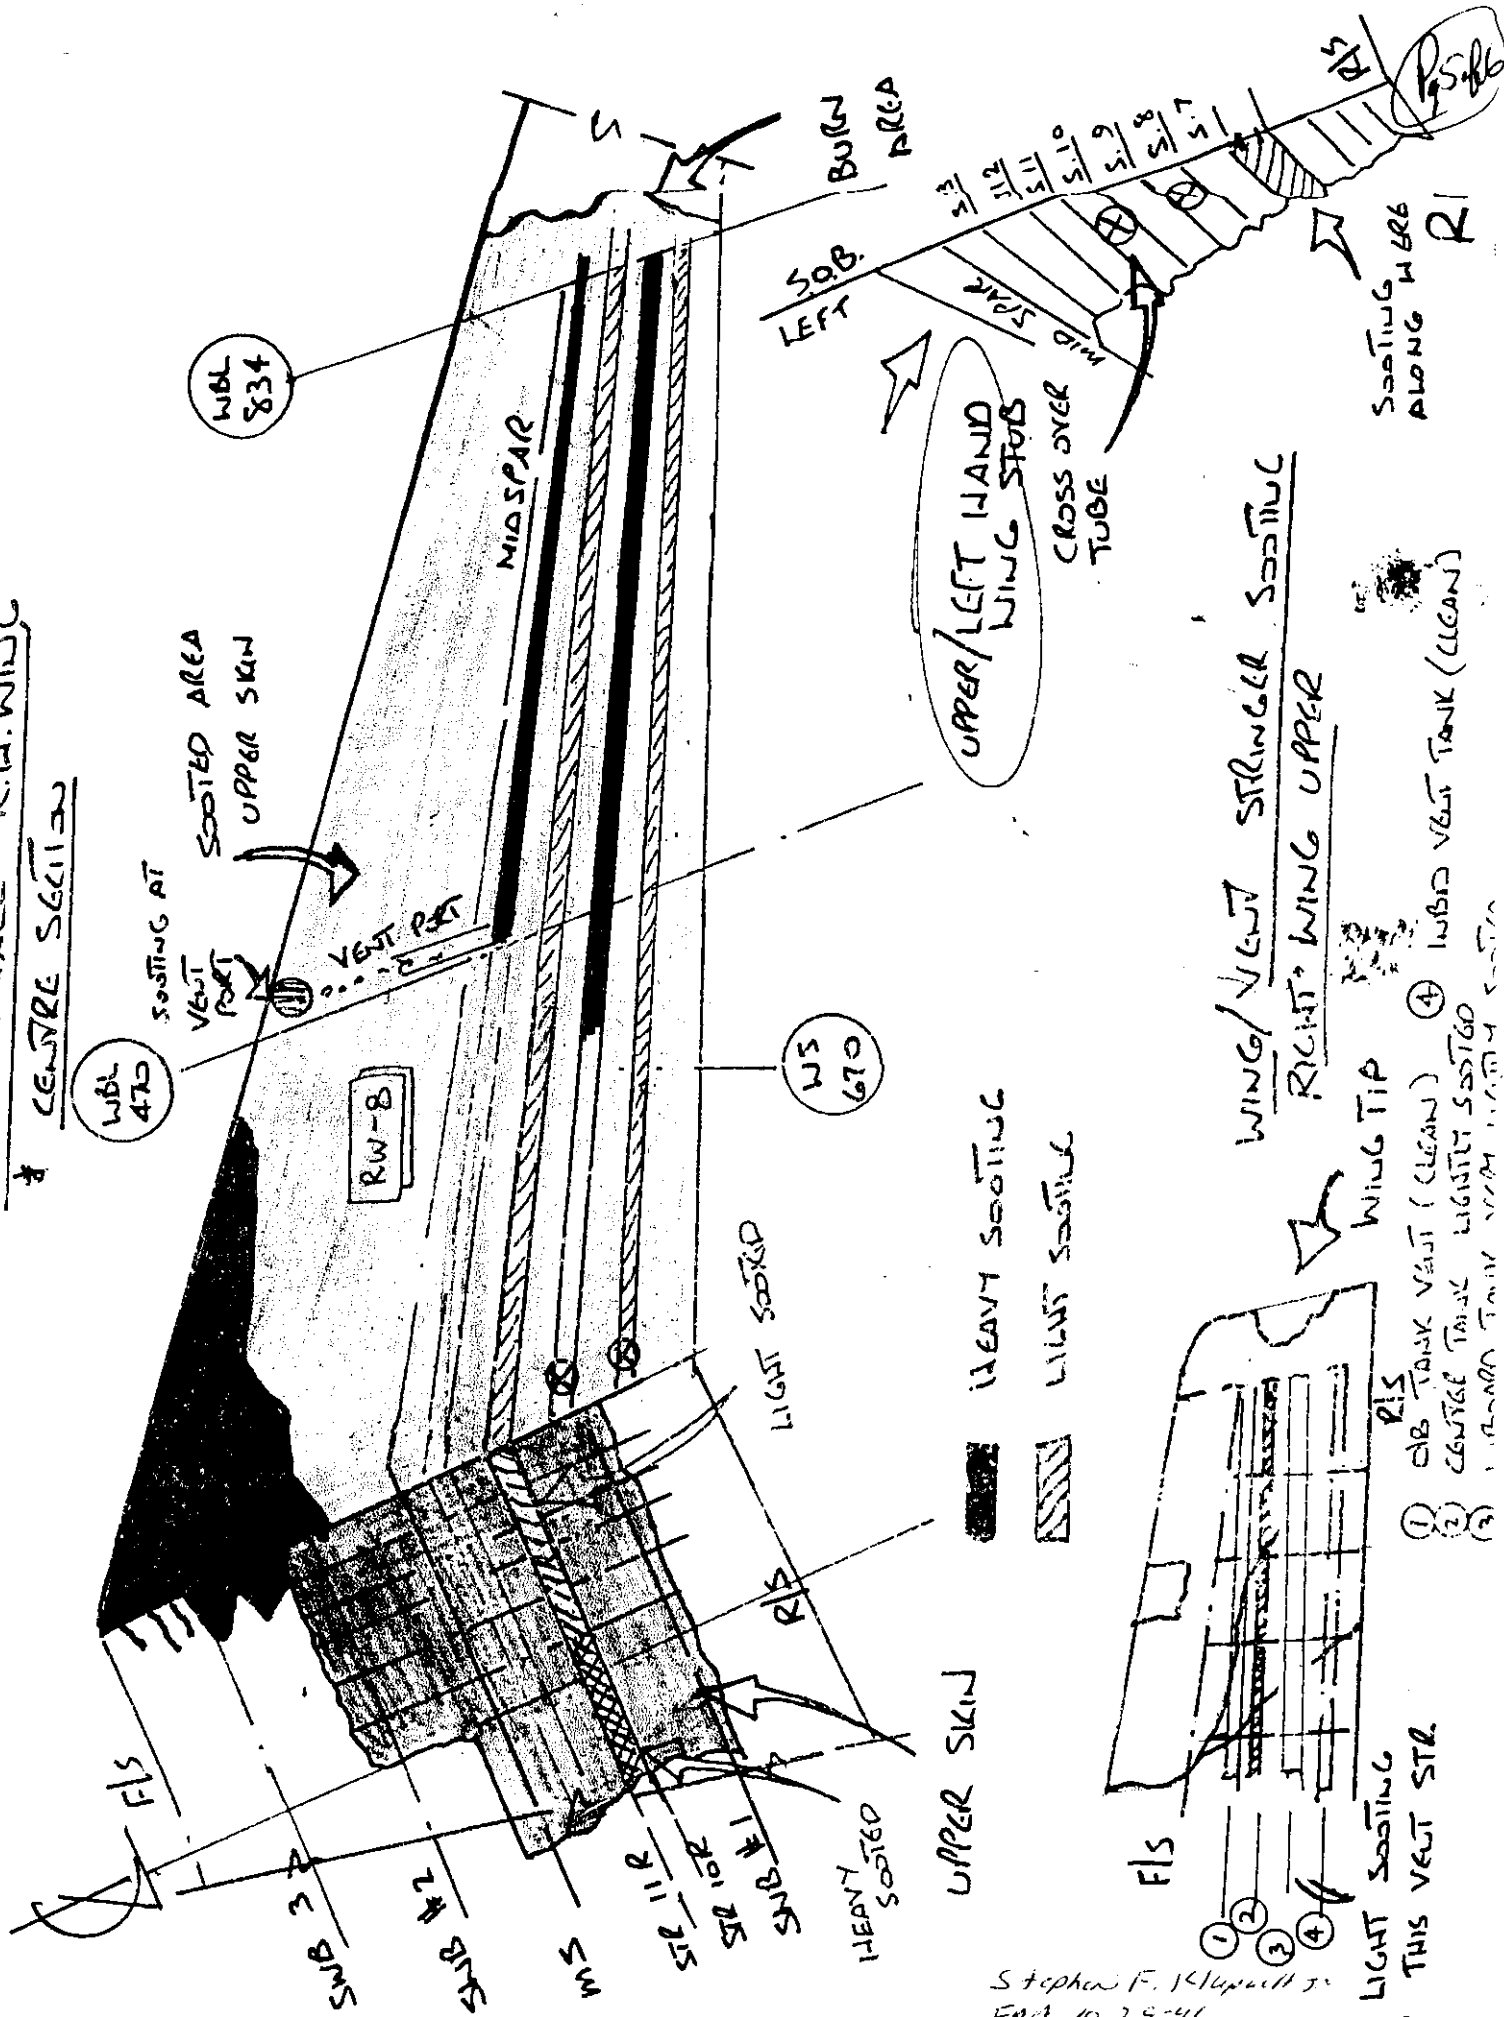
UPPER SURFACE R.H. WING  
\* CENTRE SECTION

WING/VENT STRINGER SOOTING  
RIGHT WING UPPER

- WING TIP
- ① OLB TANK VENT (CLEAN)
  - ② CENTRE TANK LIGHTLY SOOTED
  - ③ INBOARD TANK VERY HEAVILY SOOTED
  - ④ INBOARD VENT TANK (CLEAN)

- UPPER SKIN
- HEAVY SOOTING
  - ▨ LIGHT SOOTING

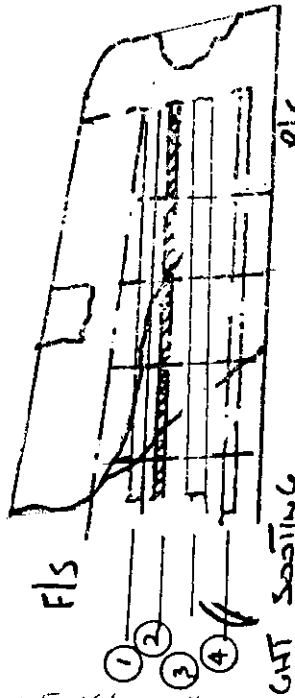
LIGHT SOOTING  
THIS VENT STR
