CO40 GREEN DEBRIS FIELD

RIGHT HAND WING UPPER SKIN

RW-9

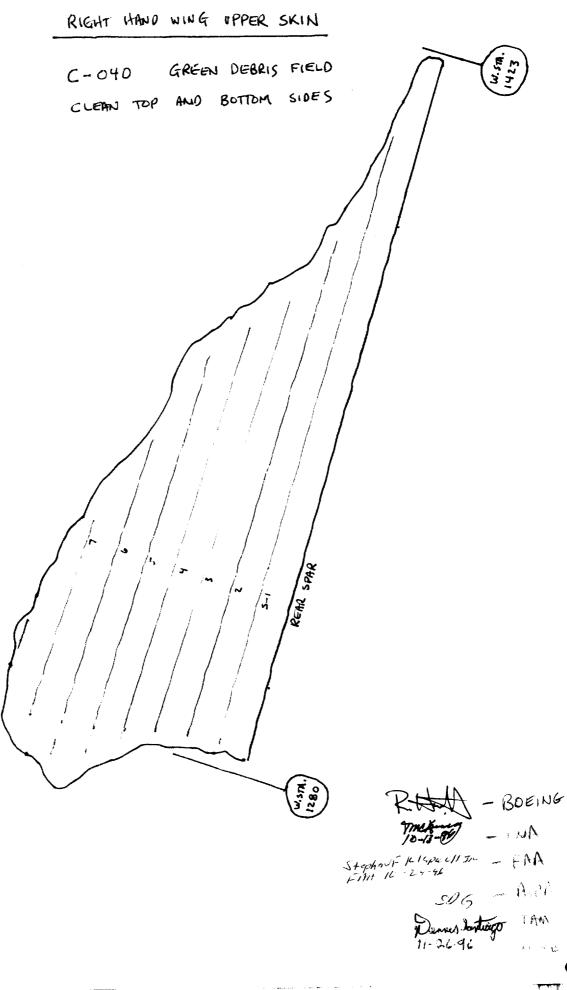
RH WING UPPER SKIN FROM WS 1280 TO 1423 WITH NO STRINGERS REMAINING ATTACHED. PART EXTENDS FROM REAR SPARTD STRINGER 8 LOCATION AT WS 1280 AND IS TORN DIAGONALLY TO THE REAR SPAR AT WS 1423. THE HORIZONTAL FLANGE OF THE REAR SPARAREMAINS ATTACHED TO THE SKIN FROM WS 1343 TO WS 1392. THE CHORD IS FRACTURED IN THE VERTICAL FLANGE AT THE RADIUSTANGENT. ALL OTHER REAR SPAR CHORD IS MISSING.

THE OUTBOARD END OF THE PANEL IS BENT DOWNWARD FROM WS 1392 OUTBD,

THIS PANEL SHOWS NO FIRE OR SOOT EVIDENCE,
