RIGHT WING

QUAT HAND MARK TIP TWA 800

RW 4
10-17-96 REV
J. TRZIL

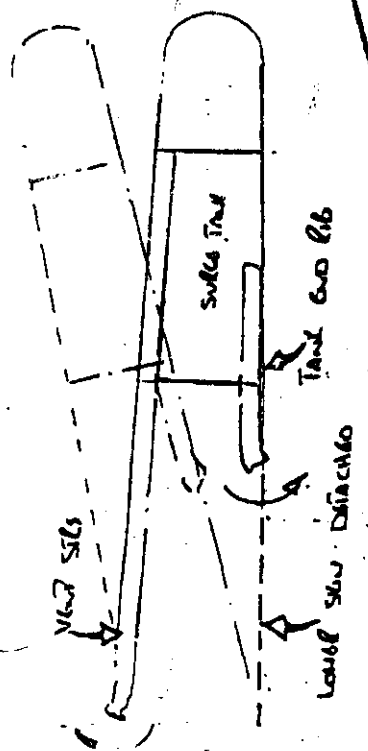
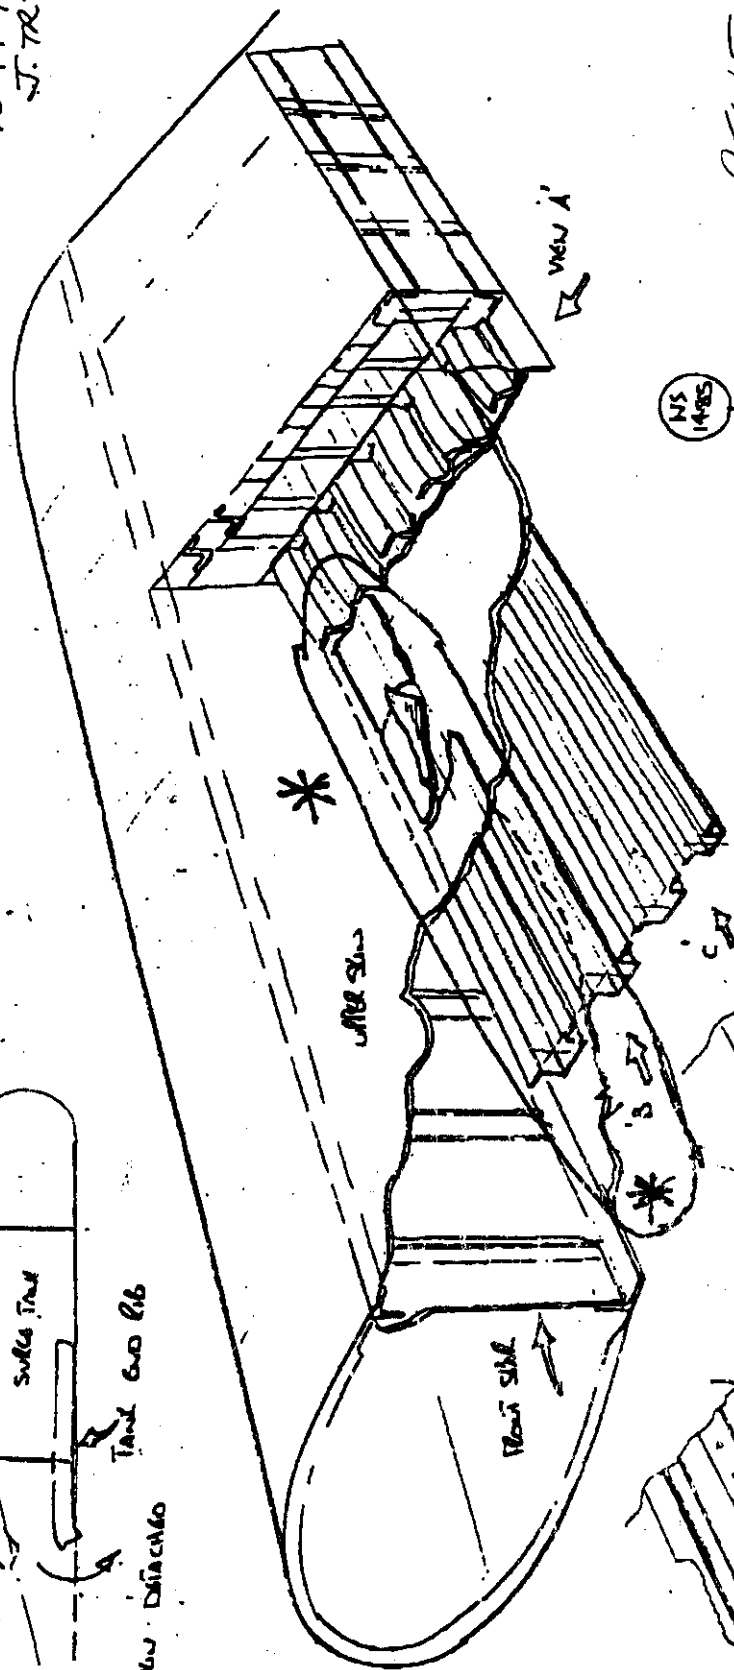
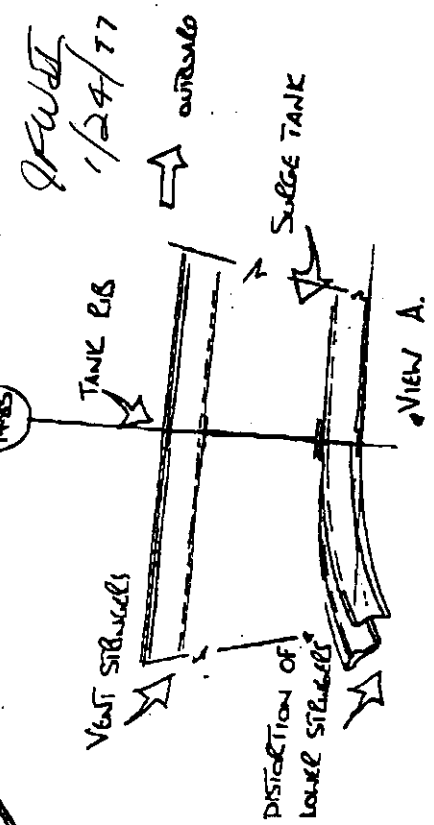
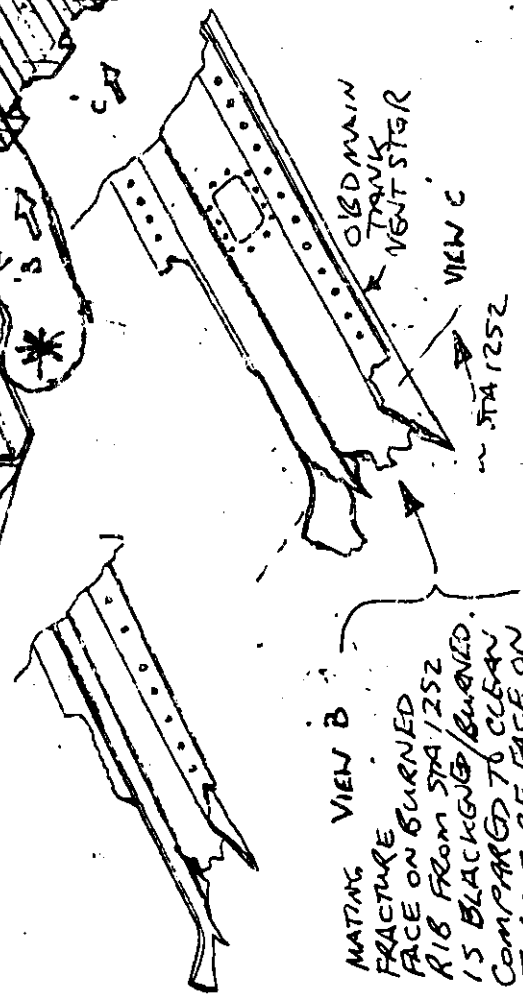
MATING VIEW B
FRACTURE
FACE ON BURNED
RIB FROM STA 1252
IS BLACKENED/BURNED.
COMPARED TO CLEAN
FRACTURE FACE ON
RW 4/RW1 VENT STR.

CHECK FRACTURE FACE OF
SEPARATION OF LOWER SKIN CLT STRINGER SPlice
JUST AFT OF FRONT SPAR.

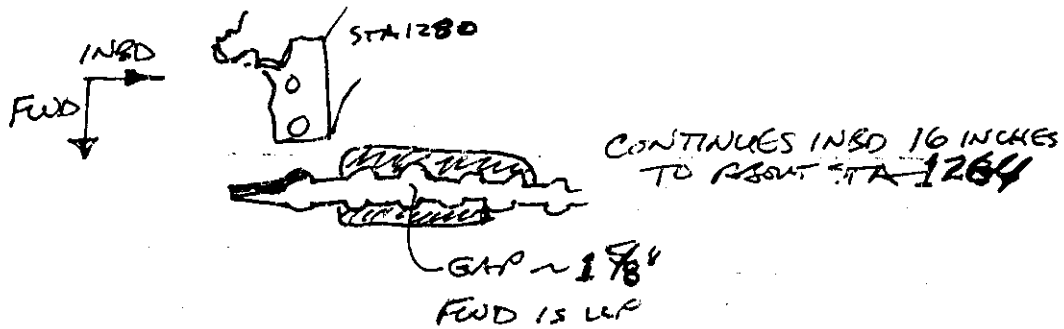
HOLE-TO-HOLE SEPARATION

RW5 STA 1280 STGR 11 ALONG SPANWISE
BEND LINE - BENDING & VERTICAL DISPLACEMENT

VERT. FLANGE FRACTURE TO ABOUT STA 1252 THEN HORIZ FL. CRACK.

OUTBD OF STA 1280 ALONG STGR 9 TO ~ STA 1220
SLANT FRACTURE OCCASIONALLY REVERSING
[INBD OF STA 1280, SLANT FRACTURE TEARING IS IN LWR SKIN]

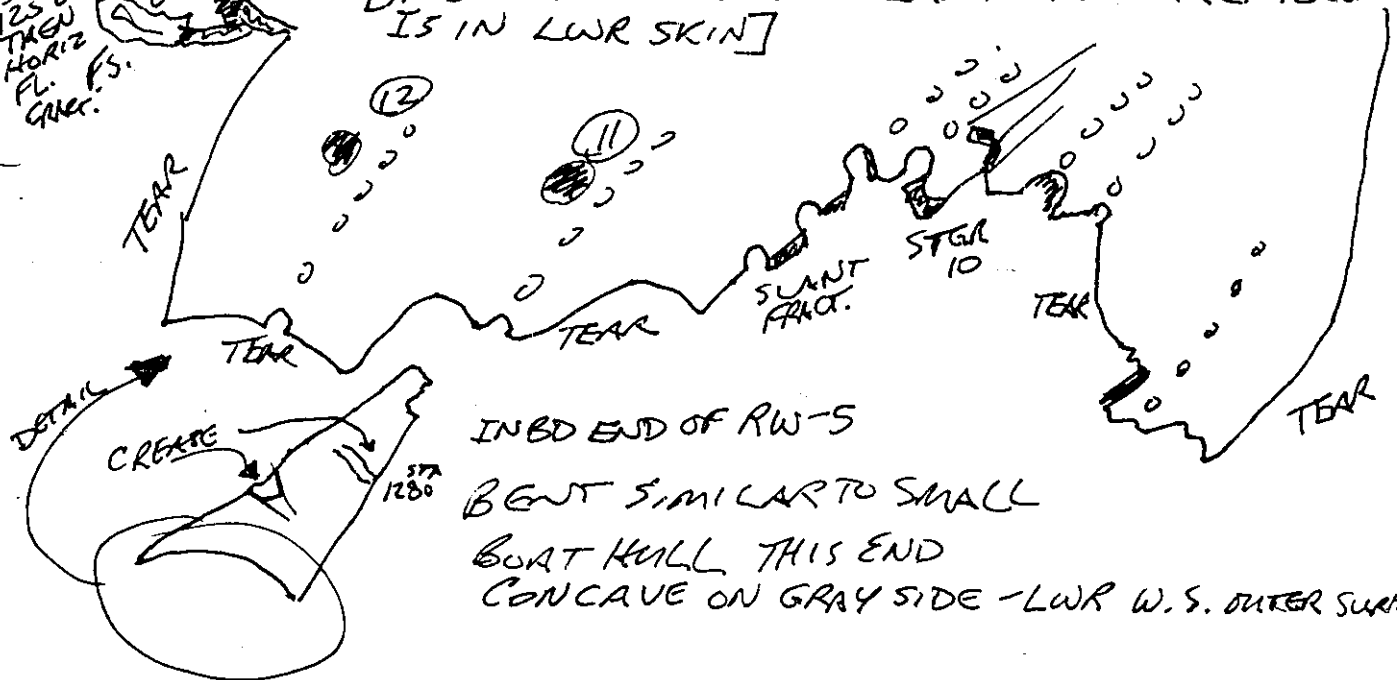
INBD END OF RW-5
BENT SIMILAR TO SMALL
BOAT HULL THIS END
CONCAVE ON GRAY SIDE - LWR W. S. OUTER SURFACE

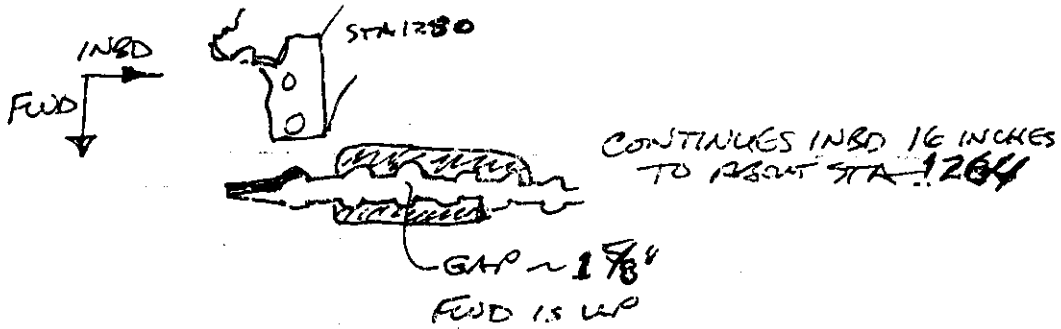
HOLE-TO-HOLE SEPARATION

RW5 STA 1280 STR 11 ALONG SPANWISE
BEND LINE - BENDING & VERTICAL DISPLACEMENT

VERT. FLANGE FRACTURE TO ABOUT STA 1252 THEN HORIZ FL. FRACT.

OUTBD OF STA 1280 ALONG STR 9 TO ~ STA 1220
SLANT FRACTURE OCCASIONALLY REVERSING
[INBD OF STA 1280 SLANT FRACTURE TENDING IS IN LWR SKIN]

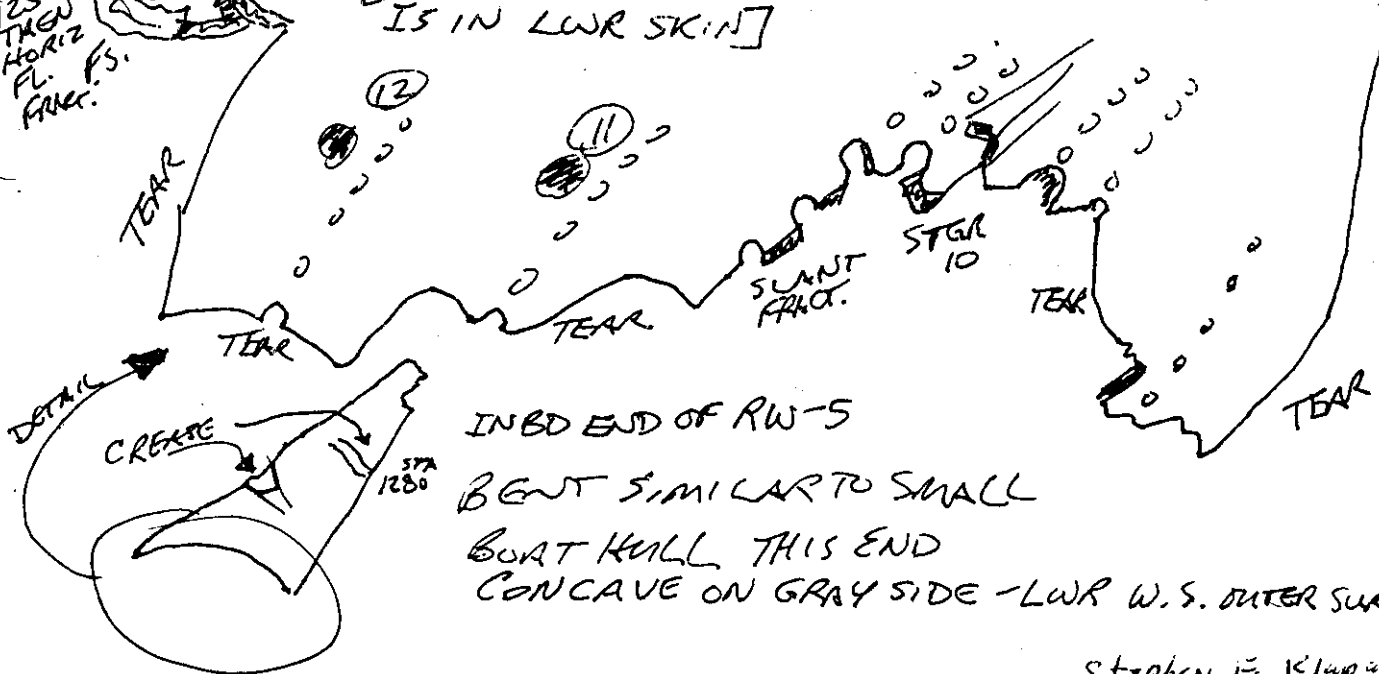
INBD END OF RW-5
BENT SIMILAR TO SMALL
BOAT HULL THIS END
CONCAVE ON GRAY SIDE - LWR W.S. OUTER SURFACE

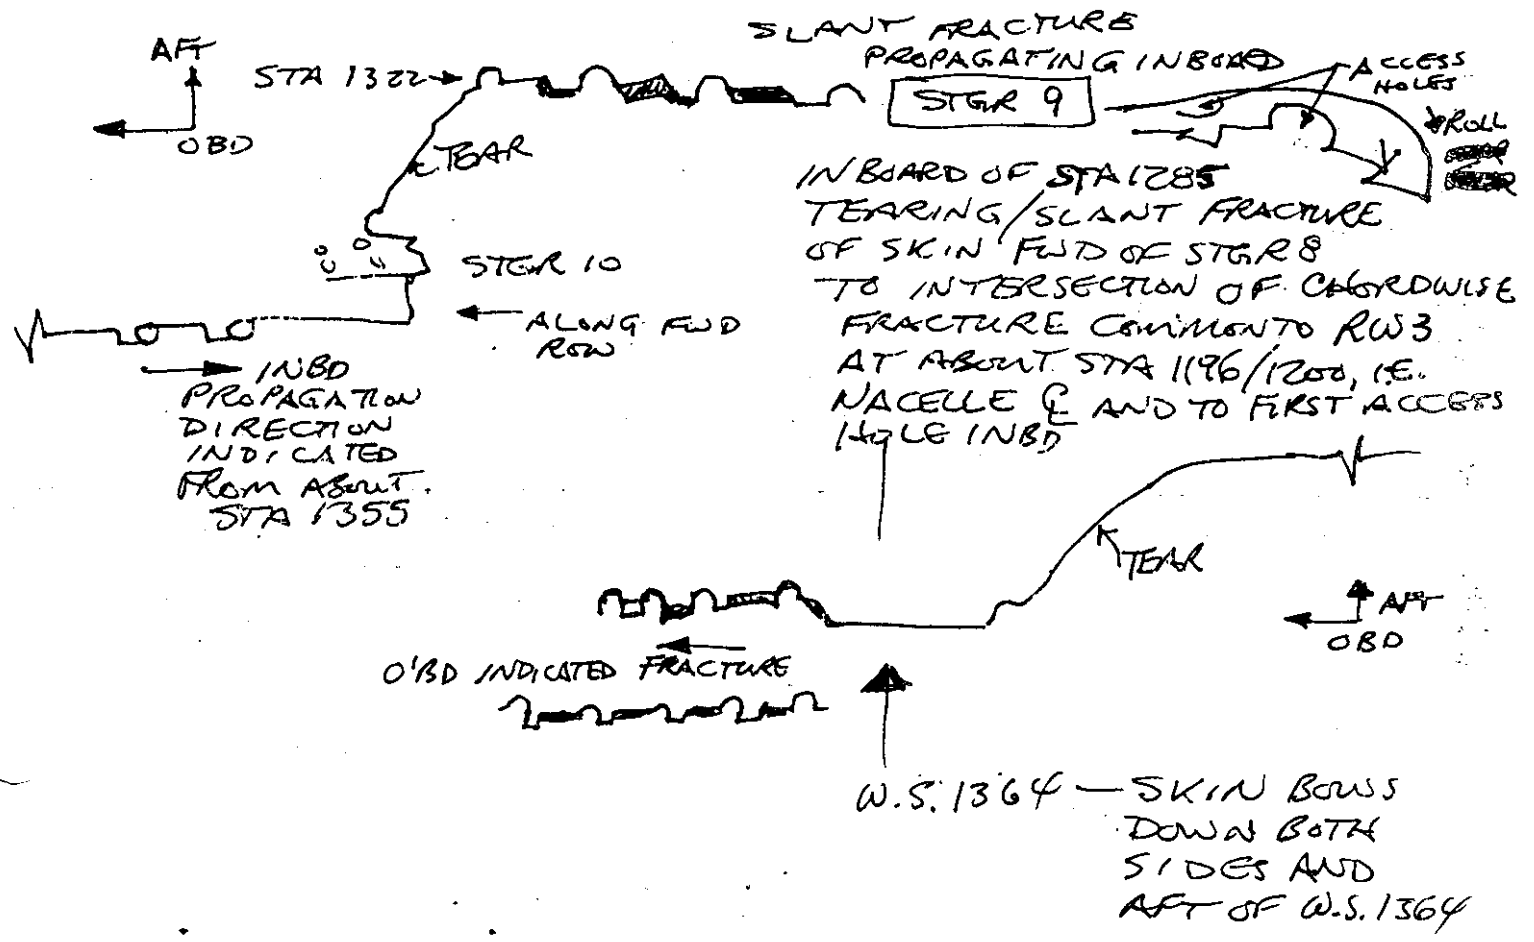
RW-10 HOLE TO HOLE SEPARATION

~ STA 1285 TO STA 1322
