Log V-2

DEBRIS FIELD FLLOATING TAG # E2007

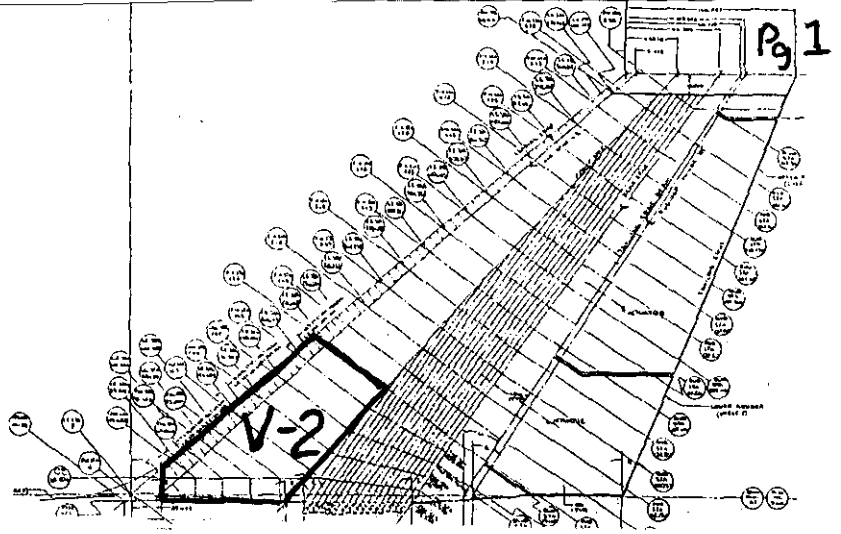
Starting at the lower edge of the leading edge the subject part can be described as follows;

1) At the mating surface with the Dorsal Fin (Part V-7), the L.H. Side is crushed upward with a portion of the Leading Edge skin missing and frames exposed. The right hand side lower 5 inches (approx.) is bent outboard.

2) The leading edge is crushed at numerous locations. There is one skin puncture on the leading edge, approx 36 inches long by 16 inches wide between Fin Sta 47 and 63.

3) At the upper end of the subject part at Fin Sta 220, the leading edge is crushed down and there is evidence of slight blue color paint transfer on the buffed leading edge skin.

4) There is also blue color paint transfer on the front spar fracture at Fin Sta 220, RBL 2.

5) The front spar web from Fin Sta 117 to 169 with a 45" segment of fin sta. 143 rib attached, LHS spar chord to the RHS spar chord, has been torn loose and displaced forward toward the leading edge. Failure modes of the chord-to-web attachments are a combination of sheared rivets, sheared out webs, bearing failures in web, and web fractures through rivet lines. The leading edge portion of the Fin Sta 143 rib that was attached to the displaced section of the front spar web has been wedged into the separation at the LHS fin sta 169 panel joint.

6) The LHS panels above and below Fin Sta 169 have separated for their entire length from the aux spar to the front spar due to rib chord failure.

7) At fin sta. 195, LHS, the lower panel has been pulled outboard 3" maximum at front spar, over a length of 30" towards the aux spar. The front spar chord is fractured at fin sta. 195. In addition to the previous damage, the left side front spar chord is bowed between fin sta. 117 to the fracture at fin sta. 195 with an apex at fin sta. 169.
