**WATER IMPACT DAMAGE  
STUDY**

# Metallurgy Group Notes - Fuselage Water Impact Damage Survey

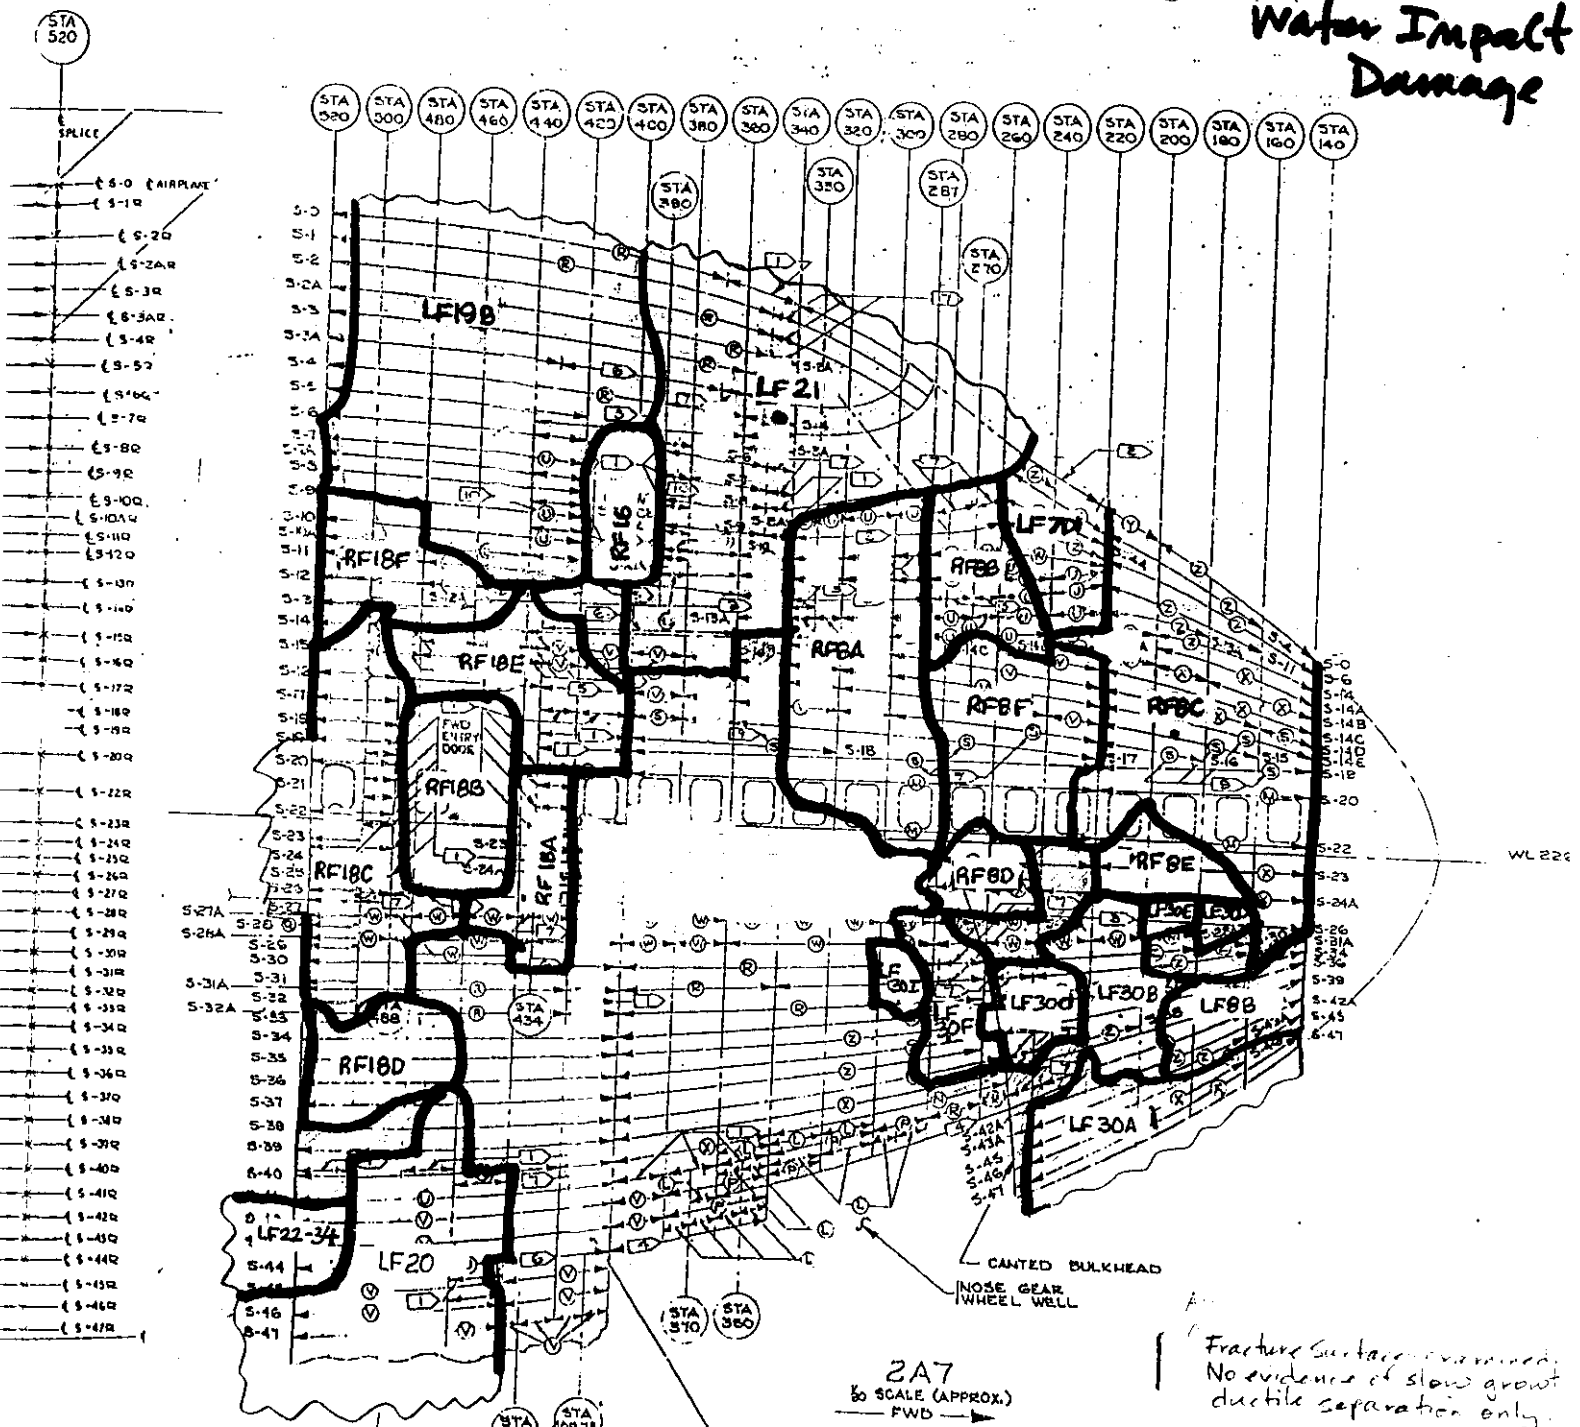
**SECTION 41 - STA. 140 - 520  
(R/H Side)**

- The right side of the airplane exhibited water impact damage up to the window belt  $\approx$  S-22R whereas the left side of the airplane exhibited water impact damage from S-45R (at Sta. 140) to S-37L (at Sta. 780).

**Water Impact  
Damage**

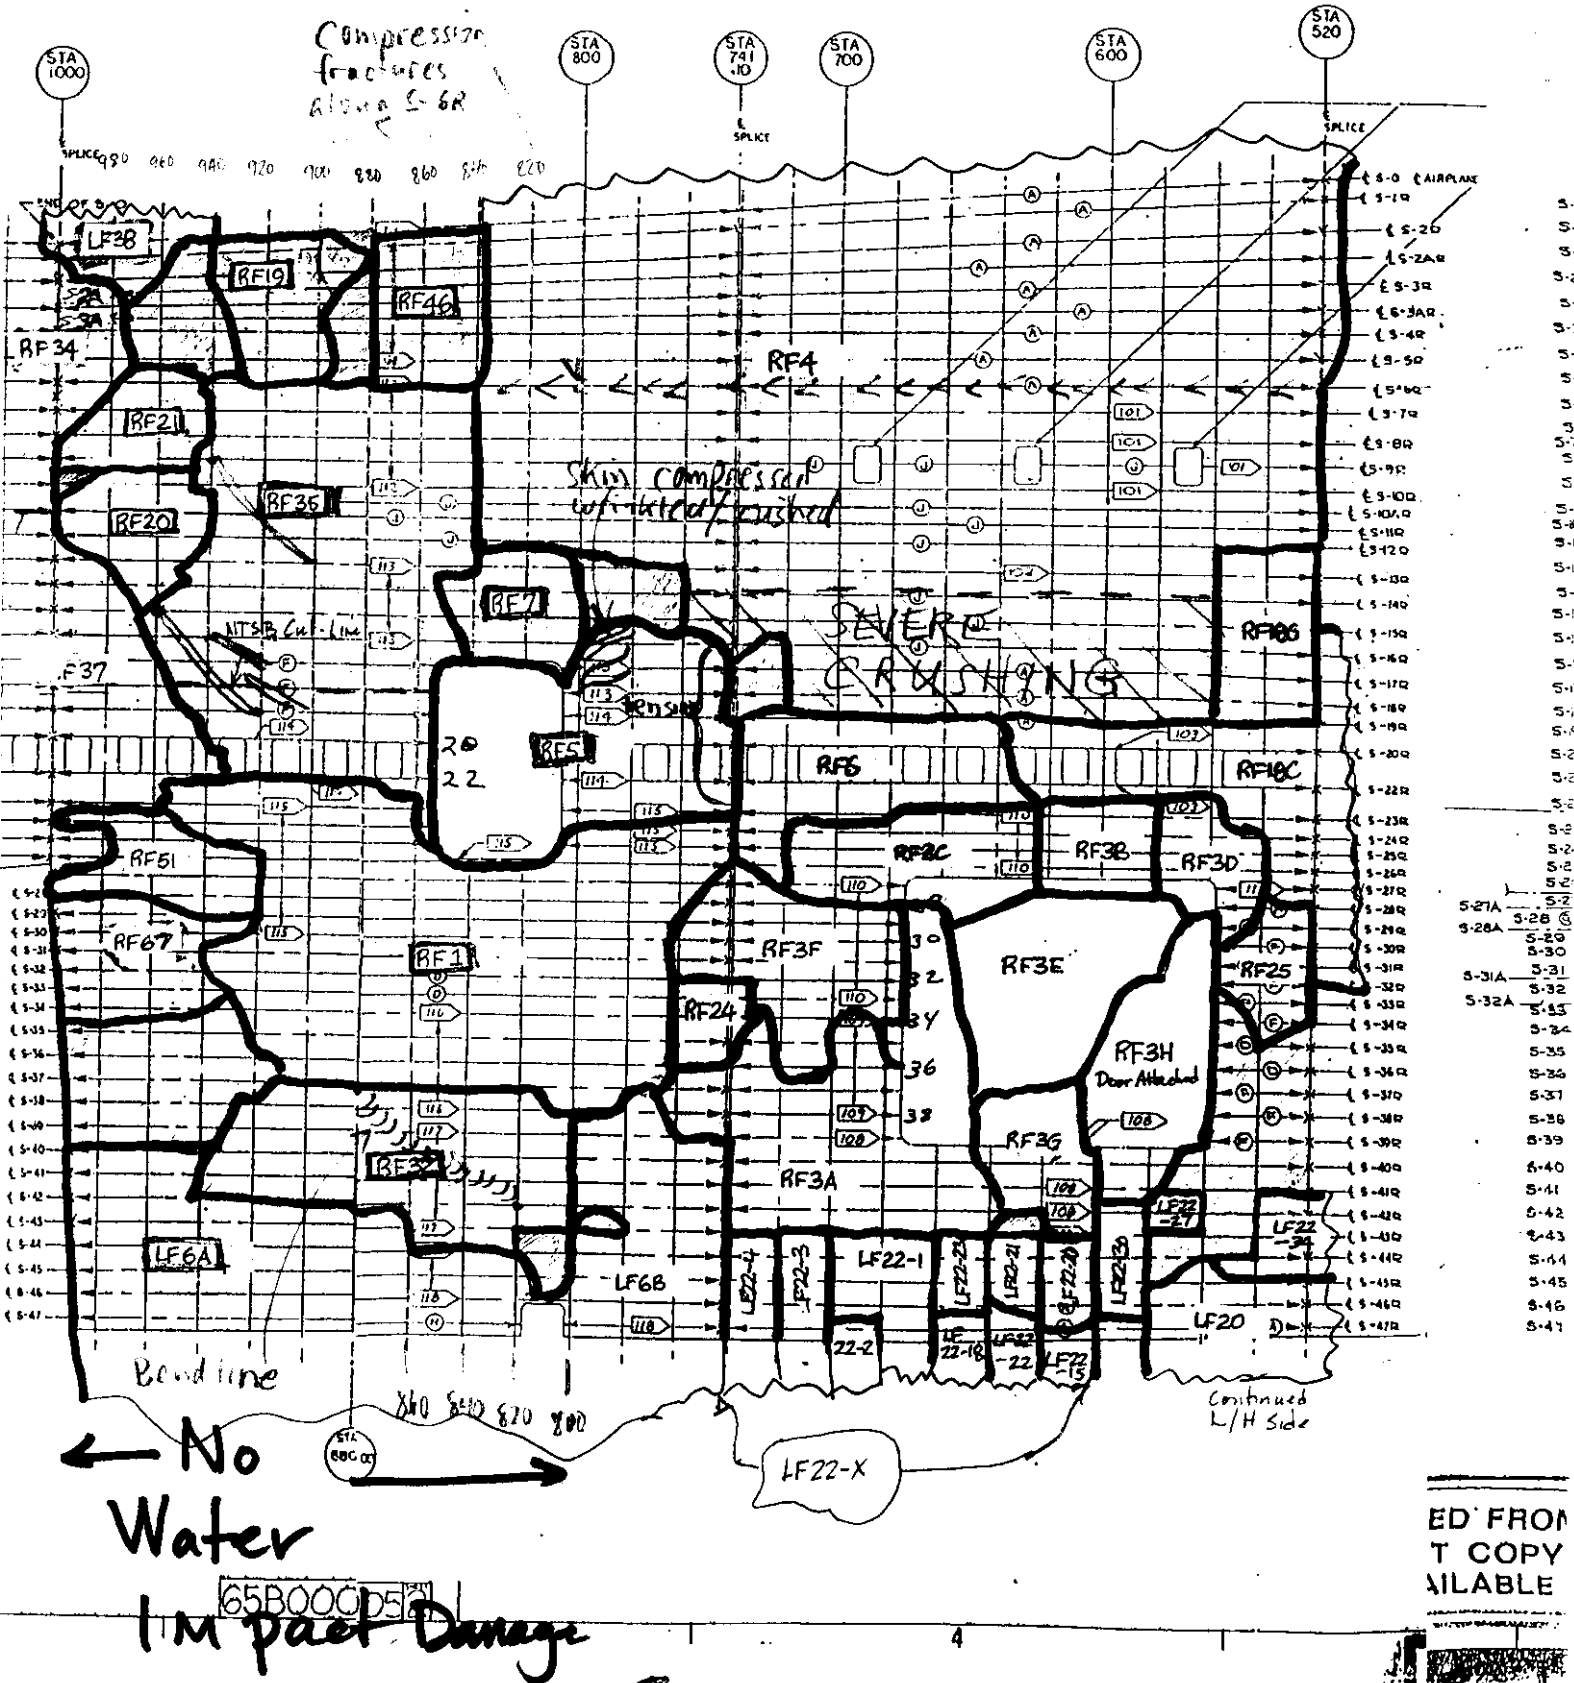
# SECTION 42 - STA. 520-1000 (R/H Side)

- No water impact damage was noted in these pieces on either right or left sides.

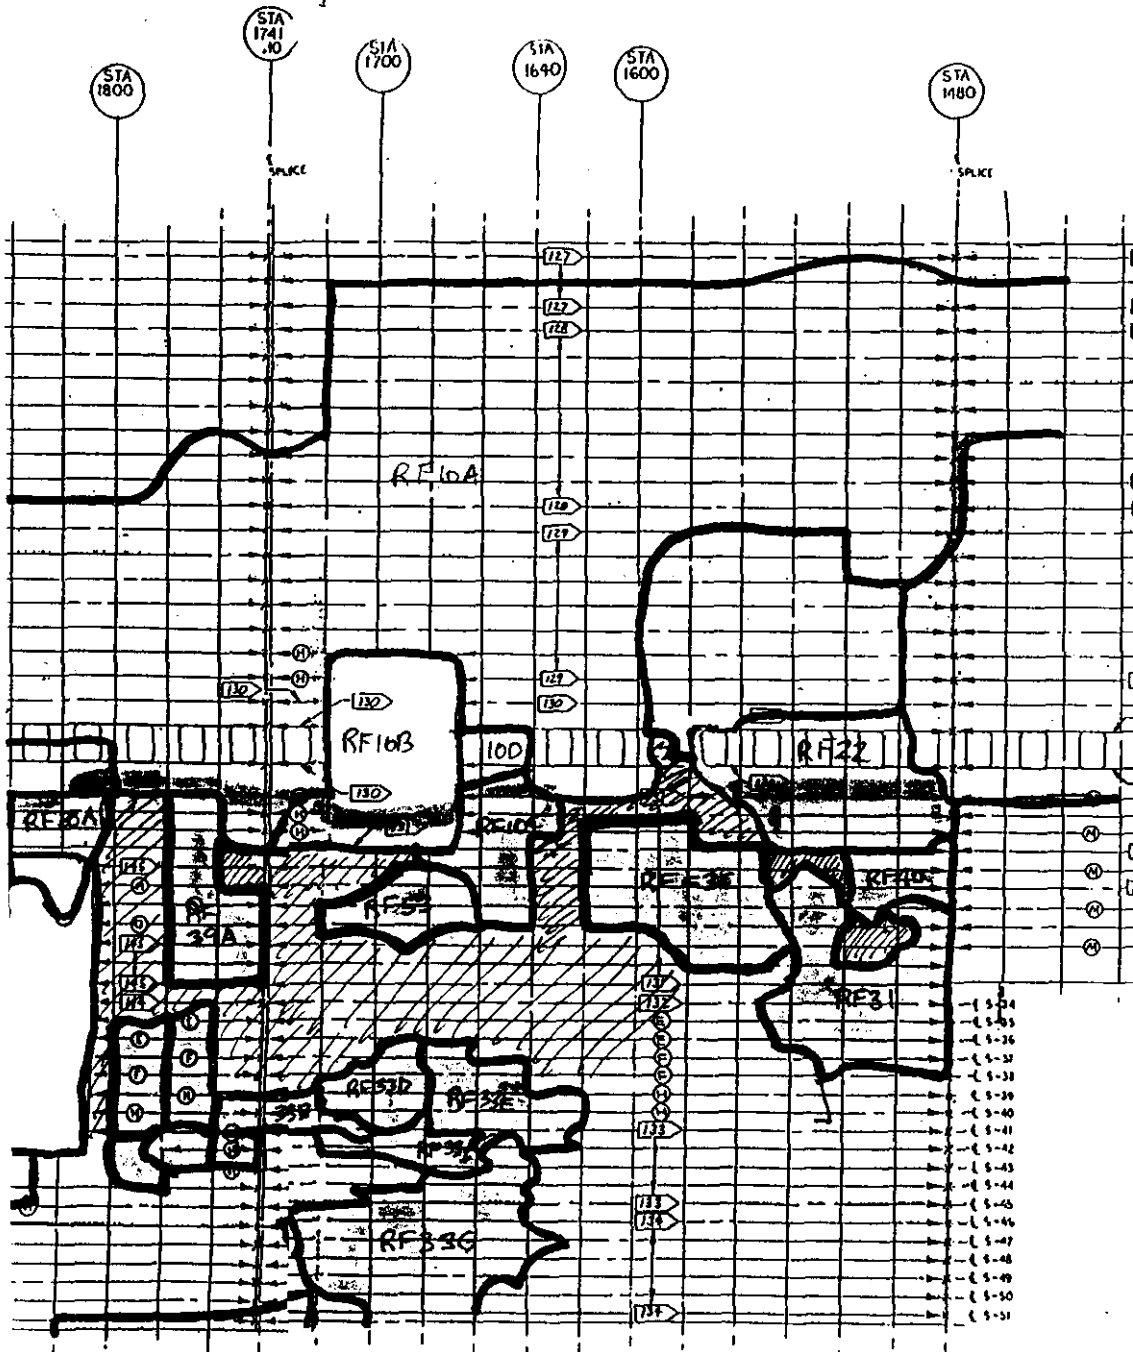
SECTION 46 - STA. 1480  
 - 2360  
 (R/H Side)

- Right side of fuselage exhibited water impact damage below the window belt (S-22R) up to Sta. 2240. From Sta. 2240 to Sta. 2360 the damage progressed upward to S-16R.
- The left side of the fuselage exhibited water impact damage primarily below stringer 28L up to Sta. 2240. From Sta. 2240 to Sta. 2360 the damage progressed upward to S-19L.

Below Blue Line  
Parts exhibited  
Water Impact  
Damage

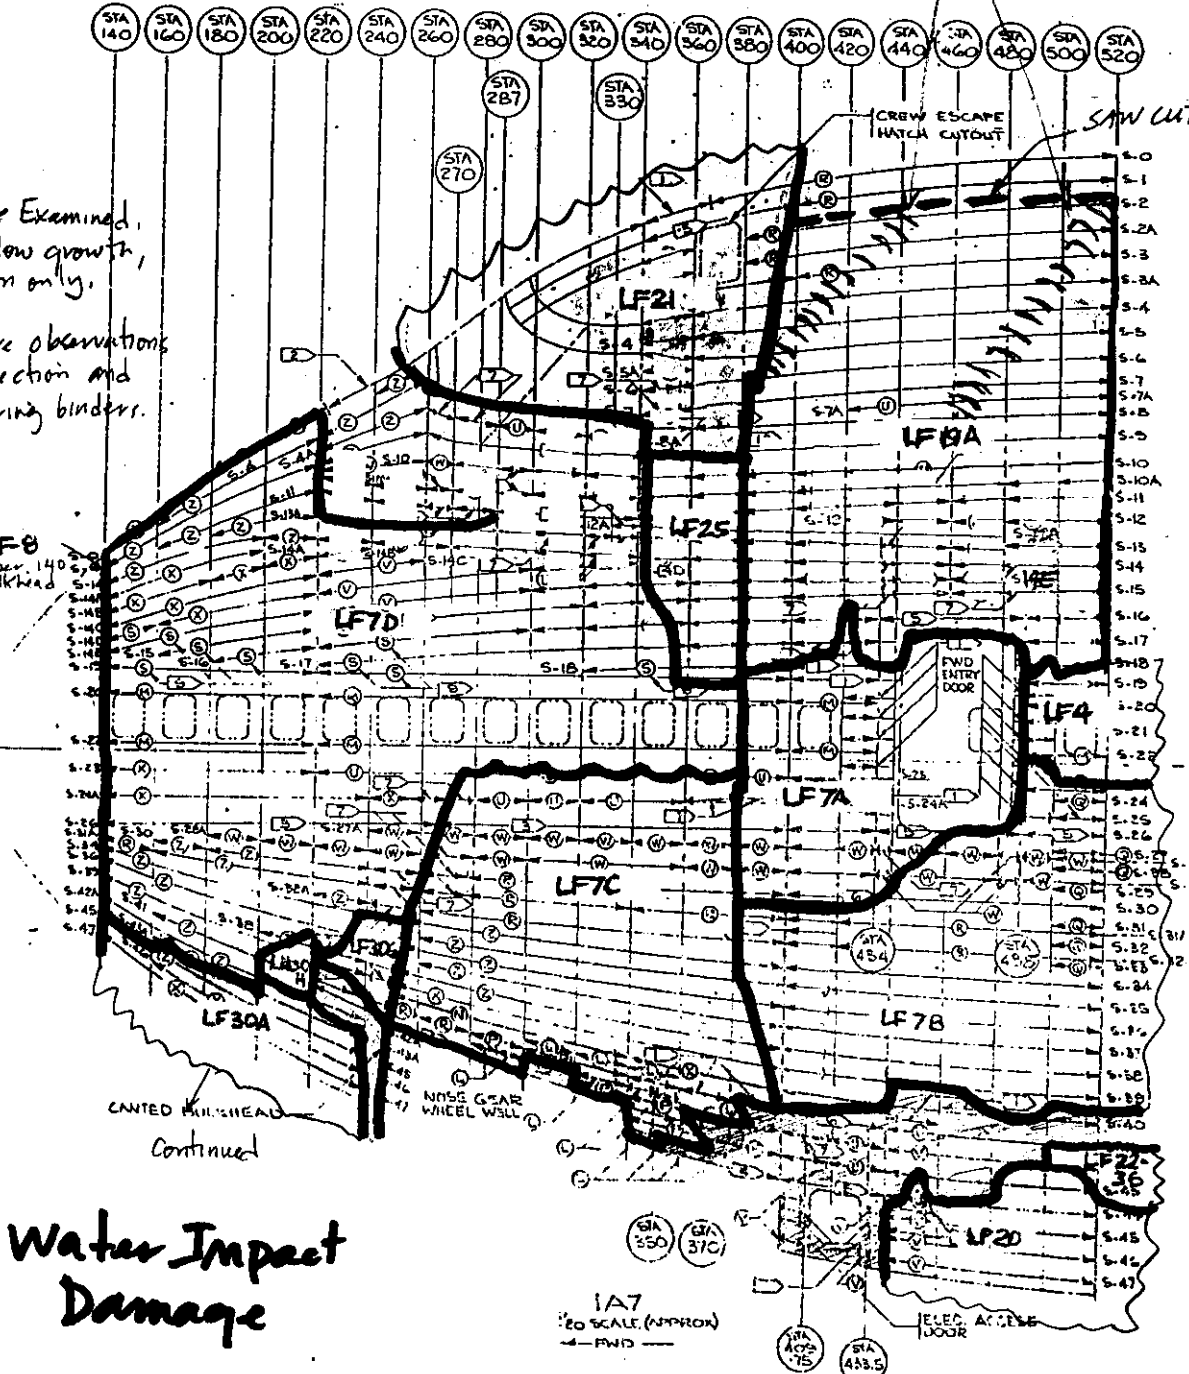
# SECTION 41 - STA. 140 - 520 (L/H Side)

Diagonal  
Wrinkles

Fracture Surface Examined,  
No evidence of slow growth,  
ductile separation only.

General fracture observations  
Made to noted section and  
documented in ring binders.

Water Impact  
Damage

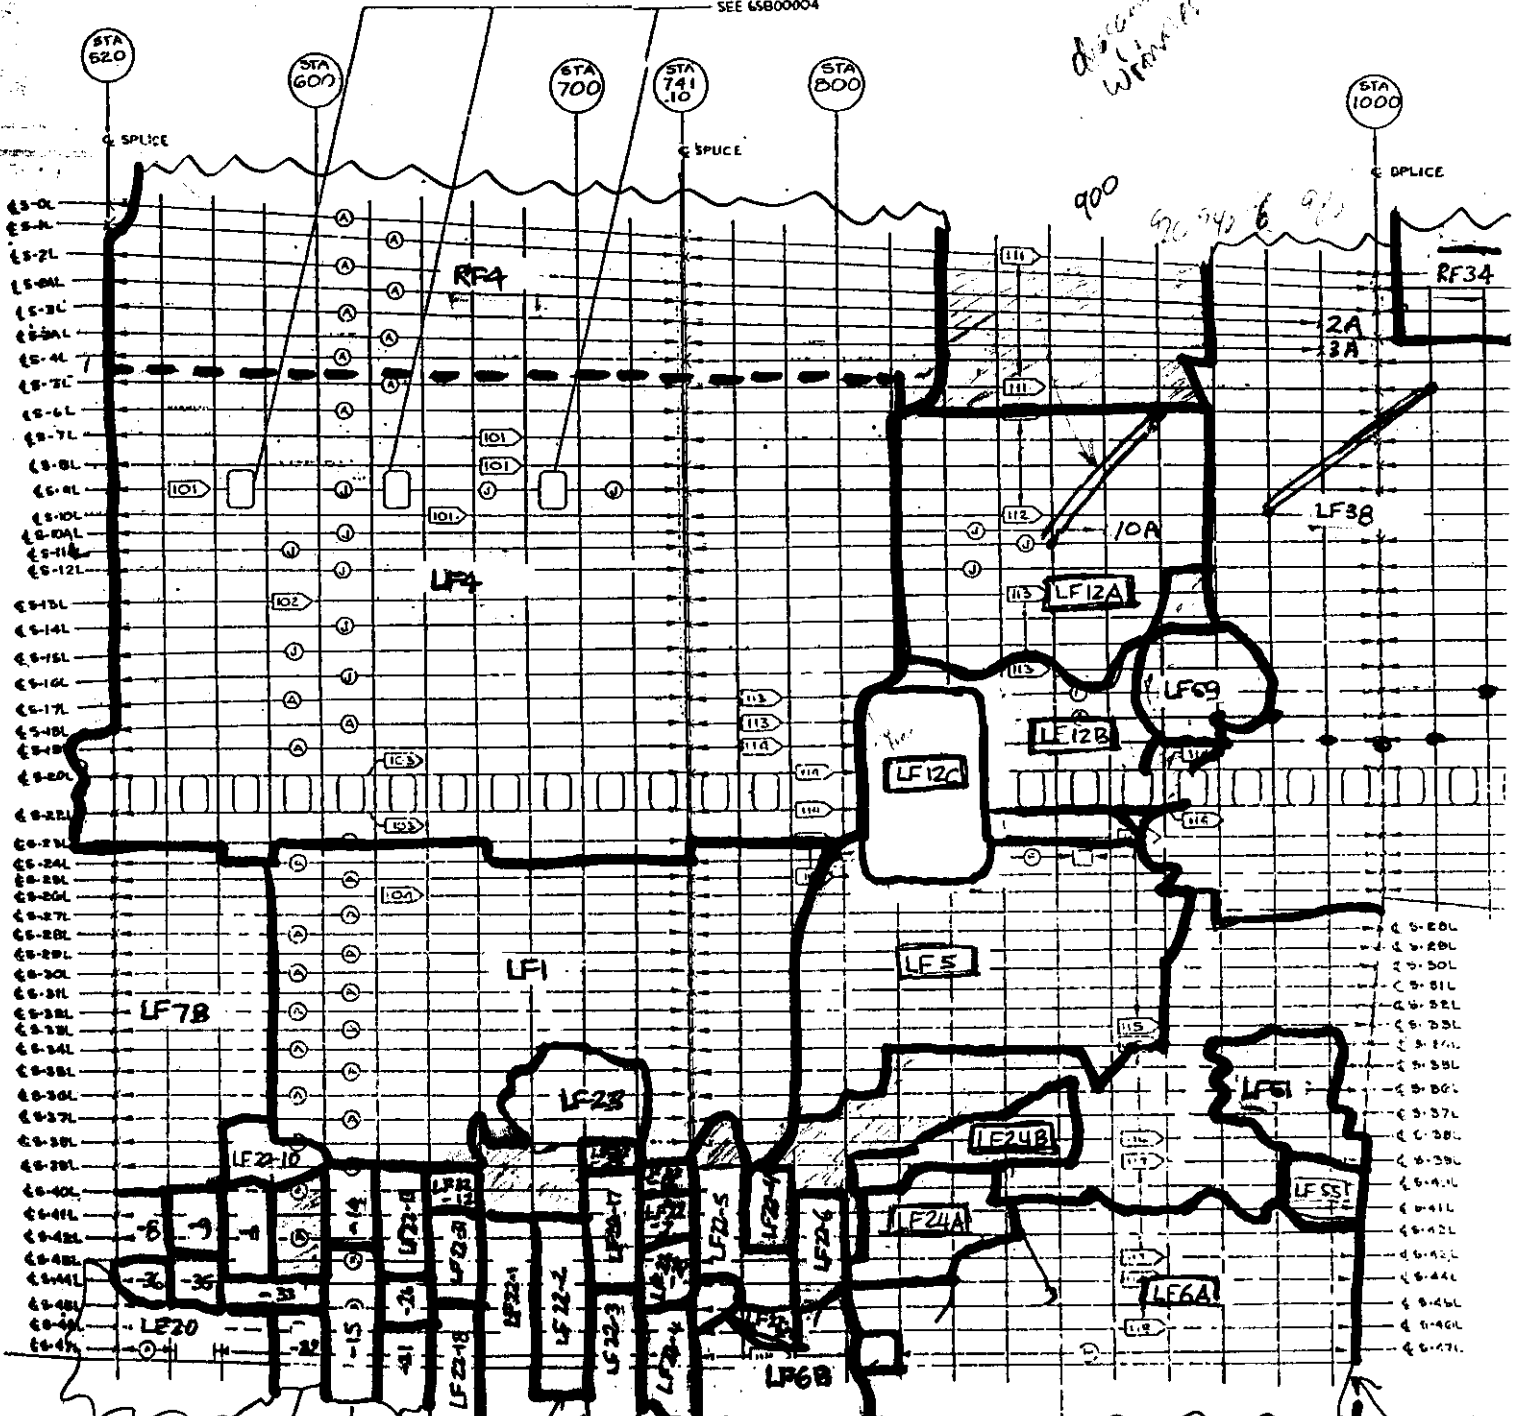
# SECTION 42 - STA. 520-1000 (L/H Side)

No  
Water  
Impact  
Damage
