**NATIONAL TRANSPORTATION SAFETY BOARD  
Office of Aviation Safety  
Washington, DC 20594**

**STRUCTURES GROUP - WING CENTER SECTION SUMMARY**

**ACCIDENT : DCA96MA070**  
**Location : East Moriches, New York**  
**Date : July 17, 1996**  
**Time : 2031 Eastern Daylight Time**  
**Airplane : Boeing 747-131, N93119**  
**Operated as Trans World Airlines (TWA) Flight 800**

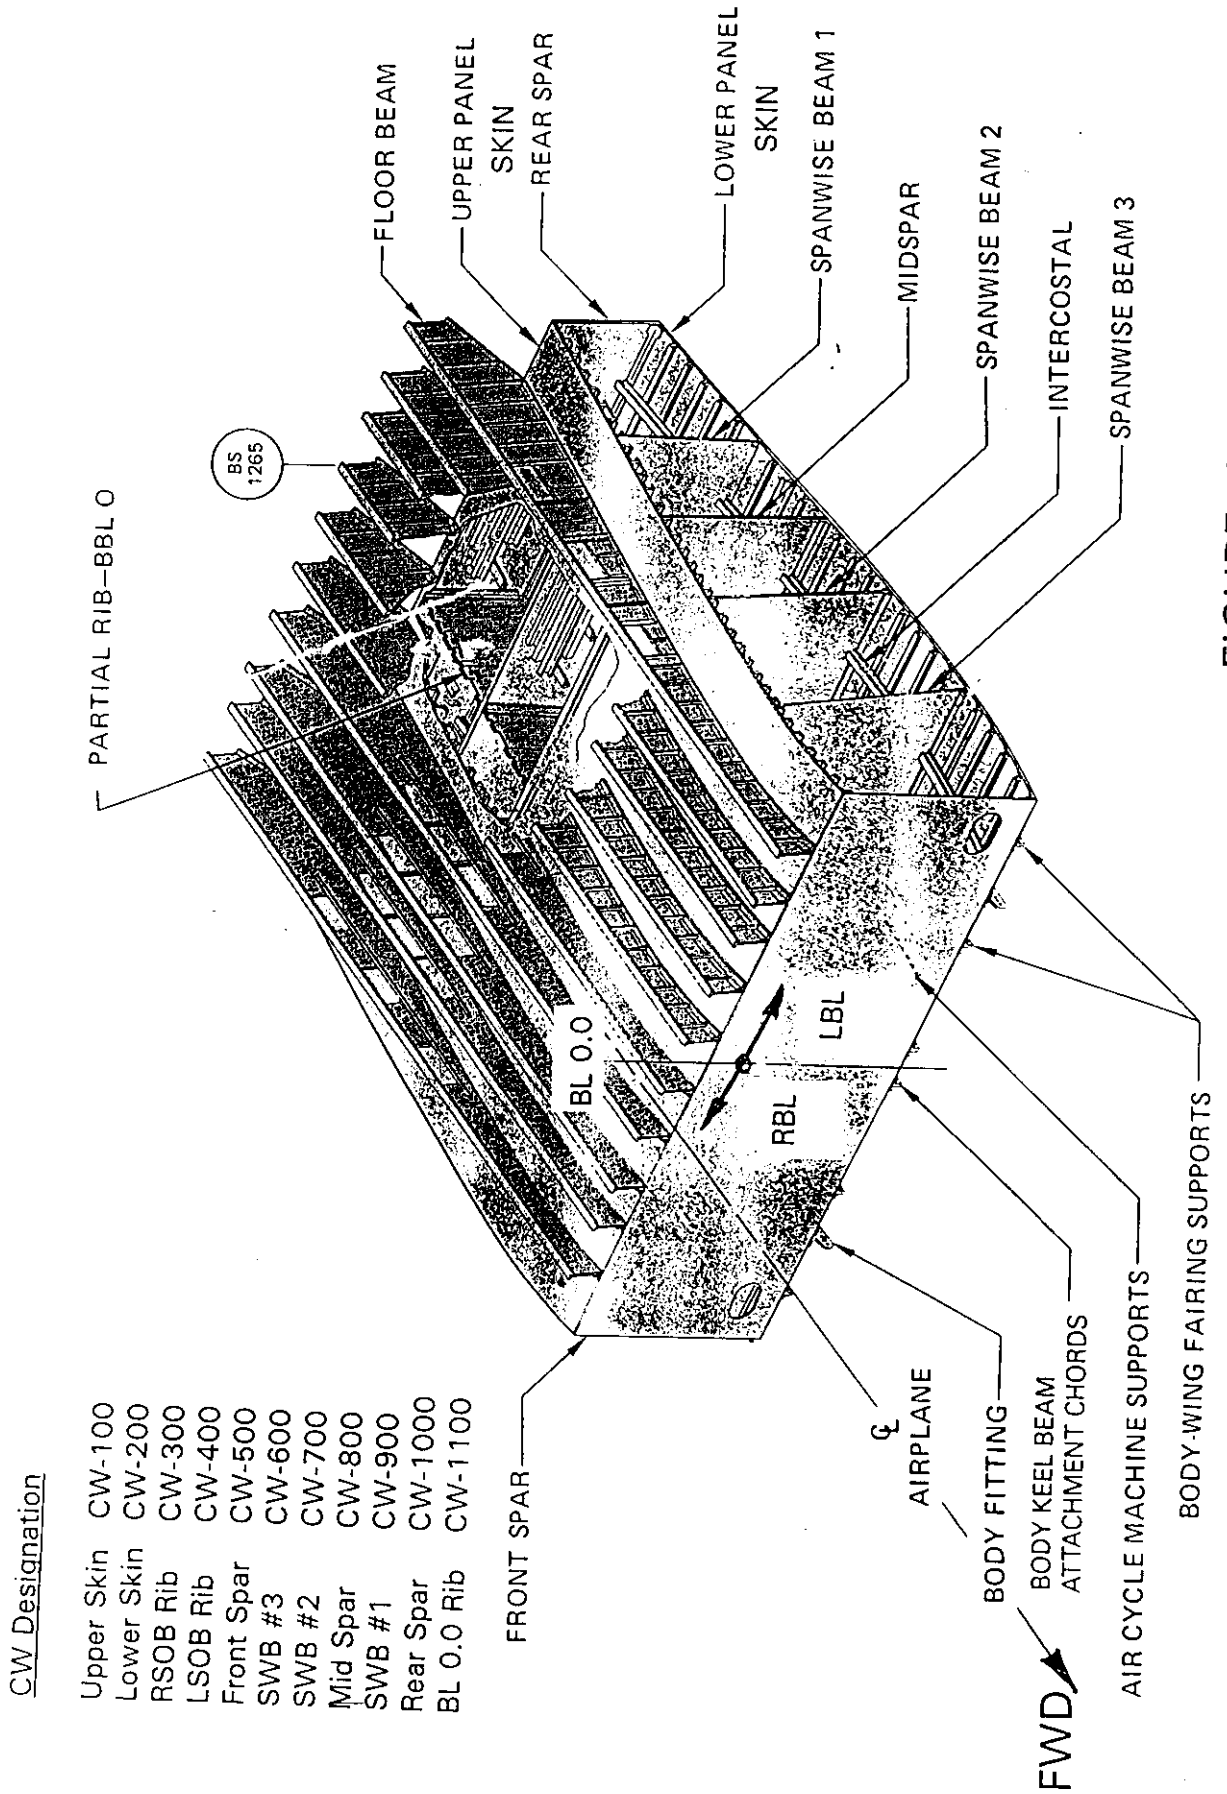
FIGURE 1

The center wing section (CWS) is a multi-cell box which connects the right and left wings through the fuselage. It is comprised of five cells formed by the Front Spar (FS), Spanwise Beam (SWB3), SWB2, the Mid Spar (MS), SWB1, and the Rear Spar (RS). The CWS extends chordwise from the front spar at approximately STA 1000 to the RS at approximately STA 1238 and spanwise between the left side-of-body (LSOB) rib at LBL 127.5 to the right side-of-body (RSOB) rib at RBL 127.5. The SOB ribs separate the CWS from the outboard wings. The MS from both of the wings connect through the CWS at fuselage STA 1140. There are three spanwise beams (SWB) in the CWS which extend from the left to right SOB ribs. SWB3 at STA 1042 is aft of the FS. SWB2 at STA 1096 is aft of SWB3 and forward of the MS. SWB1 at STA 1180 is aft of the MS and fwd of the RS. The CWS has upper and lower skin panels which are connected to all the spars and beams thus forming a closed box structure. The whole CWS box section is an airfoil shape and has the same contour as that of the outboard wings at the side of body. On N93119 (a 747-100) the center fuel tank is bounded by the RS on the back, a LSOB and RSOB on each side, and SWB3 on the front. The area between SWB3 and FS is a dry bay.

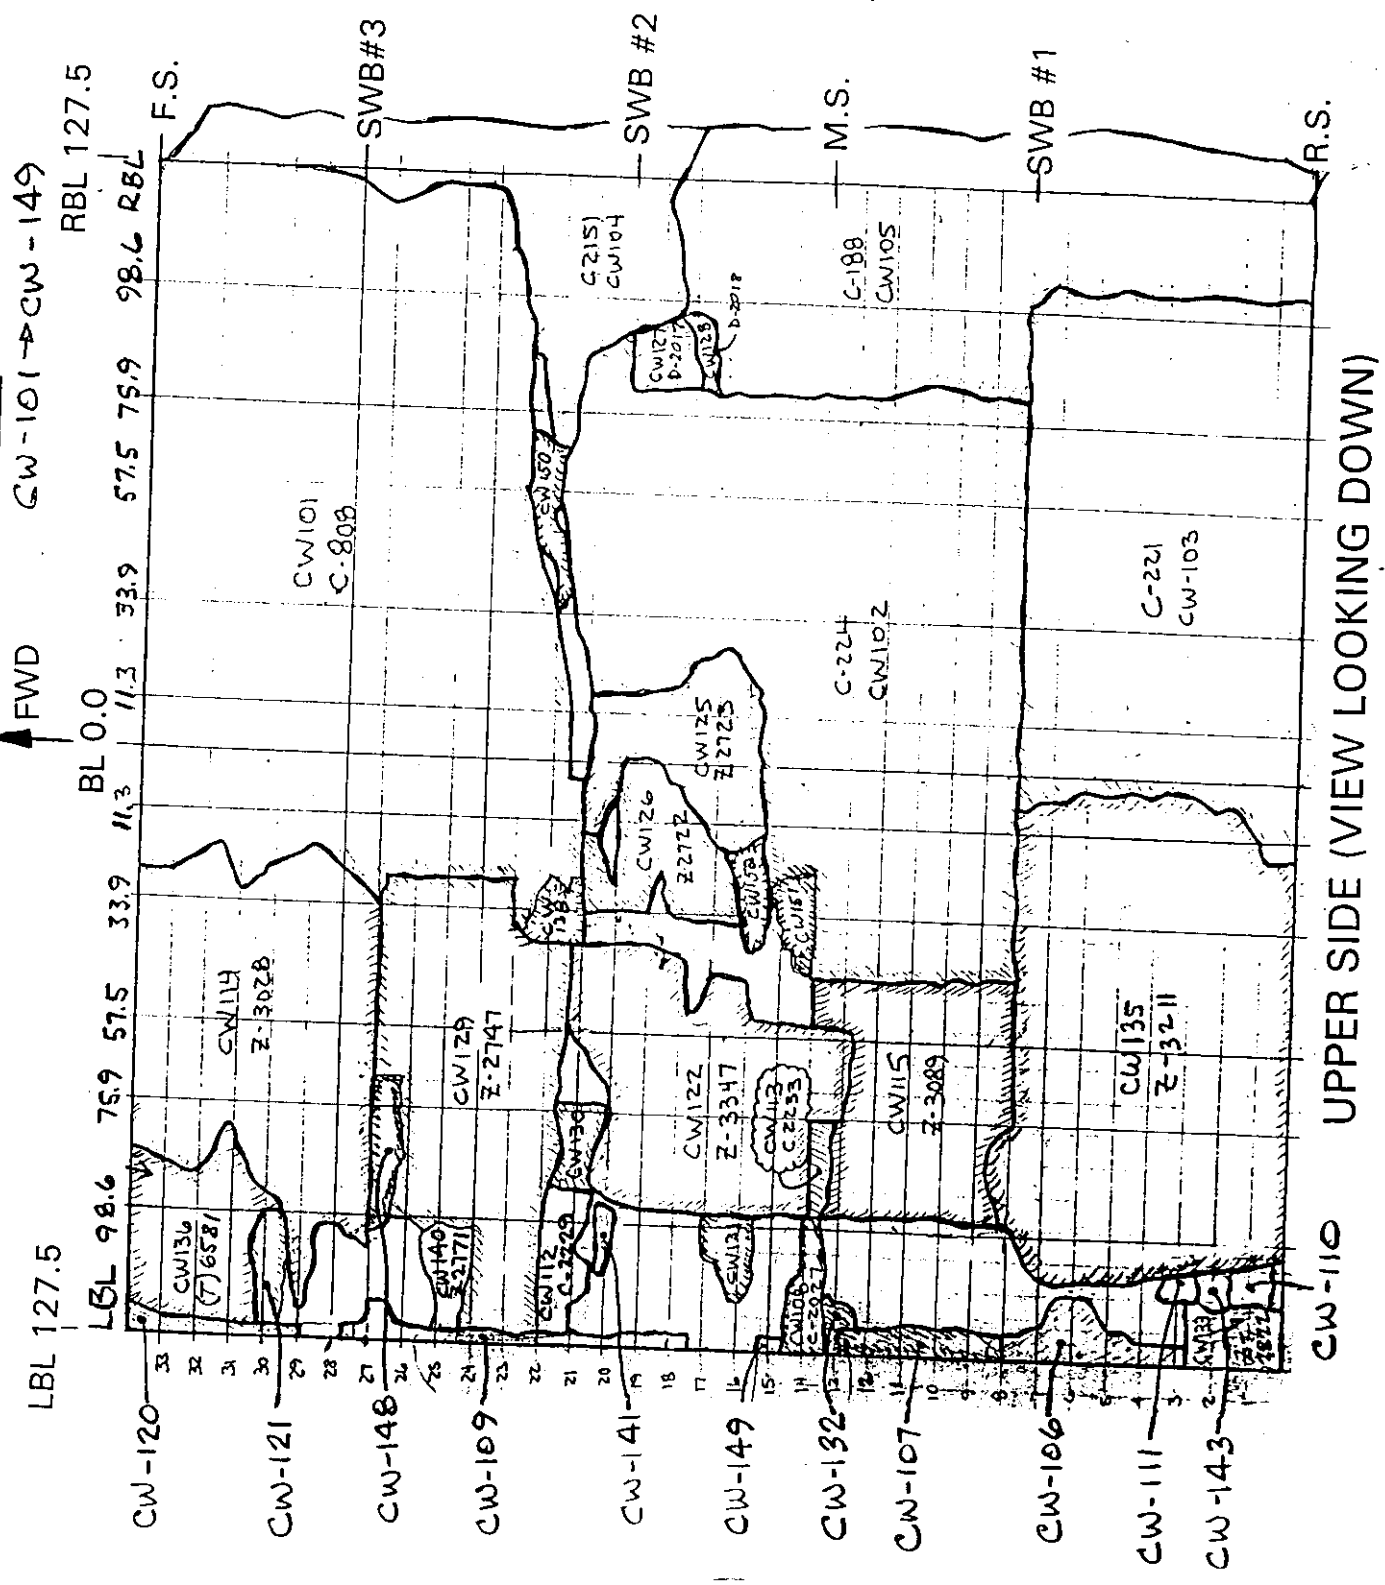
# CENTER WING TANK - UPPER SKIN

The upper wing skin fractured into eight large sections and numerous smaller sections. All of these items were found in the Green debris area.

The right forward section (CW101), included part of the upper skin panel, stringers, and floor beams, extends from the RSOB to LBL 30, and from S-22 to the FS. The underside of the skin panel contains most of the stringers from S-22 to S-33 and includes the skin flange of the FS upper chord. The panel is bowed up approximately 12" at RBL 57.5 and the stringer at S-31, 32, and 33 are buckled and broken at RBL 57.5. The tension fittings at SWB3 remain intact on the lower side of the skin panel as well as the portion that remains attached to the floor beam on the upper side. (See sketch in CW602 for complete definition of remaining tension fittings on the lower surface). The left outboard end of the panel at LBL 30.00 has a very jagged fracture and has portions curled upwards as much as 45 degrees. The stringer splice fittings at RBL 127.5 (which attaches to the RSOB) at S-30 to S-33 remain attached to the stringers. The fastener holes common to the double plus chord are elongated inboard and outboard at the lower surface of the holes with a slight elongation on the upper surface of the holes. There are small metal fragments embedded in the sealant on the lower surface of this panel. (See Metallurgy Group Report for further description of these fragments.) There is no evidence of pre-existing cracks or corrosion on this panel. Some sooting is evident on the lower surface of the panel.

The left forward section of the upper skin fractured into smaller sections. The inboard fracture edge at LBL 30 is jagged and curls upwards at 45 degrees. The outboard edge bends down at a 45 degree angle on a 15" radius and has jagged edges. The forward portion of the upper skin is buckled in an "S" shape as viewed from the front (view looking aft).

The mid section of the skin fractured into three large sections on the right and several smaller sections on the left. The right portion of the upper skin (CW104) remains attached to RW-7 which was cut for reconstruction. The stringers at S-24 through S-26 have no skin panel above them and approximately 25" of each stringer is bent upwards at 90 degrees. There is evidence of heavy sooting in this area.

The fasteners remaining in the double plus chord free flange and the stringer end splice

fittings at S-31 through S-33,(CW104) exhibit shear failures in both inboard and upward directions. This section exhibits sooting and fire damage.

A large piece of mid upper skin extending from the rear spar to S-18 with its inboard edge at RBL 80 (CW105) is still attached to the upper section of the fuselage (RF17) that is heavily burned. The fracture line running approximately at RBL 80 is extremely jagged, and the end of the panel and the attached stringers are bent upwards at 45 degrees starting at RBL 100. The upper chords of the stub beams that attach to the RBL 98 floor beam are buckled and bent aft. The inboard end of the stringers S-10 through S-13 match the general deflection of the upper skin panel. The tension fittings at RBL 98 at both SWB1 and the MS remain attached on the upper and lower surfaces of the skin. A portion of both the MS and SWB1 remain attached to the upper skin near the RSOB. The portion of SWB1 is bent aft at its inboard end and the portion of MS is bent slightly forward at its inboard end. There is heavy sooting and fire damage on the upper surface and some soot on the lower surface.

A very large section of the upper skin mid section (CW102) includes of portion of skin panel, stringers, and floor beams that extend from RBL 78 to LBL 45, and from SWB1 to S-22. It also has a large section of MS (CW801) and SWB2 (CW702) still attached. The skin panel has multiple smaller fractures and bends of varying radii in several directions, but is generally bowed up at the inboard and outboard ends. The fracture edge at LBL 45 has a local curl down. The forward edge of the panel at SWB2 is bent upwards at 35 degrees and there is a fracture in the panel aft of SWB2. Just forward of SWB2, there is a 3 inch x 1 inch vertical puncture in the skin. At LBL 20 just aft of the MS, there is a semi-circular 6 inch x 8 inch delamination on the skin lower surface that is bent down approximately 4 inches from the inner surface of the panel. It remains attached on the inboard edge. Small metal particles were found imbedded in the sealant in the lower surface of this panel. There is evidence of heavy fire damage.

The aft side of the upper skin fractured into two large pieces and several smaller pieces at the aft left corner. The right aft side (CW103) extends from LBL 5 to RBL 100 and from RS to SWB1. The upper surface of this panel is burned. Only the skin flange of the upper rear spar chord remains attached. The forward edge of the fracture goes through the fastener line at SWB1.

The inboard edge of the panel is bent upwards 10 degrees starting approximately at RBL 8. The left side (CW135) extends forward from the rear spar to SWB1, and from LBL 98.6 inboard to about LBL 5. The panel is bowed up approximately 12 inches about a fore-aft axis located at its mid span.

A significant portion of the left side of the upper skin, inboard of the LSOB, fractured into numerous small sections.

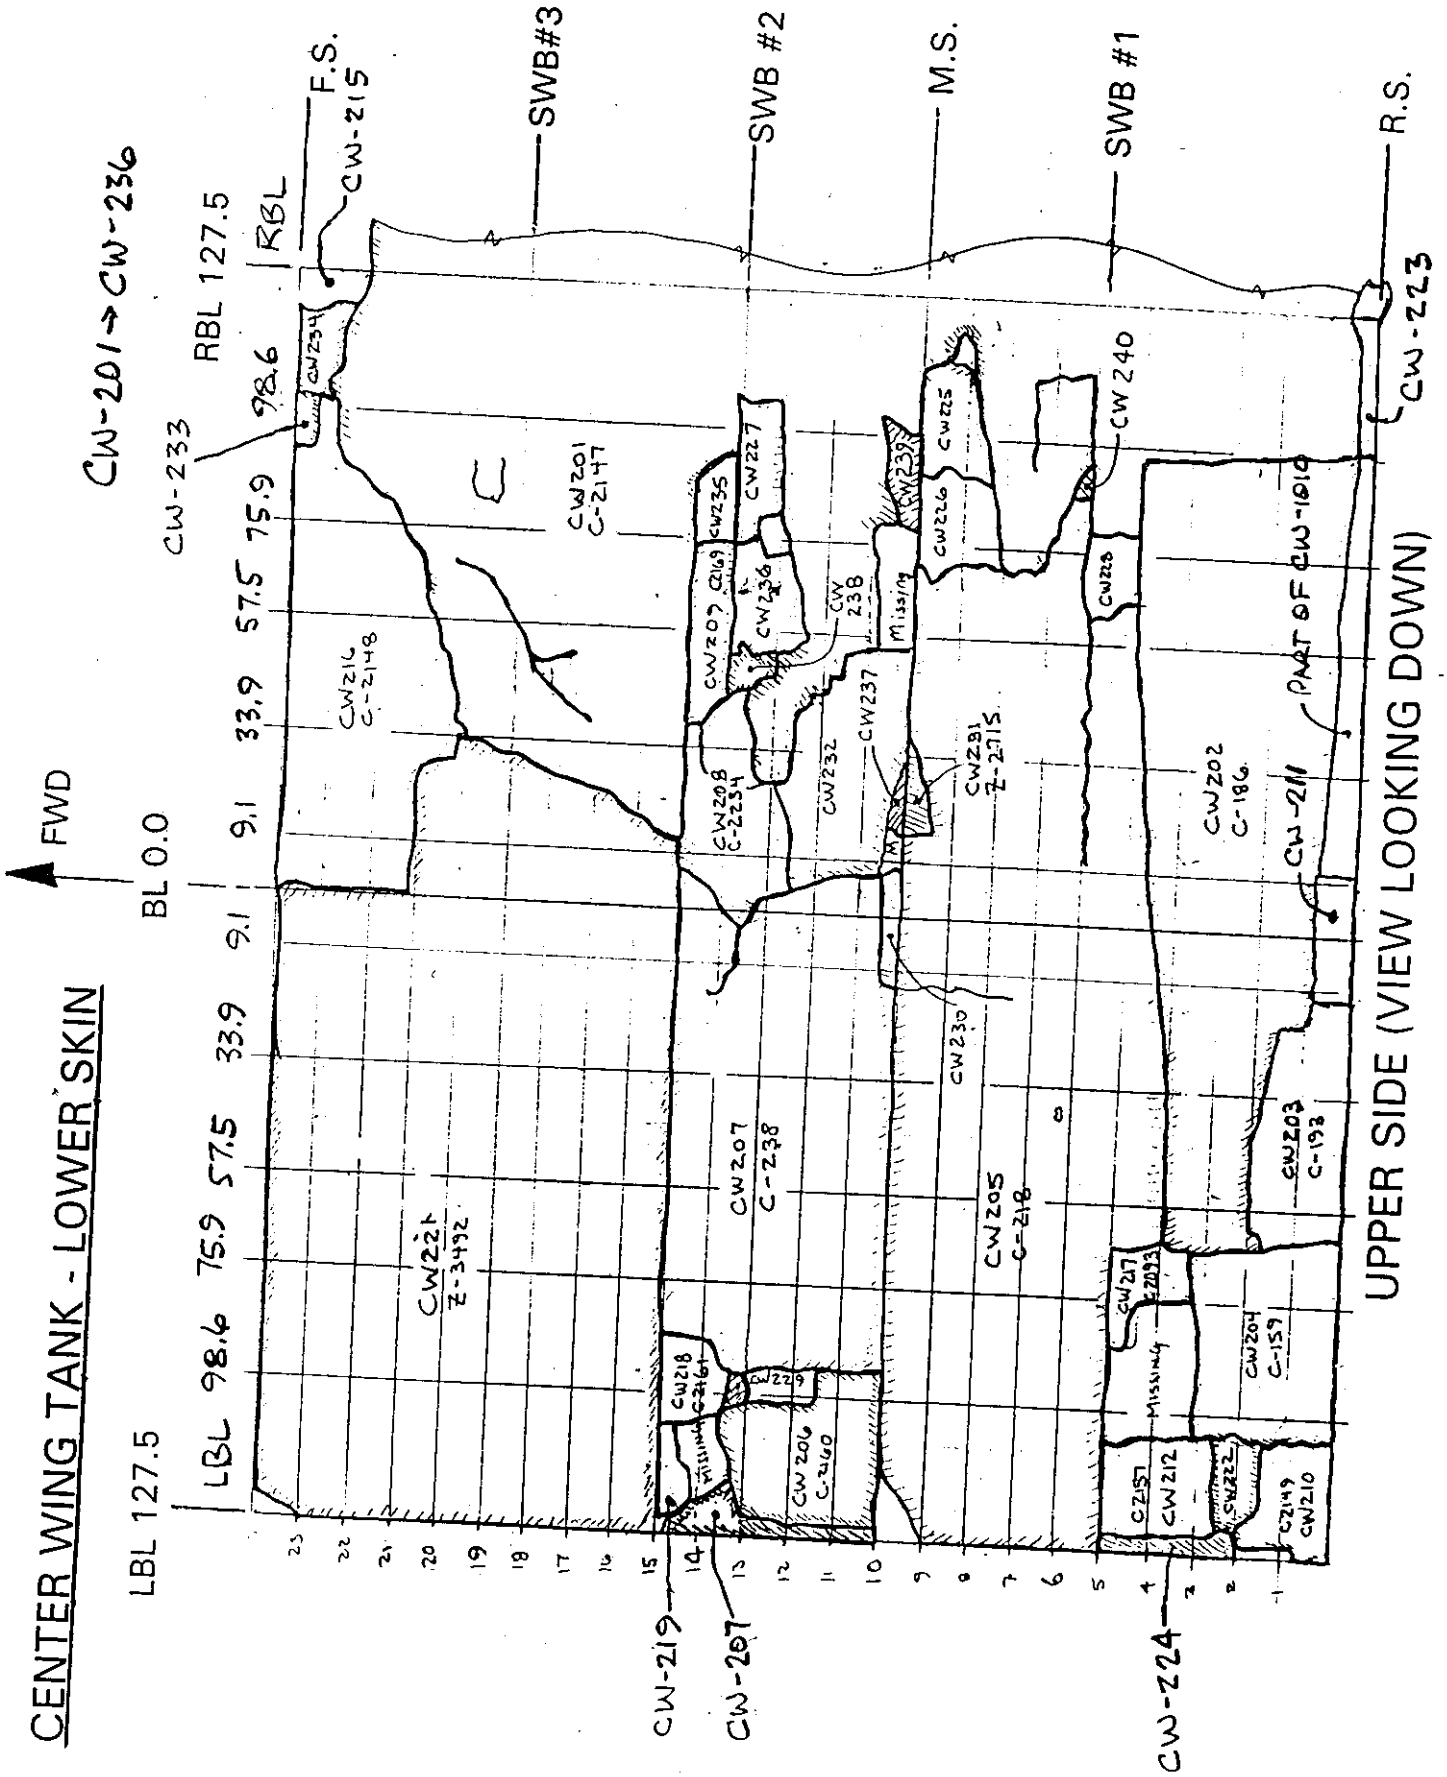
CENTER WING TANK - LOWER SKIN

The lower skin fractured into six large sections and several smaller sections. All these sections were found in the Green debris area.

The entire right side of the lower skin (CW201) extends from S-1 to S-23 was cut from the lower right hand wing skin (RW-3) for reconstruction of the CWS. The inboard edge of the skin from rear spar to S-5 is curled down and the stringers are separated from the panel from S-1 to S-4. At S-5 the stringer matches the periphery of the panel and remains attached. Between S-6 and S-8 there is a portion of the panel that is fractured at RBL 110 and the outboard edge is bent downwards whereas the inboard edge between S-7 and S-8 is bent upwards. The skin between S-11 and S-13 extending inboard, has a very jagged fracture pattern and is bent both upwards and downwards at multiple locations. The skin portion between S-15 and S-23 exhibits general upward bending with multiple smaller curvatures both upwards and downwards. Just forward of S-21, the skin is fractured from RBL 127 to RBL 100 and the outboard edge of the skin forward of this fracture is bent down. The skin splice stringer flanges remain attached to the skin panel with some fasteners, and the majority of the remaining fractured fasteners indicate tension failures. The majority of the fastener holes on the skin do not exhibit elongation except at SWB1, S-17 and S-22, where there is some elongation of holes fore and aft. On the forward right outboard side of this section, there is evidence of pillowing of the skin between the stringers in an upward direction. There is evidence of fire damage and soot accumulation. (See the Fire and Explosion Group notes for further detail).

The forward side of the lower skin separated in two large and three smaller sections (RH corner). The forward left side (CW-221) is a large section of skin panel with stringers that extends from the LSOB to RBL 33 and from S-15 to the FS. Using the area at BL 0 as a reference, the panel bends down 15 degrees at LBL 43 going outboard and bends up at a 10 degree angle at LBL 72. The depth of the bend is 7 inches at the FS and about 12 inches at SWB 3. There are small fatigue cracks on the aft side of the FS shear ties at LBL 84 and LBL 92. There is also a small fatigue crack at the fillet radius of the FS chord near the longeron splice at LBL 80. (For documentation of the fatigue cracks, see Metallurgical Group report.) The upper tension fitting on the upper surface of the skin panel at the longeron splice is fractured through the tension bolt hole and is deformed at the forward end. The lower tension fitting attached to the lower surface of the panel is intact, but the hole for the horizontal tension bolt is elongated vertically. The underwing longeron fitting exhibits a tension failure at the aft bolt hole with some bending to the left. There is some soot on the inner and outer surfaces of the skin panel.

The mid section of the lower skin fractured into one large section (CW207) and numerous smaller sections located on the right and left sides. The panel (CW207) is bent down at the center (approximately LBL 50), and there is a fracture near the forward edge that extends from the inboard edge aft of SWB2 to LBL 16. This fracture produced a section of skin panel that is bent sharply up at the aft edge and down at the forward edge. There are only a few rivets remaining in the skin panel and they exhibit shear failures. Only a portion of the skin flange of the keel beam attach chord remains attached with some fasteners, and the remaining fractured fasteners exhibit tension failures. The fastener hole that is common to the keel beam tension fitting at SWB2 exhibits elongation in the forward direction on the lower surface. The upper and lower surfaces are sooted.

The aft section of the lower skin (aft of MS) fractured in two large sections and various smaller sections at the aft left corner. A large section (CW205) is bent in "S" shape and is comprised of skin panel and stringers that extend from S-4 to the midspar (S-10) and from the

LSOB to approximately RBL <sup>92</sup>~~70~~. The S-7 and S-8 stringers remain attached to this section at the LSOB paddle fittings and are bent and twisted in several directions. There is a puncture in the skin panel 6 inches forward of SWB1 at LBL 37 with the surrounding skin bent down. The right end of this section has the general shape of an upward deflected dome that is as high as 14 inches in relation to the adjacent structure. The dome is centered about RBL 57.5 between S-8 and S-9. The sections around this area including CW232, CW231, and CW201 exhibit this same general domed shape. A spike-tooth fracture occurred at RBL 39 just forward of S-9. There is soot on the upper and lower surfaces of the panel.

Another large section (CW202) extends from RBL 98 to LBL <sup>69</sup>~~60~~ and from approximately S-1 to S-5 and has only a small section of S-5 skin flange remaining attached. The panel is bent in an inboard/outboard direction with the RH and LH sides both bent downward from BL0. The right side is bent down approximately 10 degrees and the left side is bent down starting at 10 degrees and gradually increasing to about 45 degrees. The few rivets remaining in the skin panel exhibit shear in an inboard and outboard direction, but the fasteners at RBL 57.5 at S-2, 3, and 4 are bent aft ranging from 45 to 60 degrees. On the right outboard side of this section, there is evidence of pillowing of the skin between the stringers in an upward direction. The keel beam attachment stiffeners at RBL & LBL 9.0 have pulled away from the lower skin and the fasteners exhibit evidence of tension failures. There is evidence of sooting on the lower surface of the skin.

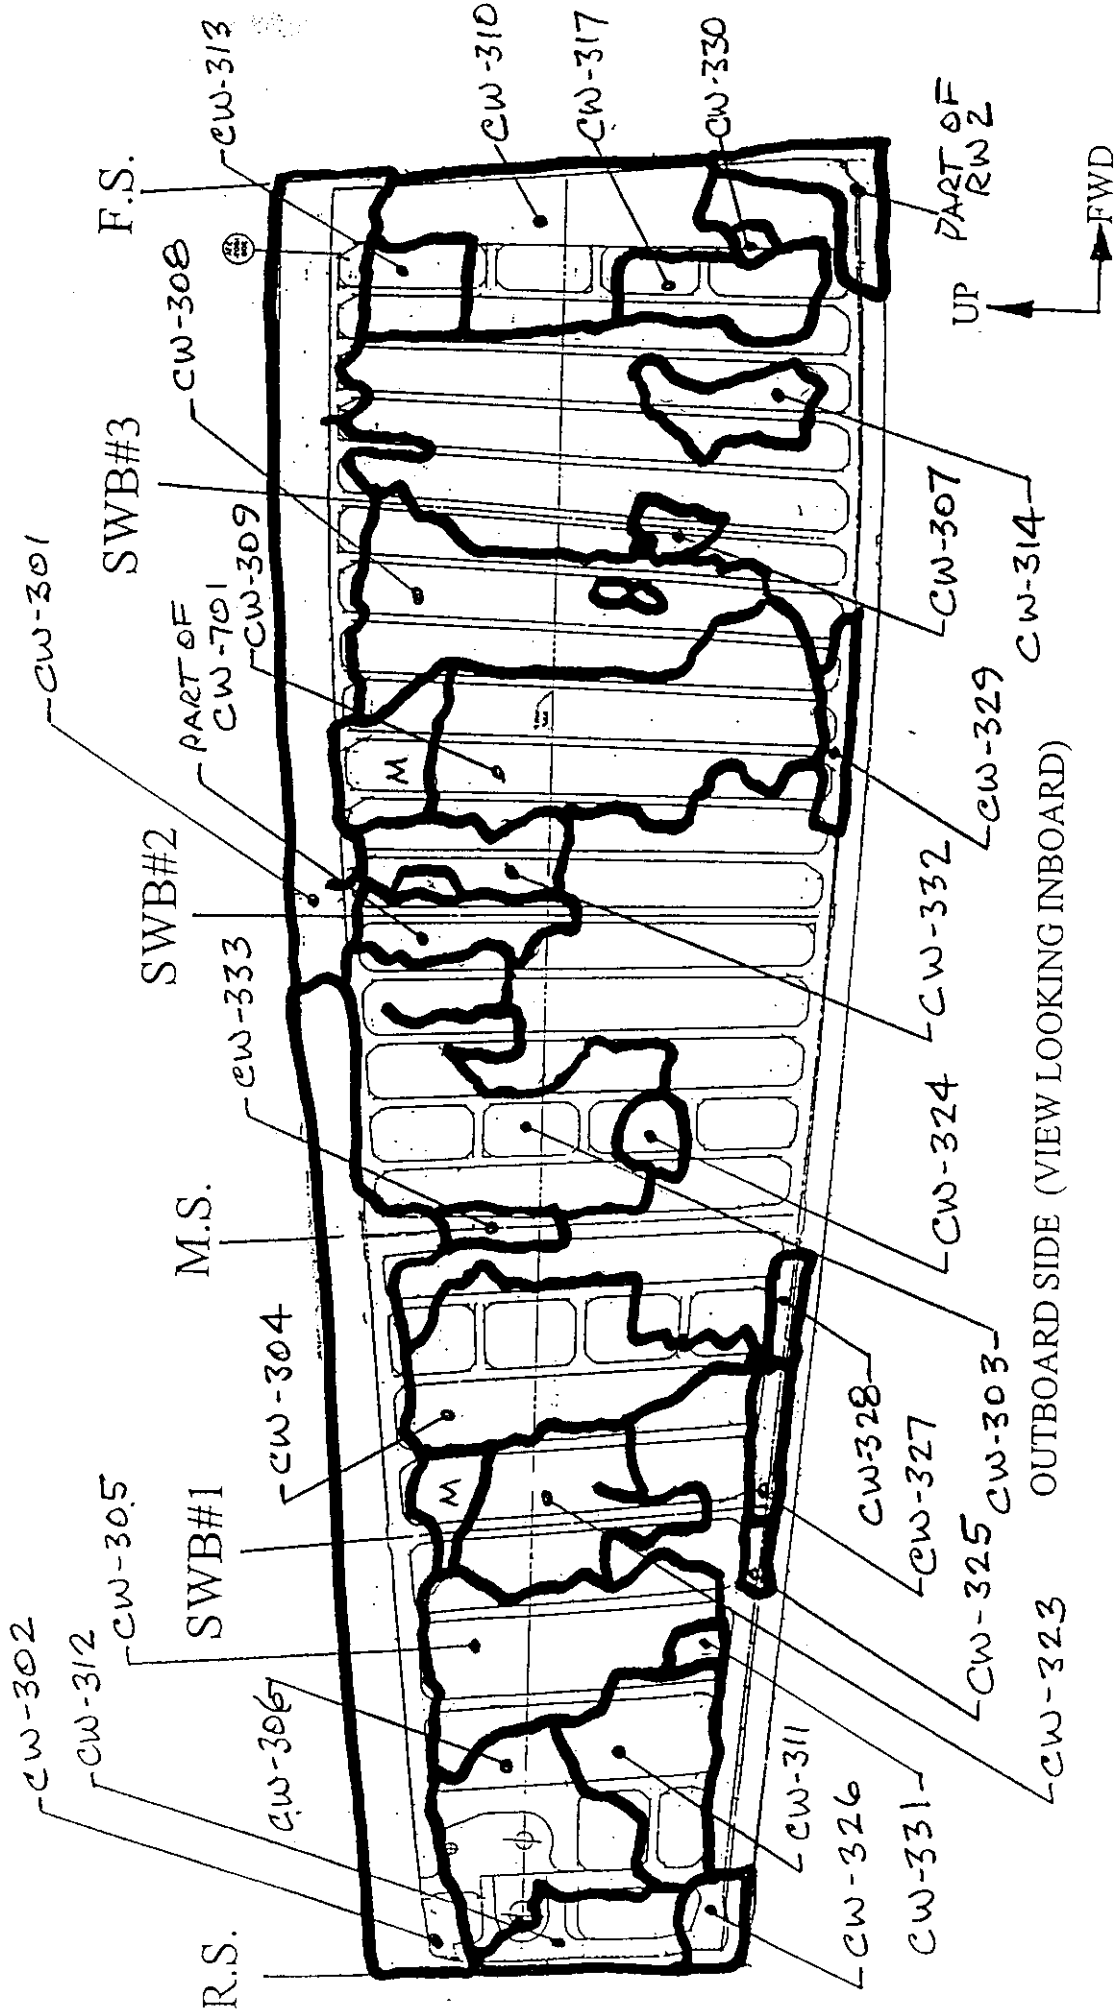
CWT SIDE-OF-BODY RIB RBBL 127.5

The RSOB fractured into six larger sections and numerous smaller sections. The majority of the pieces were recovered from the Green debris area. Recovery locations of some of the sections are unknown and are designated with white tags. These pieces were assembled on the floor to determine the mode of failure. In general, the RSOB exhibited evidence of outboard bulging in the forward and mid sections.

The RSOB forward section is comprised of CW308, CW309, CW310, CW317, and CW335 which exhibit evidence of outboard bowing when assembled. In addition, other forward smaller sections (CW313, CW314 and CW317) also exhibited evidence of bowing. One piece (CW314) is bowed inboard at the center with rivets remaining in the fastener holes that exhibit shear failures. CW313 and CW317 are heavily bowed outboard at their centers. CW313 has a few fasteners remaining in the holes that exhibit combinations of tension and shear failures. CW317 has rivets that exhibit tension failures and some that exhibit shear failures. The webs of all three sections are sooted on the inboard side and clean on the outboard side.

The mid section of the RSOB is made up of CW303, CW304, and CW323. The segment CW303 extends forward 36 inches from the MS location up to SWB2, and is 40 inches high. The upper edge of this segment remains attached to the double plus chord vertical flange located between CW301 and CW302. The web is generally flat except for the lower fracture edge which has a slight inboard curvature (an indication of outboard bowing). There are soot deposits on this part. The section CW304 previously had a Yellow tag and was changed to a White tag. The aft fracture edge of this part mates with CW323. A small section CW323 has forward and aft sides

bowed inboard 2 inches about SWB1 stiffener. When assembled with other pieces this section exhibited evidence of outboard bowing.

The aft section of the RSOB includes CW305, CW306, CW311, and CW312. The section CW305 contains the first two stiffeners aft of SWB1 and exhibits a significant outboard bulge of heavy web and stiffeners. The fracture lines are clean. The remaining sections of the aft RSOB are relatively flat.

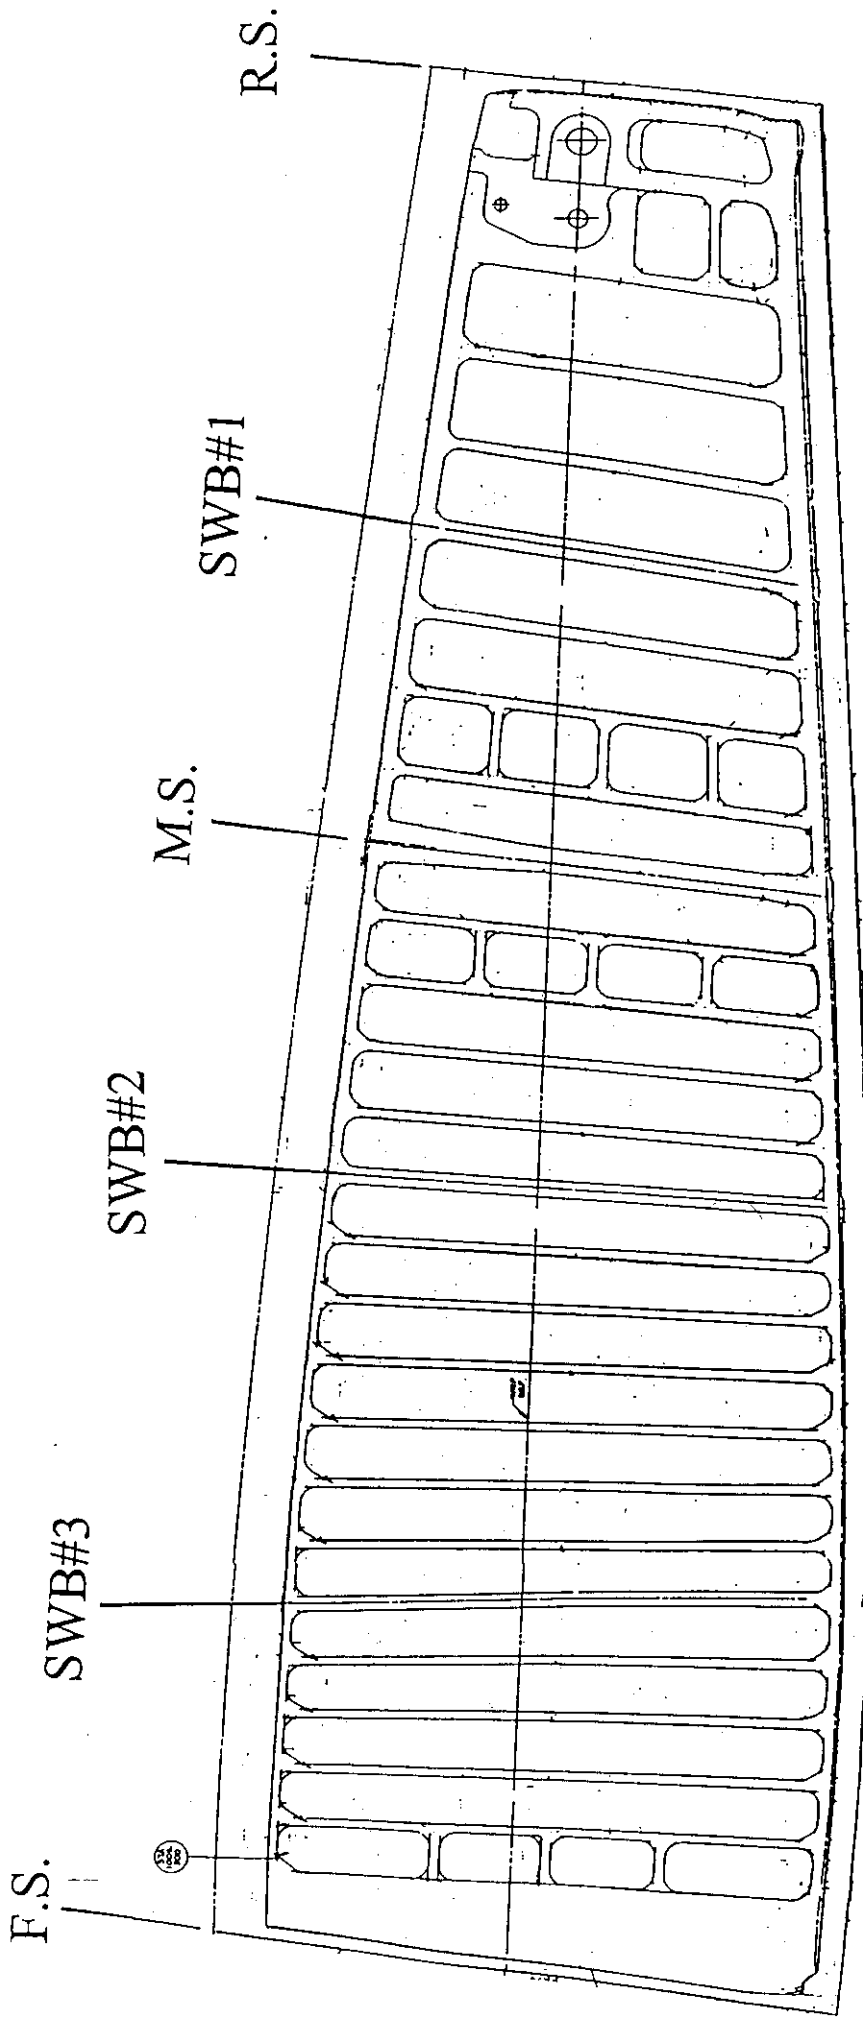
CWT SIDE-OF-BODY RIB LBBL 127.5

The web of the LSOB fractured into numerous small sections. The average size of the web pieces are approximately six to eight square inches. About 70 percent of the web remains either unrecovered or unidentified. Recovered pieces are curled and bowed, and a general direction of the bow could not be determined.

The lower chord of the LSOB rib fractured into numerous smaller lengths ranging from 2 inches to about 20 inches. These chord sections have "U" or "S" shapes. The lower chord pieces were assembled to determine the mode of failure. The assembly exhibited a general inboard outboard wave shape running forward and aft. The MS stiffener fractured into two sections (CW407A and CW407B). The lower section (CW407B) remained attached to the lower chord and is bowed outboard. The upper mid spar section (CW407A) is bent 90 degrees outboard at the lower end. There is no evidence of any fire damage or soot accumulation on the pieces of the LSOB rib.

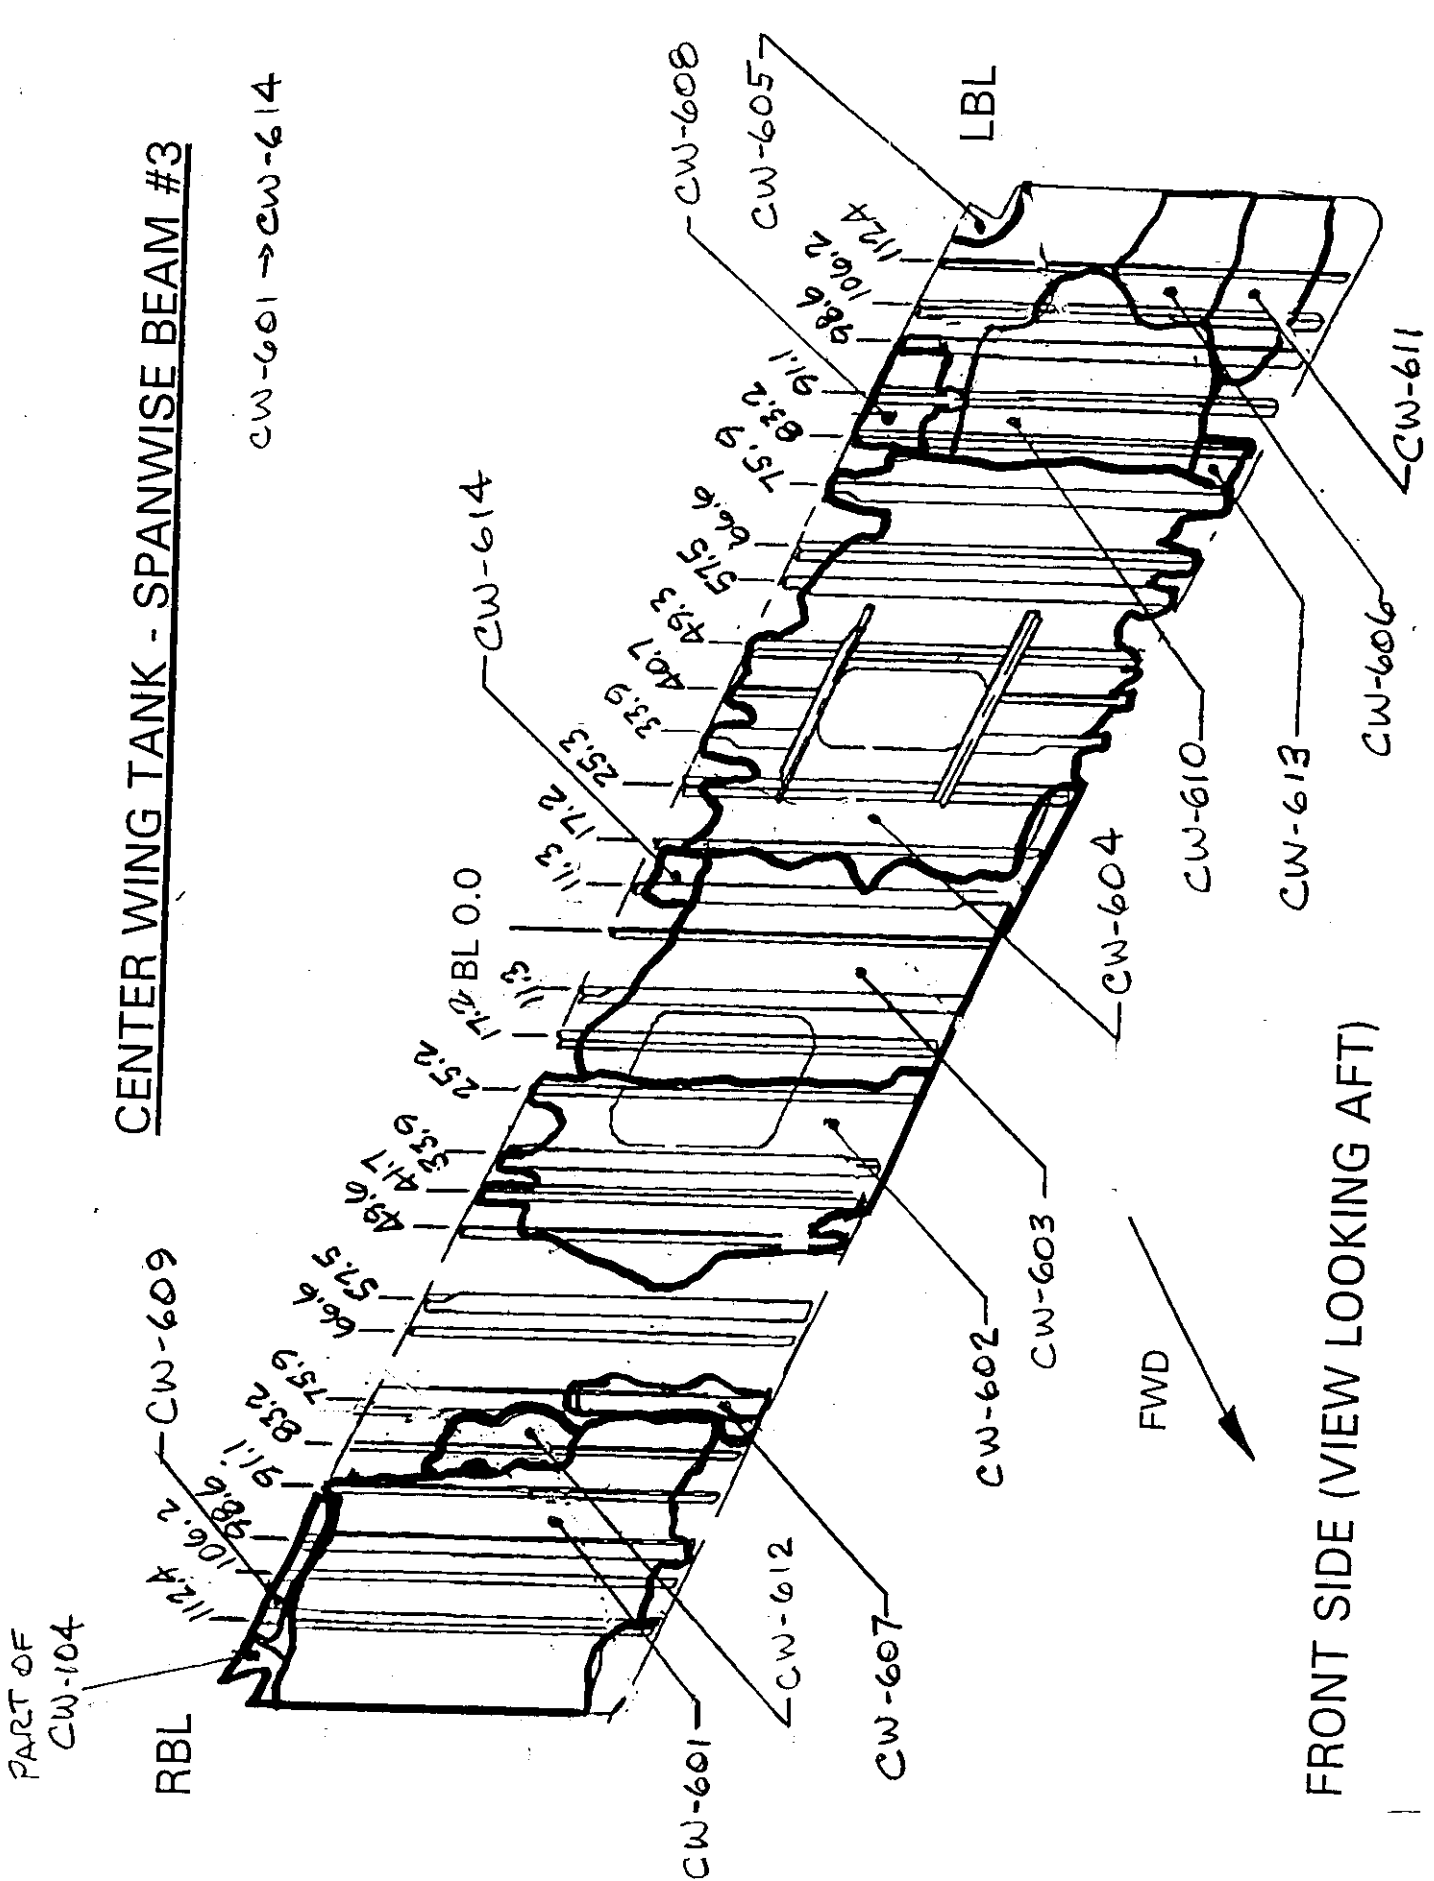
# CENTER WING TANK - SPANWISE BEAM #3

The SWB3 fractured into five large sections, extending across most of the span, and several smaller sections. The right outboard segment from RSOB to RBL 78 was found in the Green debris area and exhibited fire damage. Three vertical stiffeners remained attached to the web, but were separated from the upper shear ties. The area of SWB3 near RBL 95 was laterally crushed and badly mangled, and the stiffeners were bent slightly forward. The web/stiffener structure is bowed forward from the bottom. Spike-toothed fractures were observed at seven locations on SWB3 between RSOB and RBL 83.24.

The structure from inboard of RBL 57 to LBL 75.9 separated into three large sections and was found in the Red debris area. There was light to medium soot on these sections. In general, the vertical stiffeners remained attached to the web but the lower shear ties had separated from the lower skin. The web of the beam in this area was relatively straight.

The section outboard of LBL 75.9 to LSOB fractured in numerous small pieces. All of these pieces were found in the Green debris area and exhibited evidence of sooting. The web was curled 90 degrees forward at LBL 100.

The forward face of this beam constitutes the aft face of the dry bay area of the CWS. All the heads of the rivets that are used to assemble the web to the stiffeners are coated with black sealant on the forward face. The spacing between the rivets is 1.5", in both vertical and horizontal directions. Most of the stiffeners exhibited impact damage and were fractured anywhere from 0" to 12" below the upper skin.

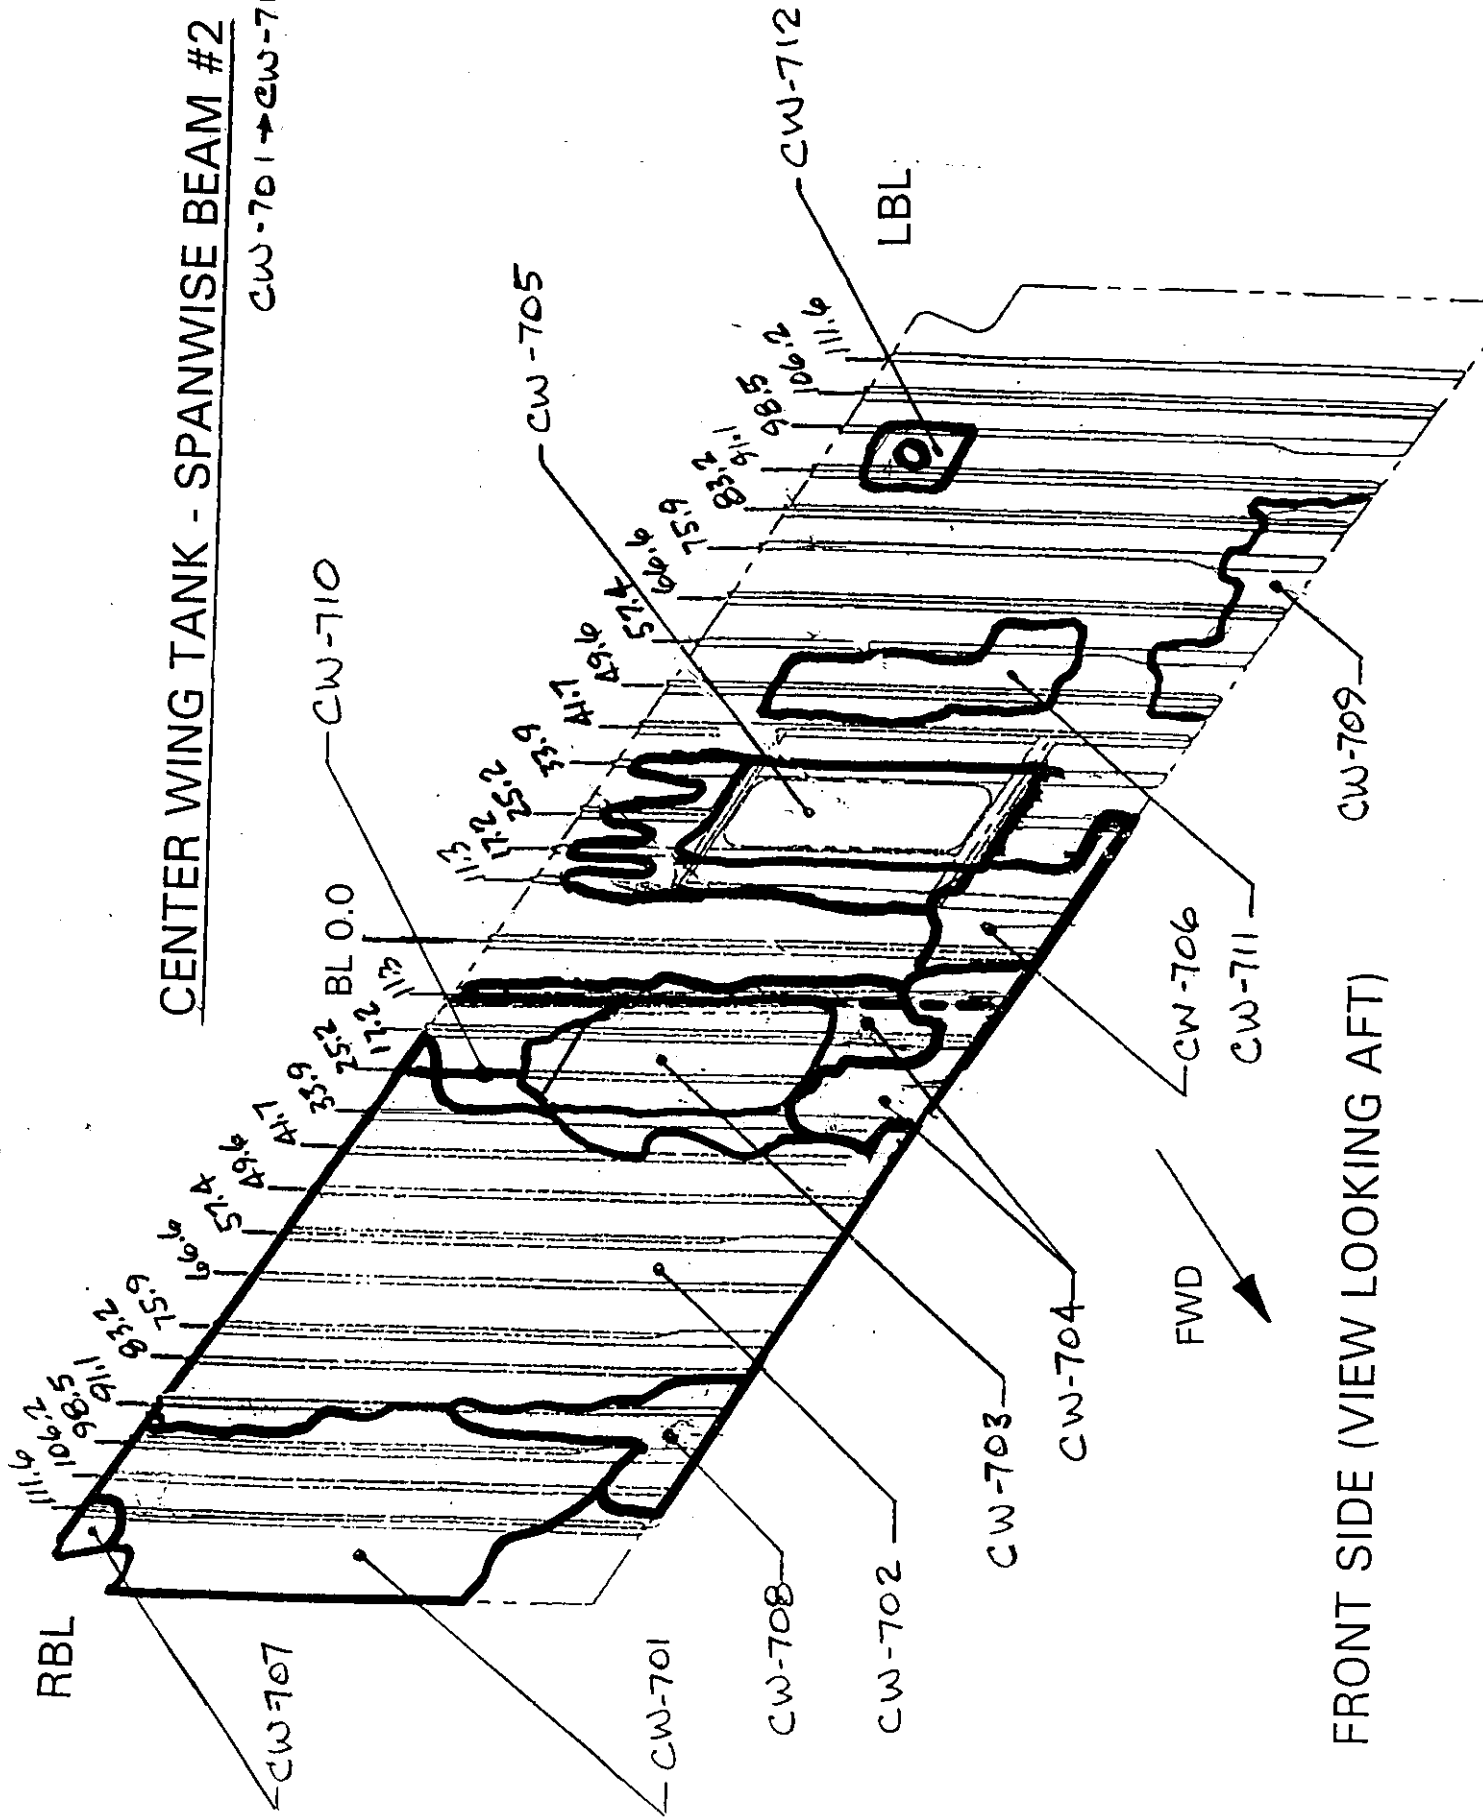
# CENTER WING TANK - SPANWISE BEAM #2

The SWB2 fractured into four large and several smaller sections. All of the pieces were found in the Green debris area, except for one piece near the center (CW703) that was found in the Red area. The location of one piece (CW706) was unknown (white tag). The right outboard section from RBL 98.5 to the RSOB rib was heavily distorted and bent with multiple folds. The section from RBL 91.10 to RBL 25.2 (CW702) remained attached to the upper skin, and the web was fractured just under the upper chord from RBL 57 to the right outboard end. The lower edge of the web separated from the lower chord and the remaining fasteners in the web exhibited shear fractures. This piece exhibits spanwise compression damage (accordion shape) to the web and attached stiffeners. The outboard edge of this web section was generally curled aft. Spike-tooth fractures were evident in this section and the entire section was sooted with the exception of the lower edge of the web.

The manufacturing door with a small piece of web attached (CW703) was found in the Red debris area. The rivets that attached the door to SWB2 exhibited shear and/or tension failures. The door exhibited an S-shape deformation, with forward bending except at the lower left corner, which was bent aft and shows impact damage on lower edge. The deformed shape of the door did not match the shape of its surrounding structure. The door had three penetrations in the forward direction. Light soot, as opposed to heavy soot on the surround structure, was observed on the forward side of the door.

A section of lower chord and web from the right, inboard portion of SWB2 (CW704) was found in the Yellow debris area. The lower chord separated from the CWS lower skin and the fasteners attaching the chord to the skin failed in tension, except one fastener just outboard of RBL 9 which exhibited aft bending. The inboard edge of the web (inboard of the stiffener at RBL 9) had numerous horizontal fractures and was curled tightly forward at several locations. The web just outboard of the stiffener and directly below the door (CW703) was bent 180 degrees aft. The web inboard and outboard of RBL 25 has multiple penetrations with very jagged features around the edge of the hole. Spike-tooth fractures were observed on portions of the web section.

Section CW705, which consists of web and stiffeners just left of BL 0.0 including a honeycomb access door, was recovered in the Green debris area. The stiffeners, web, and door exhibited forward bending. The access door was bowed forward and the middle of the door was missing, with the surrounding honeycomb shredded forward. Most of SWB2 left of the door is missing.
