**NATIONAL TRANSPORTATION SAFETY BOARD  
Office of Aviation Safety  
Washington, DC 20594**

**STRUCTURES GROUP - WING CENTER SECTION SUMMARY**

**ACCIDENT : DCA96MA070**  
**Location : East Moriches, New York**  
**Date : July 17, 1996**  
**Time : 2031 Eastern Daylight Time**  
**Airplane : Boeing 747-131, N93119**  
**Operated as Trans World Airlines (TWA) Flight 800**

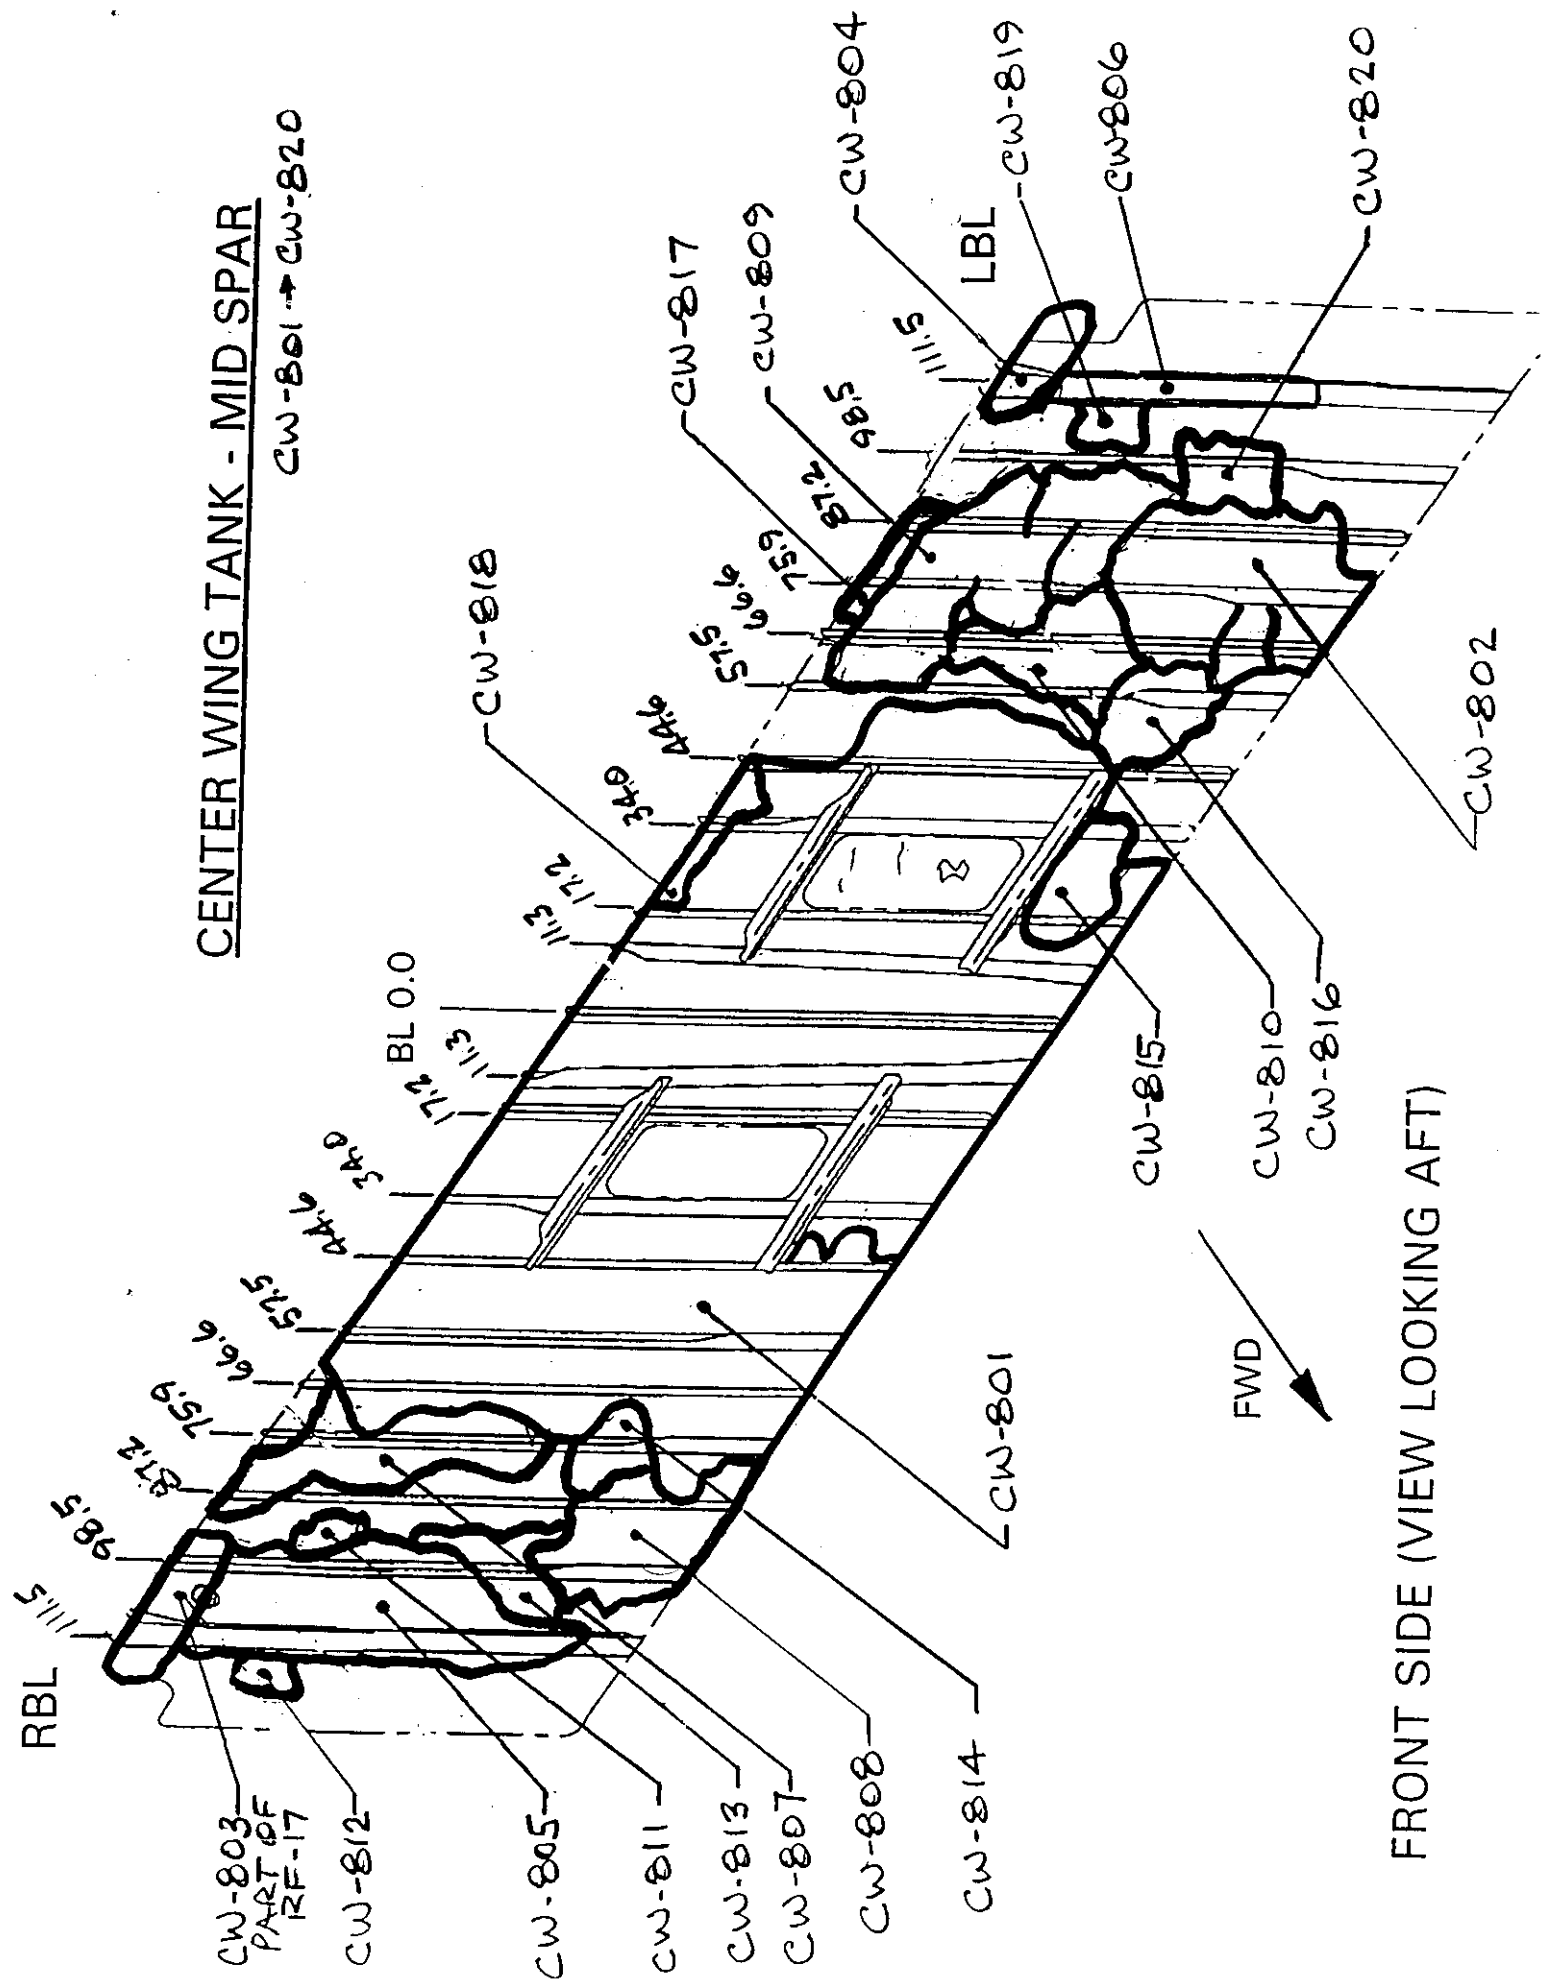
CENTER WING TANK - MID SPAR

The mid spar fractured into one large section (RBL 85 to LBL 49) and several smaller pieces from the right and left outboard area (RSOB to RBL 68 and LBL 49 to LBL 110, respectively). One of the right outboard pieces was recovered from the Yellow debris area (CW805), but the rest were found in the Green debris area. Reconstruction of these pieces revealed no distinct deformation pattern of the web or stiffeners, but did contain evidence of sooting. The

lower end of the stiffener web flange on CW805 was bent inboard and aft.

The large section of the mid spar extended from RBL 85 to LBL 49 and from the lower chord to the upper chord (CW801), with 12 stiffeners remaining attached. This section of the mid spar exhibits evidence of fire damage and sooting. The lower chord is bent aft 45 degrees at LBL 17.27 and is fractured at RBL 34.00. The upper chord remains attached to the upper skin panel from RBL 17.00 to LBL 17.00. The left side of the mid spar was bent aft approximately 12" at LBL 44.65. The lower, left half of the mid spar bent diagonally aft from LBL 17.00 at the upper chord to RBL 34.00 at the lower chord. The extreme left lower corner at LBL 44.65 bent aft 90 degrees. The right access door was bowed slightly forward. A portion of the left access door aft skin was burned and bent aft. The forward skin of this door is missing.

The mid spar section from LBL 49 to LBL 110 fractured into numerous pieces. The bulkhead web attach flange of the stiffeners remained attached to the web for most of the pieces and the web is bowed aft both inboard and outboard about LBL 75. One section of the mid spar between LBL 60-90 exhibited an "S" shape deformation inboard to outboard and was sooted.

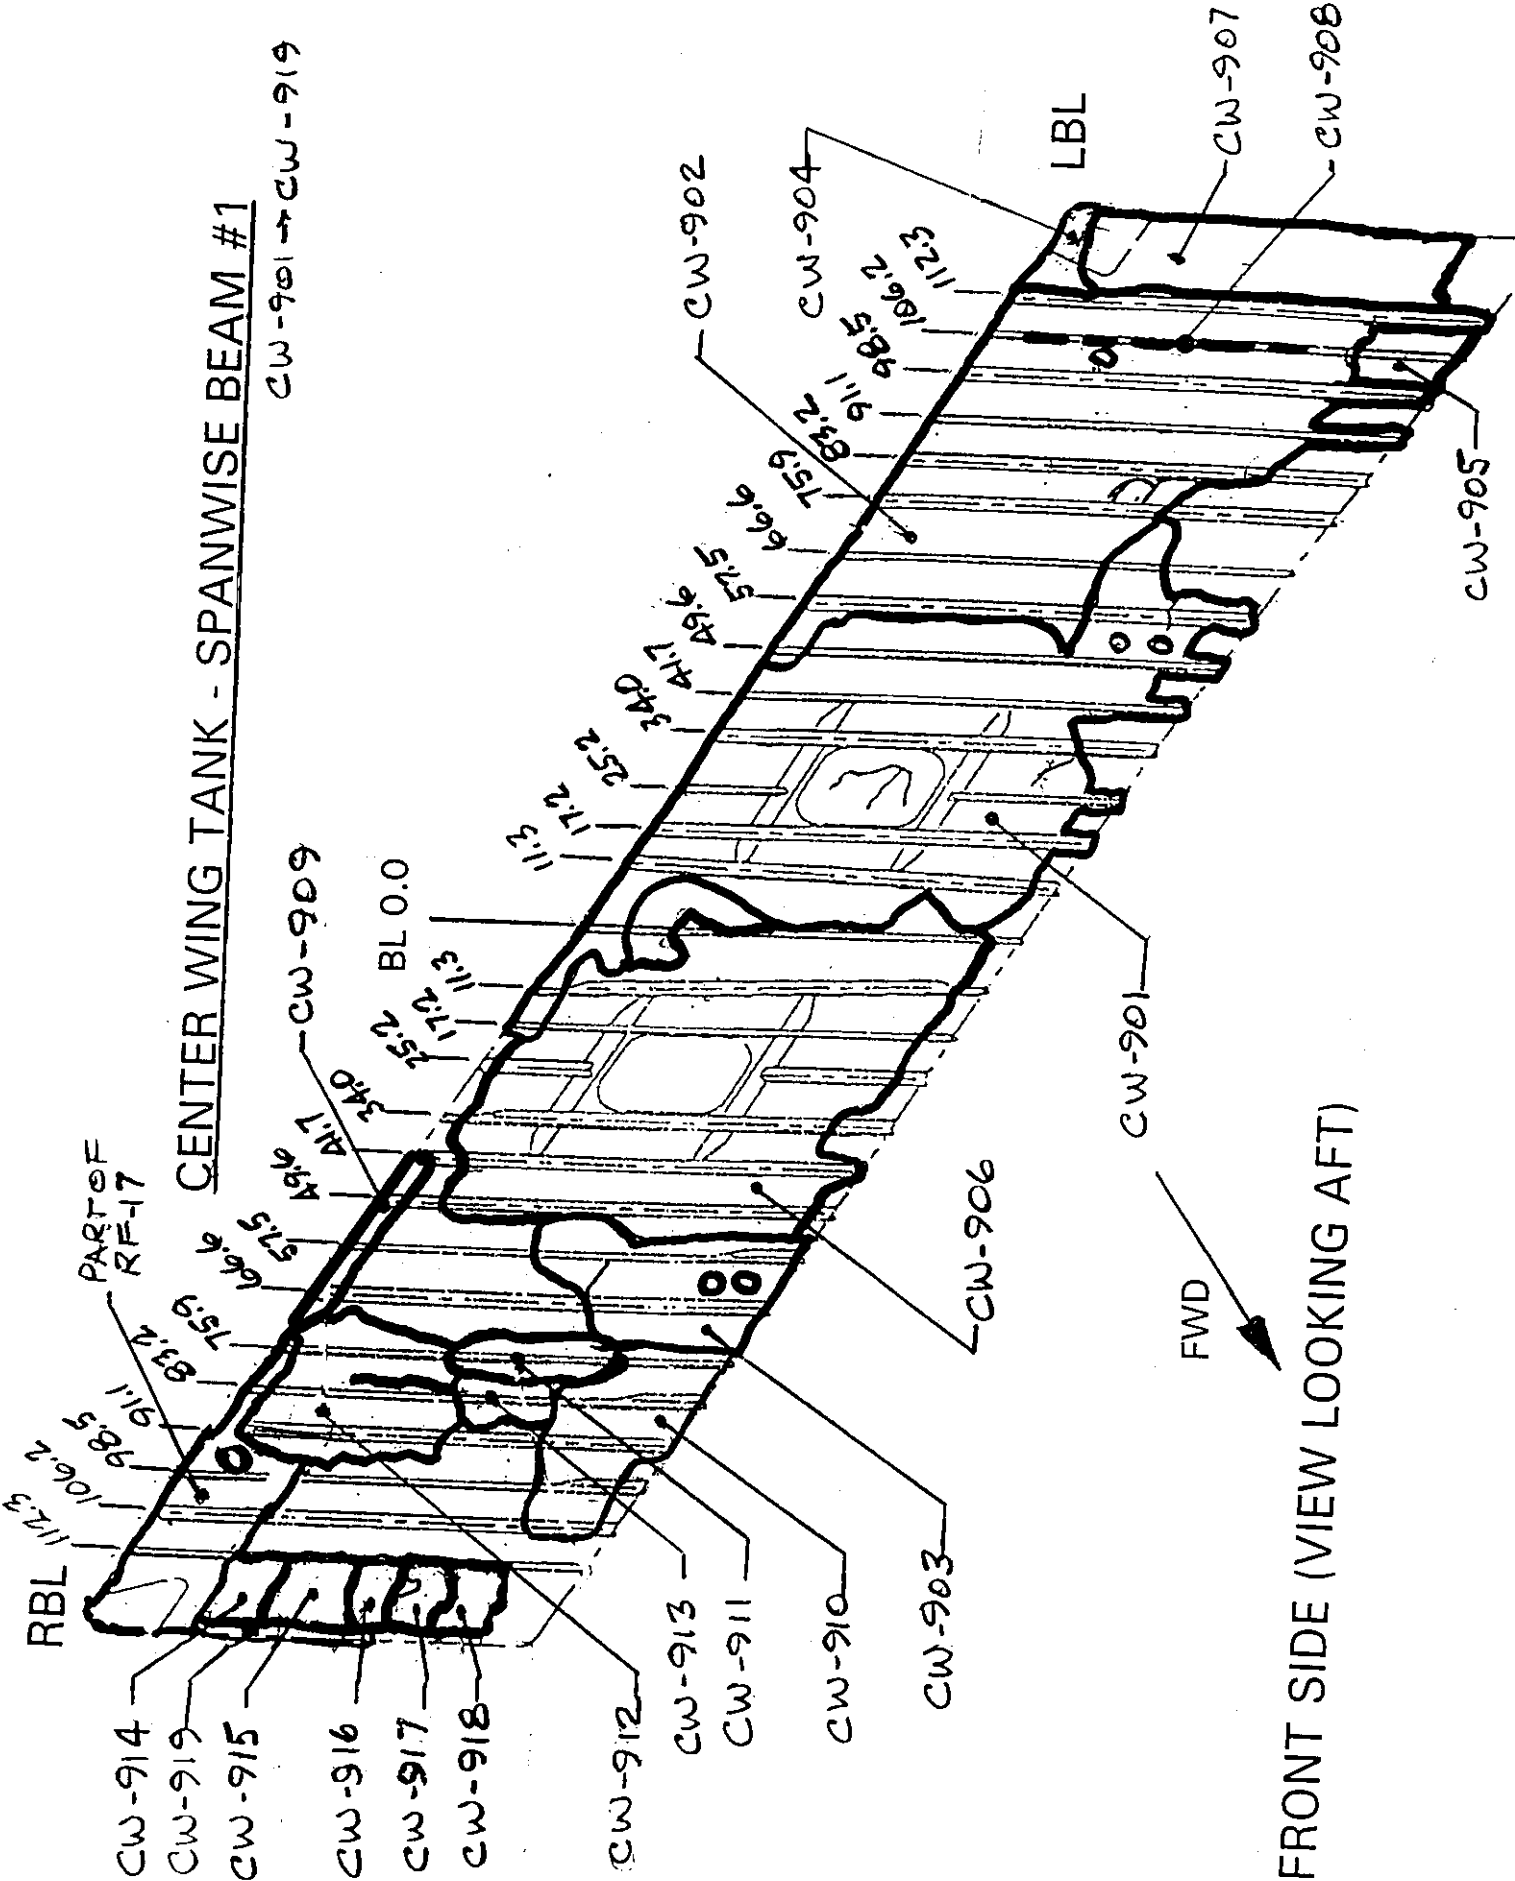
CENTER WING TANK - SPANWISE BEAM #1

The SWB1 fractured into three large sections (on the left side) and numerous smaller sections. The smaller sections were located on the right side from RSOB to RBL 53.00 (CW903, CW909 to CW913) and were found in the Green debris area (except CW911, which has been tagged white).

CW909 included a 36-inch section of upper chord and the web between RBL 76 to RBL 40. Some of the fasteners common to the upper skin exhibited tension and/or shear failure. The free flange of the chord at the outboard end was bent up. The lower web edge at RBL 60 had a portion of the web bent forward, and exhibited spike-tooth fractures. Only the web flange of the LBL 49.6 stiffener remained and was bent forward. There was sooting on the skin flange and the web flange of the upper chord at the aft side and some sooting on the forward side of the web.

Two inboard lower web edges at RBL 67 (CW911) were curled aft. The upper portion exhibits a 4-inch long spike-tooth fracture along its lower edge.

The fasteners through the upper shear tie common to the upper skin on the SWB1 section from BL0 to RBL 53 remained attached and exhibited tensile failure.

The forward side of the access door remained intact and the aft face sheet was missing with very little damage to the honeycomb core.

The left side of SWB1 fractured into three large sections, (CW901, 902, 907) and each of the sections had evidence of heavy sooting with local areas of fire damage. A large section (CW901) extending from the stiffener at LBL 57.51 to approximately BL 0. This includes the upper chord, the web, one access door, stiffeners at LBL 11 through LBL 57.51, and stabilization

straps. The upper 34" of the stiffener at LBL 57.51 is not attached to the web and shows a shear failure of the rivets common to the web on CW902. The rest of the stiffeners remained attached to the web. The majority of the stiffener free flanges remain attached except at LBL 11.00. The stiffeners did not exhibit any notable bending in the fore/aft direction. The access door remained attached to the adjacent vertical stiffeners and web. There is a hole in the honeycomb core and the core ribbon around the hole is shredded in the aft direction.

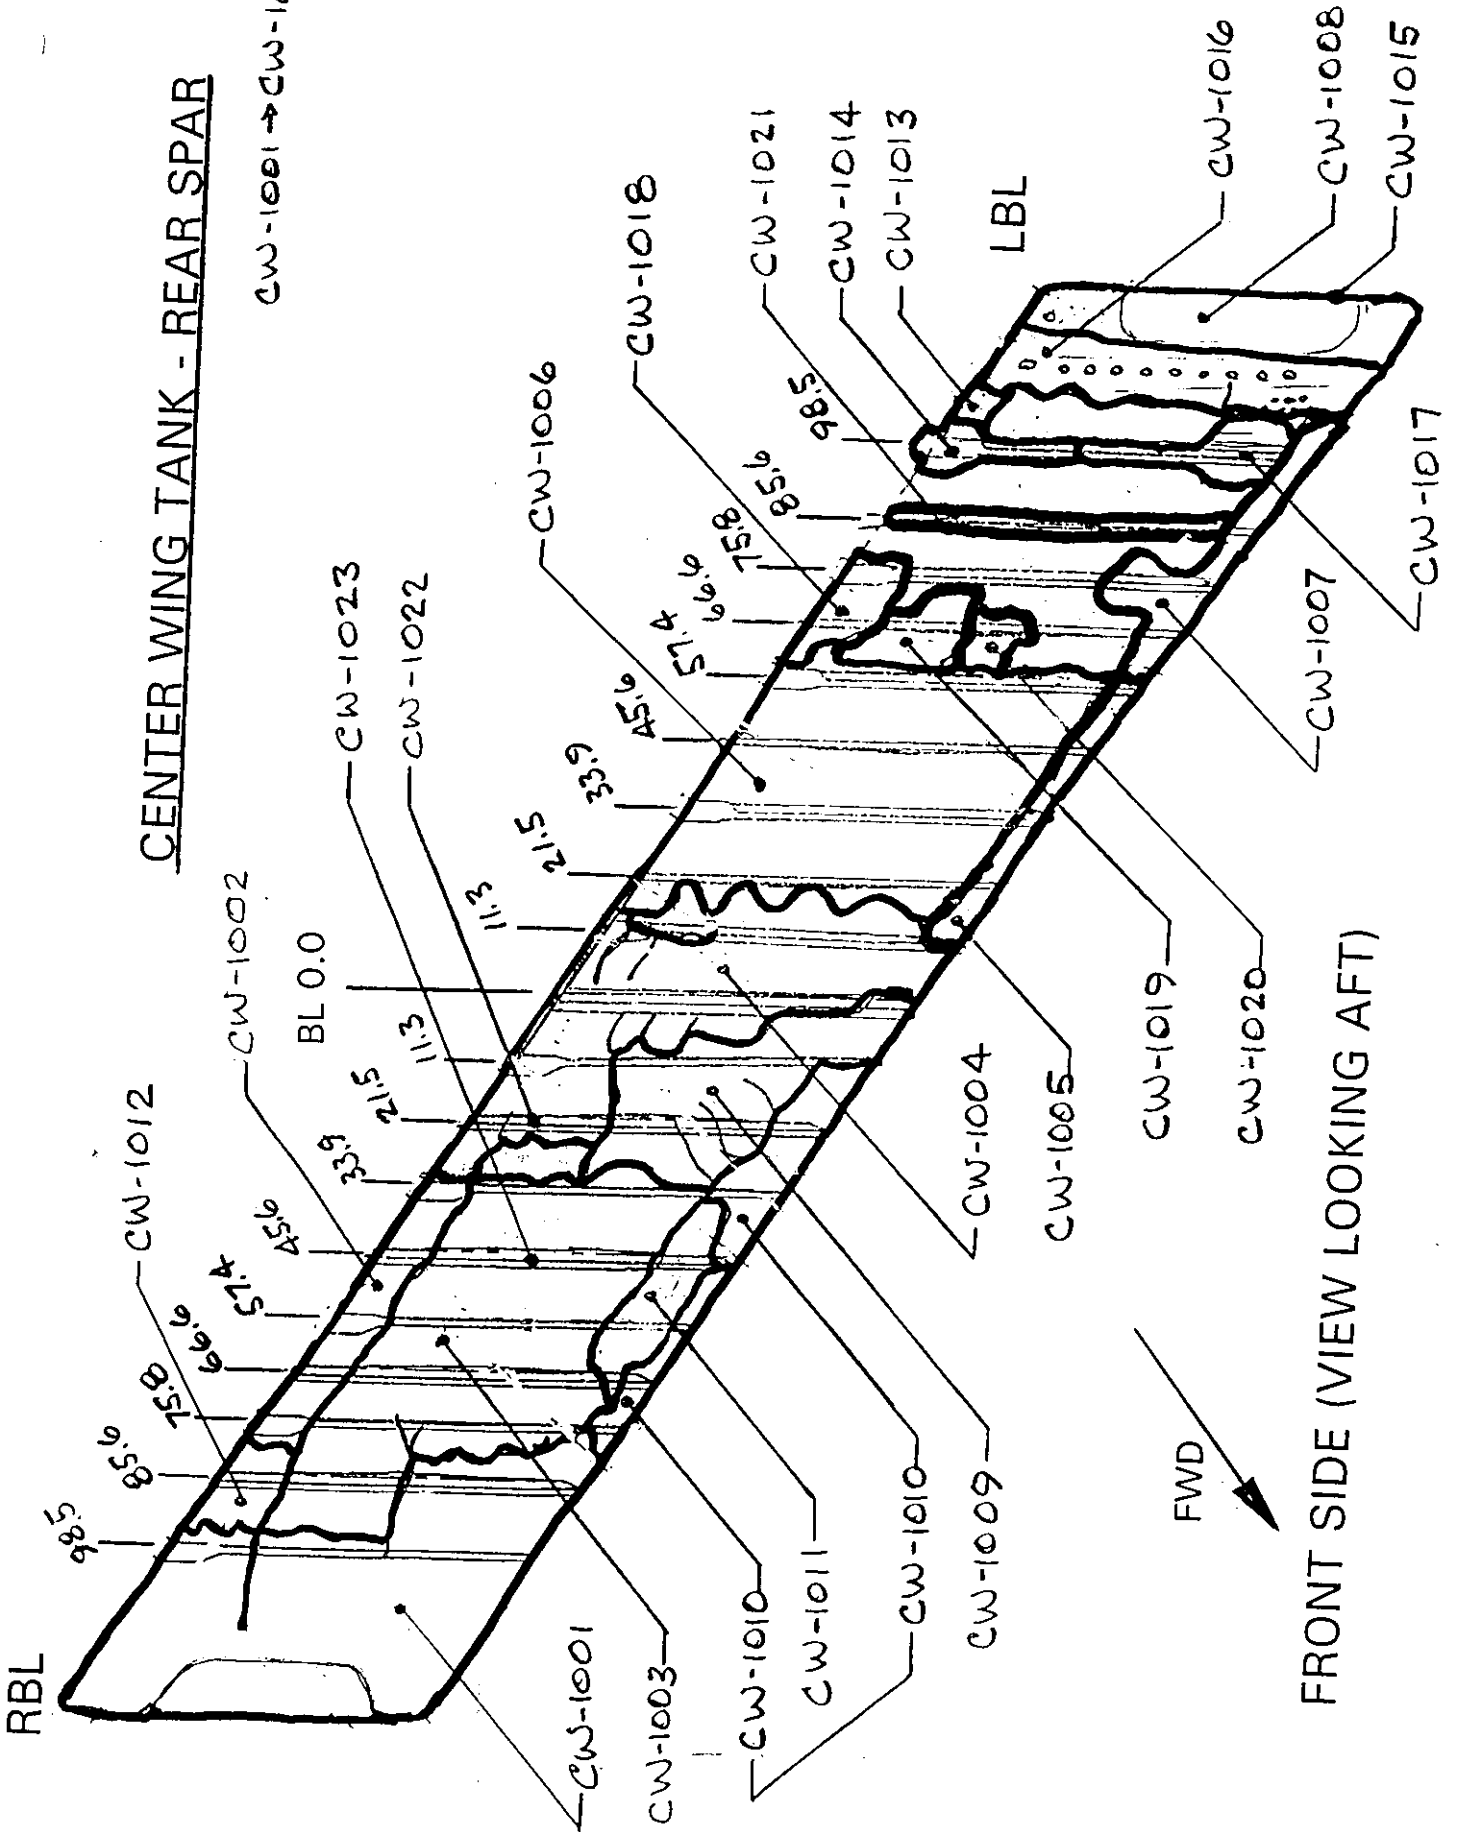
CENTER WING TANK - REAR SPAR

The RS fractured into four large pieces (CW1001, CW1003, CW1004 and CW1006) and numerous smaller pieces. All were found in the Green debris area. Section CW1001 included the right hand rear spar terminal fitting (pickle fork fitting) and the rear spar web from upper to lower surface and from RSOB to RBL 85.00. CW1001 remained attached to a section of upper fuselage that was heavily burned. The pickle fork remained attached to the web but the free flange of the fork legs buckled/crippled, with the lower spar chord being displaced 12" to 16" aft of its original location. There was no soot on the forward side of the web and the aft side of the web was dirty, typical of its normal exposure to the dirt inside the wing landing gear wheel well.

The section inboard of the right pickle fork fractured into numerous smaller sections. Another section (CW1010) consisted of a lower portion of the web and lower spar chord from RBL 10 to RBL 85. The skin flange of the lower spar chord and the attached lower skin panel was bent upwards at RBL 52 at approximately a 20 degree angle. The fasteners common to the spar chord, web, and missing stiffeners (at the lower chord) showed tension failures.

A section containing a portion of the web from LBL 11 to RBL 33 at the upper spar chord and LBL 19 to BL 0 at 10" above the lower chord suffered damage on the entire periphery of the web, with the edges bent both forward and aft. The lower portion of the web was bent forward approximately 180 degrees. The CWS scavenge pump is not attached to the spacer plate or the spare web. The mounting spacer plate for the CWS fuel scavenge pump remained in place on the aft side of the rear spar, but it had been deformed away from the spar web except at the 9-11 clock position. The three bolts that mount the spacer to the spar web were in place and the safety wires were still attached. There was a partially sooted outline of the pump housing on the spacer plate and a difference in soot levels on the forward side of the spar web where the pump is mounted as compared with the remainder of the web. There is only a very light soot deposit on the spar web where the spacer plate has been deformed from the web. The forward side of the lower portion of the web that is bent up 180 degrees has a location that shows impact damage to the web and to the fillet seals on the fastener heads. This section shows heavy soot and fire damage on not only the forward and aft surfaces but also on the web and stiffener fracture edges. It also shows marked difference of soot levels as compared with the adjacent segments. The stiffener to web interface at LBL 11 shows both sooted and unsooted regions on the interface where the stiffener is missing. The protruding portion of the fasteners that have failed also show soot accumulation. (See Fire and Explosion group notes for details of the sooting and fire damage). Two segments of the rear spar (CW1009) remained attached to stiffeners that remained attached to the keel beam box.

The left outboard end of the CWS rear spar consisted of small (CW1008, CW1015 and CW1016) segments of the outboard leg of the left rear spar pickle fork fitting near the SOB, along with a portion of the left rear spar terminal fitting and the web adjacent to the fitting. The terminal fitting on CW-1008 was fractured on the inboard side at approximately the inboard edge of the pickle fork. The fasteners common to the pickle fork and terminal fitting on CW1008 remained intact. The outboard aft flange of the pickle fork (CW1015) was broken from CW1008, consistent with a counter-clockwise rotation of CW1015 (as viewed from above). The fracture was primarily in the fillet radius between the two portions of the fitting. The holes in the terminal fitting showed deformation downwards and inboard. Marks observed on the outboard side of the fail-safe strap on CW-1015 were coincident with the fastener locations on the adjacent outboard wing segment.

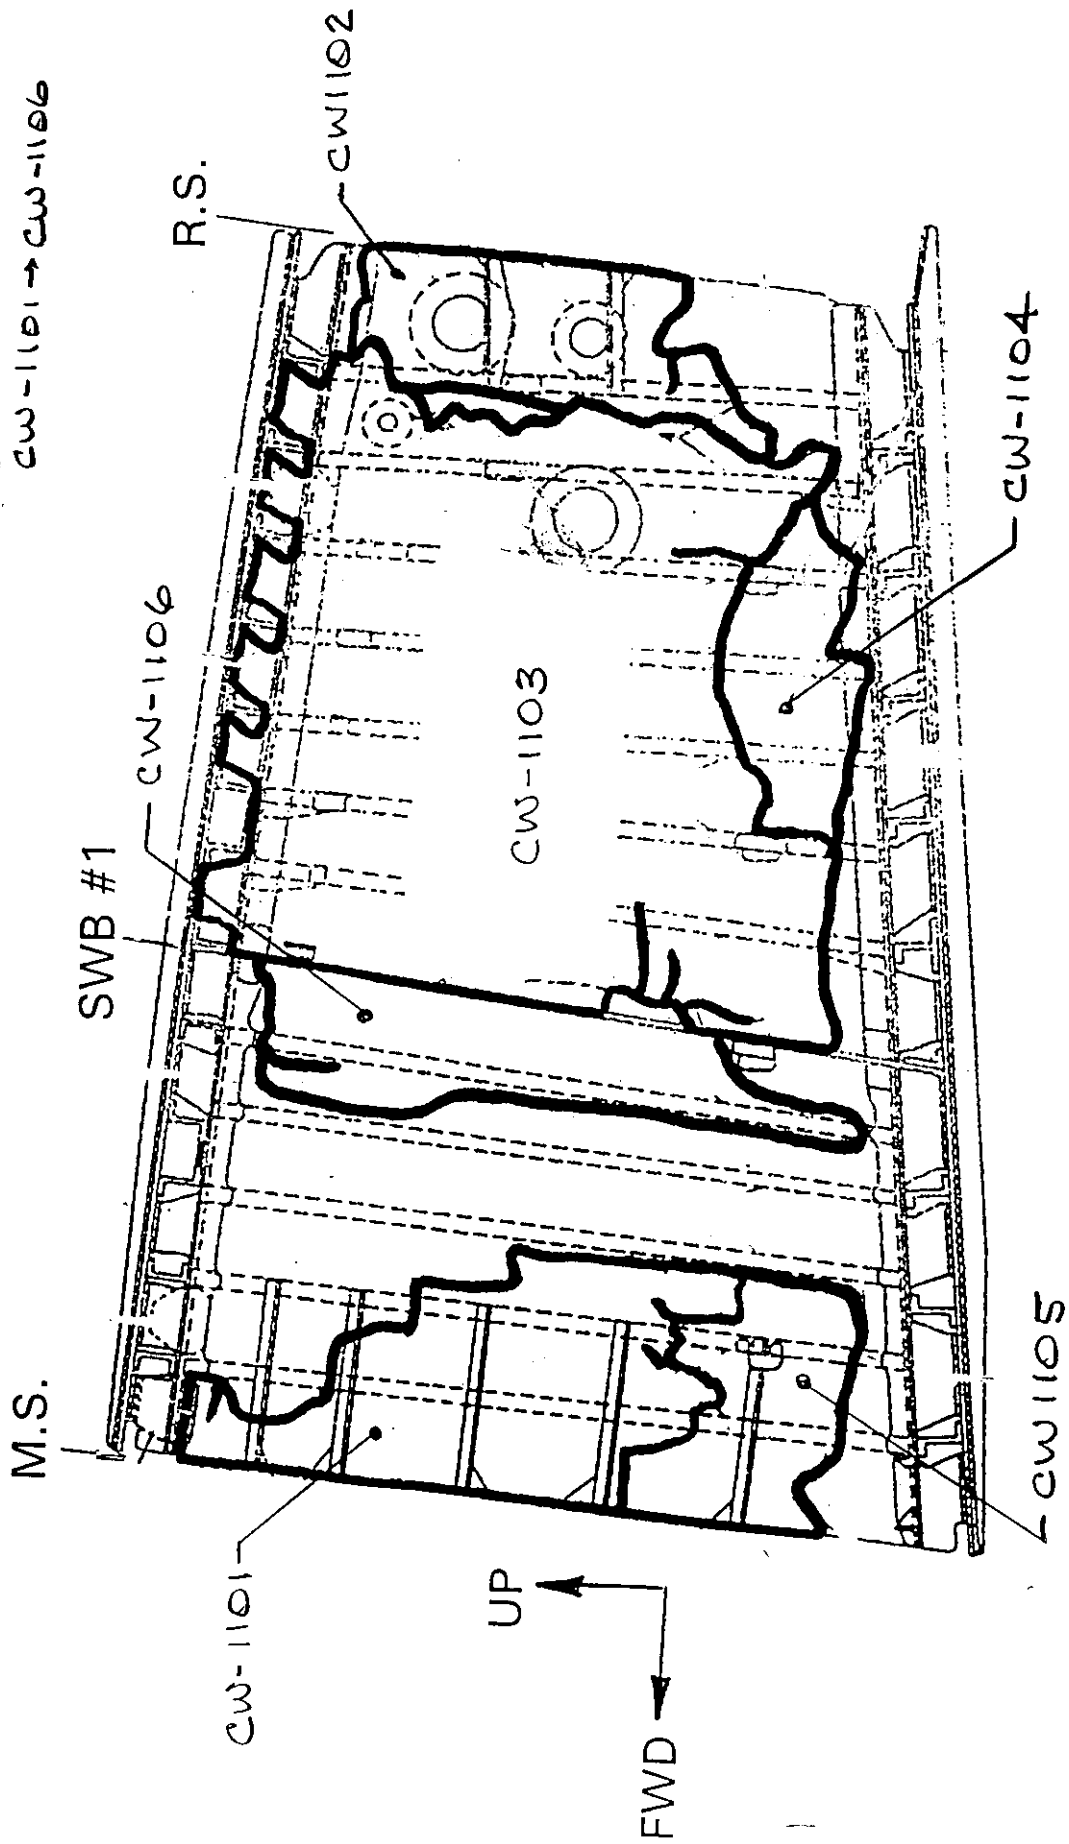
CENTER WING TANK - BL 0.00 RIB

The BBL 0 rib extends from the MS to SWB1 (forward bay), and from SWB1 to the RS (aft bay) along the centerline of the center wing tank. The aft bay section fractured into one large and several smaller pieces. The forward bay fractured into several pieces. All the pieces were found in the Green debris area.

A large section (CW1103) of the BBL 0 rib, extends from SWB1 aft to CW1102 (about 8 inches forward of RS) and from the upper skin panel down to a few inches above the lower skin panel. This section is bowed about 5 inches to the left at its center. The connection at the forward end where the rib attaches to the SWB1 is bent to the right. All the vertical stiffeners remain attached to the panel, except some have outer flanges missing. There is evidence of sooting on both sides of the part.

The BBL 0 rib between MS to SWB1 fractured in several smaller sections. A segment (CW1101) of the BBL 0 rib from the MS extending aft 20 inches has a general "S" shape along the forward vertical edge. The bow in the upper end is centered about 11 inches from the top and bows to the right. The bottom has jagged fractures which are bent up and to the left. A small section (CW1105) mates to CW-1101 and is fractured just above the lower rib chord on the lower side. The fractures around the periphery of the part do not follow fastener lines. There is a flap of web on the front of the part about 4 inches wide that is folded over to the right. CW-1106 extends from the

SWB1 forward about 10 inches and from the upper chord down 52 inches, and is generally flat. The top 6 inches of the forward edge is folded down to the left. All the sections between MS and SWB1 exhibit evidence of sooting.
