**NATIONAL TRANSPORTATION SAFETY BOARD
Office of Aviation Safety
Washington, DC 20594**

STRUCTURES GROUP - WING FACTUAL SUMMARY

ACCIDENT : DCA96MA070
Location : East Moriches, New York
Date : July 17, 1996
Time : 2031 Eastern Daylight Time
Airplane : Boeing 747-131, N93119
Operated as Trans World Airlines (TWA) Flight 800

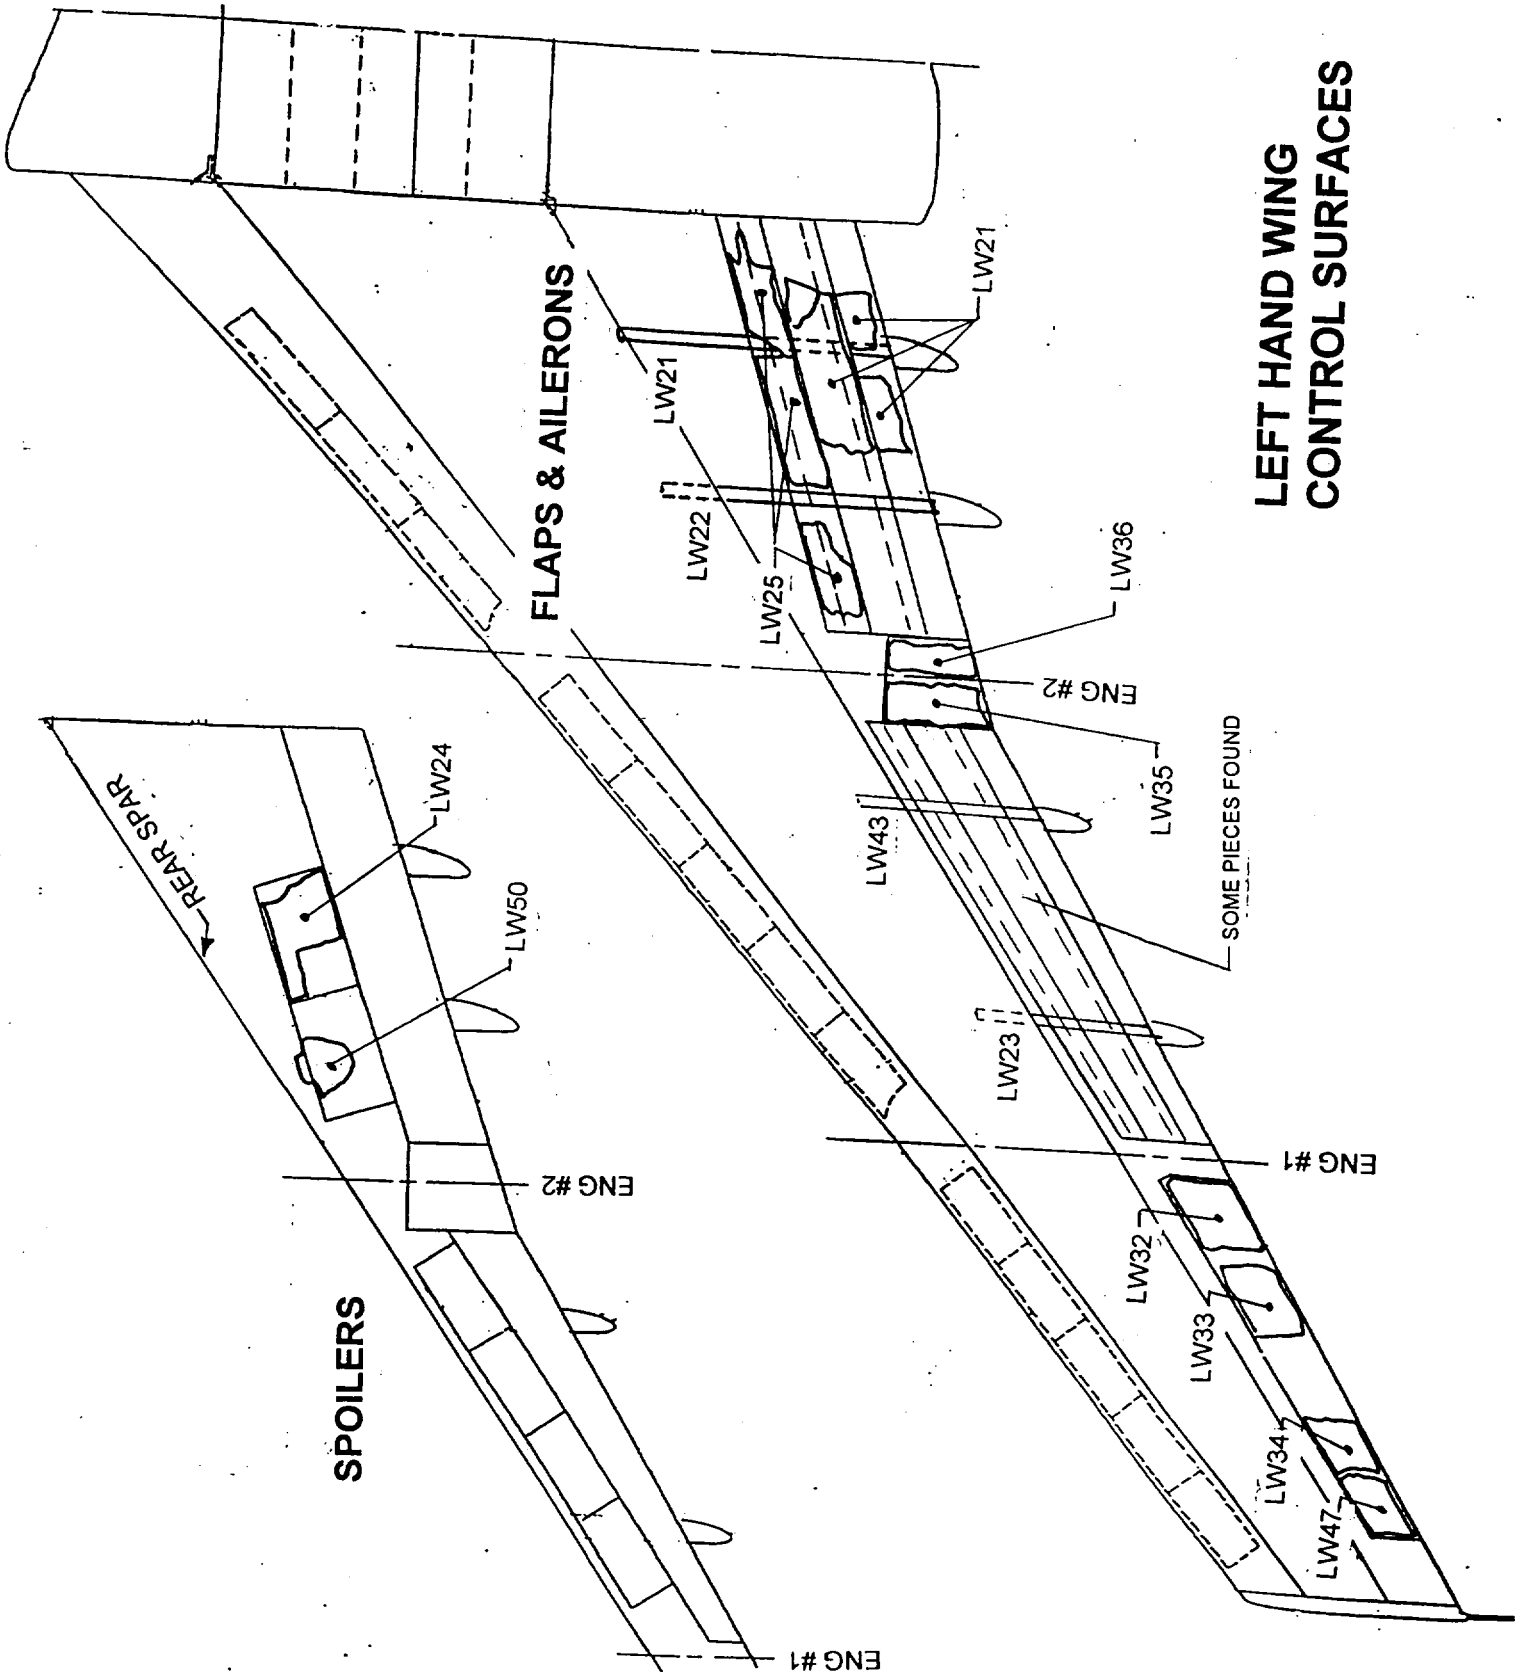
**LEFT HAND WING
CONTROL SURFACES**

The left side inboard fore flap broke in three distinct pieces (LW25). All of these pieces suffered fire damage and severe impact damage. A large section of the inboard mid flap remained attached to the flap track assembly (LW21). The mid flap box suffered severe impact damage. The upper and lower surfaces of the mid flap section also exhibited evidence of fire damage. Only a very small area of the left-hand outboard flaps were identified (a few square feet), and these small pieces were not individually documented.

All four ailerons were found in pieces, with the largest varying in length from 4 to 8 feet. The left outboard aileron broke in several pieces (LW47, LW34, LW33, LW32) and exhibited evidence of fire damage on some pieces. The inboard aileron broke into two sections near the middle (LW35 and LW36) and had been severely damaged by impact and fire. The right outboard aileron broke into three distinct pieces (RW15). These three sections suffered minor impact damage on the skin surfaces but no fire damage. The inboard aileron actuator and associated mounting bracket (RW17) were recovered from the Green area. The actuator and a small section of aileron structure separated from the remaining aileron structure. No evidence of fire damage was documented.

All four inboard spoilers and their actuators were recovered. The inboard-most on each wing (LW24 and RW35) show fire and soot damage, and the outboard-most on each wing show impact tearing and fracture damage.
