**NATIONAL TRANSPORTATION SAFETY BOARD
Office of Aviation Safety
Washington, DC 20594**

STRUCTURES GROUP - WING FACTUAL SUMMARY

ACCIDENT : DCA96MA070
Location : East Moriches, New York
Date : July 17, 1996
Time : 2031 Eastern Daylight Time
Airplane : Boeing 747-131, N93119
Operated as Trans World Airlines (TWA) Flight 800

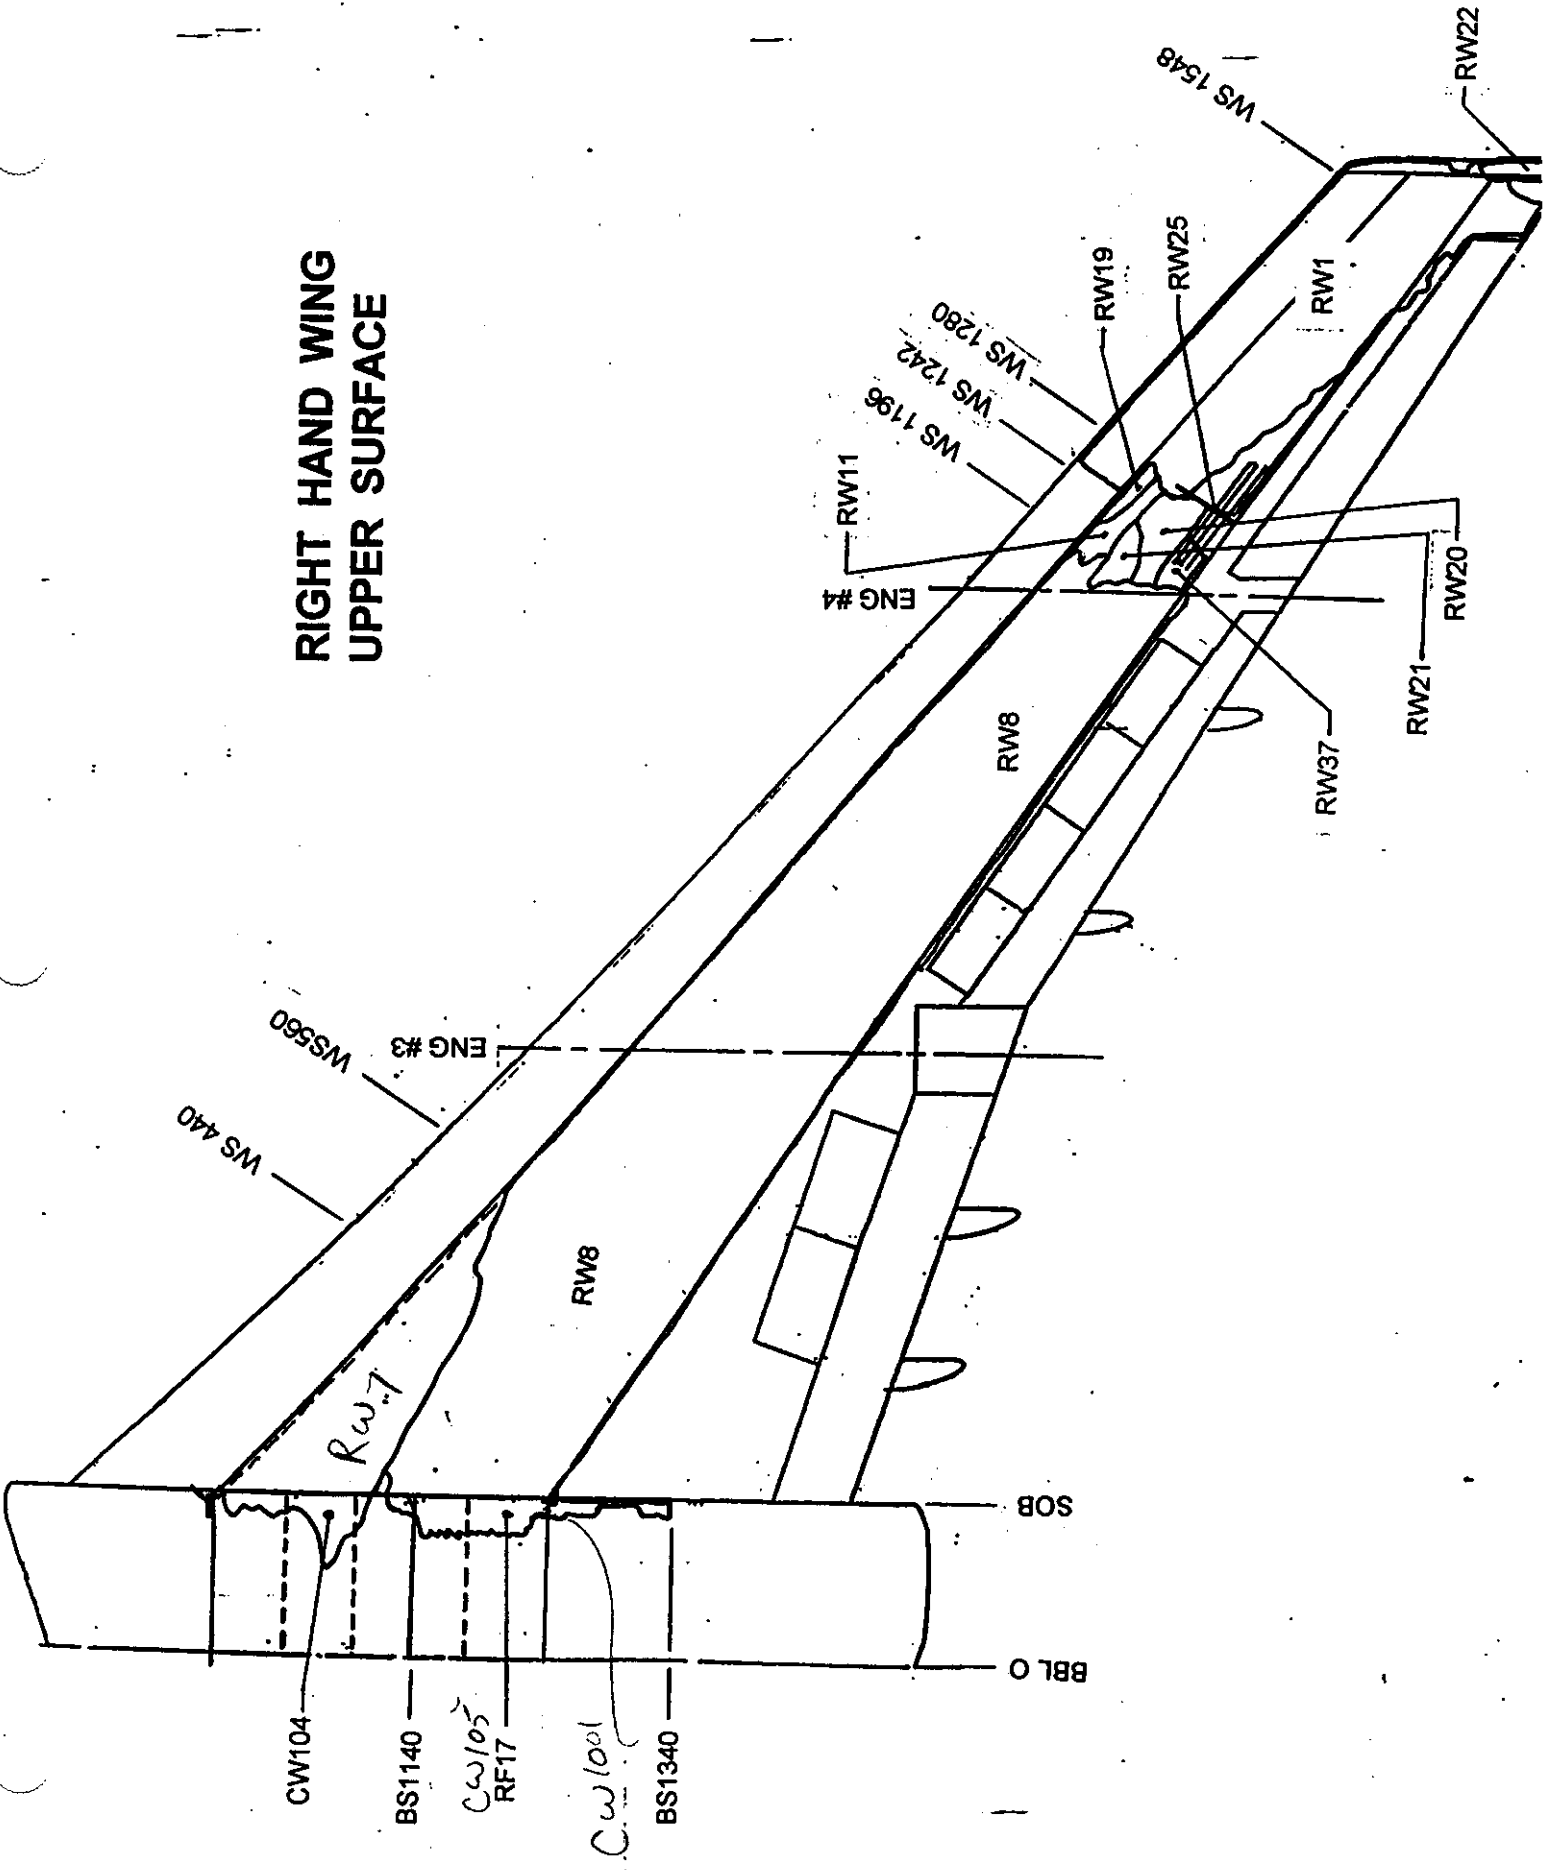
**RIGHT HAND WING
UPPER SURFACE**

There is evidence of fire and soot damage to the upper wing skin and associated stringers immediately outboard of engine #4 exhibiting heavy soot and some fire damage (RW8). The inner surface of the upper skin inboard of the #4 engine exhibited soot in vent stringer passages but no fire damage (reference to Fire and Explosion Group notes).

The wing structure between the inboard and outboard sections had broken into several pieces. The upper wing skin measured from WS 1224 (just outboard of #4 engine) to WS 1280 and had broken into numerous sections (RW11, RW19, RW20, RW21, and RW37). Layout of these pieces showed upward bending, and also panel segments (RW11, RW20, and RW21) were buckled in compression and bent upwards at the inboard and outboard ends. No evidence of fire damage or soot accumulation was observed on these pieces, although some stringers that remained attached to the upper skin (RW8) in this area, exhibited heavy sooting and some fire damage. A separated rib at WS 1252 (RW24) exhibited heavy fire damage, and an adjacent 10 foot piece (RW25), which includes segments of the WS 1280 rib, a vent stringer, and a Z-stringer, was less sooted and burned. The lower wing skin piece (RW10) from WS 1224 to WS 1482 shows a general spanwise curl downwards and is twisted over its length. Most of the stringers show a buckling of the free flange. There was no evidence of any pre-existing cracking or corrosion on these pieces of wing skin.

The upper wing skin from the SOB out to approximately WS 1200 broke into many small segments. These segments vary from a few square inches to a maximum of twenty square feet. Most of the larger pieces are curled upward from an inboard to outboard direction (opposite the direction of the lower skin). There is no evidence of any soot or fire damage to the inner or outer surface of these upper wing skin segments.

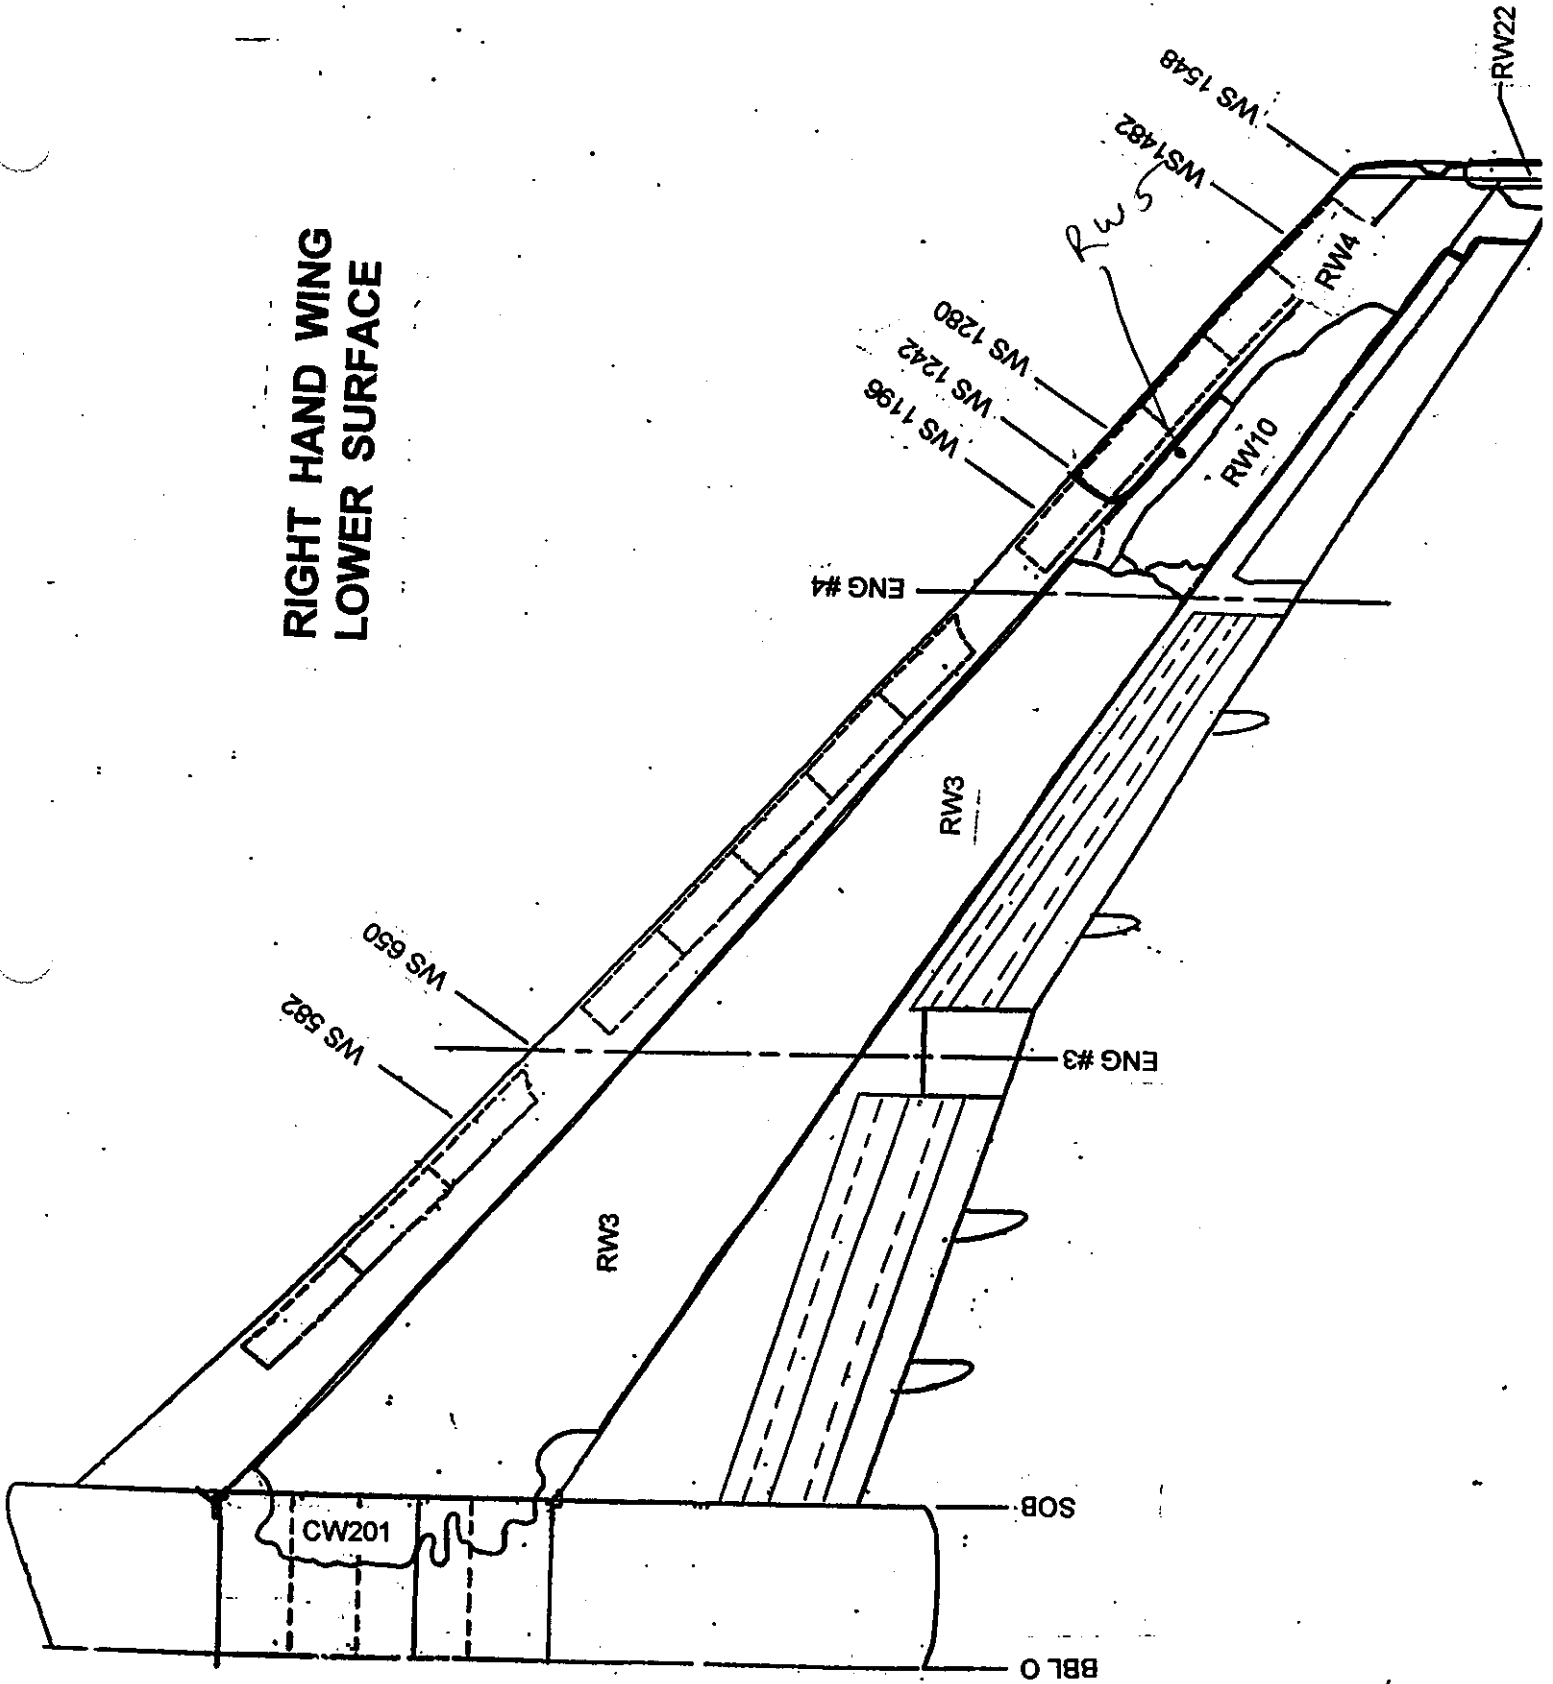
**RIGHT HAND WING
LOWER SURFACE**

The front spar from WS 1196 to the SOB had mainly separated from the upper and lower skins and was found in many pieces of various sizes. Only a 15-foot section outboard of engine #3 and a 10-foot section inboard of engine #4 remained attached to the lower skin (RW3).

A large section of the rear spar between the #3 and #4 engines remained attached to the lower skin and exhibited fire and impact damage (RW3). A 10-foot section of the rear spar between WS 440 and WS 560 (including the main landing gear "H" fitting) remained attached to the upper skin (RW8), and a 6-foot section of the rear spar between WS 582 and WS 650 remained attached to the lower wing skin (RW3).

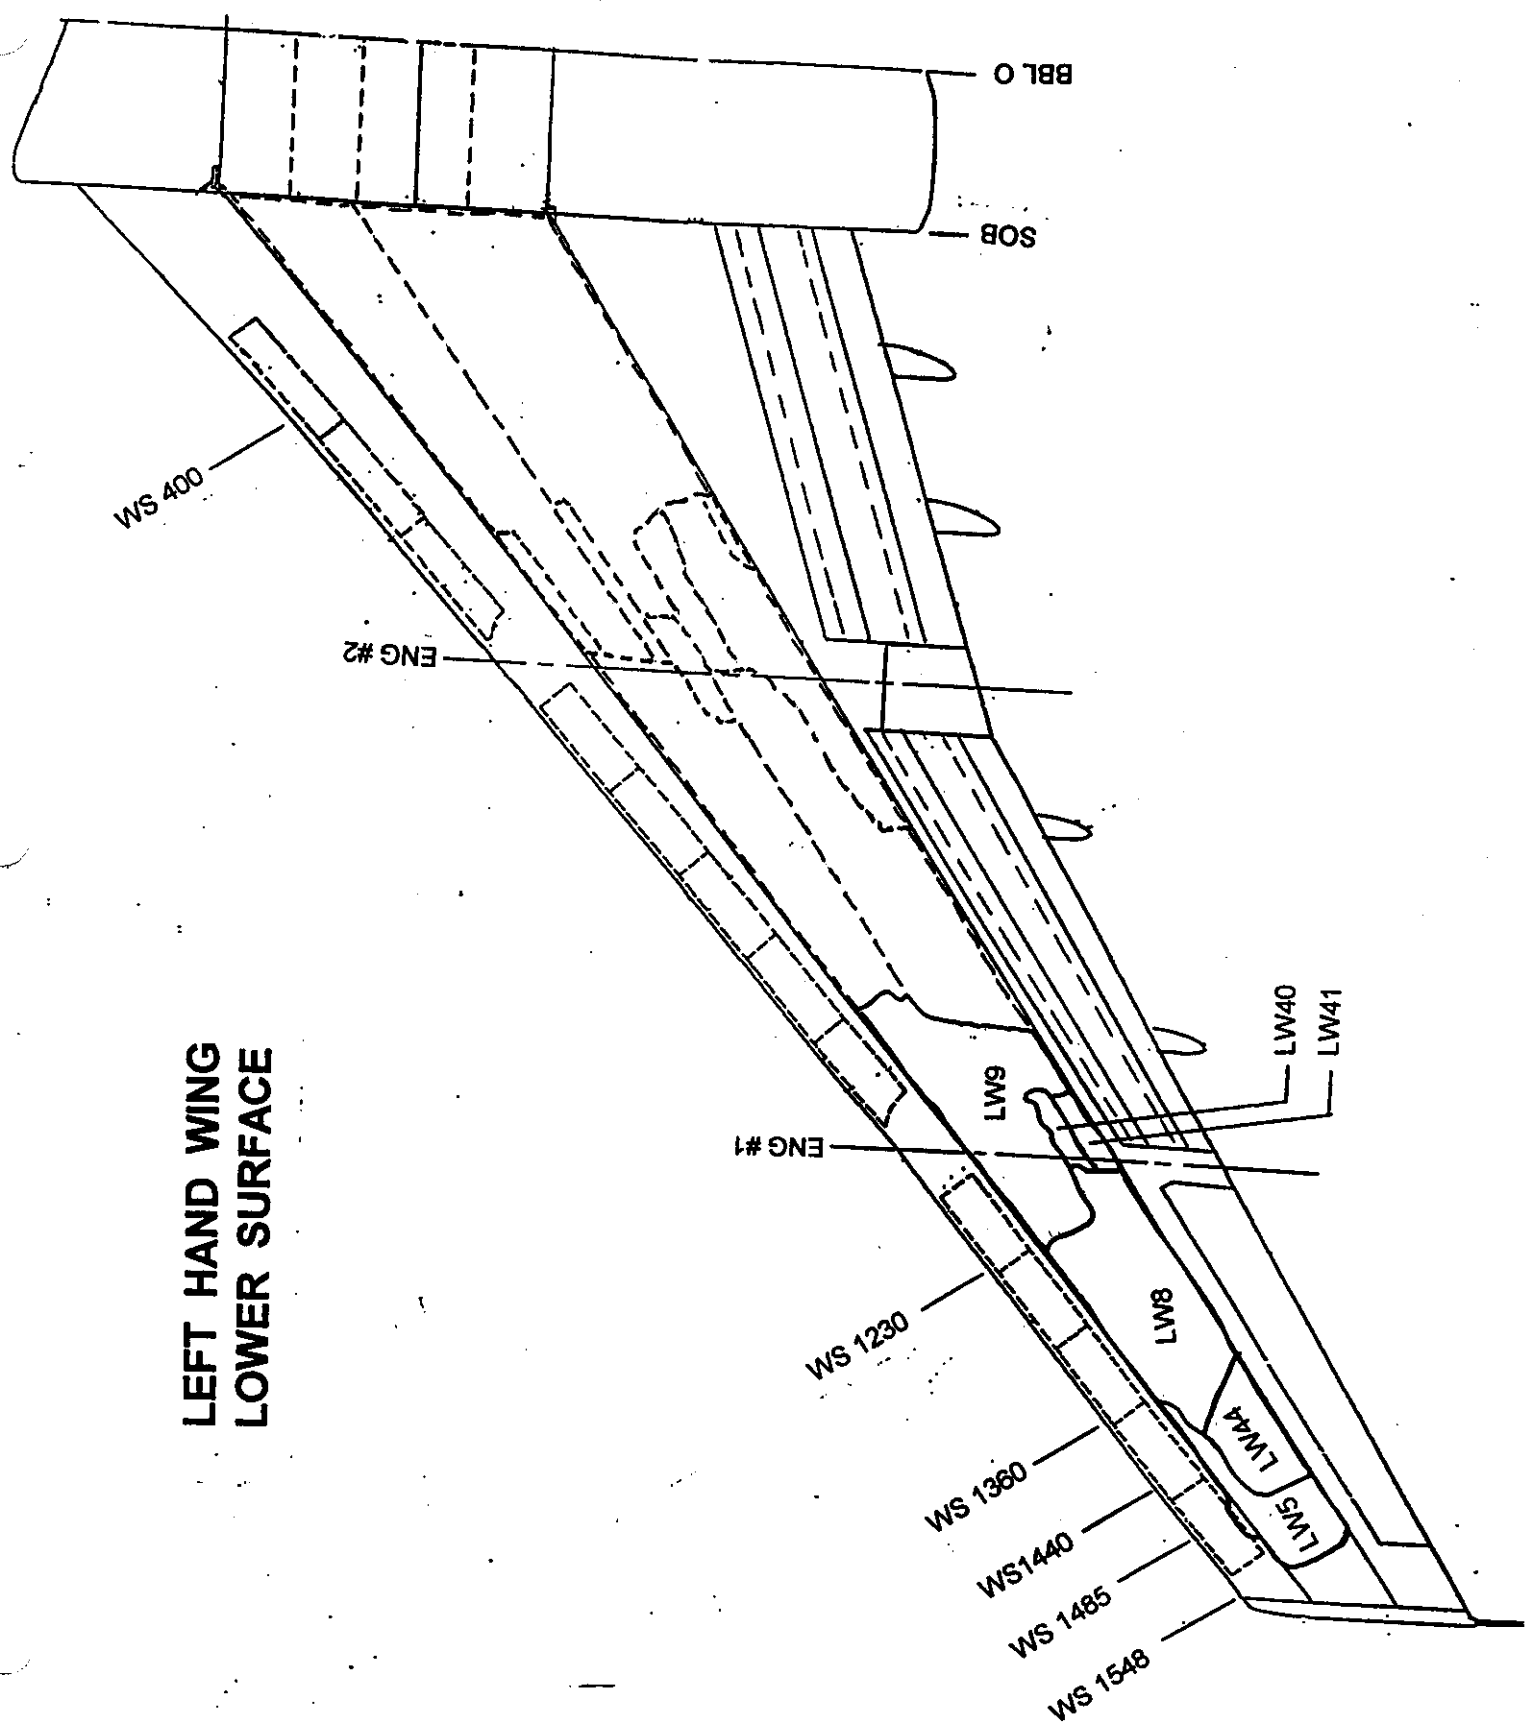
**LEFT HAND WING
LOWER SURFACE**

The upper and lower skin (LW5&6) remained attached to the front spar between WS 1440 to WS 1548. The inboard end of the lower skin (LW5) at WS 1440 exhibited evidence of downward bending, and towards the outboard end, (WS 1548), the front spar is fractured and the skin panel end is bent down over the outboard 10 inches (LW5).

There is evidence of sooting on the lower skin inner surface at WS 1230 near the front spar (LW9). A section of the front spar that remained attached to the lower skin and the corresponding fracture surfaces of the spar and the skin also exhibited evidence of sooting. The adjacent section of the lower skin (LW8), which is bent upward at the inboard end, exhibited no evidence of sooting. These localized sooting areas show soot on the inside surface only but not on the inside surface of the mating pieces. In some cases, the soot extends to and onto the fracture face, but is not evident on the mating piece or its fracture face.

The lower wing skin inboard of approximately WS 1230 was broken into numerous large pieces. These pieces exhibit a pronounced downward bending condition. There is evidence of exterior sooting on the lower skin pieces from WS 400 to WS 1200. There is no evidence of sooting on the inner surface of the wing lower skin, except on some curled pieces near the rear spar and #1 engine (LW40 and LW41) and in a small (2 square foot) area near the front spar just outboard of the #1 engine (LW9 outboard end).

Small segments of rear spar remained attached to the lower skin at WS 1230 (3 feet, on LW8) and WS 1485 (5 feet, on LW5). The remaining rear spar was missing or found in small pieces.

Five segments of the front spar remained attached to the lower skin from #1 engine outboard to WS 1280 (LW8 and LW9). Another segment of the front spar remained attached to the lower skin from WS 1400 To WS 1530 (LW5). A third piece of front spar remained attached to a piece of upper wing skin from WS 1280 to WS 1400 (LW10). The remaining front spar was missing or found in small segments.

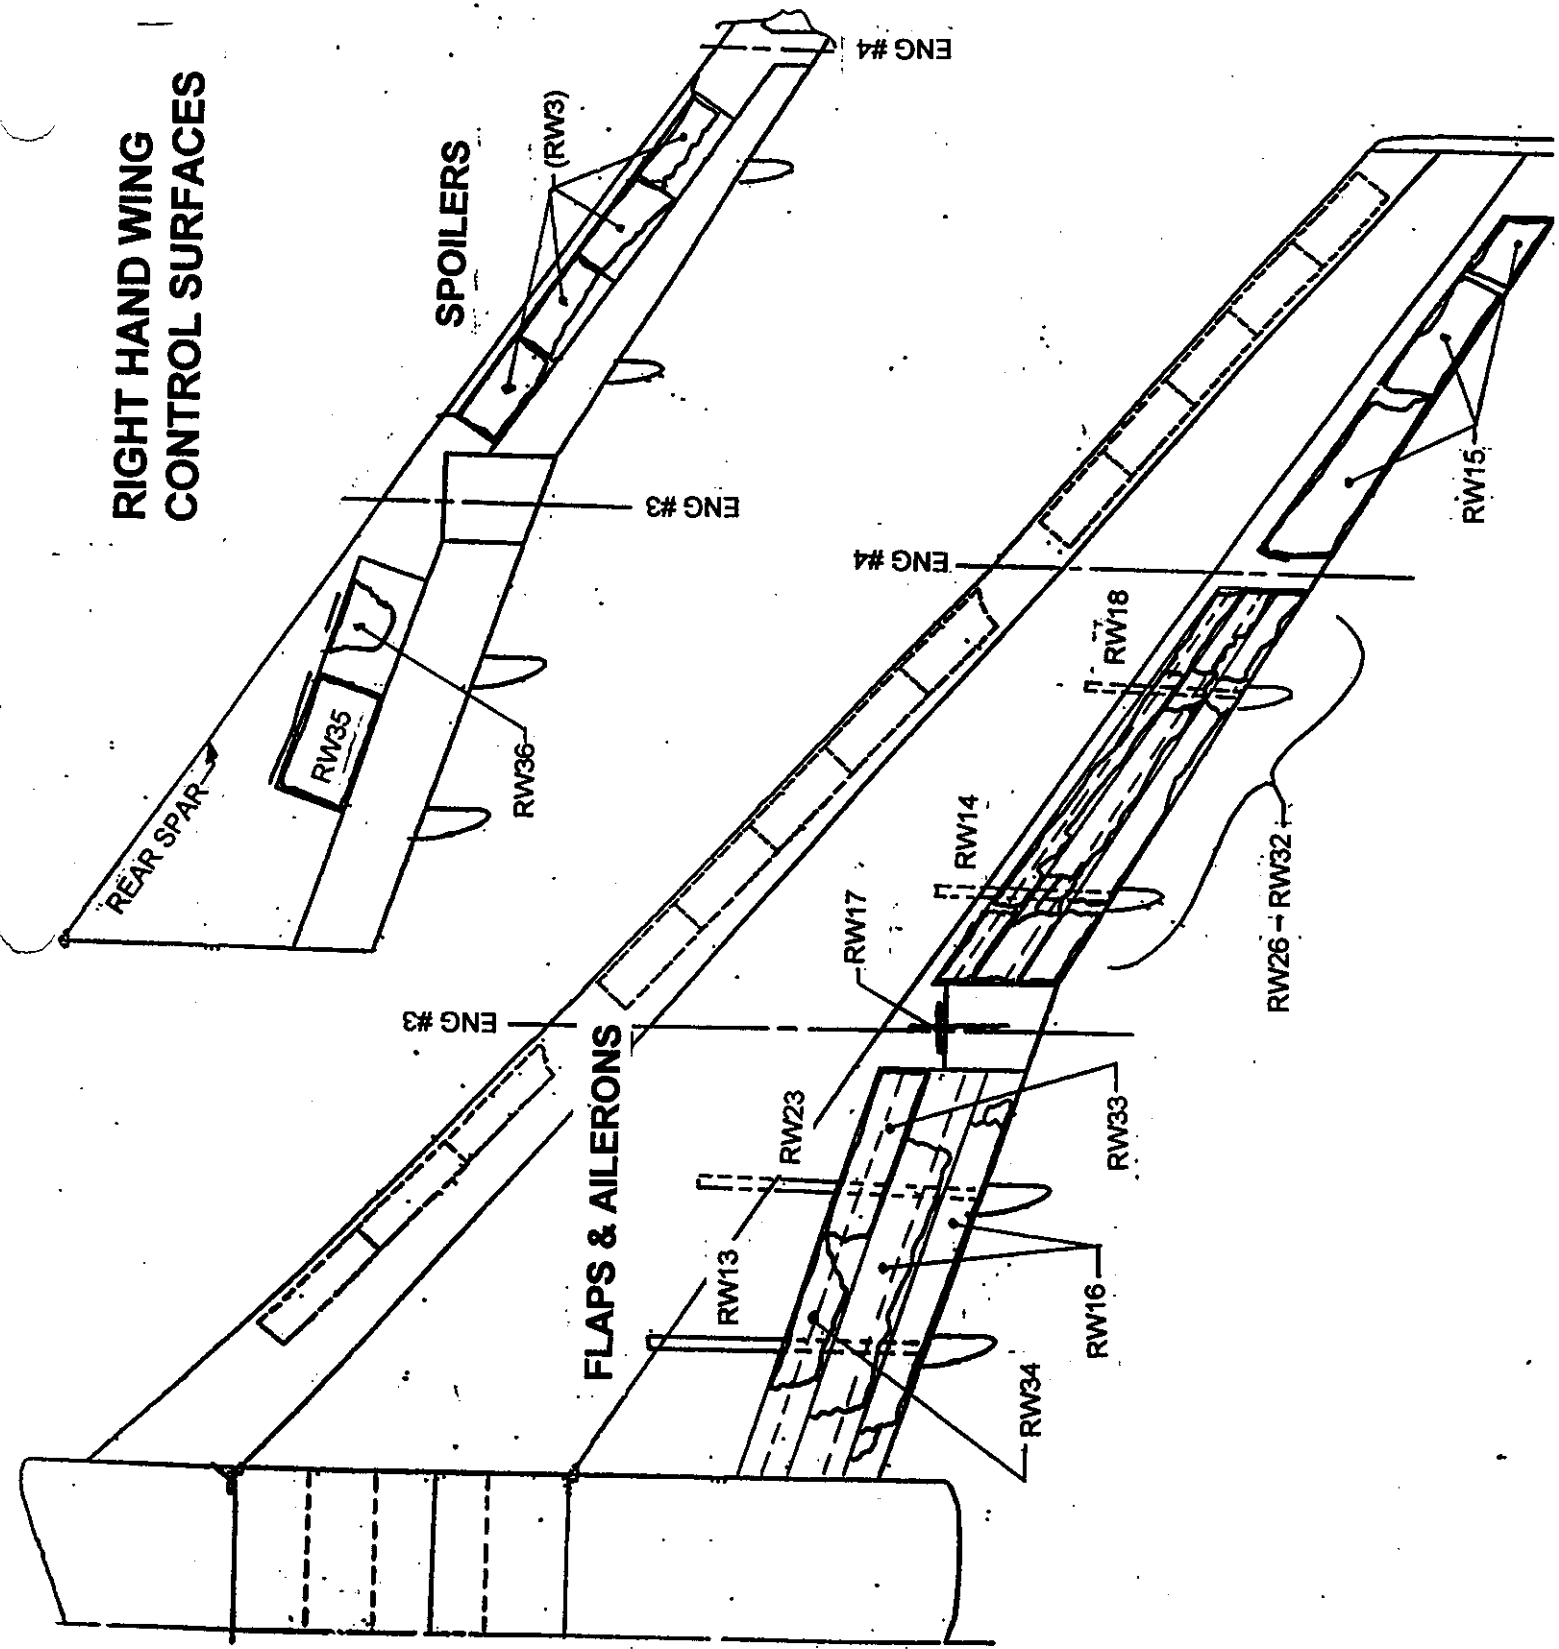
**RIGHT HAND WING
CONTROL SURFACES**

Most of the right-hand wing trailing edge flaps were identified/recovered. The inboard flaps separated into large pieces and show little or no fire or soot damage. There is evidence of severe impact damage, including damage to the honeycomb and associated skin (RW16, RW34, RW33). The outboard flaps separated into numerous smaller pieces and show heavy fire damage. The entire outboard flap sections were recovered and identified, except for a very small area (RW26 to RW32).

All four inboard spoilers and their actuators were recovered. The inboard-most on each wing (LW24 and RW35) show fire and soot damage, and the outboard-most on each wing show impact tearing and fracture damage.

The outboard spoilers on the right wing were still attached to the rear spar (RW3) but were badly burned. The outboard spoilers on the left wing were not identified.

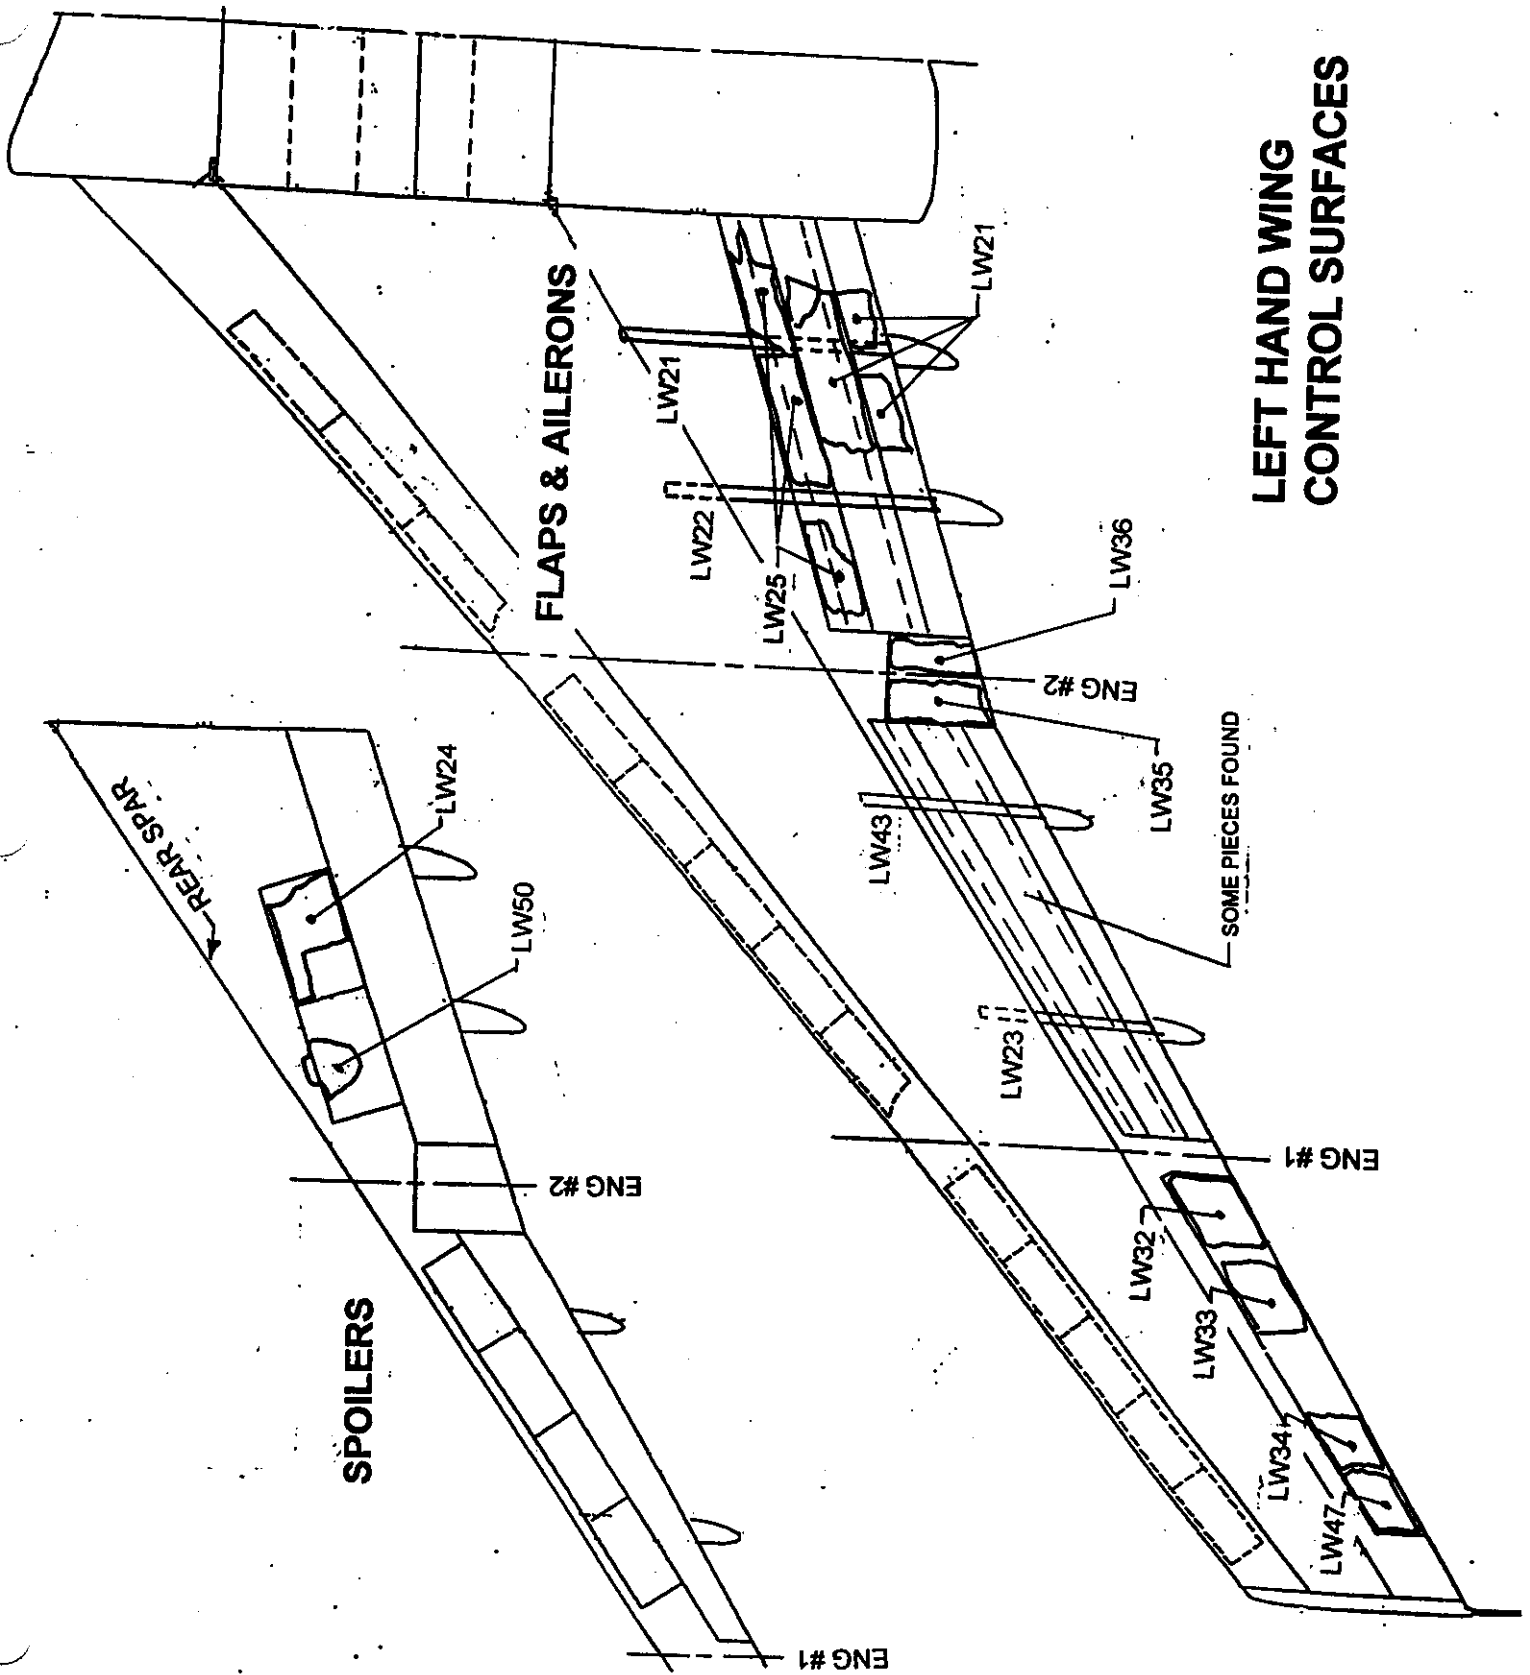
**LEFT HAND WING
CONTROL SURFACES**

The left side inboard fore flap broke in three distinct pieces (LW25). All of these pieces suffered fire damage and severe impact damage. A large section of the inboard mid flap remained attached to the flap track assembly (LW21). The mid flap box suffered severe impact damage. The upper and lower surfaces of the mid flap section also exhibited evidence of fire damage. Only a very small area of the left-hand outboard flaps were identified (a few square feet), and these small pieces were not individually documented.

All four ailerons were found in pieces, with the largest varying in length from 4 to 8 feet. The left outboard aileron broke in several pieces (LW47, LW34, LW33, LW32) and exhibited evidence of fire damage on some pieces. The inboard aileron broke into two sections near the middle (LW35 and LW36) and had been severely damaged by impact and fire. The right outboard aileron broke into three distinct pieces (RW15). These three sections suffered minor impact damage on the skin surfaces but no fire damage. The inboard aileron actuator and associated mounting bracket (RW17) were recovered from the Green area. The actuator and a small section of aileron structure separated from the remaining aileron structure. No evidence of fire damage was documented.
