STRUCTURES GROUP CHAIRMAN'S FACTUAL REPORT OF INVESTIGATION

December 13, 1994

A. ACCIDENT : DCA-94-MA-076

LOCATION : Aliquippa, PA
DATE : September 8, 1994
TIME : 1904 Eastern Daylight Time (EDT)
AIRCRAFT : Boeing 737-3B7, N513AU,

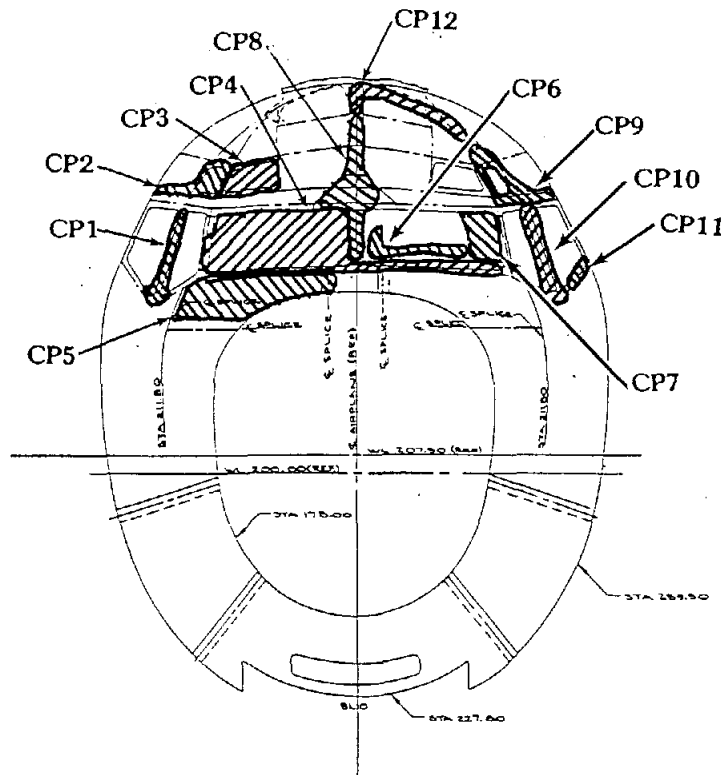
VIEW LOOKING AFT

Cockpit (CP) support posts CP-1, -10, and -11 exhibited compression damage along the posts. CP-2, -3, -4, and -5 exhibited compression damage surrounding the window framing and also exhibited overload fractures at the forward and aft window posts, with a windshield wiper arm remaining attached to the CP-5 support and the CP-4 window attached and shattered. CP-6, -7, -9, and -12 sustained postimpact fire damage, and CP-8, -9, and -12 exhibited compression damage.
