NATIONAL TRANSPORTATION SAFETY BOARD

Structures Group Chairman's
Factual Report

DCA09MA026

Location: Hudson River, Weehawken, New Jersey
Date: January 15, 2009
Time: 1527 (EST)
Aircraft: Airbus A320-214, N106US, S/N 1044

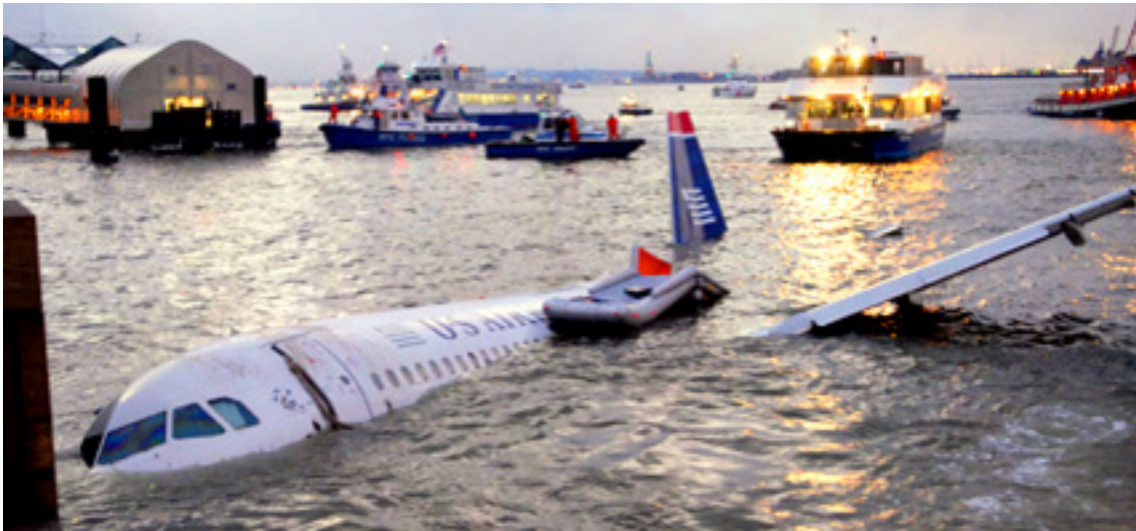
Figure 1 - USAirways flight 1549 after the passenger evacuation.

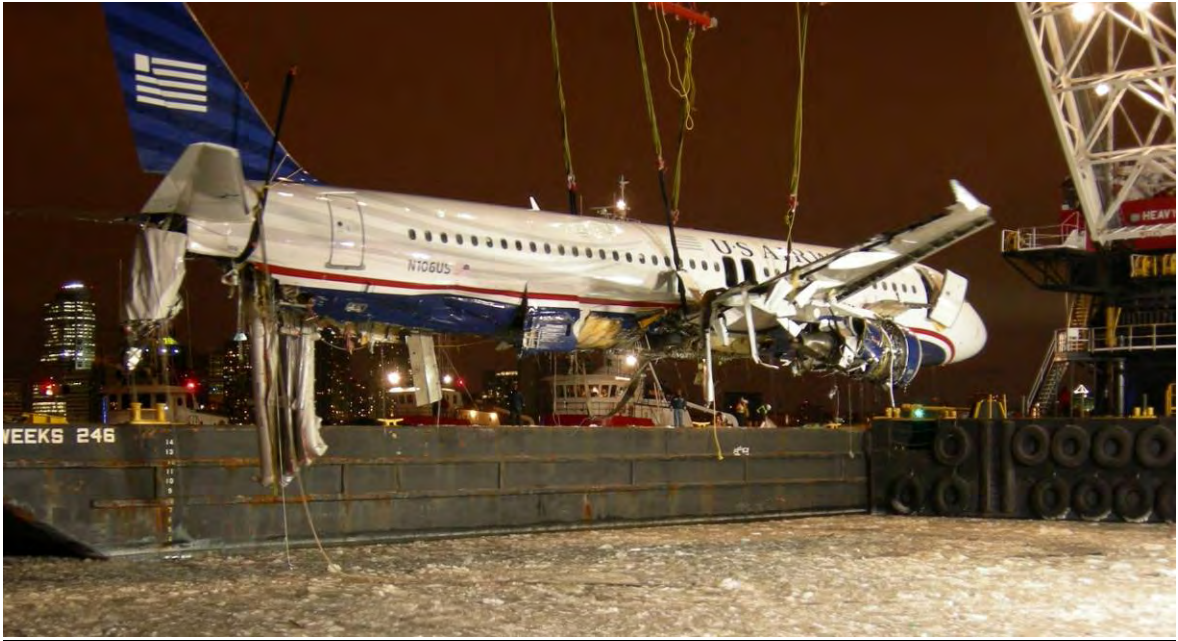
Figure 2 - USAirways Flight 1549 being placed on the recovery barge.
