NATIONAL TRANSPORTATION SAFETY BOARD  
Office of Aviation Safety  
Washington, DC 20594

STRUCTURES GROUP CHAIRMAN'S FACTUAL REPORT

DCA-95-MA-054

Location: Carrollton, Georgia  
Date: August 21, 1995  
Time: 1252 Eastern Daylight Time  
Aircraft: Atlantic Southeast Airlines flight 529, Embraer EMB-120, N256AS

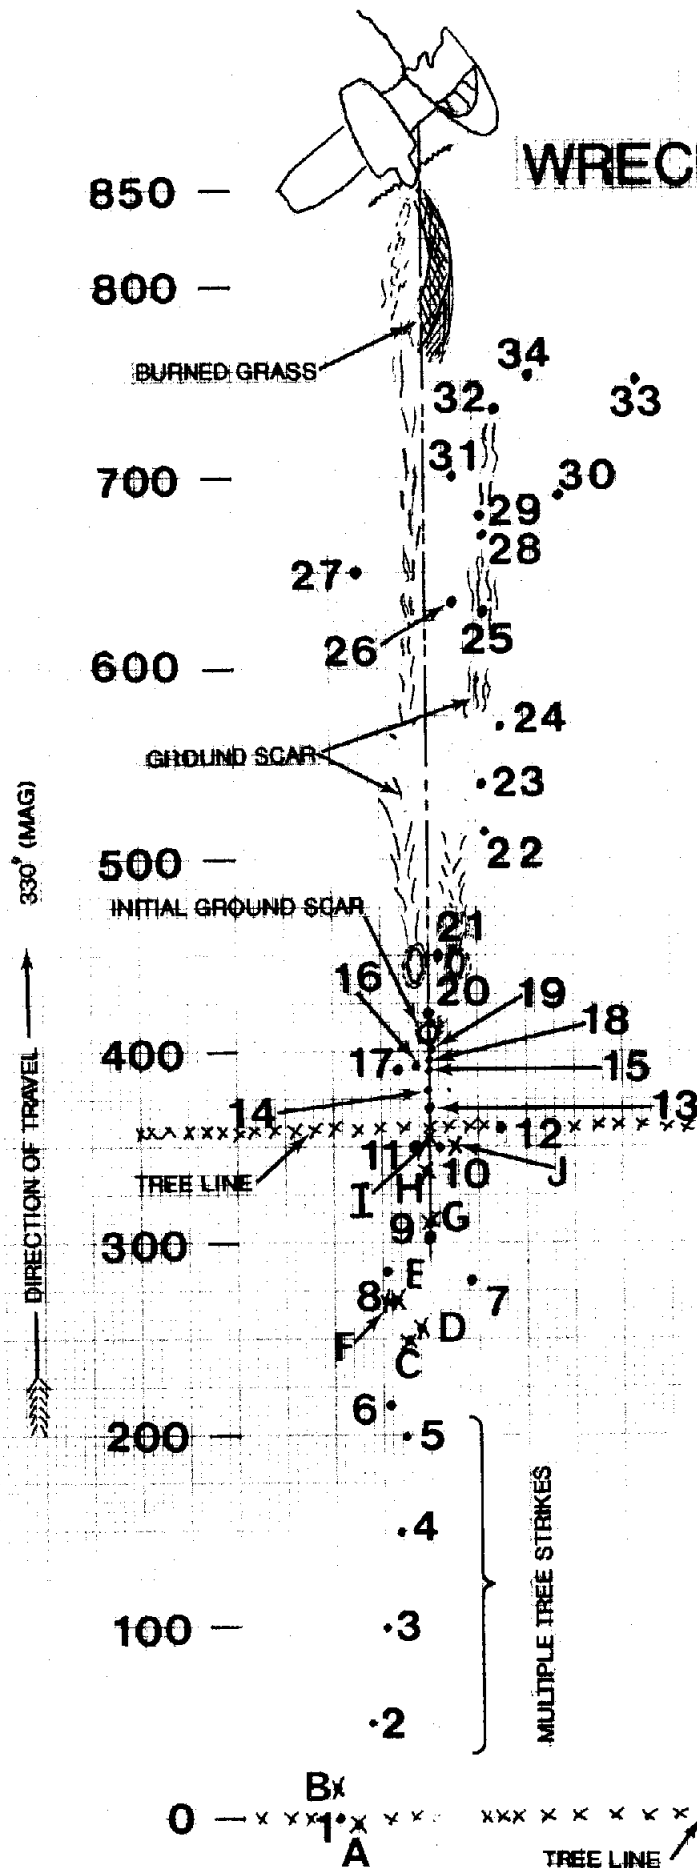
# FIGURE 1 WRECKAGE DISTRIBUTION DIAGRAM

Several ground scars were observed in the field. The first ground scar was located approximately 40 feet northwest of the tree line, and several pieces of the left wing were located nearby. Two longer scars were located approximately 80 feet northwest of the tree line; the lateral distance between these scars (relative to the centerline of the wreckage path) was 11 feet. Debris from the airplane was scattered along the wreckage path in the field, with the majority of the debris on the right (east) side of the path centerline. The left engine's propeller assembly had separated and was located approximately 160 feet from the tree line. Several ground scars were observed between the initial ground scars and the main wreckage and a separated portion of the left wing. The location of tree strikes and the distribution of major pieces and ground scars are included in figure 1, Wreckage Distribution Diagram.

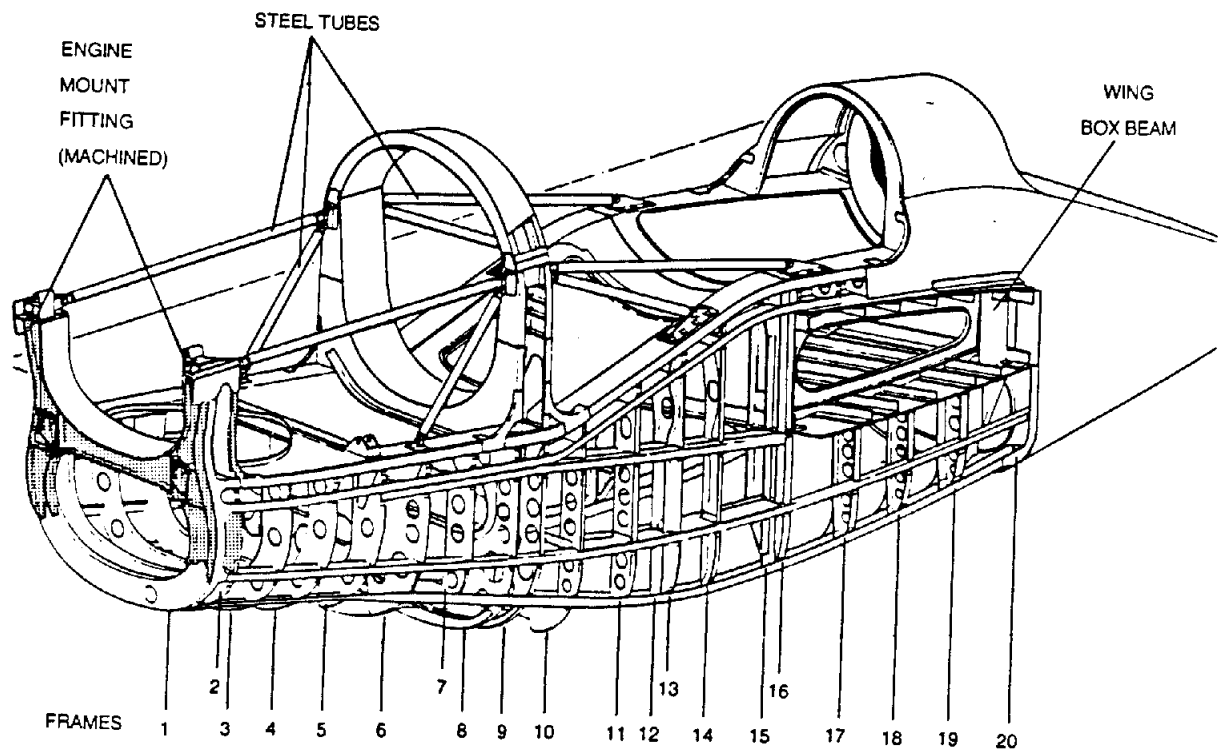
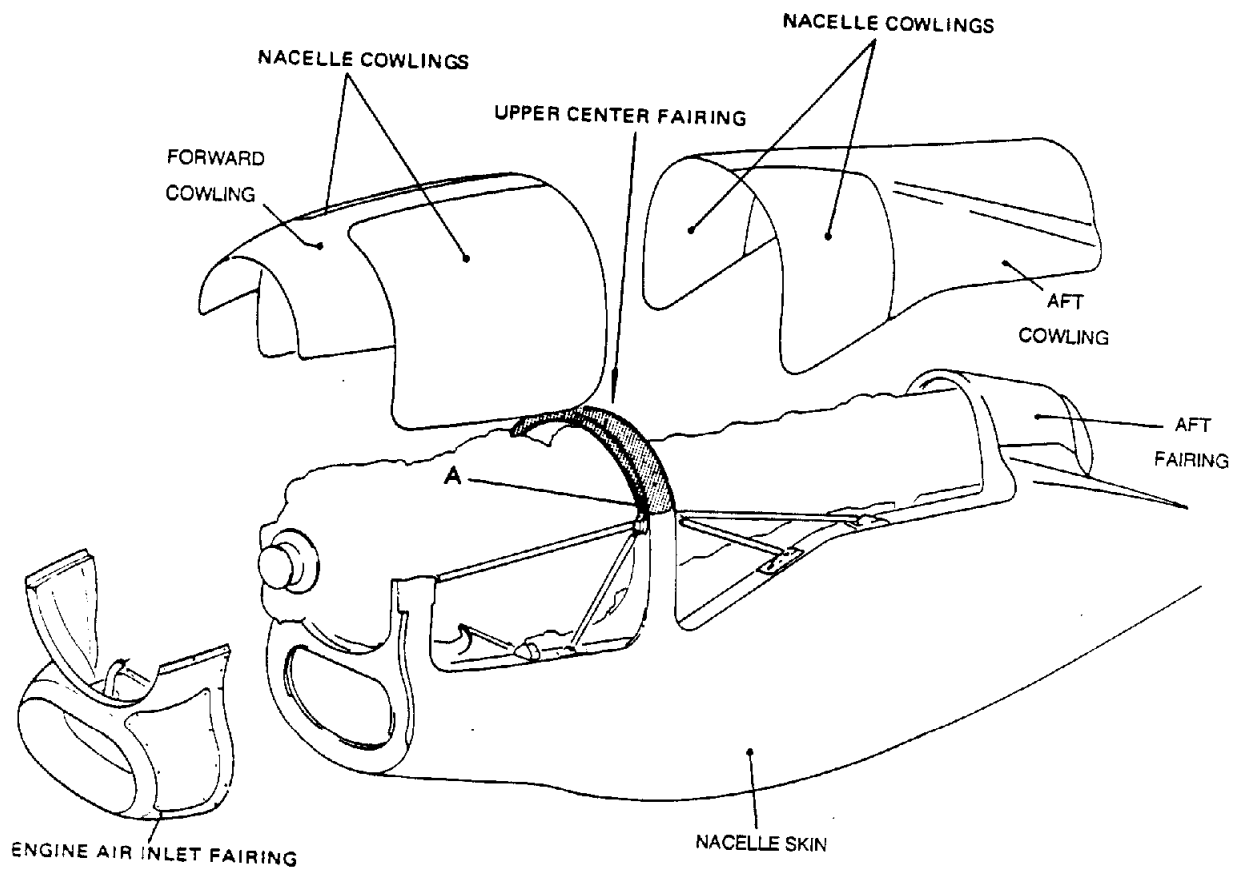
**FIGURE 2. NACELLE STRUCTURE AND SKIN**

The outboard member of frame 1 of the nacelle was deformed aft approximately 90° and twisted outboard slightly. There was also a semi-circular flattened area in the middle of the outboard member of frame 1. The "axis" of the flattened area was oriented upward

approximately 20° from the horizontal. The forward, inboard engine mount bolt had sheared in an upward and slightly outboard direction. The corresponding area of the attach fitting was smeared in the same direction. The engine inlet and the lower nacelle were bent inboard. The inboard nacelle skin exhibited buckling creases consistent with inboard movement of the nacelle.

The engine air inlet fairing and the forward portion of the forward cowling remained with the propeller/gearbox assembly but were deformed outboard. Both steel tubes connected to the forward and aft engine mounts were found separated from the terminal ends. The inboard tube was bent slightly; the outboard tube was not bent.

Five of the six hinges that secure the inboard and outboard forward cowling doors were attached but were bent in a direction consistent with up and aft movement of the cowling doors. The area underneath several of the hinges was damaged consistent with overtravel of the hinges. The forward, inboard hinge had separated, and the area of the inboard door where the hinge was attached was torn. The forward edge of both forward cowling doors was bent upward.
