STRUCTURES GROUP CHAIRMAN'S FACTUAL REPORT

DCA-94-MA-065

Location: 2180 feet southwest of runway 18R threshold, Charlotte/Douglas
International Airport, Charlotte, NC
Date: July 2, 1994
Time: 1843 Eastern Daylight Time
Aircraft: USAir flight 1016, DC-9-31, N954VJ

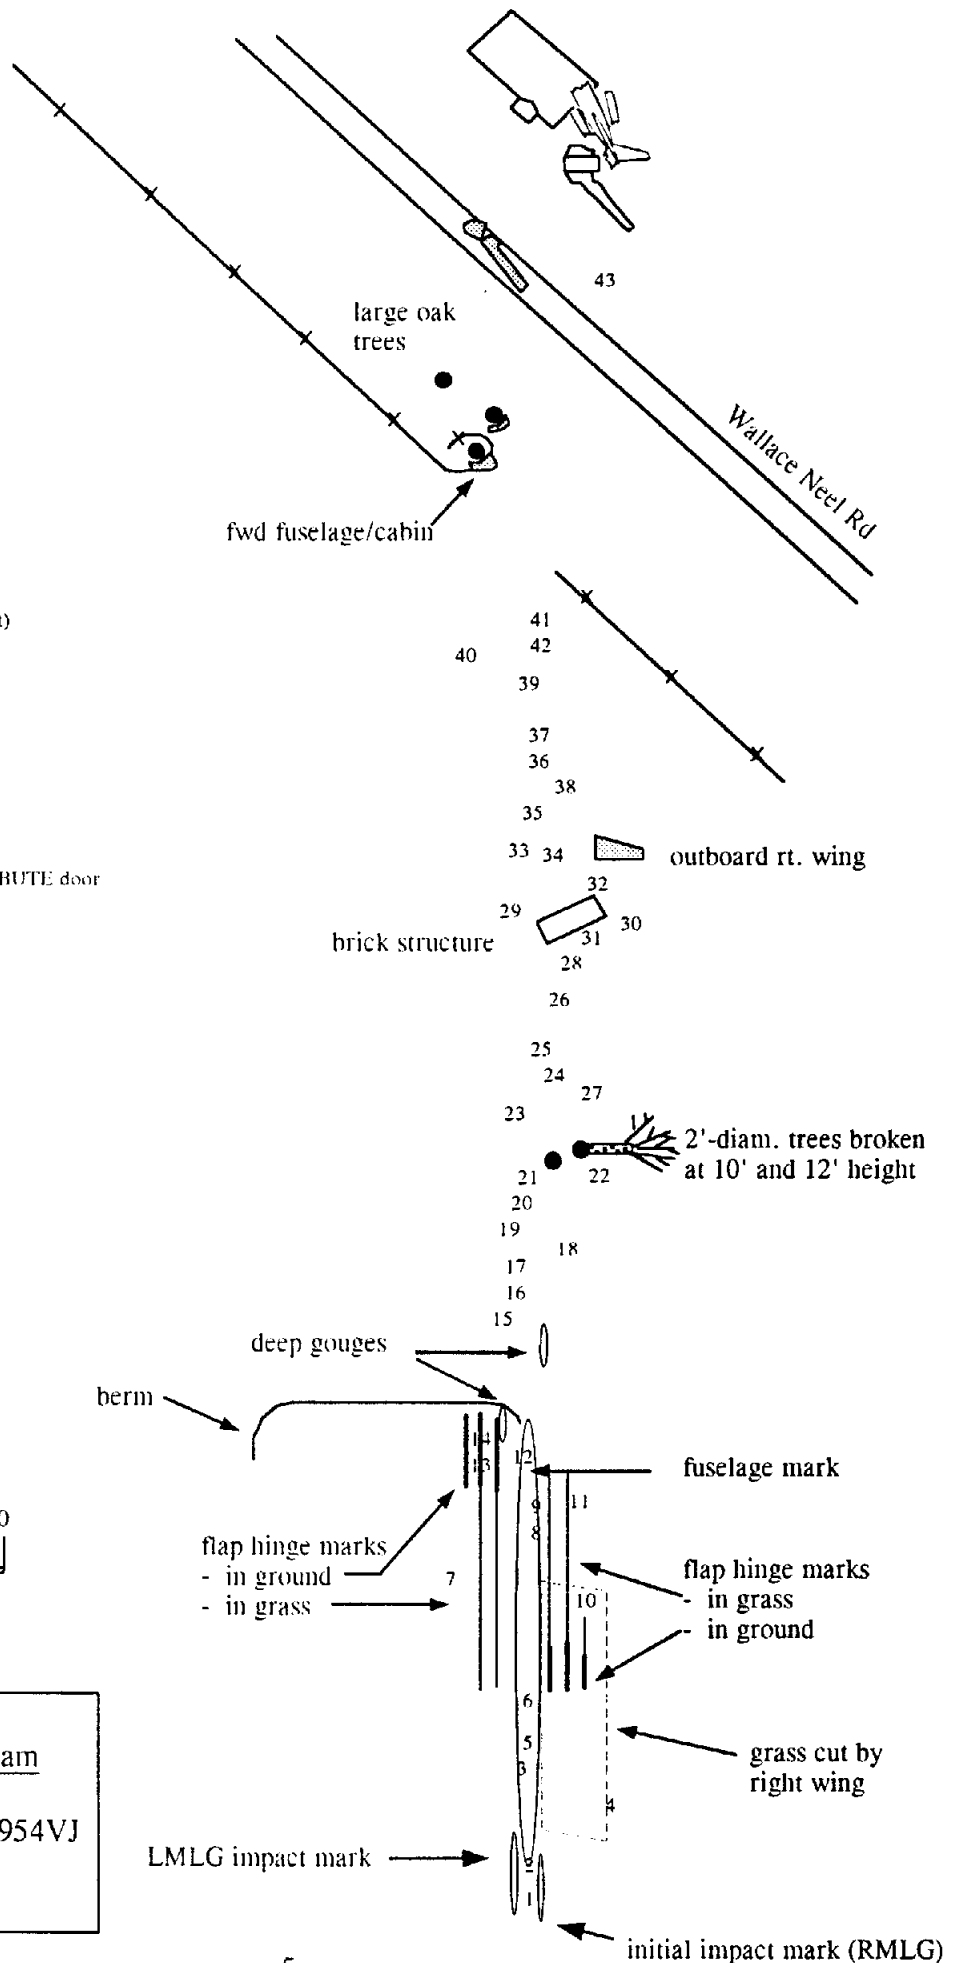
Figure 1
Wreckage Distribution Diagram
USAir flight 1016, DC-9-31, N954VJ
Charlotte, NC
July 2, 1994

Several distinct ground-impact marks from the airplane were identified. The first ground-impact mark was located on airport property in a grassy field approximately 2180 feet on a bearing of 240^{o1} from the threshold of runway 18R. The elevation of this location was identified by Global Positioning System (GPS) equipment as 748 feet (elevation of runway 18R is 743 feet). The spacing of the ground scars was compared with the airplane's dimensions to correlate the ground scars with specific airplane structure. The initial ground scar was consistent with being from the right main landing gear. The next ground scar (18 feet farther in the direction of airplane travel) was consistent with the left main landing gear. The furrows attributed to the right and left main gear wheels were approximately 9 inches deep and 40 feet and 53 feet long, respectively. These ground scars were followed by narrow ground scars that were consistent with the spacing of the right wing's flap hinges. There was also a large swath in the grass along the right side of the airplane's ground travel path; the distance to the edge of the swath was consistent with one-half of the airplane's wing span. Narrow cuts observed in the grass along the left side of the airplane's travel path were consistent with the spacing of the left wing's flap hinges. Figure 1 contains a diagram of impact marks and wreckage distribution.

Portions of the wreckage were scattered throughout the debris path, which was oriented along a heading of approximately 211°. The first item in the debris field was identified as the water spray deflector for the APU, which is located on the underside of the fuselage at fuselage station 996. One of the lower VHF antennas and pieces of red glass were found 75' beyond the water spray deflector. The debris field contained a wooded area of sheared trees between approximately 500 and 800 feet from the initial impact mark. The aft portion of the fuselage, including the empennage and the two engines, was the last major section of the airplane in the debris field and came to rest through a carport adjacent to a house located across Wallace Neel Road. The length of the debris field, as measured (by tape measure) from the initial ground scar to the aft end of the fuselage, was 1063 feet.

The locations of other major pieces of the airplane and ground obstacles are as follows. A portion of the left inboard gear door was found approximately 200 feet from the initial ground impact mark. A berm located along the left side of the debris field approximately 300 feet from the initial impact mark contained ground scars consistent with the left wing flap hinges. Two large gum trees (approximately 2-foot diameter) broken approximately 10 and 12 feet above ground level were located nearly 500 feet from the initial impact. These trees were located just to the right (northwest) of the centerline of the debris field and were the first major trees to be impacted. The tail cone was found approximately half-way down the debris field. The nose gear was found among the remnants of a small brick structure approximately 50 feet beyond the tail cone. Most of the right wing was found in one section approximately 90 feet beyond the tail cone. Several tall trees along the right side of the debris field in the vicinity of the right wing had been discolored by fuel. Two separate fires that had burned car tires found on the ground were located near the right wing and the brick structure. Two sections of the fuselage were crushed against large trees across the street from the house, and an adjacent tree contained scraping on its north and west sides. The cockpit and a section of the forward fuselage came to rest on Wallace Neel Road in front of the house. A portion of the airplane that included the center wing section, most of the left wing, and a section of the fuselage over the center wing section was located near the house and aft fuselage section. The left main landing gear had separated from the wing and was jammed against the house beneath the aft fuselage section. The right main landing gear was located between the empennage and Wallace Neel Road.

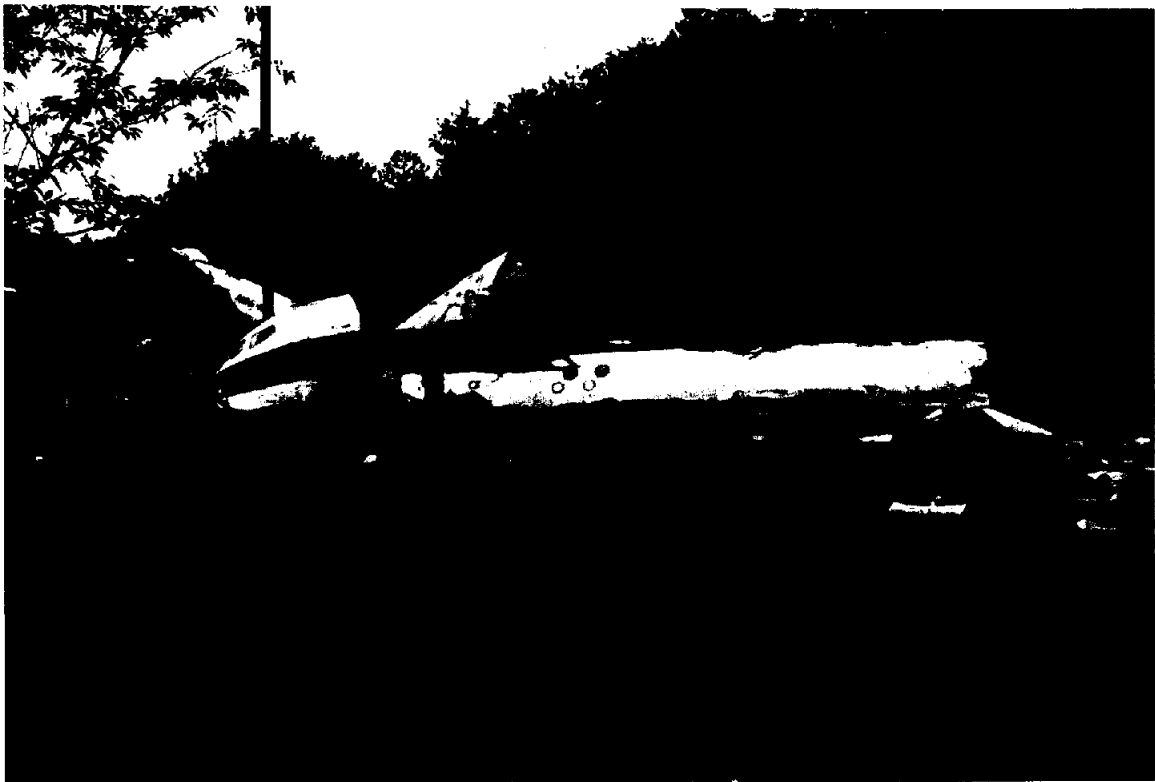
An approximate 40-foot portion of the forward fuselage consisting of the cockpit, the forward galley, and the left side of the passenger cabin and forward cargo compartment came to rest on Wallace Neel Road facing a southerly direction. This section was lying on its right side and the nose section was canted to the left relative to the fuselage. Except for a portion of the skin above floor level on the left side aft of the cockpit, only the skin, frames, and stringers on the left side below floor level remained with this fuselage section.

Figure 6. Cockpit and left/forward fuselage section on road.

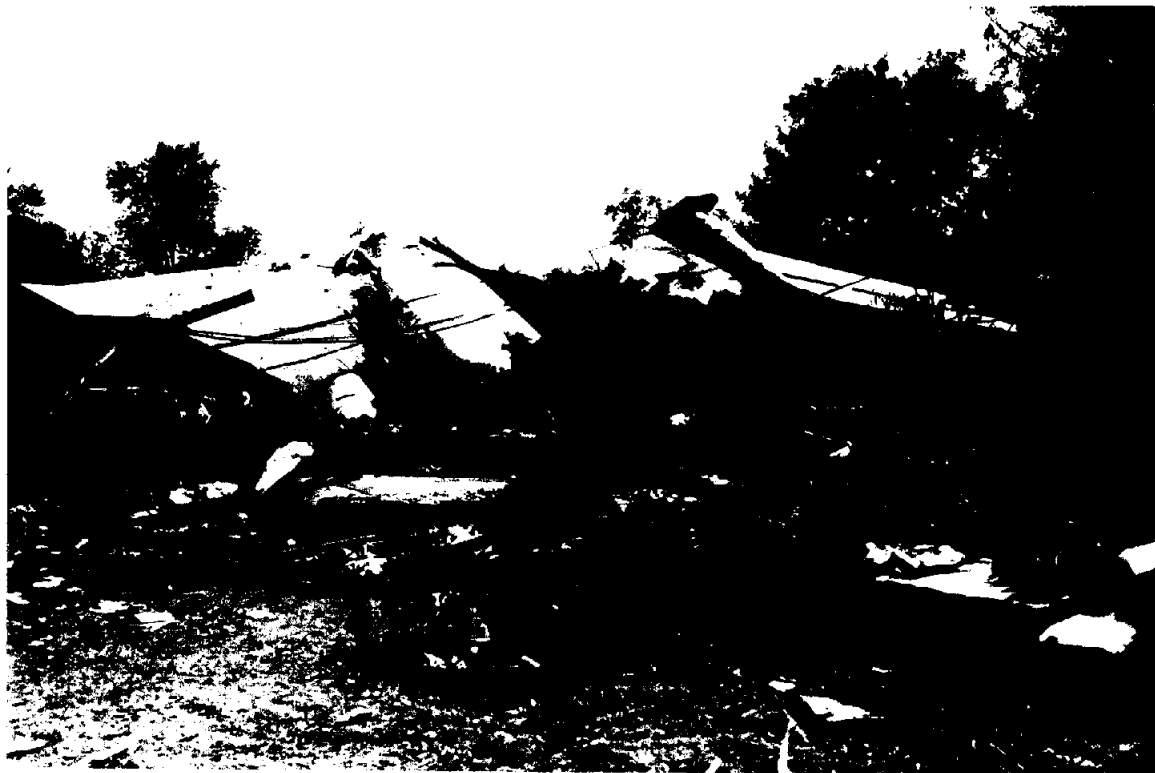
The aft fuselage section located against the house on Wallace Neel Road consisted of the fuselage from near station 870 (i.e., between the third and fourth aft-most windows) to the point where the tail cone had separated. The empennage sustained severe fire damage, with greater fire damage on the left side. Power lines along Wallace Neel Road were entangled with the empennage.

Fire had burned away the left elevator and a portion of the left horizontal stabilizer section that remained attached to the empennage. The right horizontal stabilizer and elevator were intact except for the outboard tip, but had sustained substantial fire damage and sooting on the underside. Most of the rudder aft of the hinge line had been destroyed by fire. Fire had also destroyed upper portions of the leading edge and inspar areas of the vertical stabilizer.

Figure 7. Aft fuselage, empennage, and left/center wing section.
