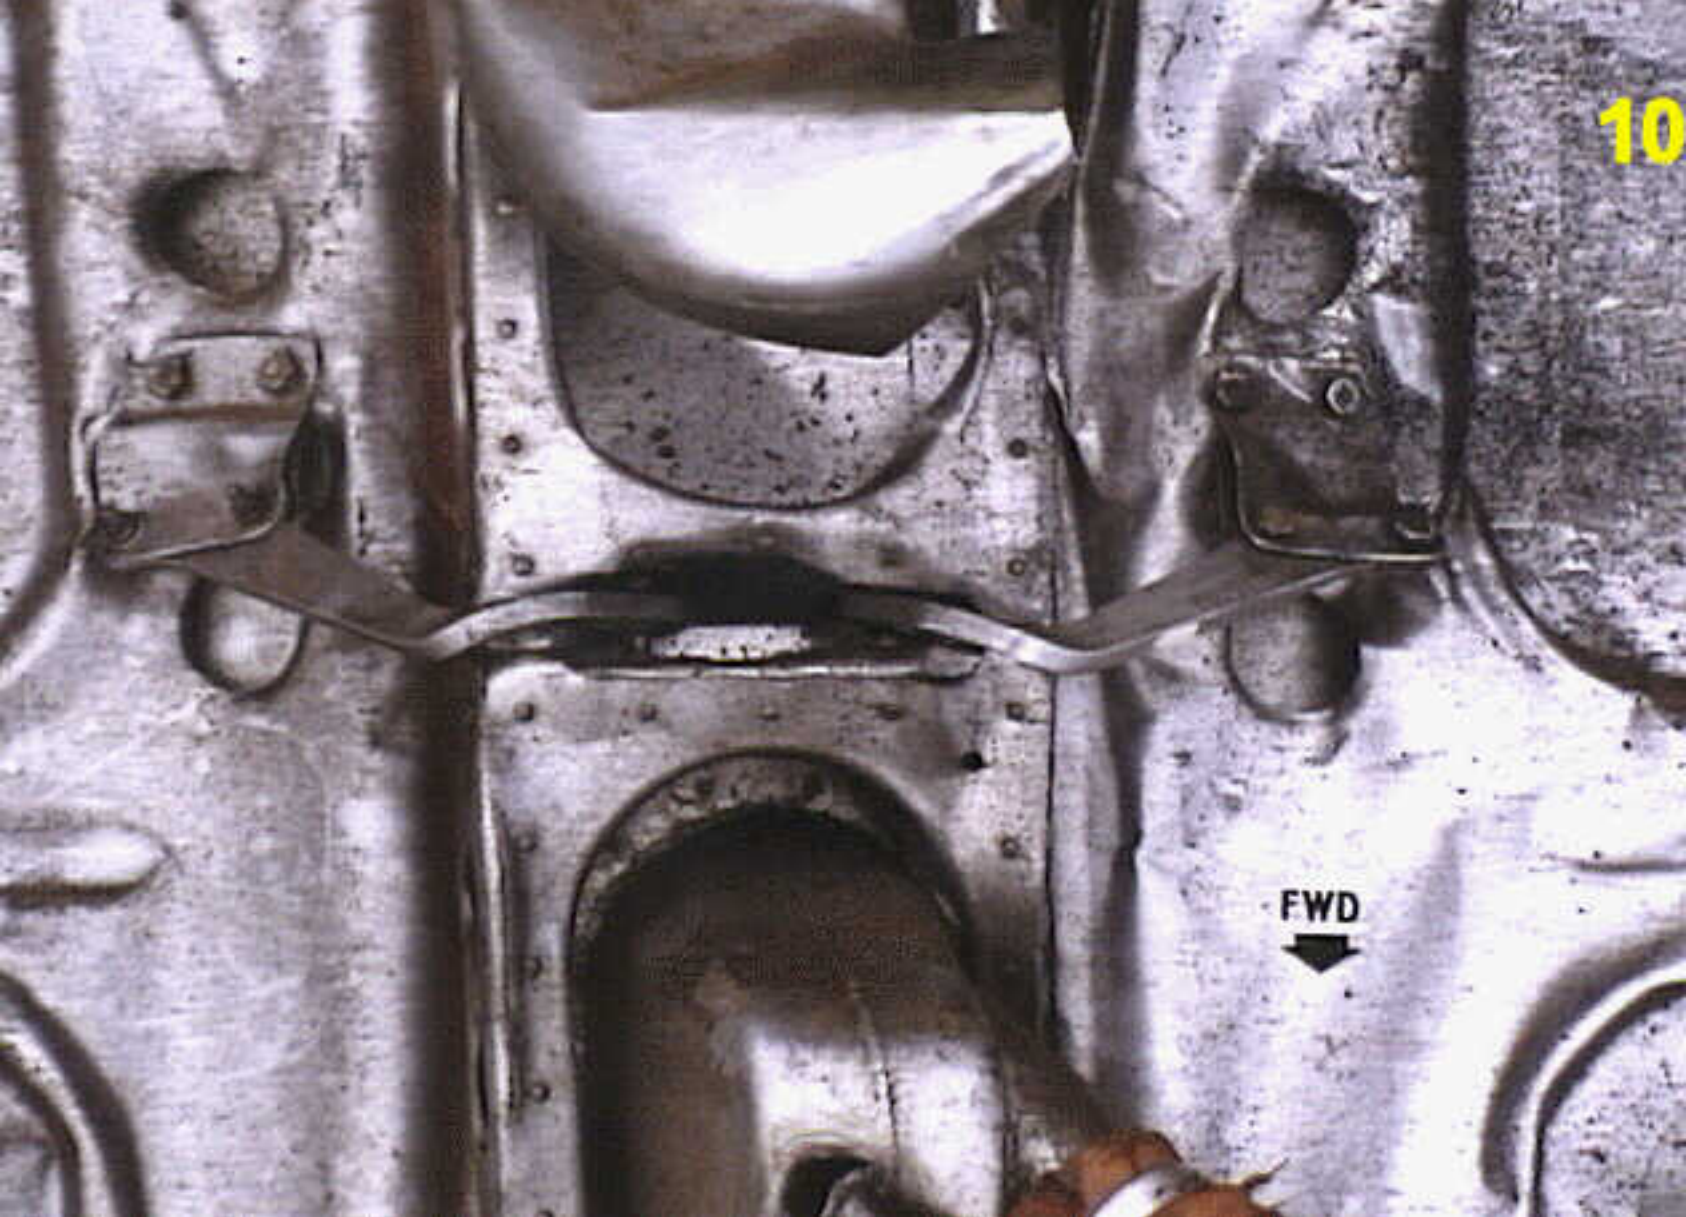
Structures 7A - Photo 10. Damage to middle hinges of left forward cowling doors.
