Docket No. SA-532

NATIONAL TRANSPORTATION SAFETY BOARD

STRUCTURES GROUP CHAIRMAN'S FACTUAL REPORT

DCA09MA026

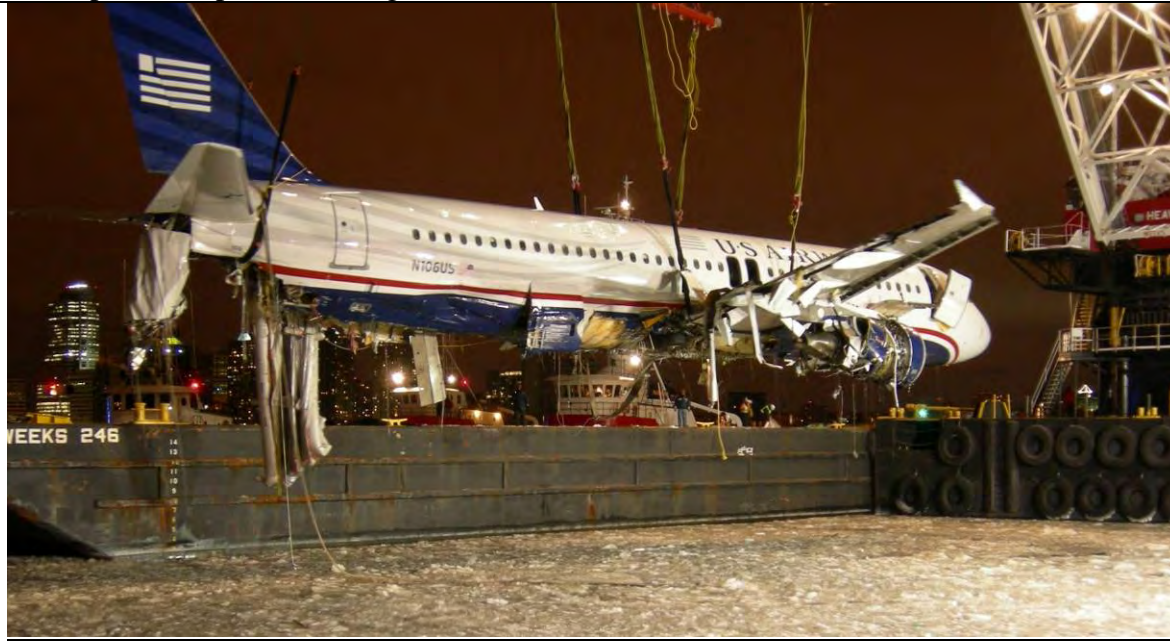
Photo 1

Description: Airplane wreckage.

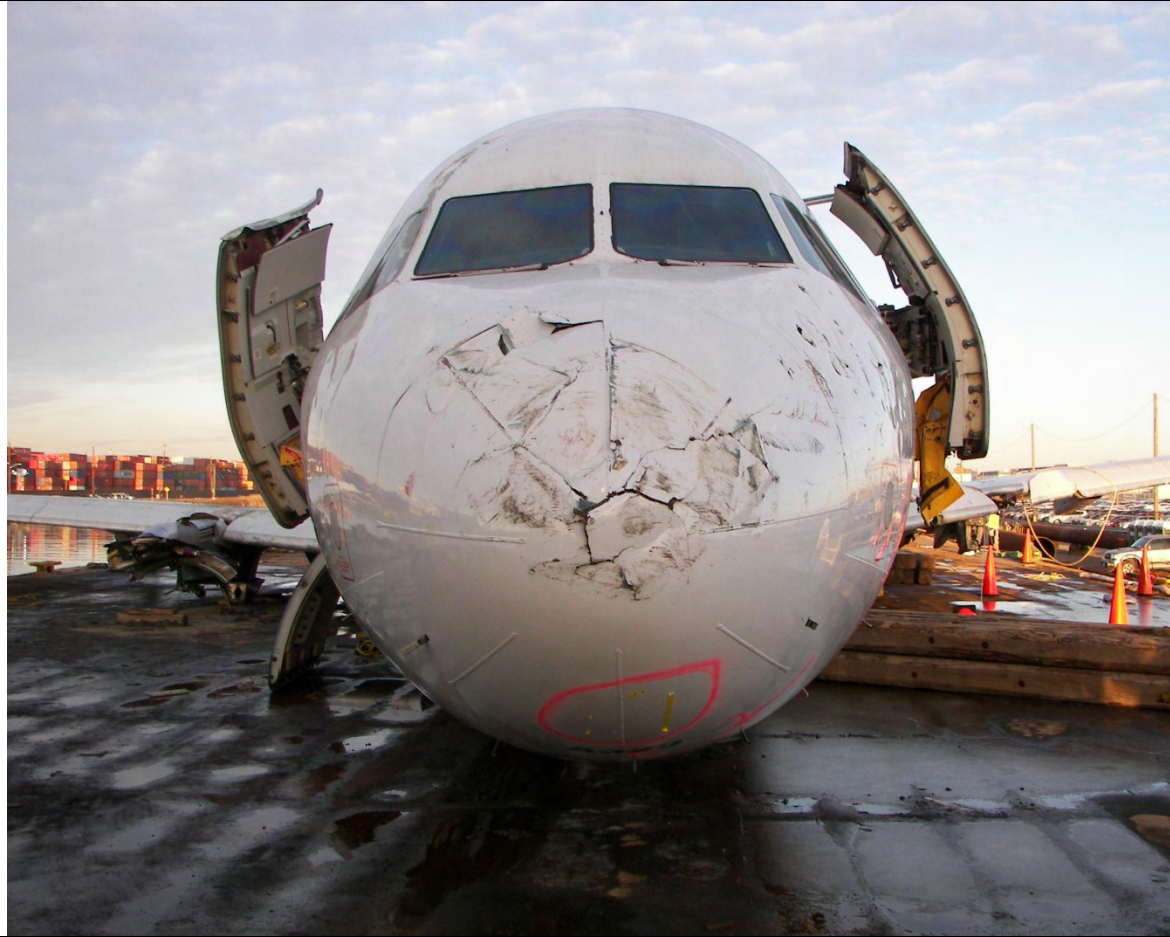
Photo 2

Description: Radome damage.

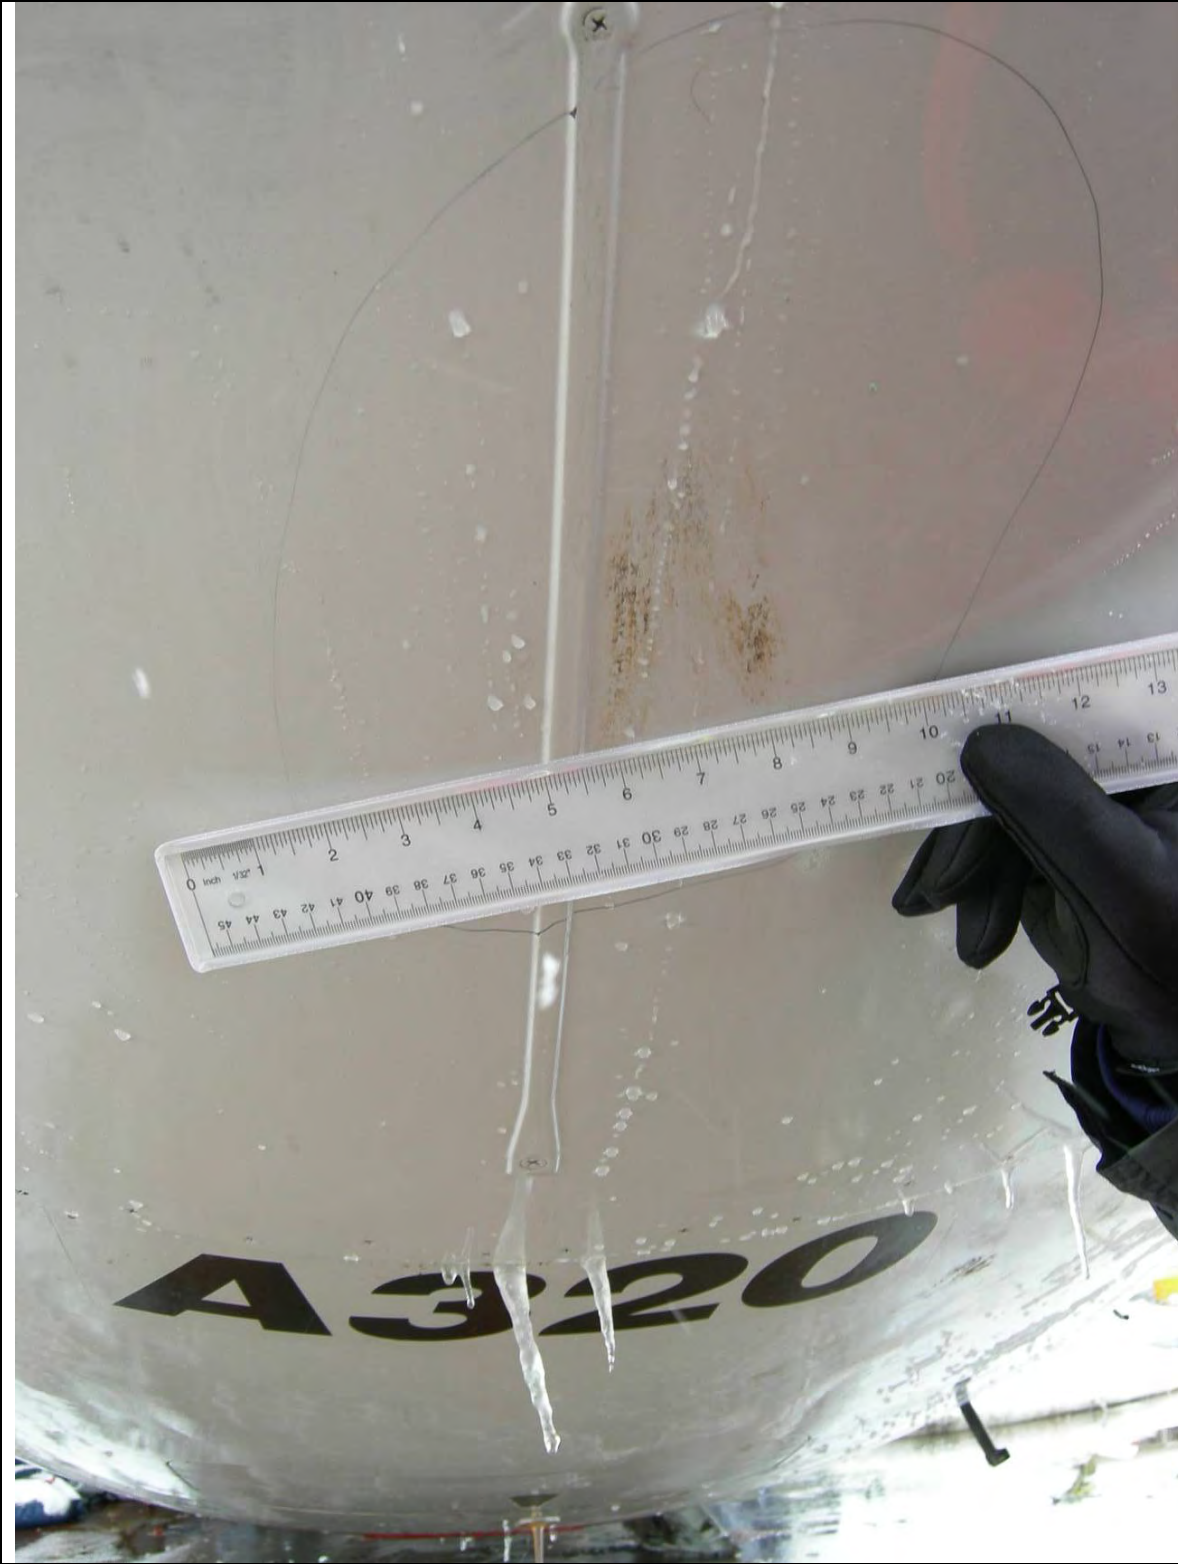
Photo 3

Accident #: DCA09MA026 | N106US
Description: Soft body impact damage to lower side of the radome.

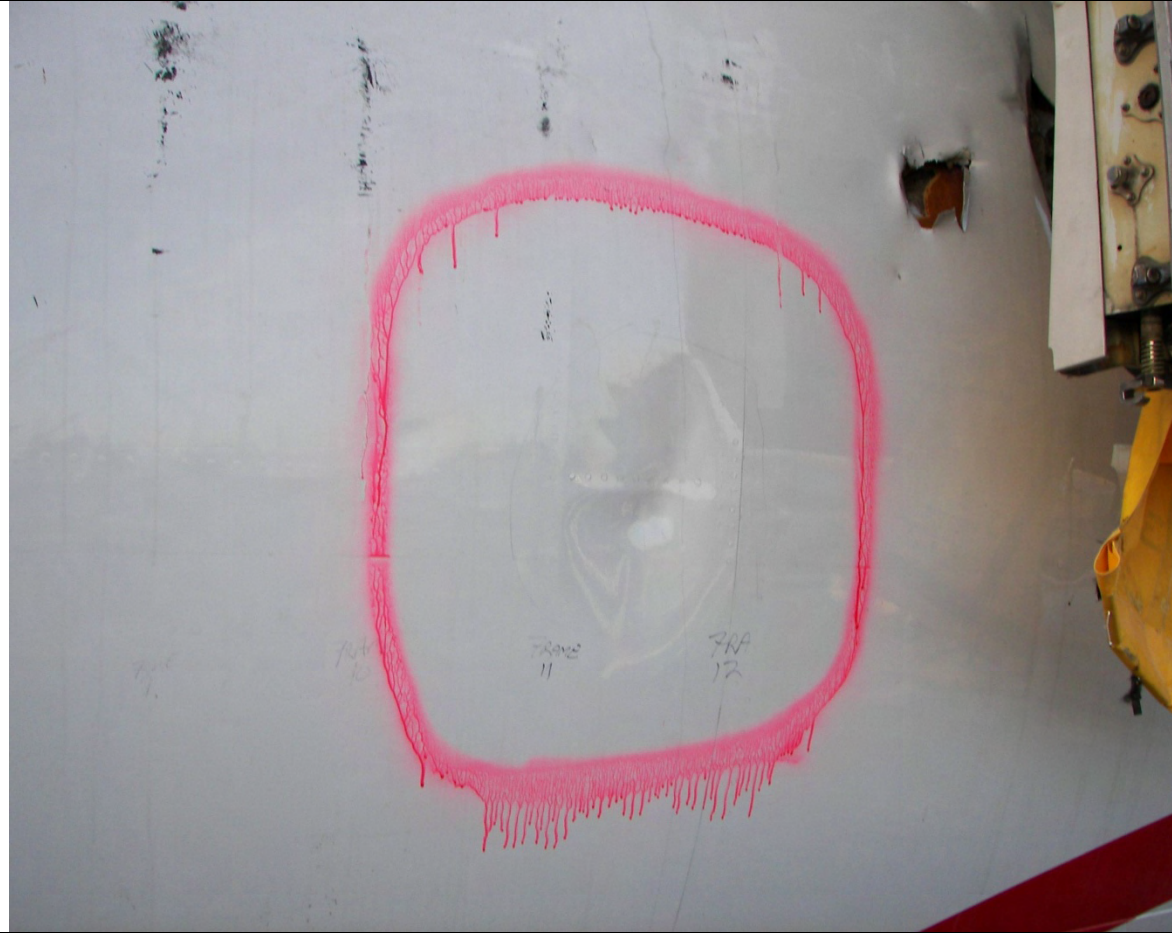
Photo 4

Description: Left hand side forward fuselage soft body impact damage.

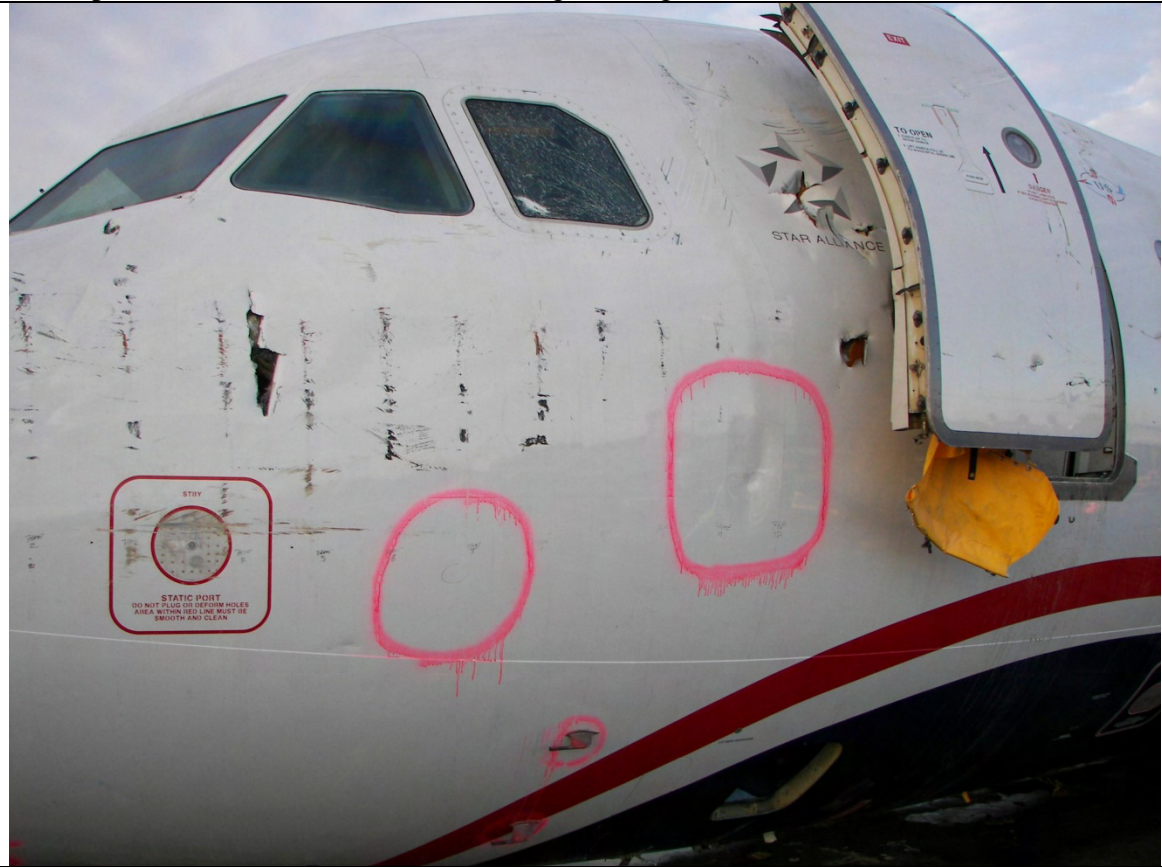
Photo 6

Description: Left hand side forward fuselage damage FR1 to FR12.

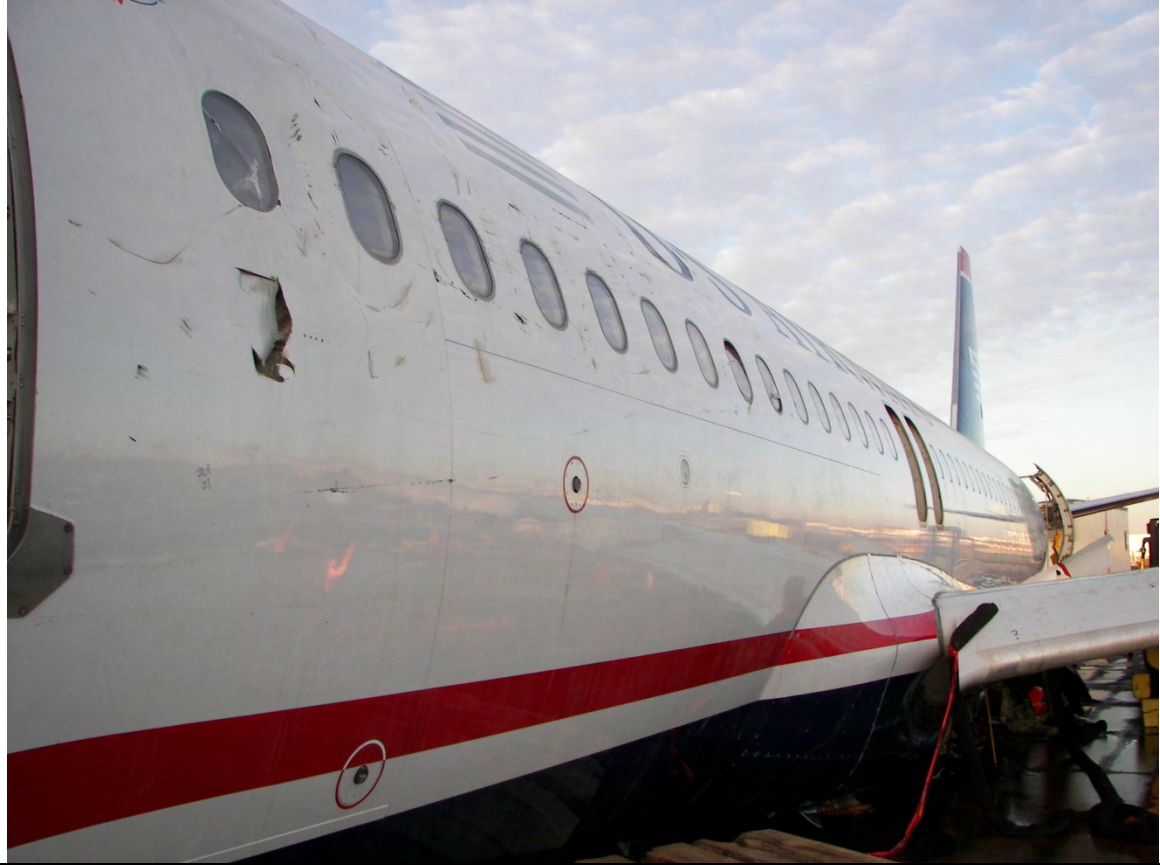
Photo 7

Description: Left hand side forward fuselage damage aft of the L1 door.

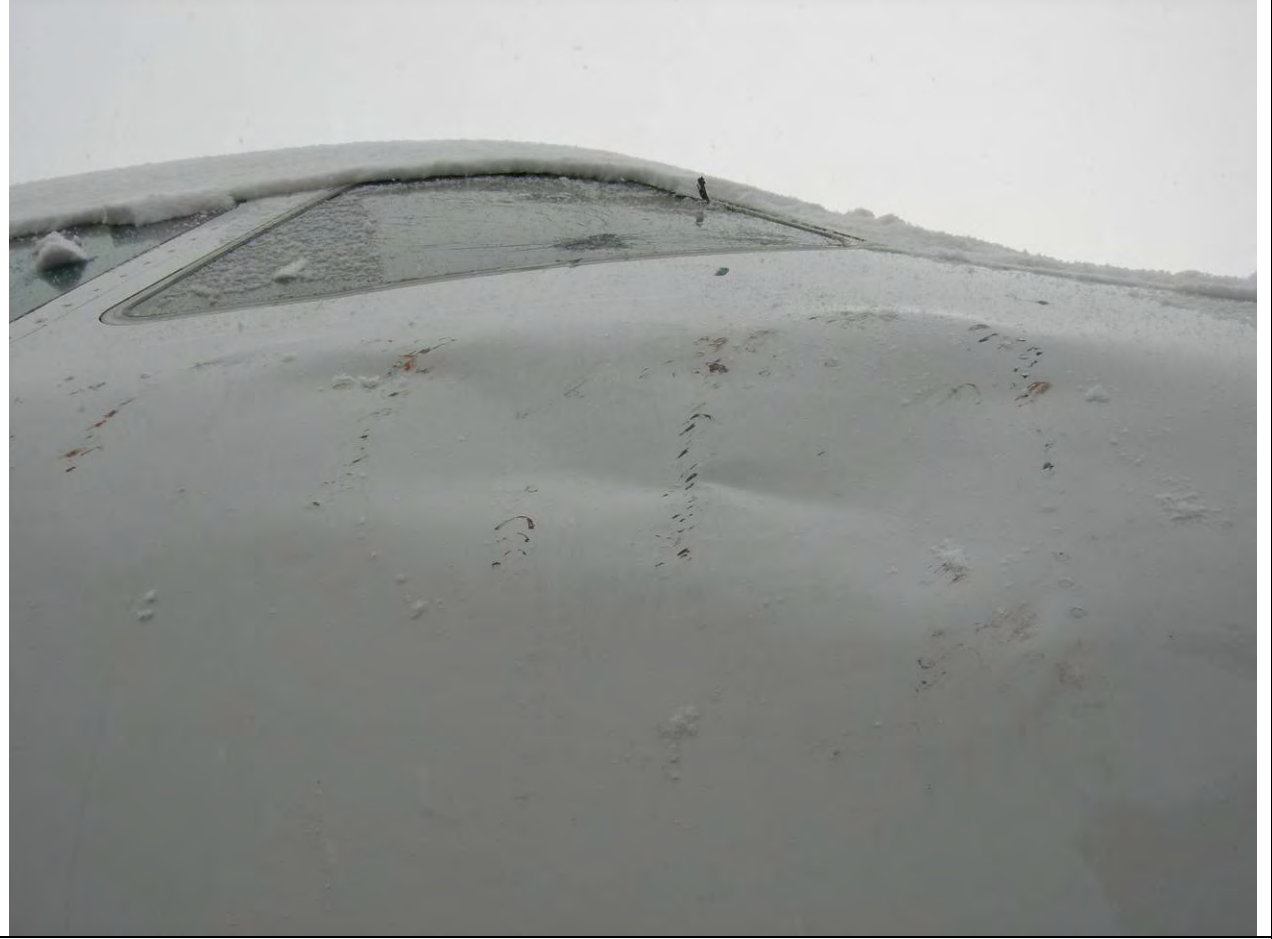
Photo 8

Description: Right hand side fuselage damage.

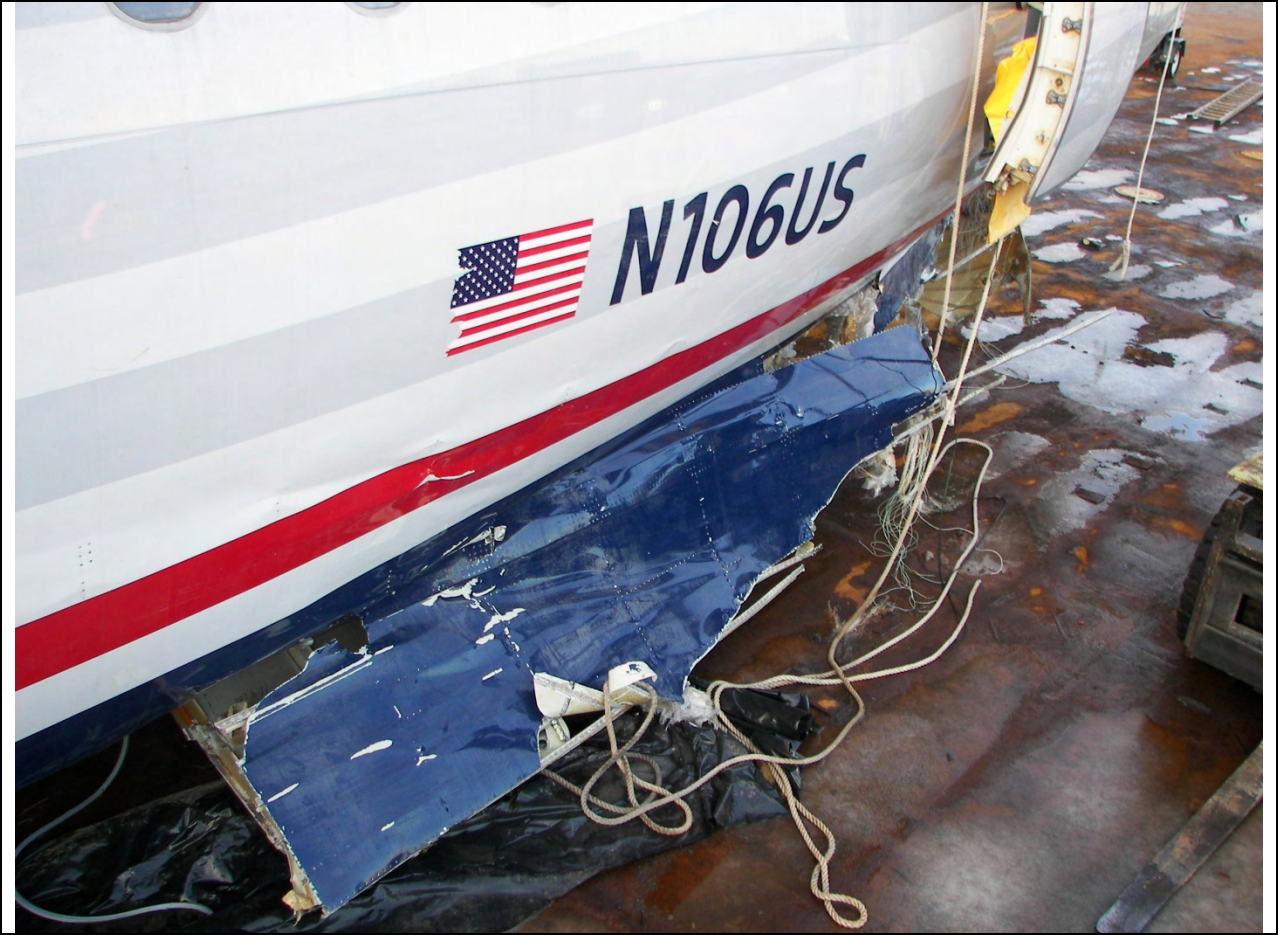
Photo 9

Accident #: DCA09MA026	N106US
Description: Left hand side aft lower fuselage damage.

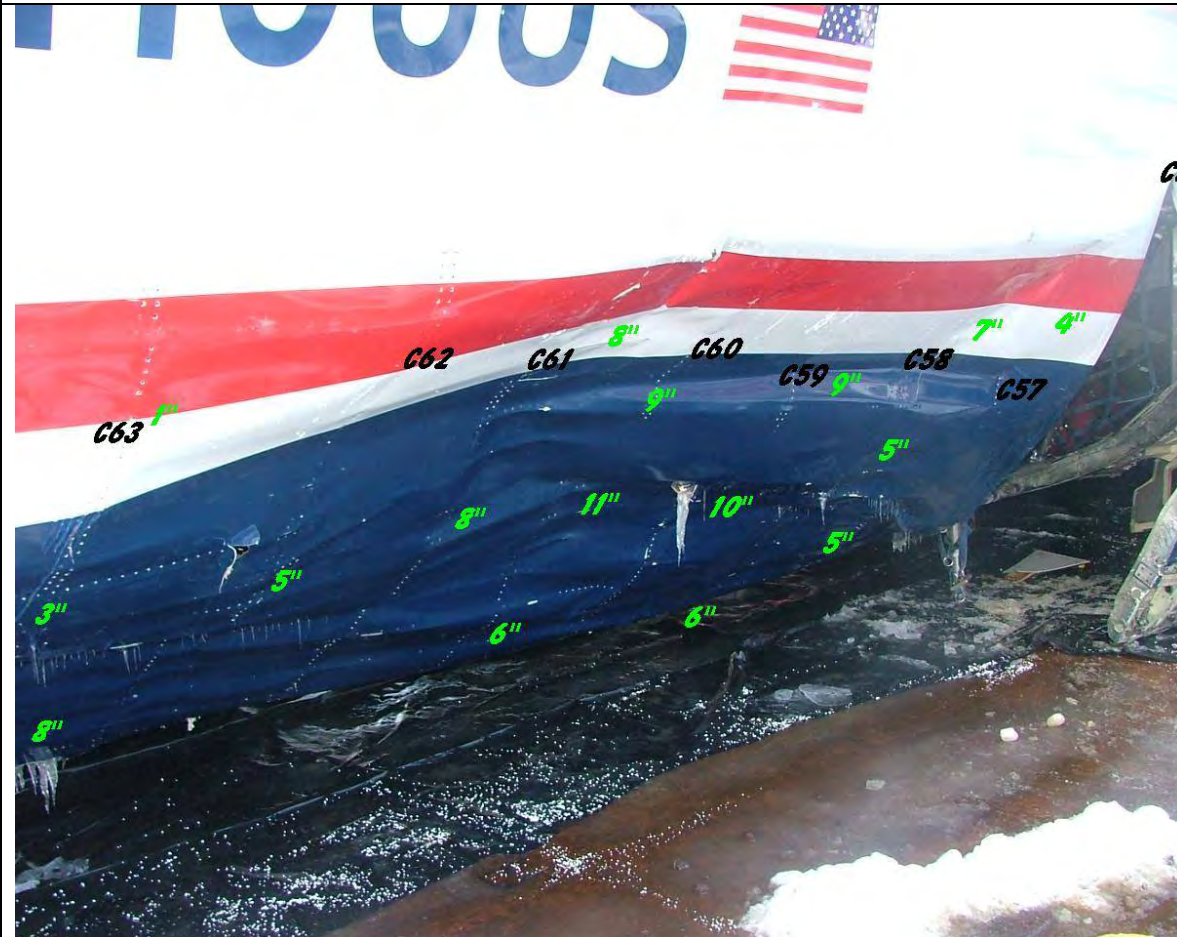
Photo 10

Description: Right hand side fuselage damage between frames 56 to 64 and stringers 23 to 41.

Note: Measurements are approximate only. Measurements were taken with rope to approximate the normal fuselage contour and a tape measure to measure the perpendicular depth from the rope.

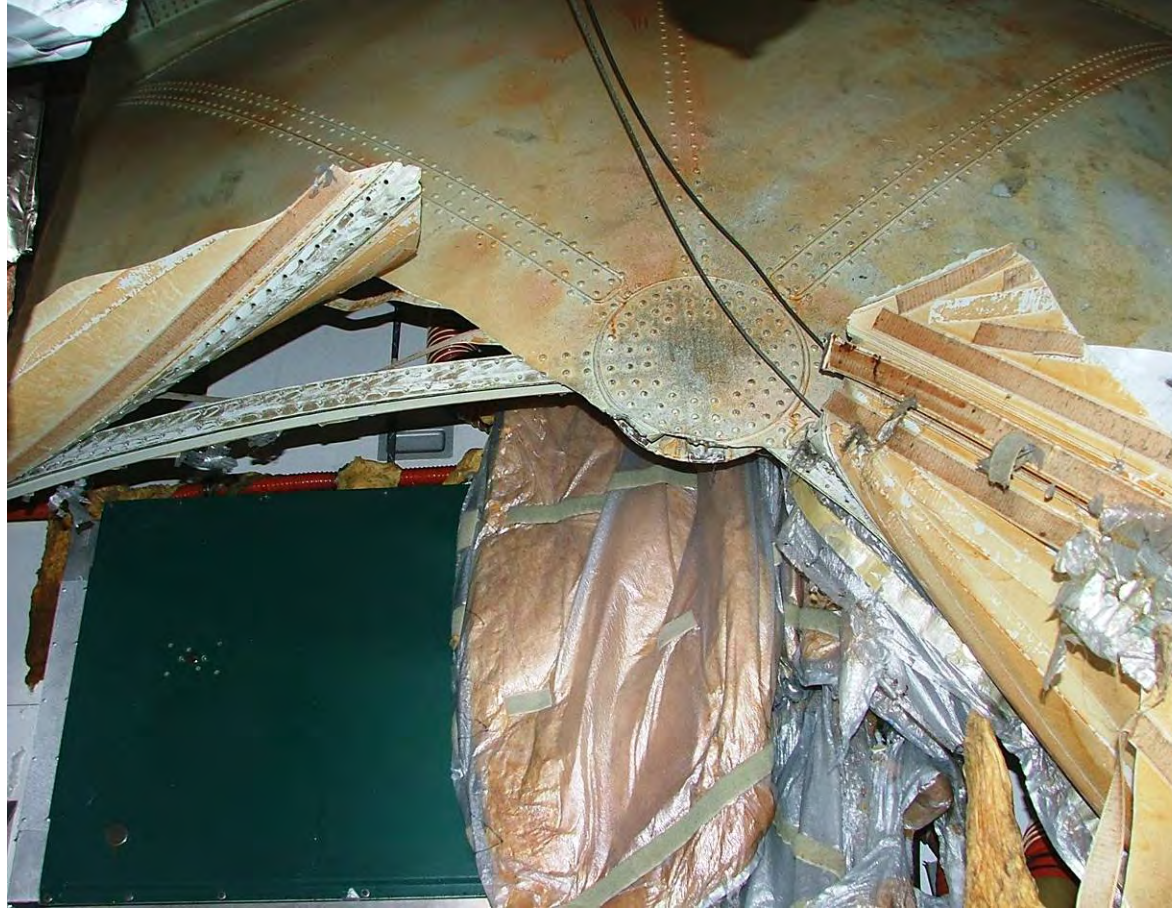
Photo 12

Accident #: DCA09MA026	N106US
Description: Aft pressure bulkhead.

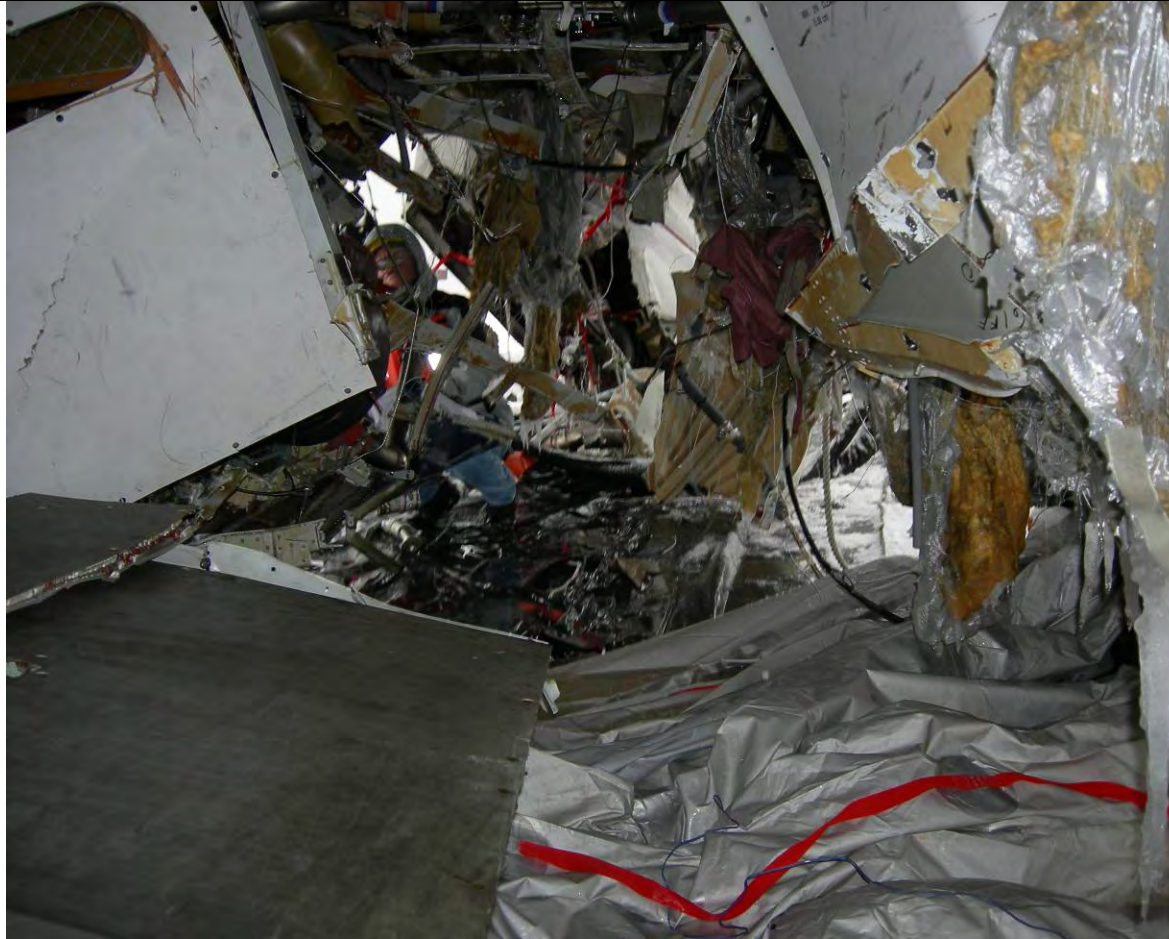
Photo 13

Description: Frame 57 looking aft at the tail cone damage.

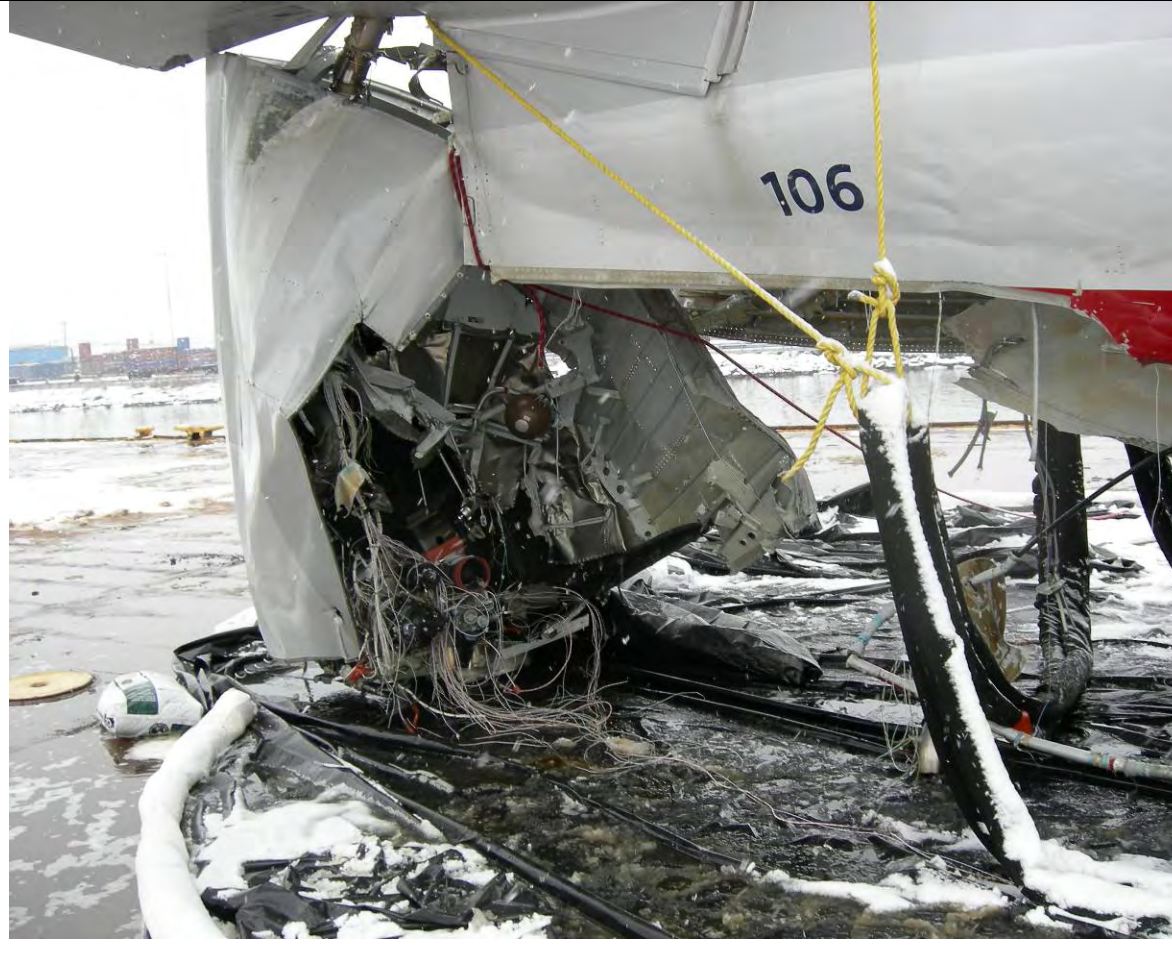
Photo 14

Description: Rear tail cone damage looking aft from frame 70.

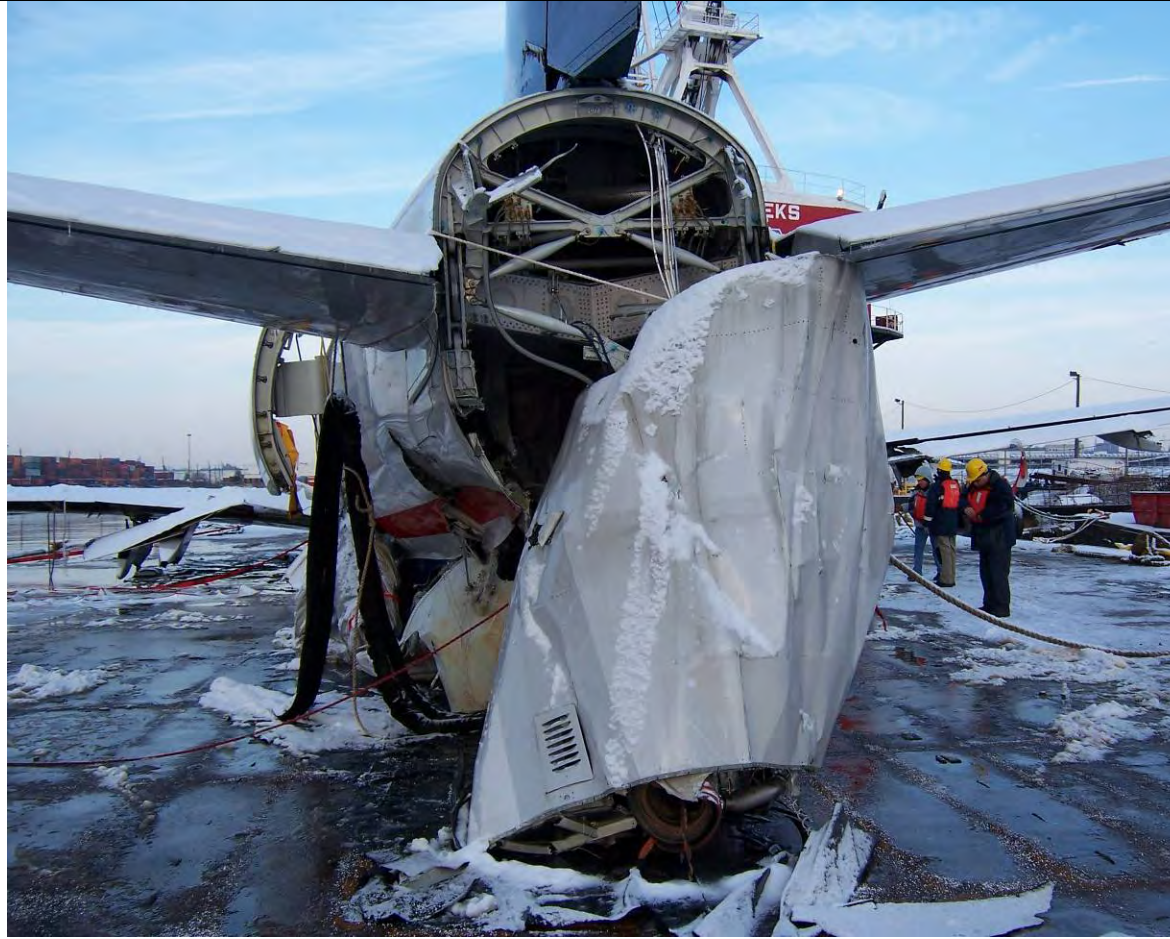
Photo 15

Description: Tail cone damage.

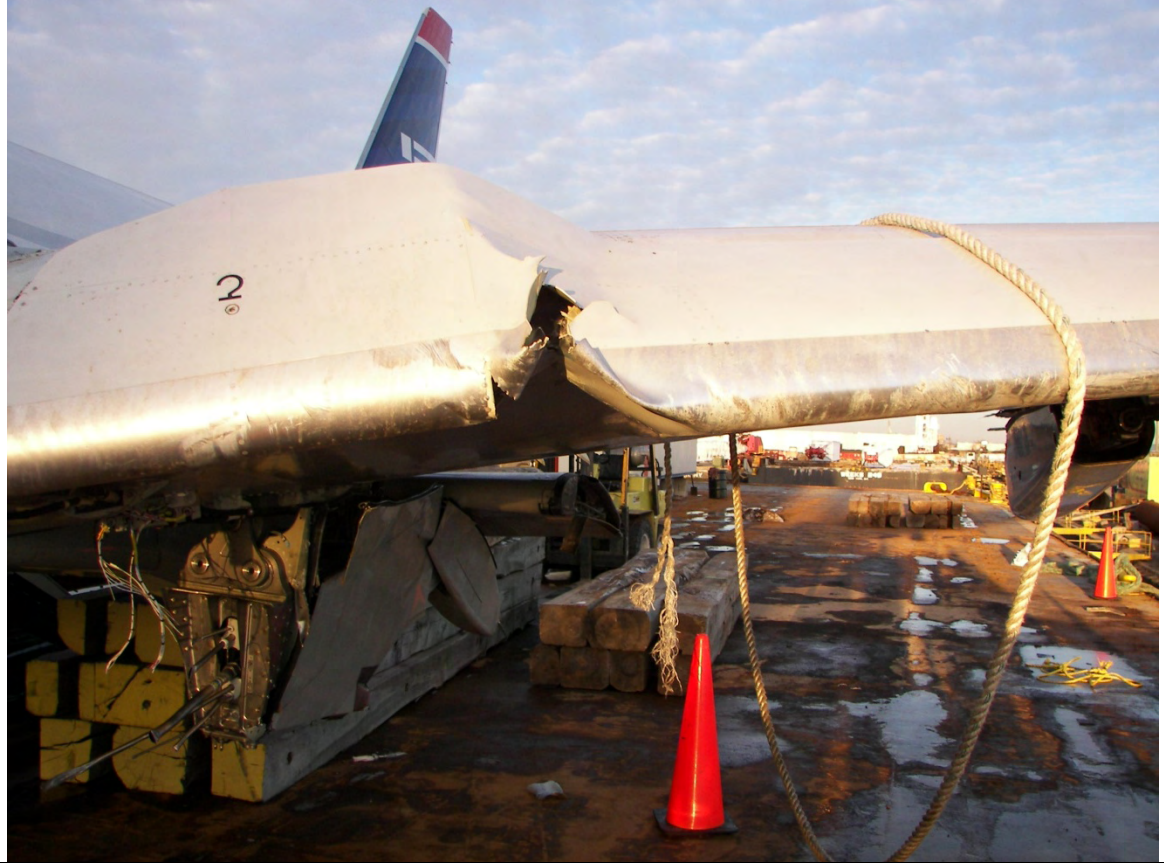
Photo 17

Description: Left hand side Slat #2 damage.

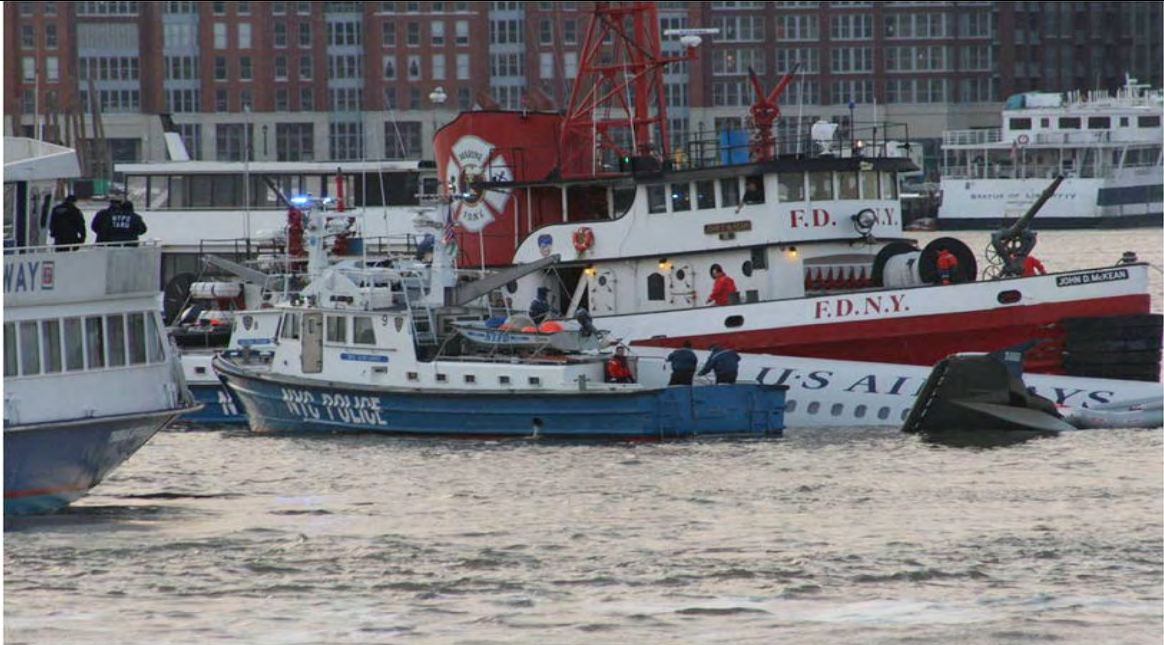
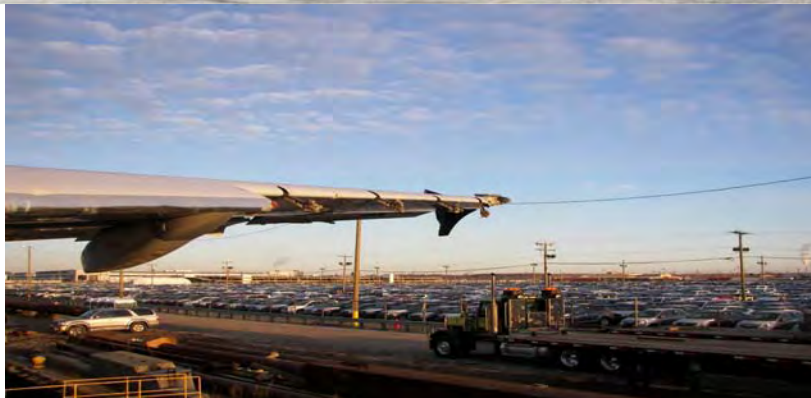
Photo 18

Description: Left hand side Slats #4 and #5 before (present) and after recovery (missing).

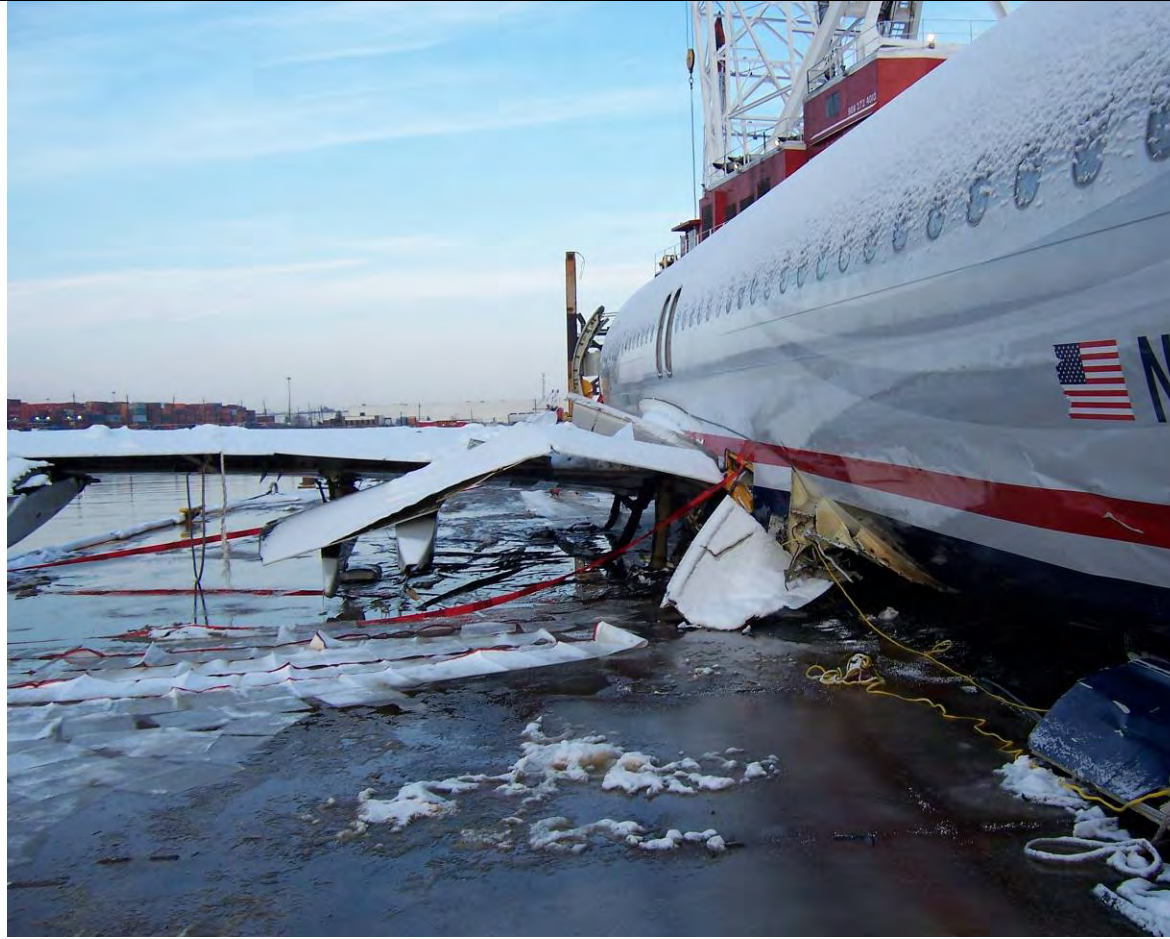
Photo 19

Description: Left hand inboard flap damage.

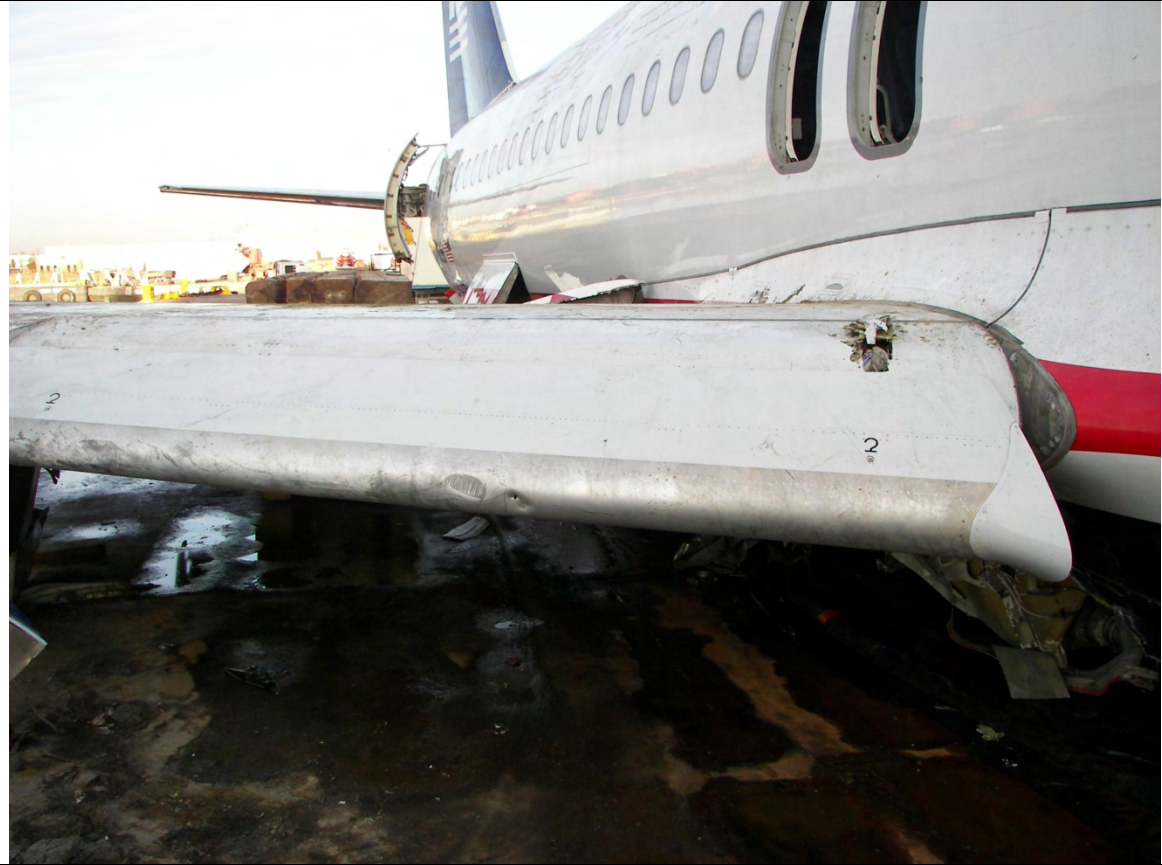
Photo 20

Description: Right hand side wing leading edge recovery damage.

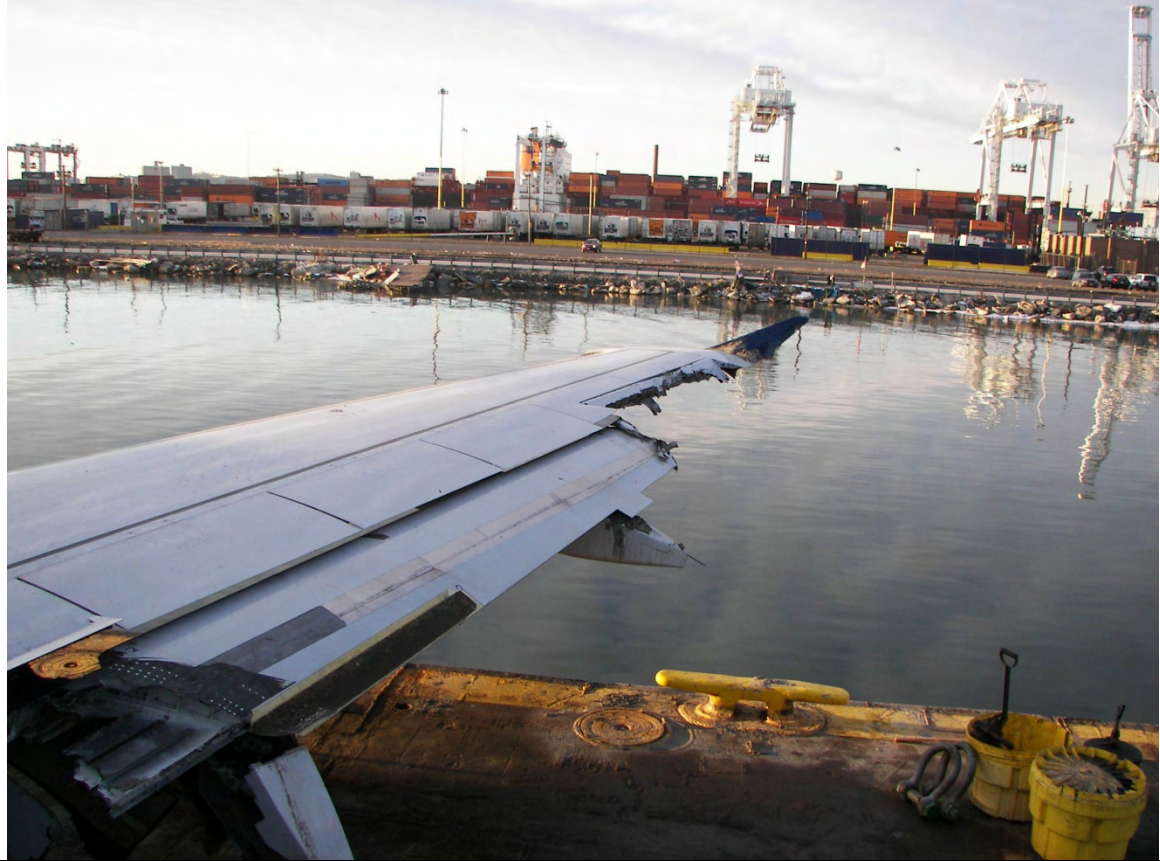
Photo 22

Description: Missing right hand aileron.

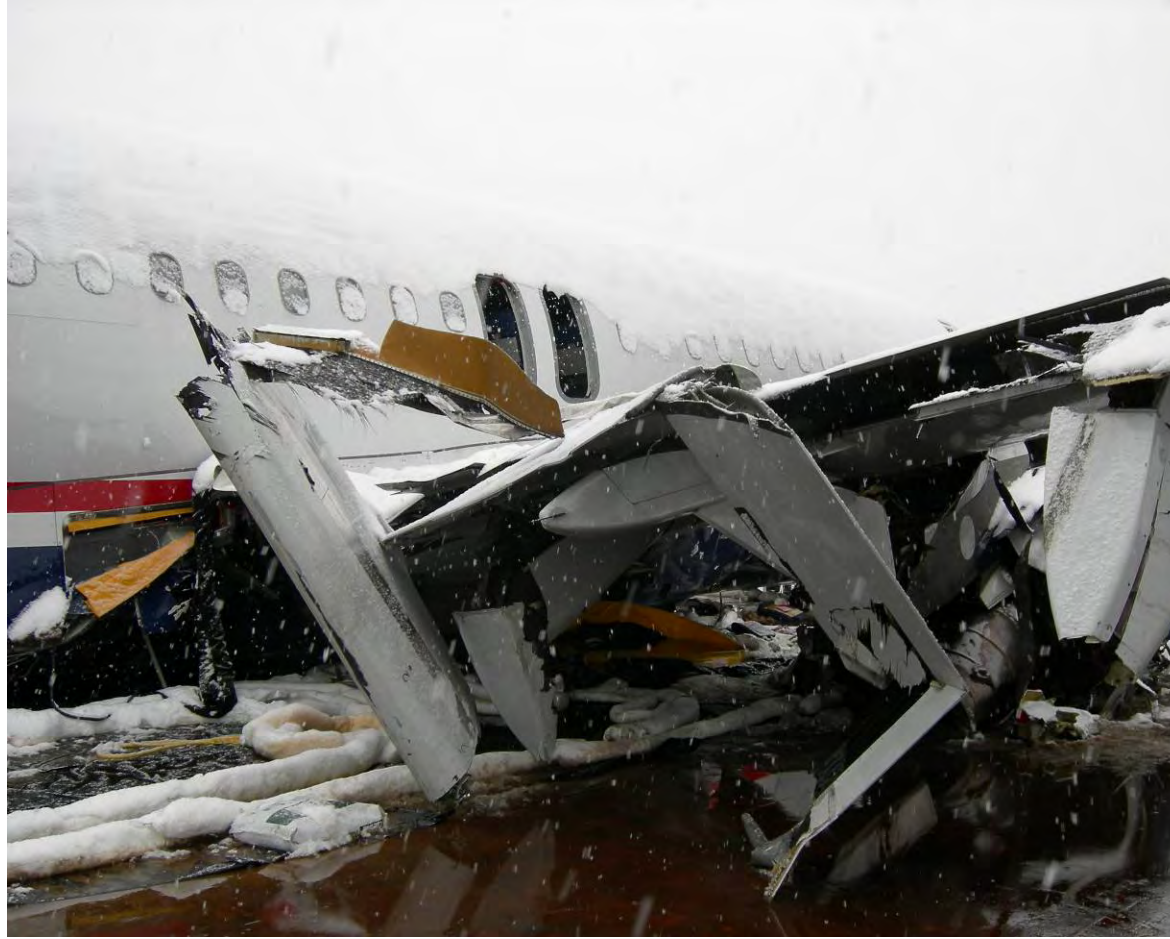
Photo 23

Description: Right hand inboard and outboard flap damage.

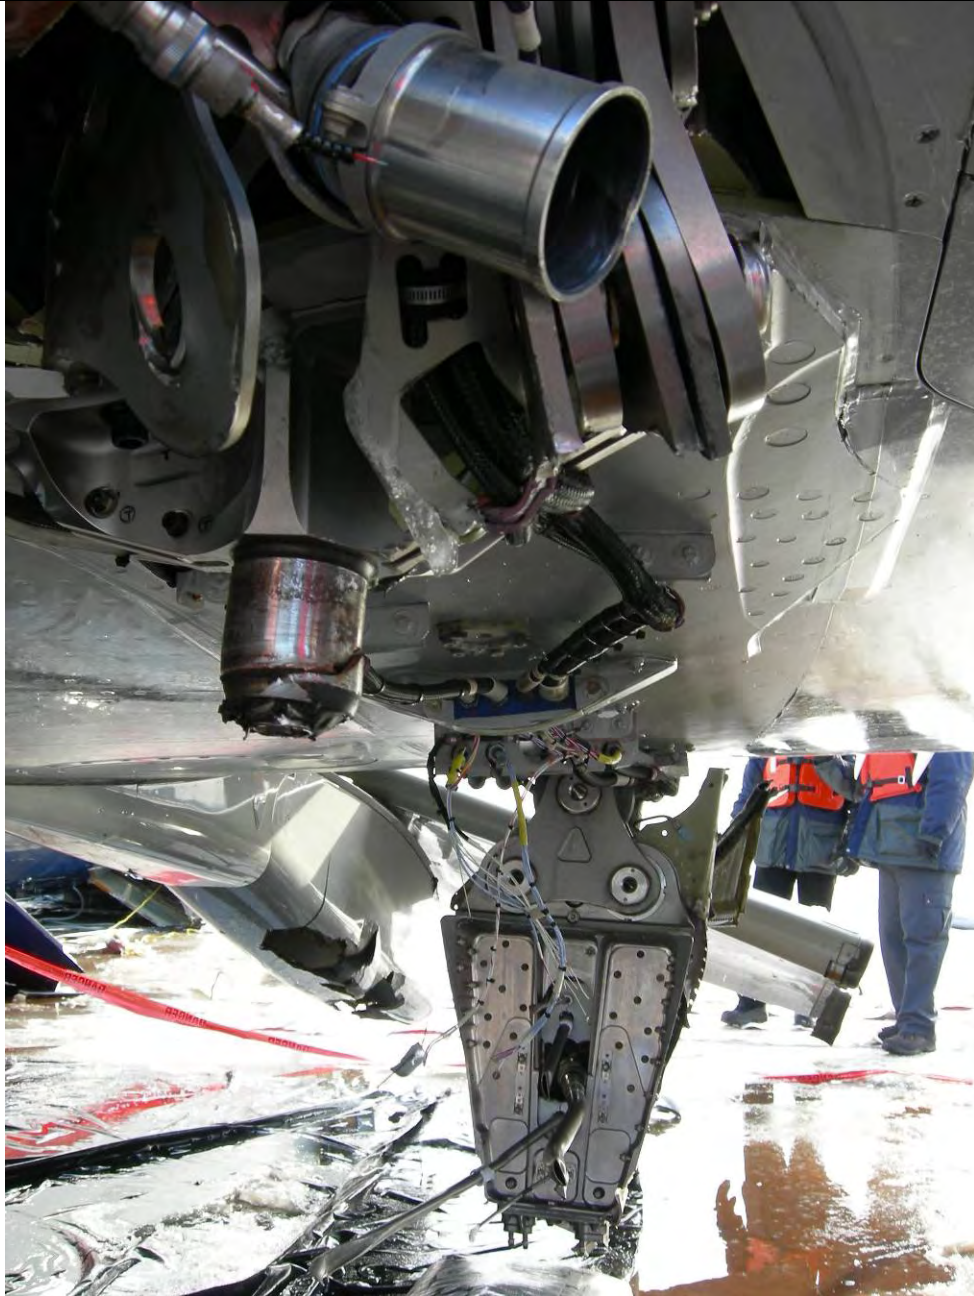
Photo 24

Description: Left hand pylon damage.
