Docket No. SA-532

NATIONAL TRANSPORTATION SAFETY BOARD

STRUCTURES GROUP CHAIRMAN'S FACTUAL REPORT

DCA09MA026

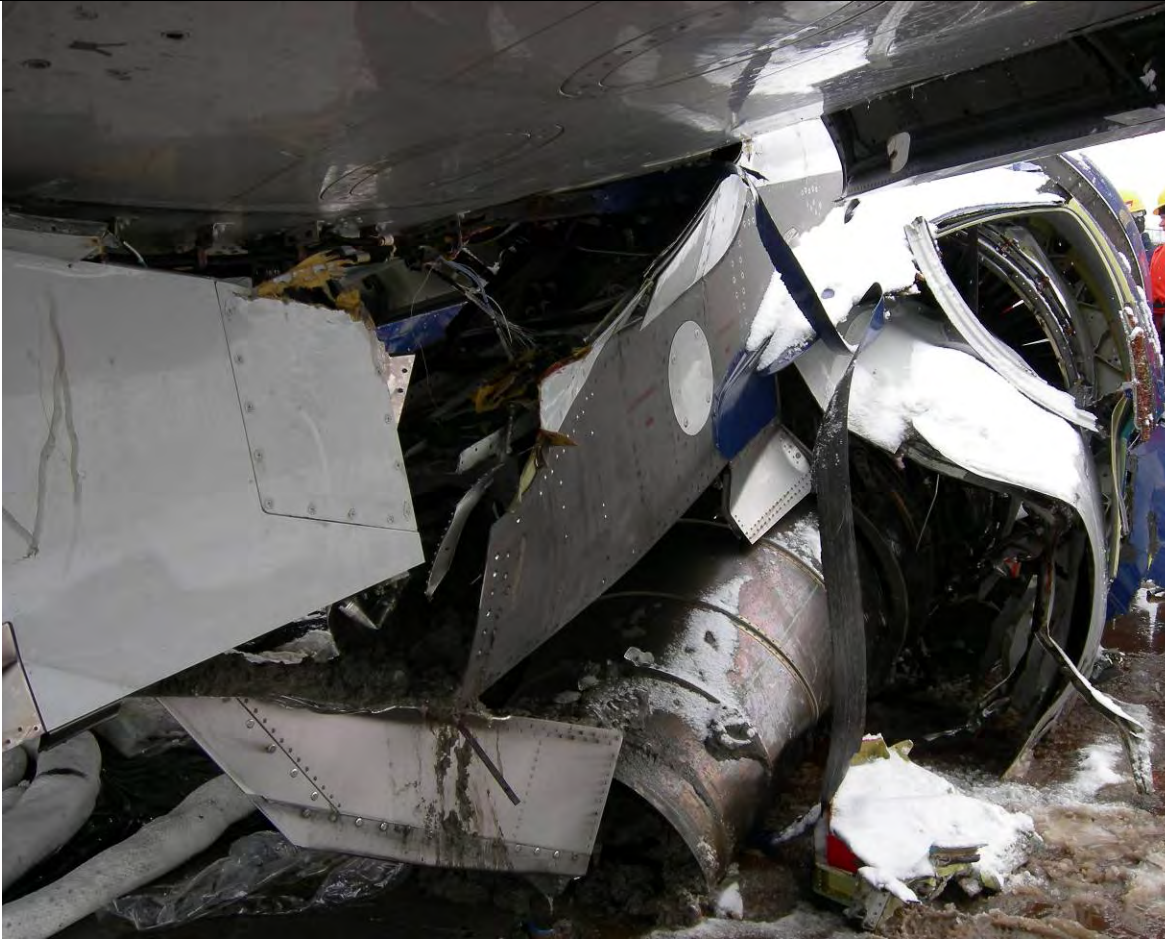
Photo 25

Description: Right hand pylon damage.

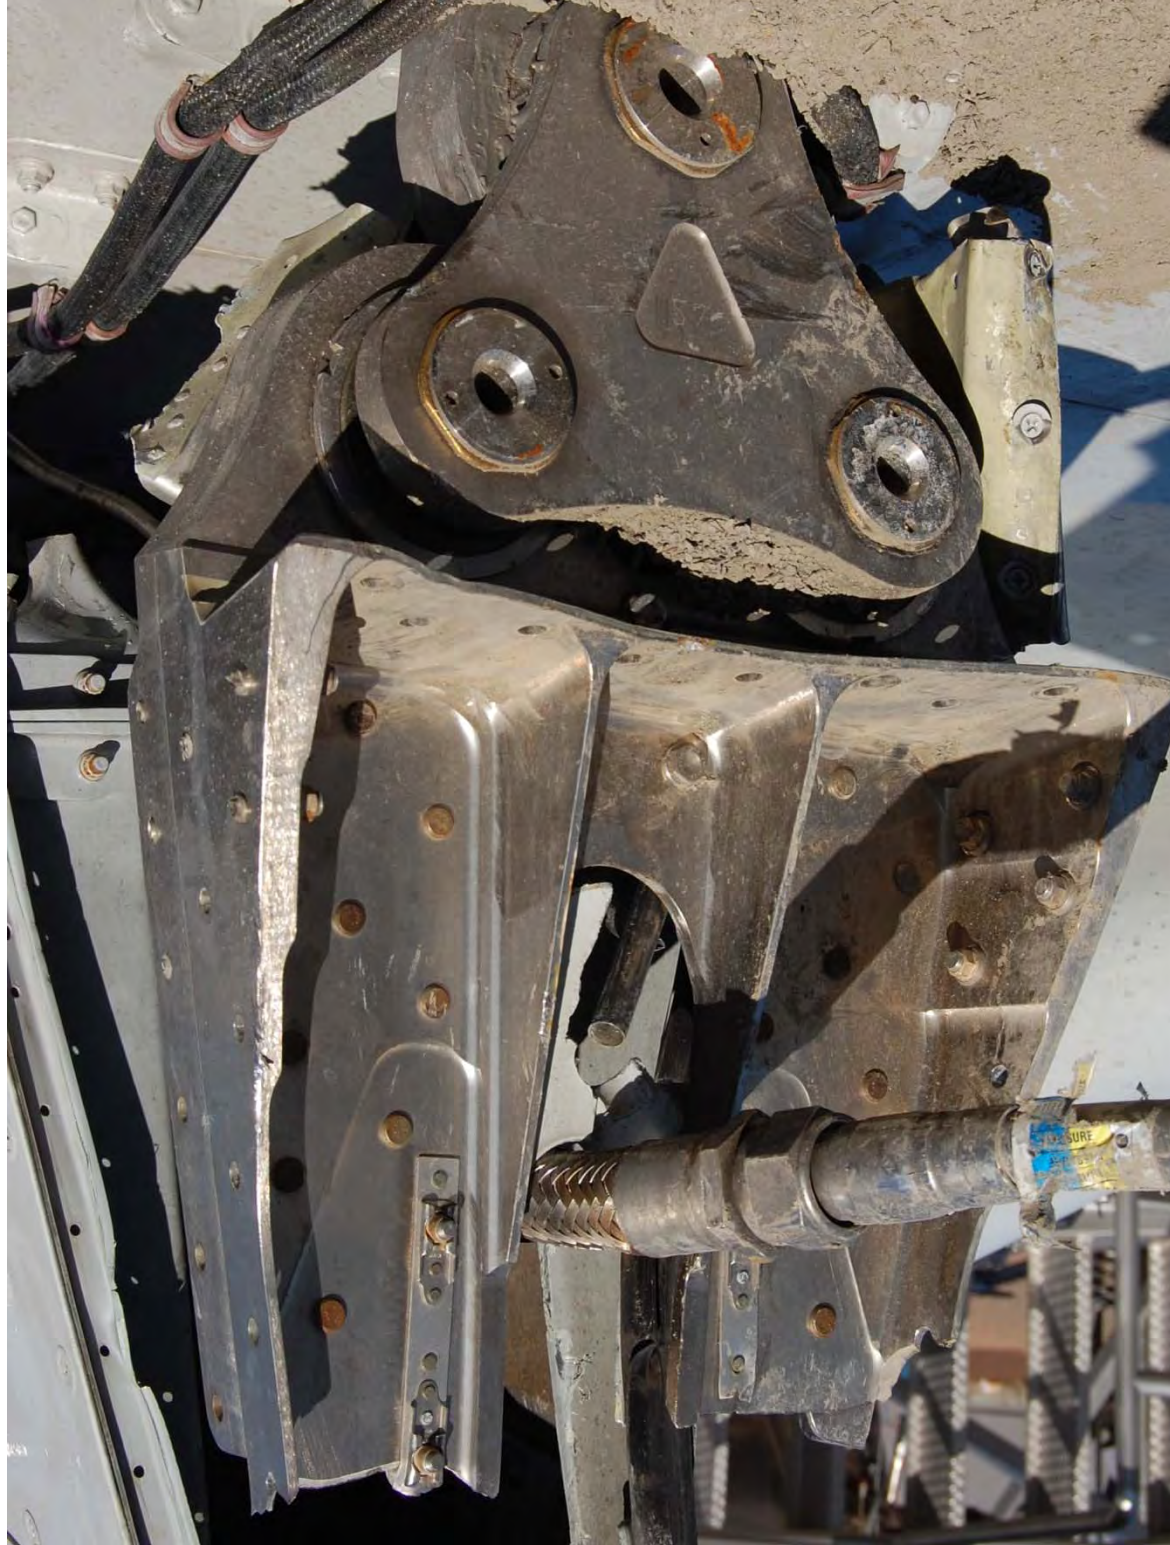
Photo 26

Description: Right hand pylon, aft bulkhead fracture.

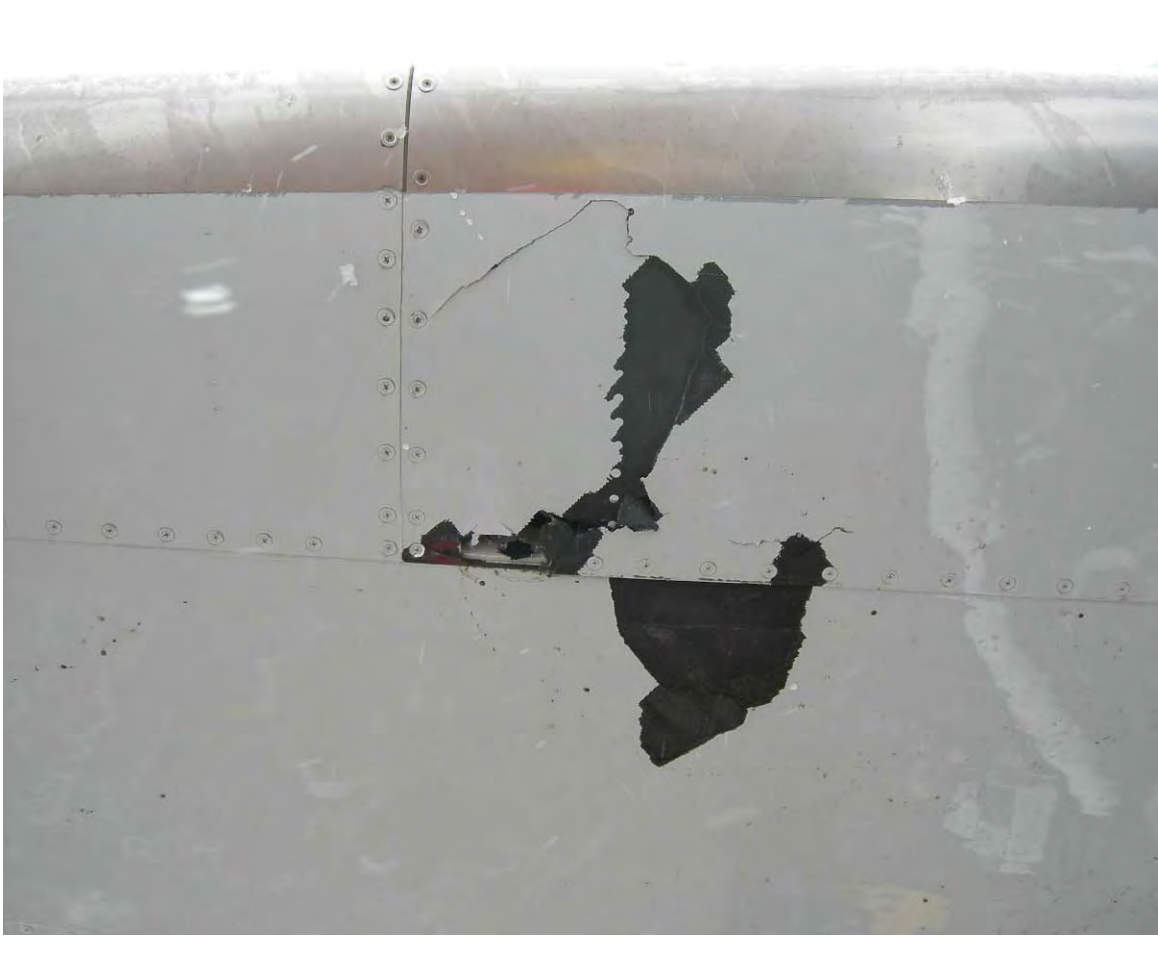
Photo 28

DCA09MA026	N106US
Description: Right hand horizontal stabilizer lower skin panel fracture.

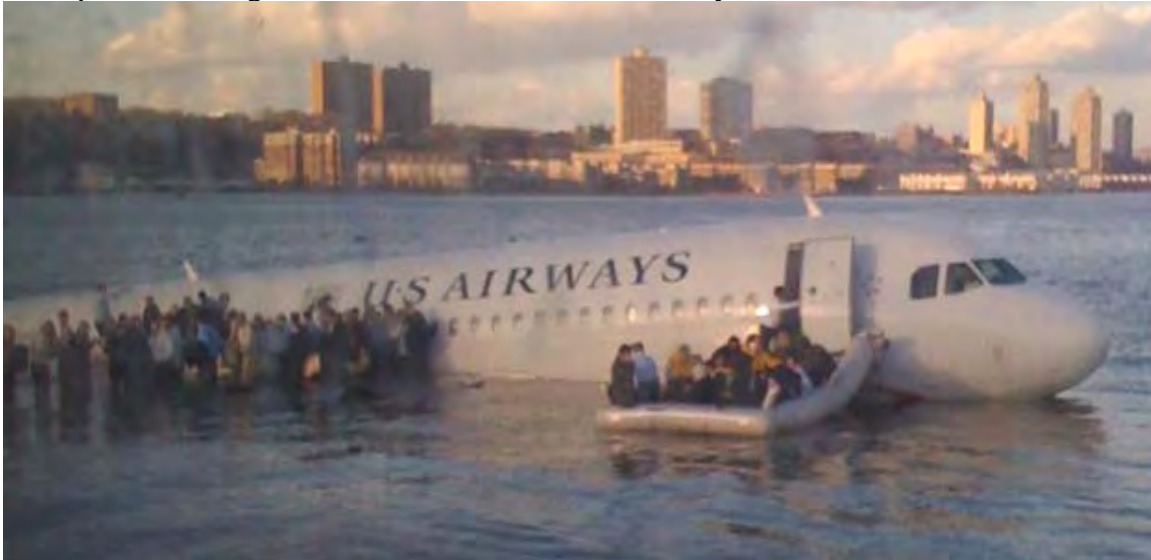
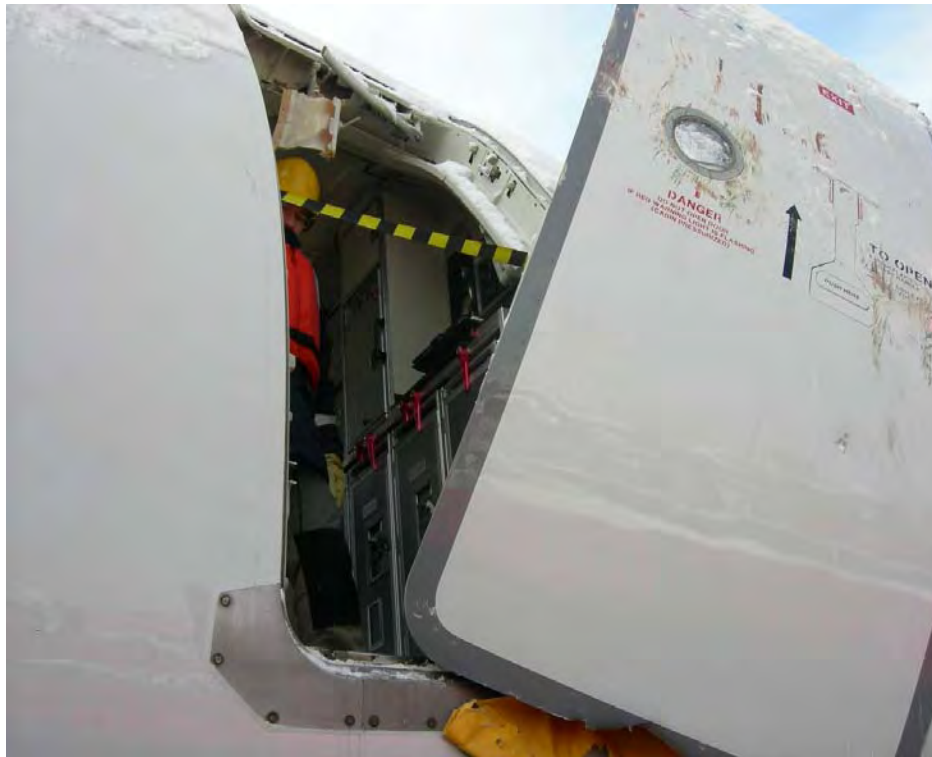
Photo 29

Description: Passenger door R1 before and after recovery.
