Addendum 1
Structures Group Chairman's
Factual Report

STRUCTURES GROUP CHAIRMANS FACTUAL REPORT

DCA09MA026

Location: Hudson River, Weehawken, New Jersey
Date: January 15, 2009
Time: 1527 (EST)
Aircraft: Airbus A320-214, N106US, S/N 1044

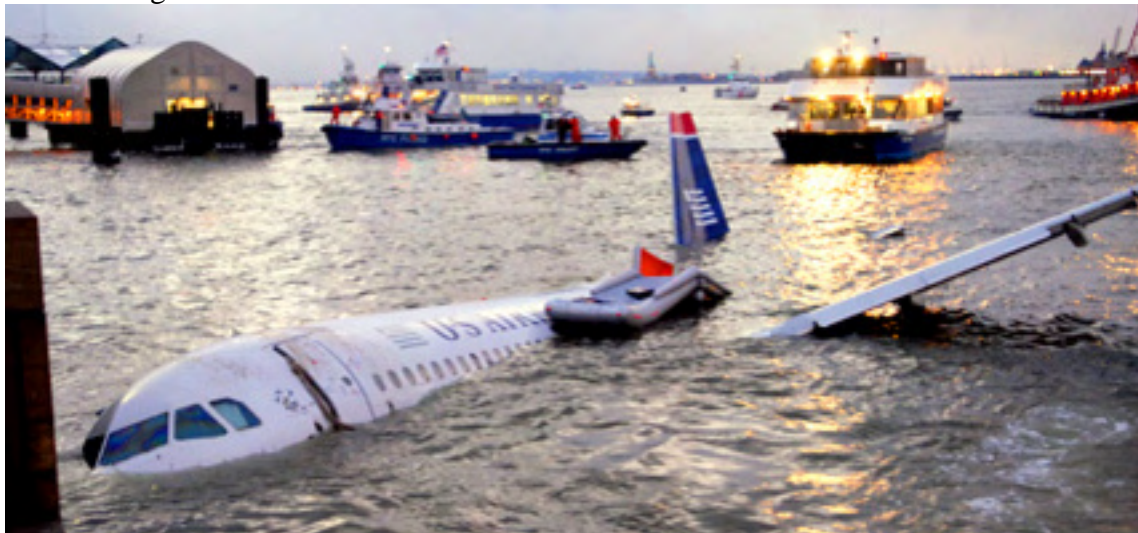
Figure 1- USAirways N106US after the passenger evacuation.

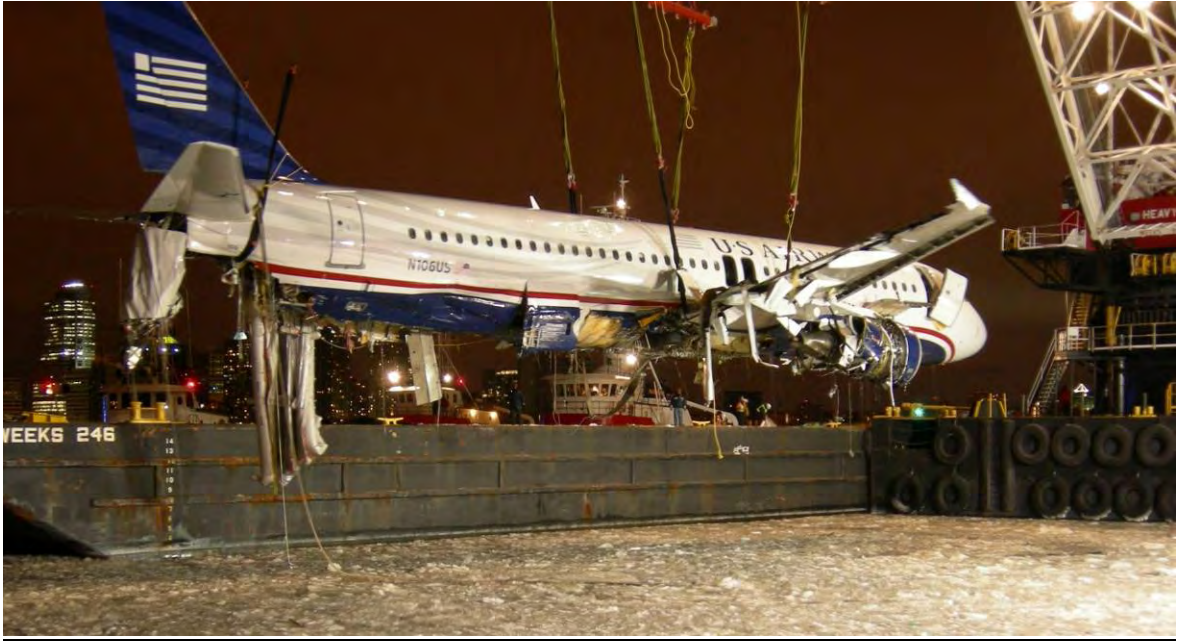
Figure 2 - USAirways N106US being placed on the recovery barge.

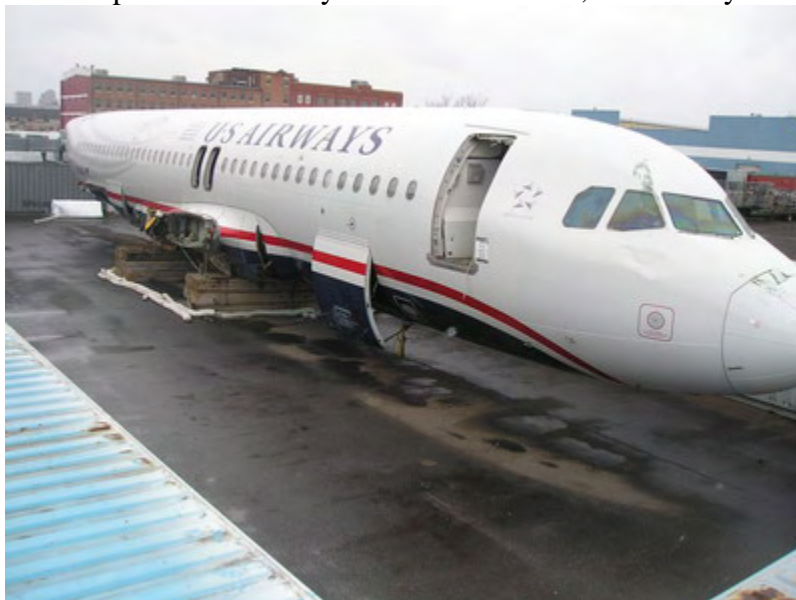
Following the original damage assessment performed just after the event, the wings were cut off outboard of wing rib 1 (including the main landing gear) and the vertical tail (VTP) and horizontal tail (HTP) planes were removed to allow for wreckage transportation. To facilitate the removal of the HTP, the fuselage structure below the HTP was cut between frame stations (FR) 74 and 75. The wreckage was then transferred from Weeks Marine in Jersey City, New Jersey to Harrison, New Jersey by truck. The airplane wreckage was again inspected at Joe Supor & Son facility located in Harrison, New Jersey.

Figure 3 – USAirways N106US after removal of the wing and stabilizers.
