NTSB METALLURGIST'S FACTUAL REPORT
USAir FLIGHT 427, NO. 1 SLAT TRACK

METALLURGIST'S FACTUAL REPORT

Report No. 95-29

Place : Aliquippa, Pennsylvania
Date : September 8, 1994
Vehicle : Boeing 737-3B7, N513AU
NTSB No. : DCA94-M-A076
Investigator : Cynthia Keegan, AS-40

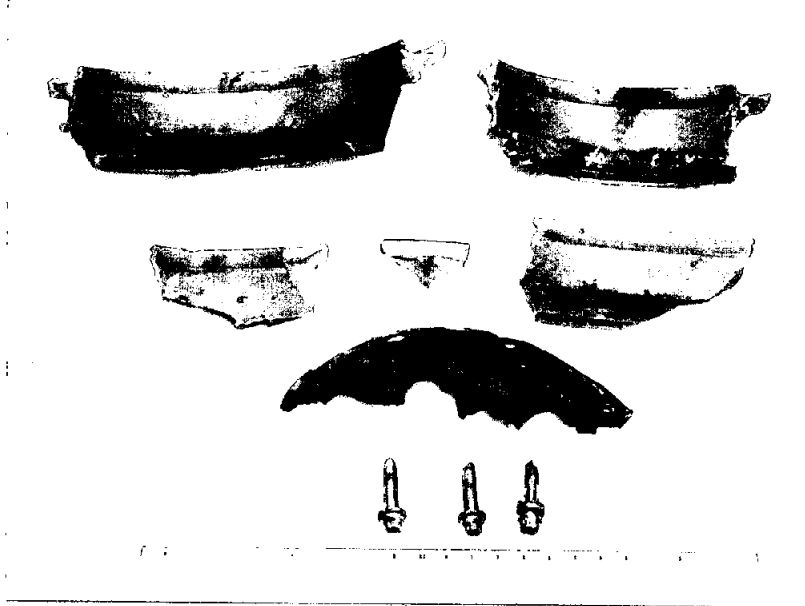
An overall view of the wheel and bolt pieces is shown in figure 1. Visual examination of the wheel pieces revealed features typical of overstress separations. No evidence of preexisting fracture areas was noted. The three bolt pieces are at the bottom of figure 1 and were head portions. Visual examination of the bolt fractures (in the shanks adjacent to the threaded ends) revealed fracture features and deformation consistent with bending overstress separations. No evidence of preexisting fracture areas was noted.

Figure 1: Overall view of the wheel pieces and bolt pieces.
