**Docket No. SA-532**

Addendum 1  
Structures Group Chairman's  
Attachment 2 to the Factual Report  
Photos

### **STRUCTURES GROUP CHAIRMAN'S FACTUAL REPORT**

DCA09MA026  
May 26, 2009

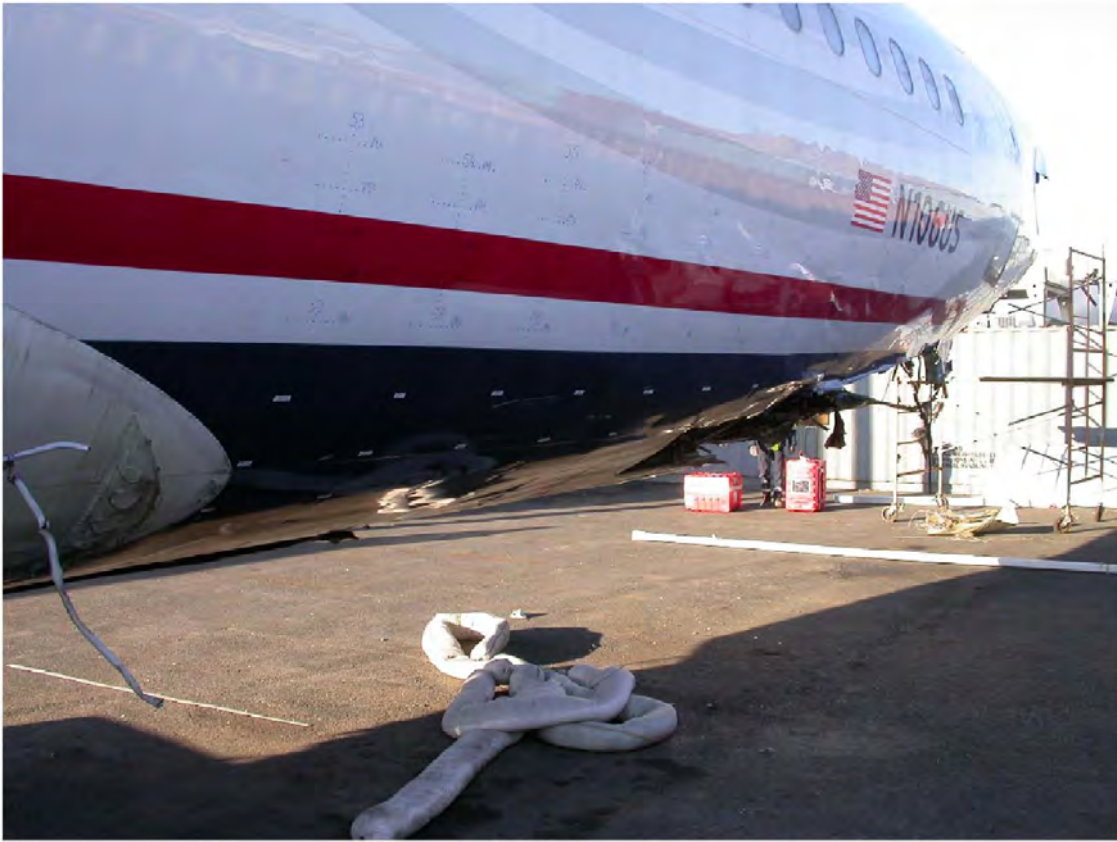
Photo 1

Description: Section 16/17 LH.

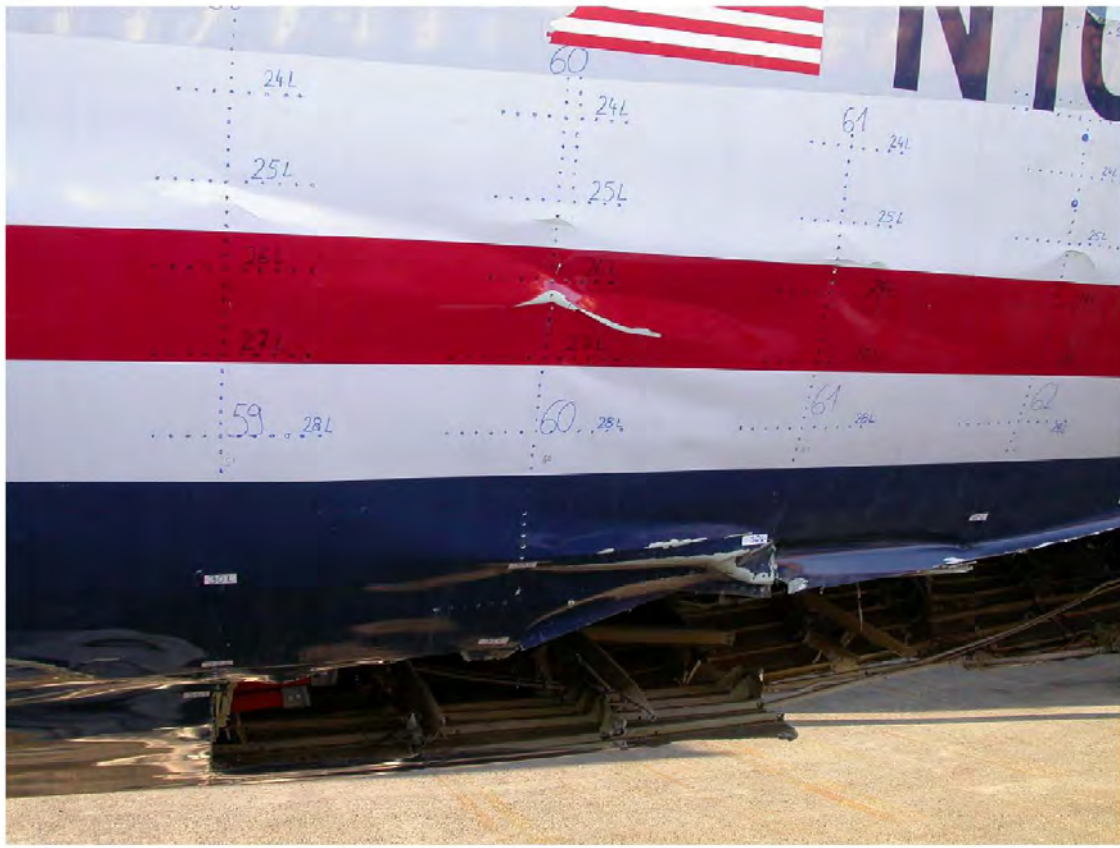
Description: Section 16/17 LH FR59 to FR62.

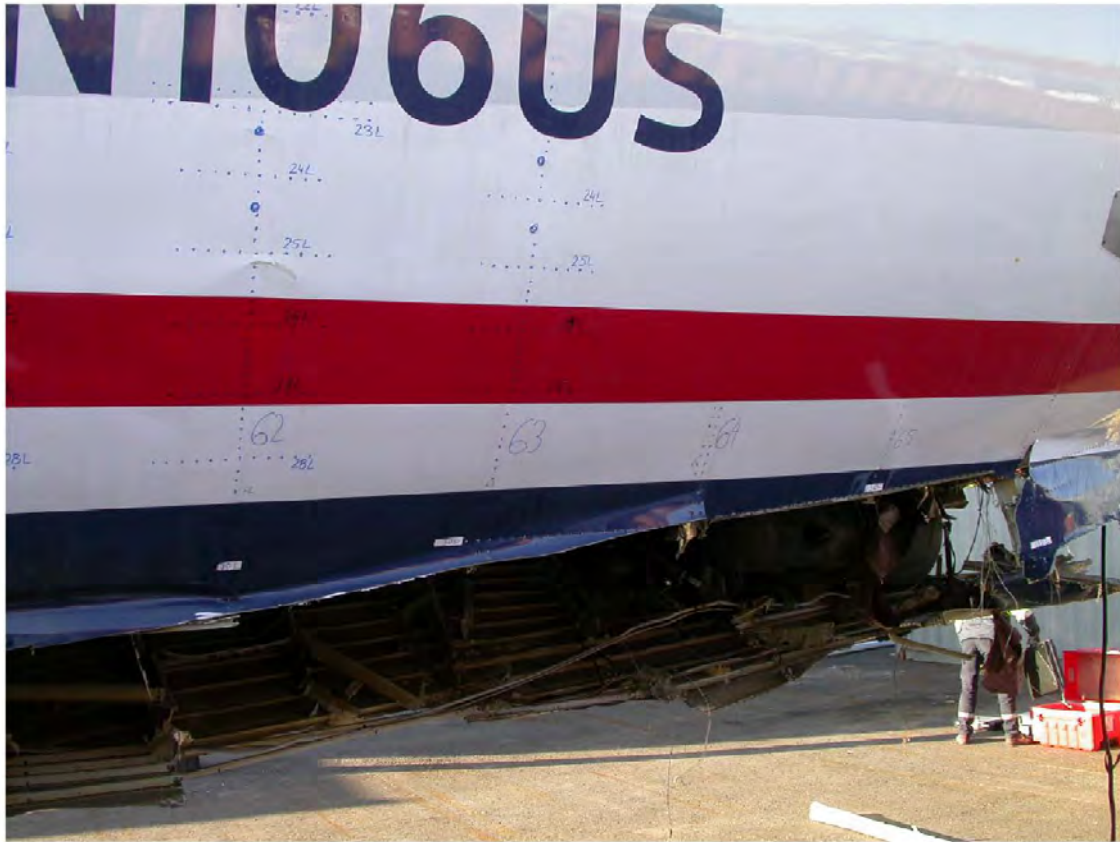
Photo 5

Accident #: DCA09MA026 | N106US  
Description: Section 16/17 LH FR 62 to FR 65.

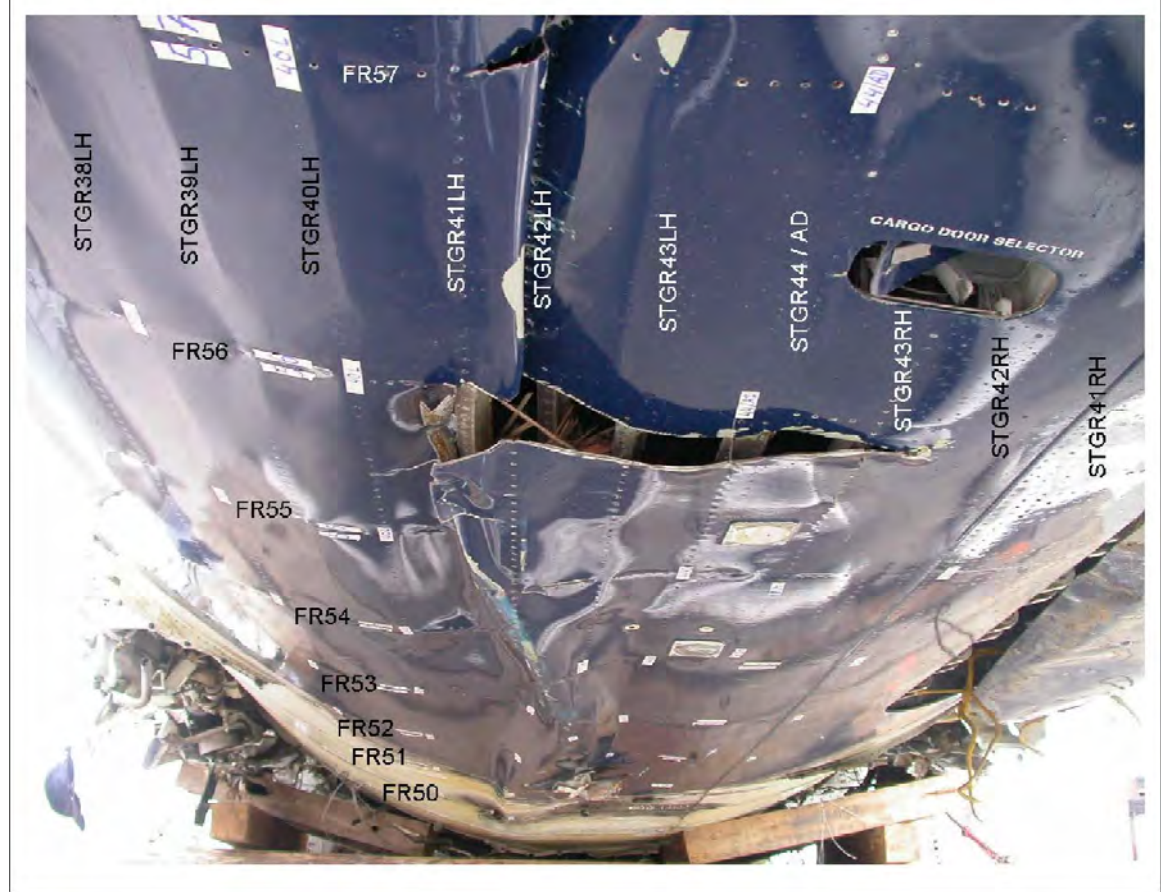
Photo 6

Description: Aft lower fuselage viewed looking up.

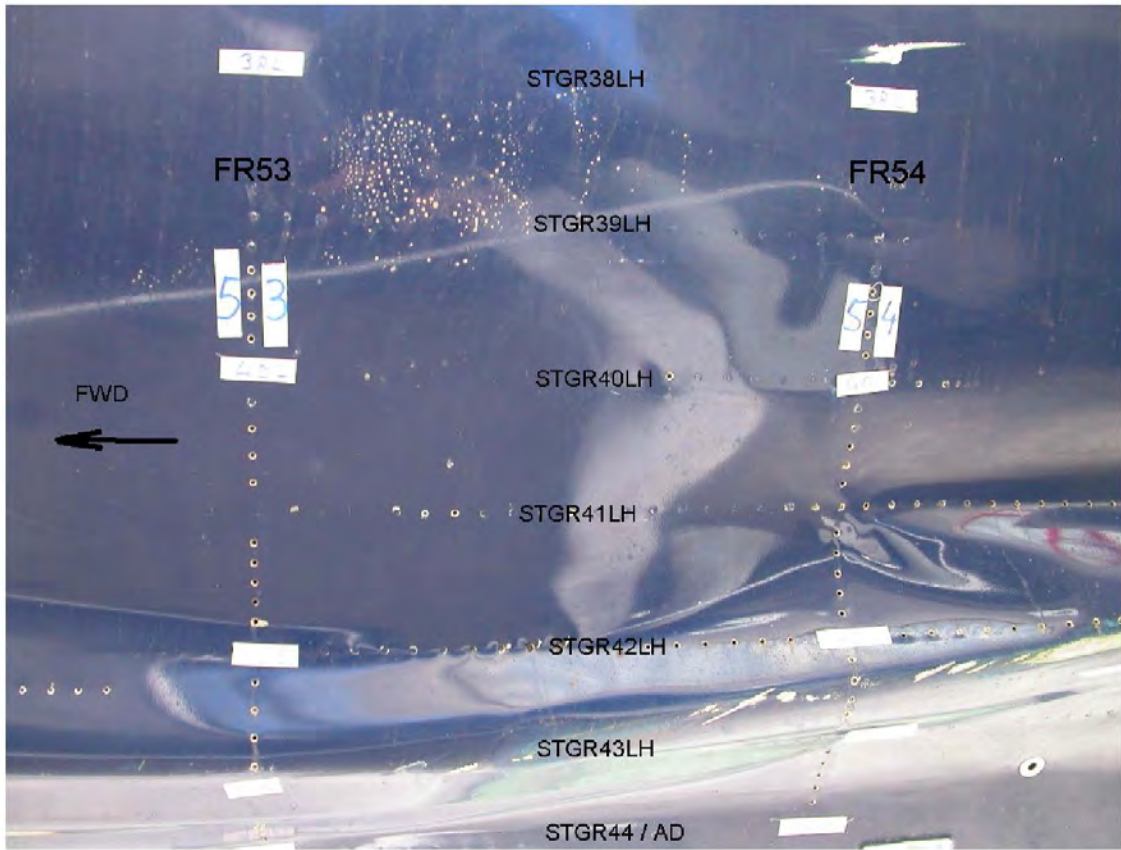
Photo 7

Description: LH FR53 to 54 viewed looking up.

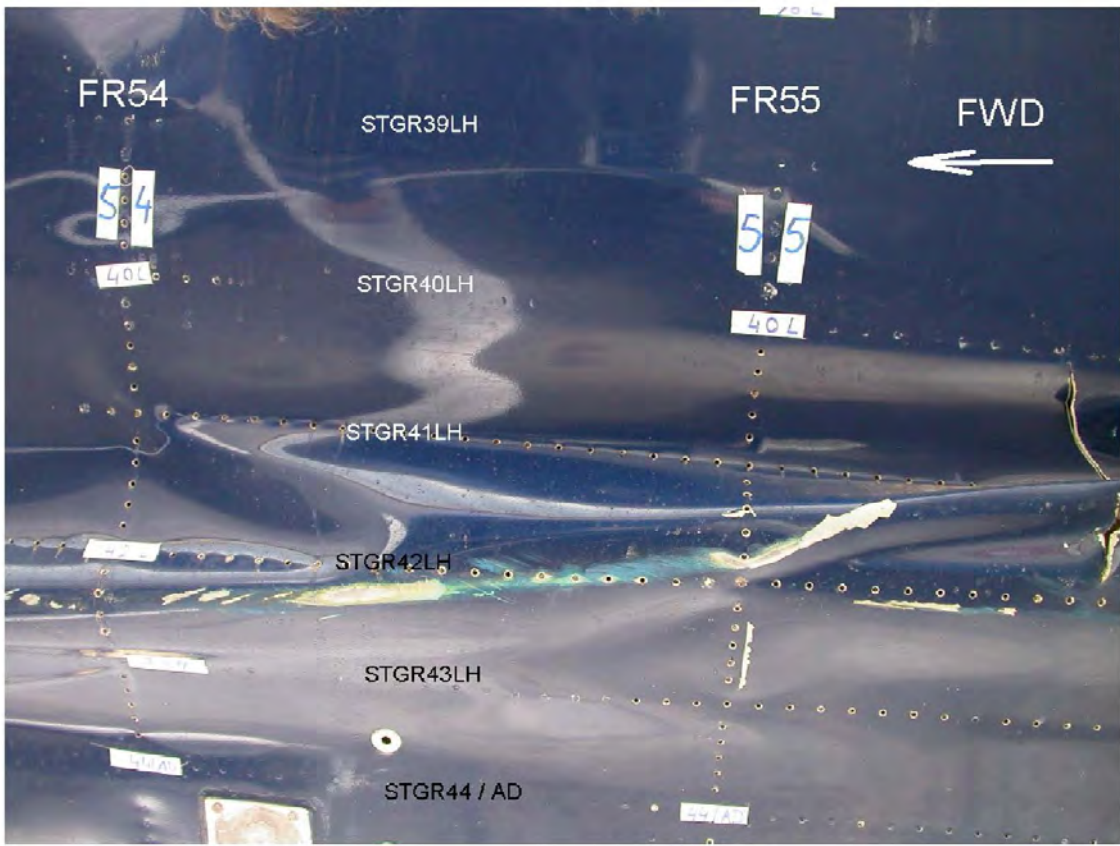
Photo 8

Description: LH FR54 to 55 viewed looking up.

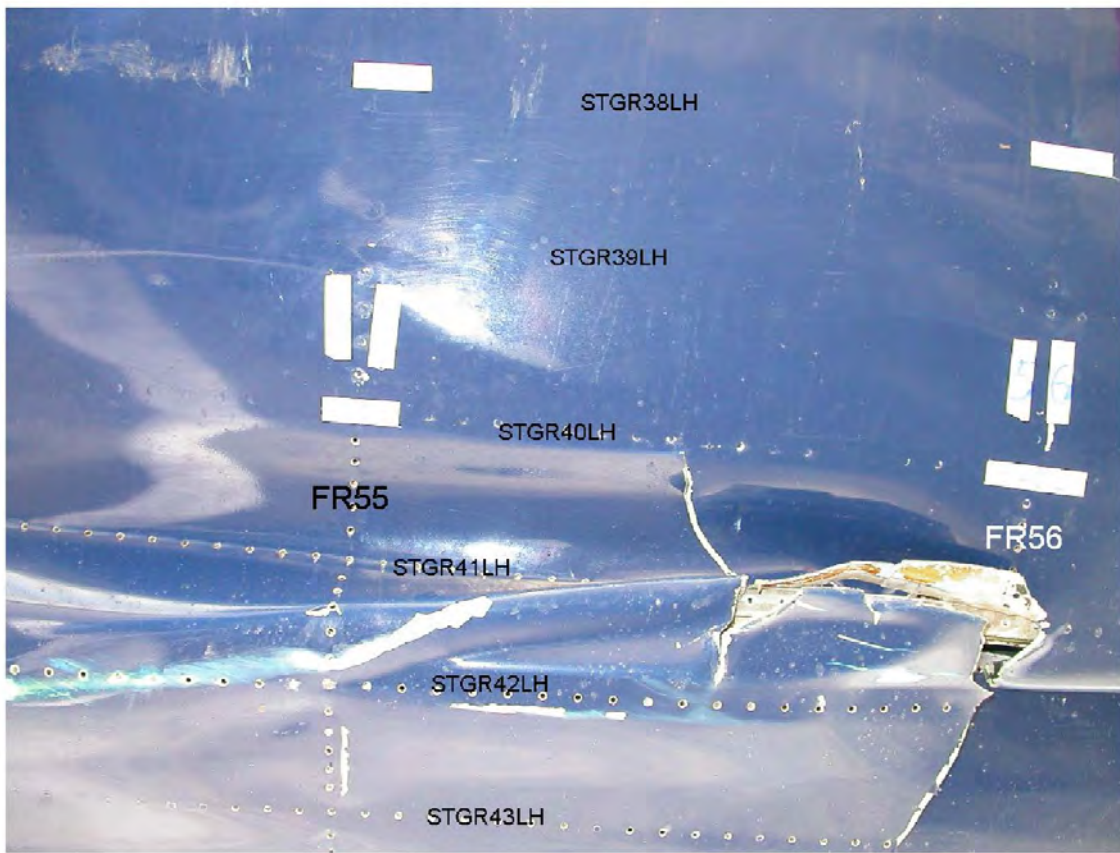
Photo 9

Description: LH FR55 to FR56 viewed looking up.

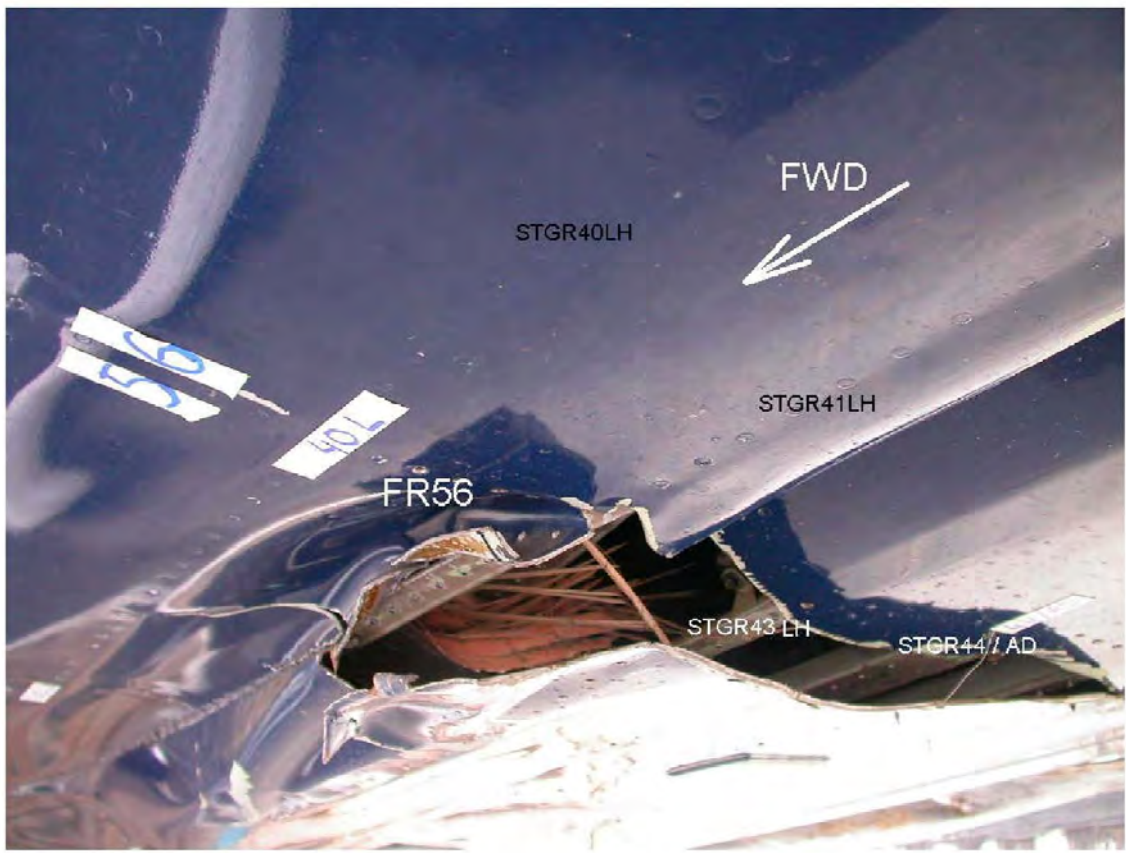
Photo 10

Description: LH Frame 56 viewed looking up.

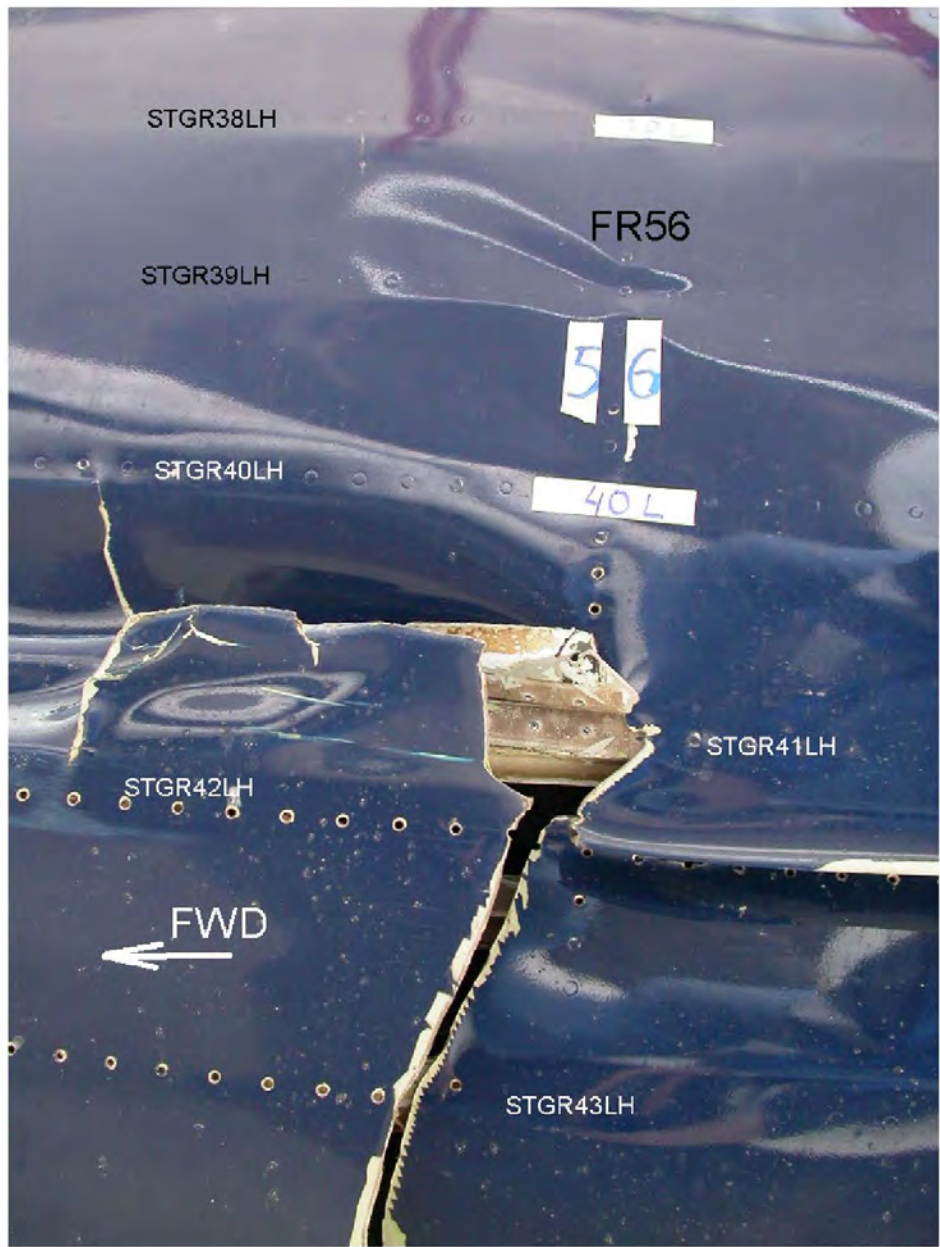
Photo 11

Accident #: DCA09MA026 | N106US  
Description: LH Frame 56 viewed looking up.

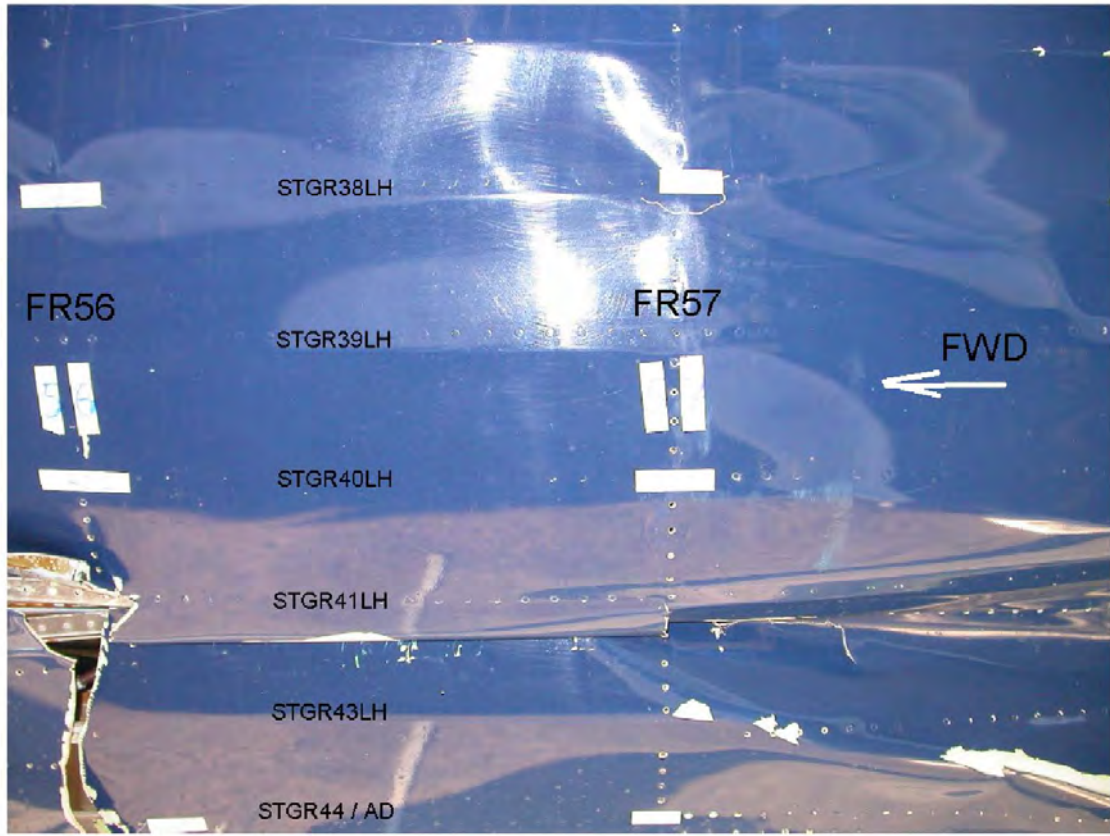
Photo 12

Description: LH FR56 and FR57 viewed looking up.

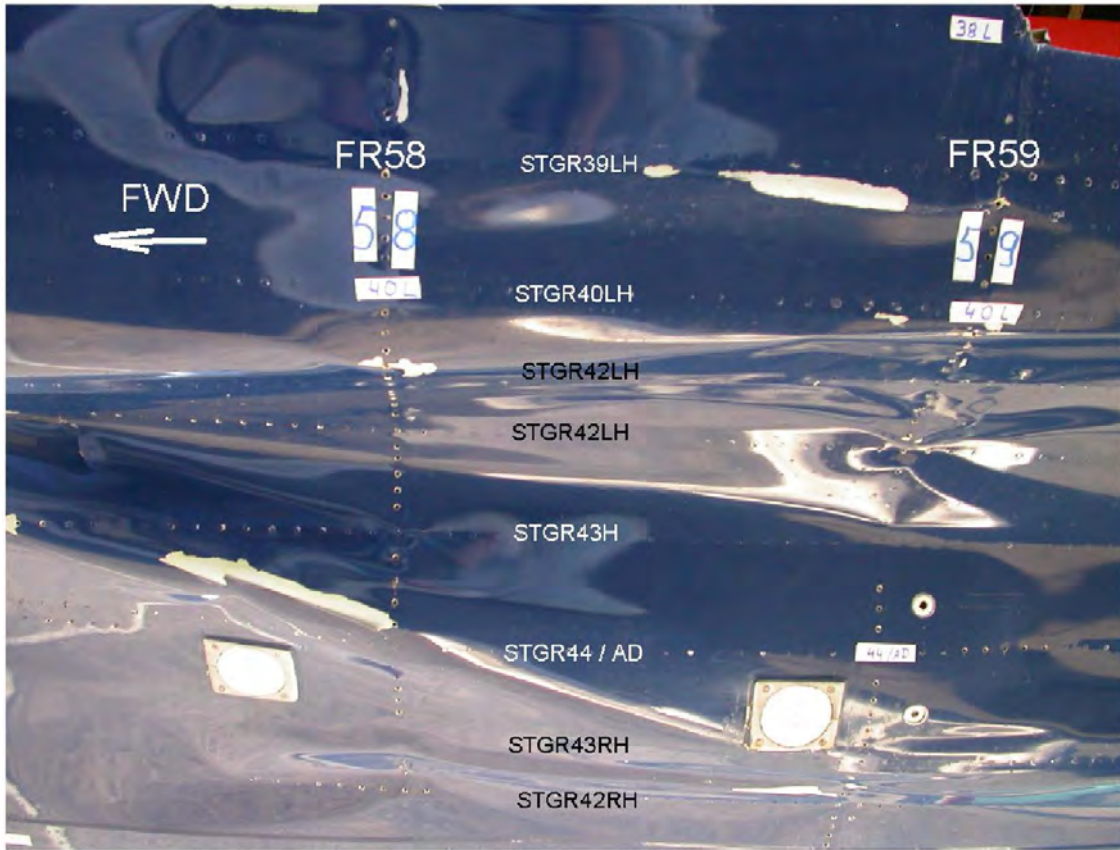
Photo 13

Description: LH FR58 and FR59 viewed looking up.

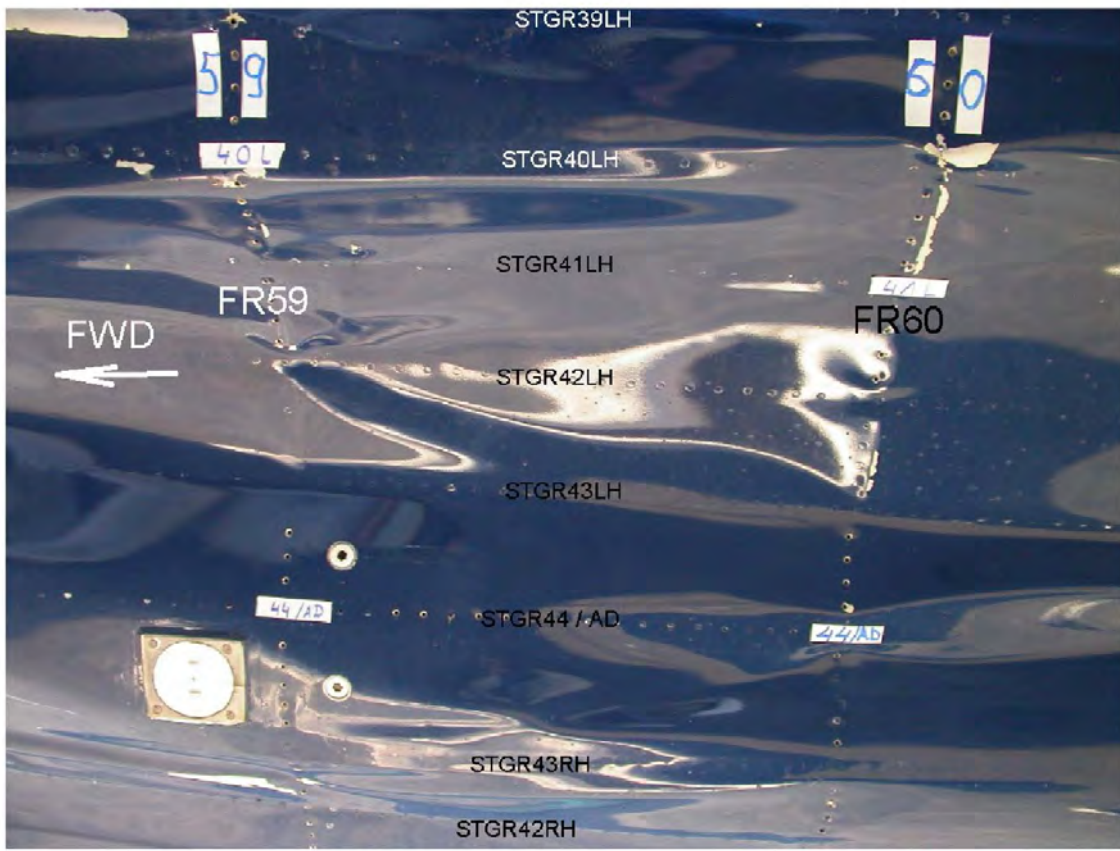
Photo 14

Description: LH Frame 59 and 60 viewed looking up.

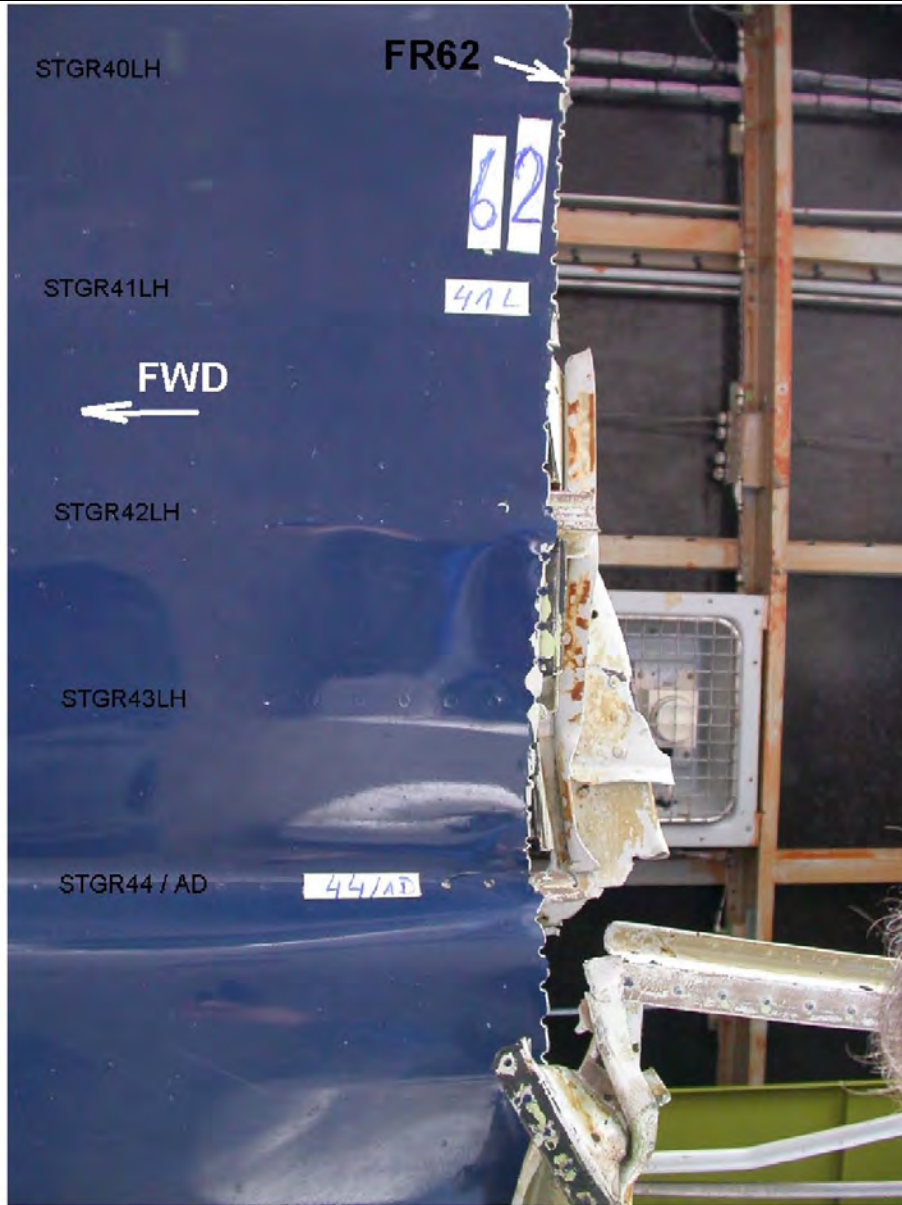
Description: LH Frame 62 viewed looking up.

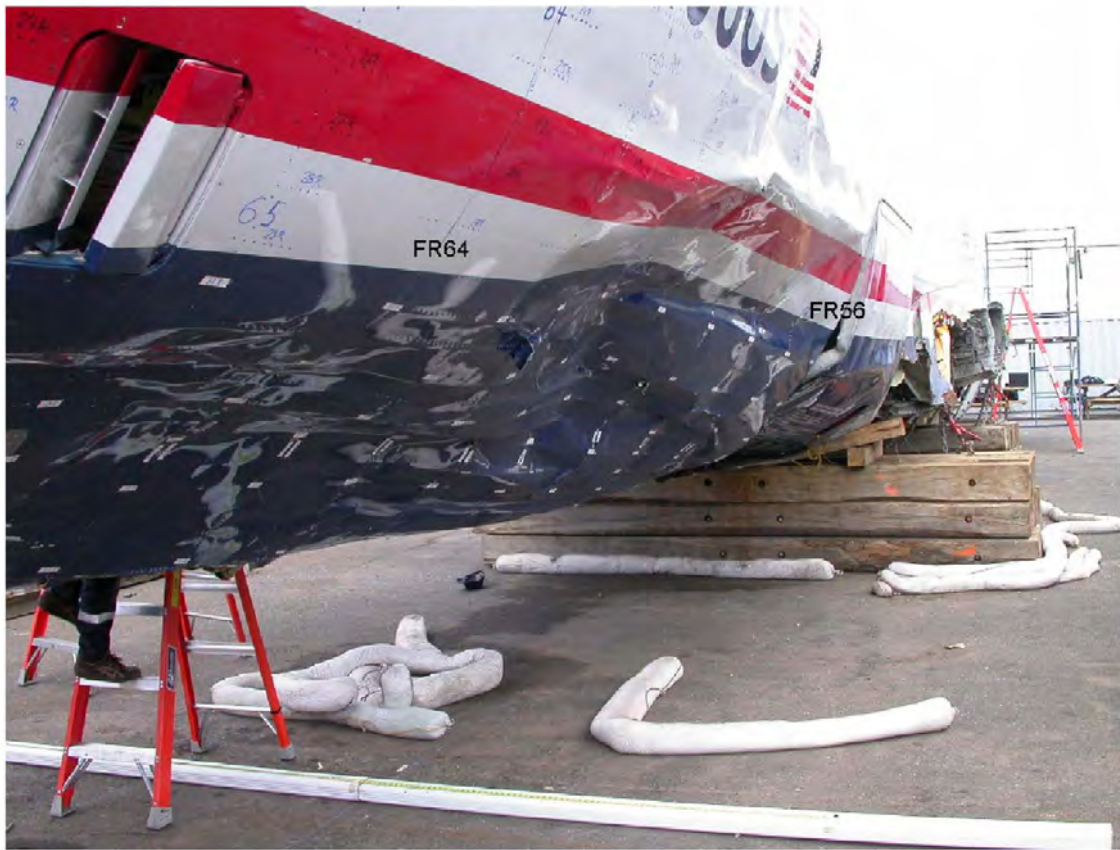
Photo 17

Description: RH Frame 56 to 65.

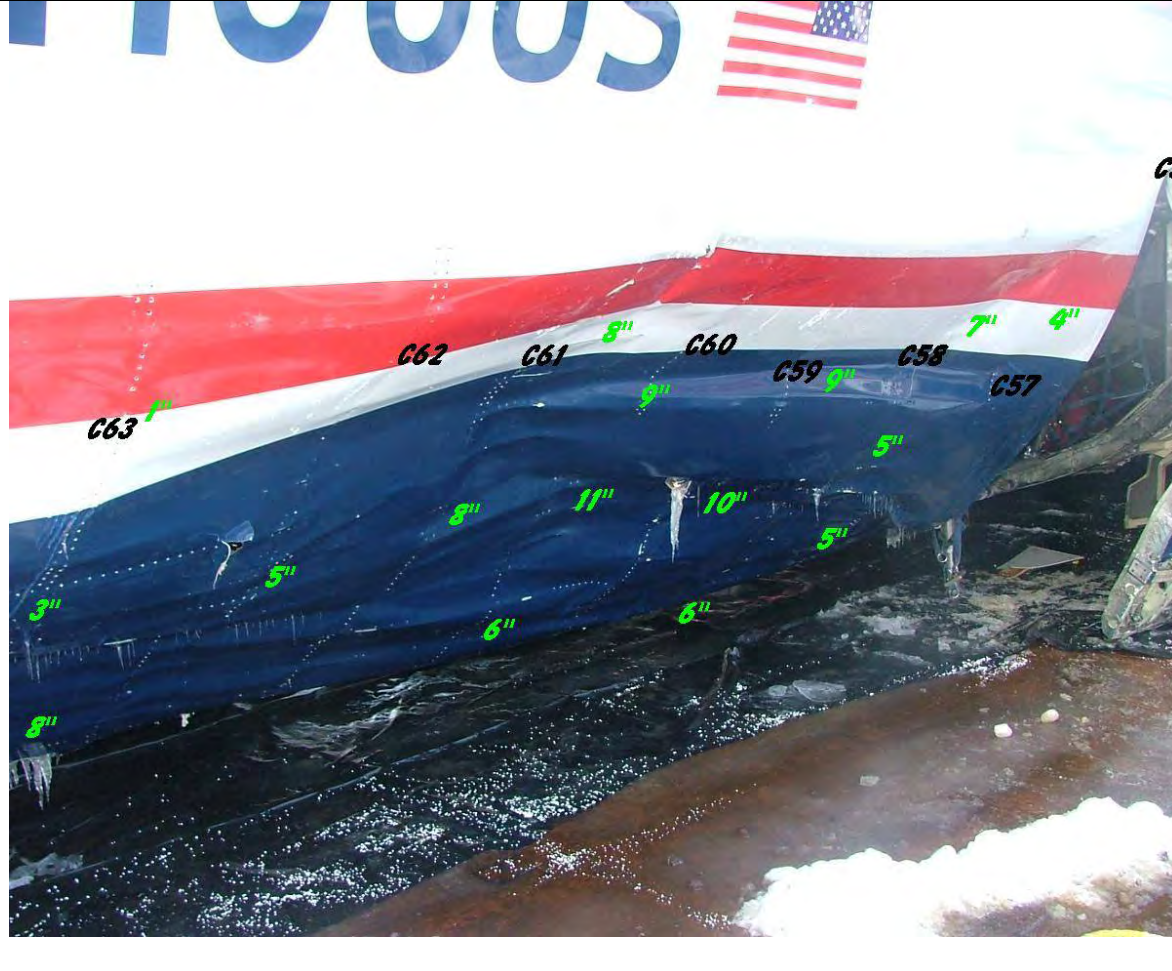
Photo 18

Description: RH F57 to FR 63.

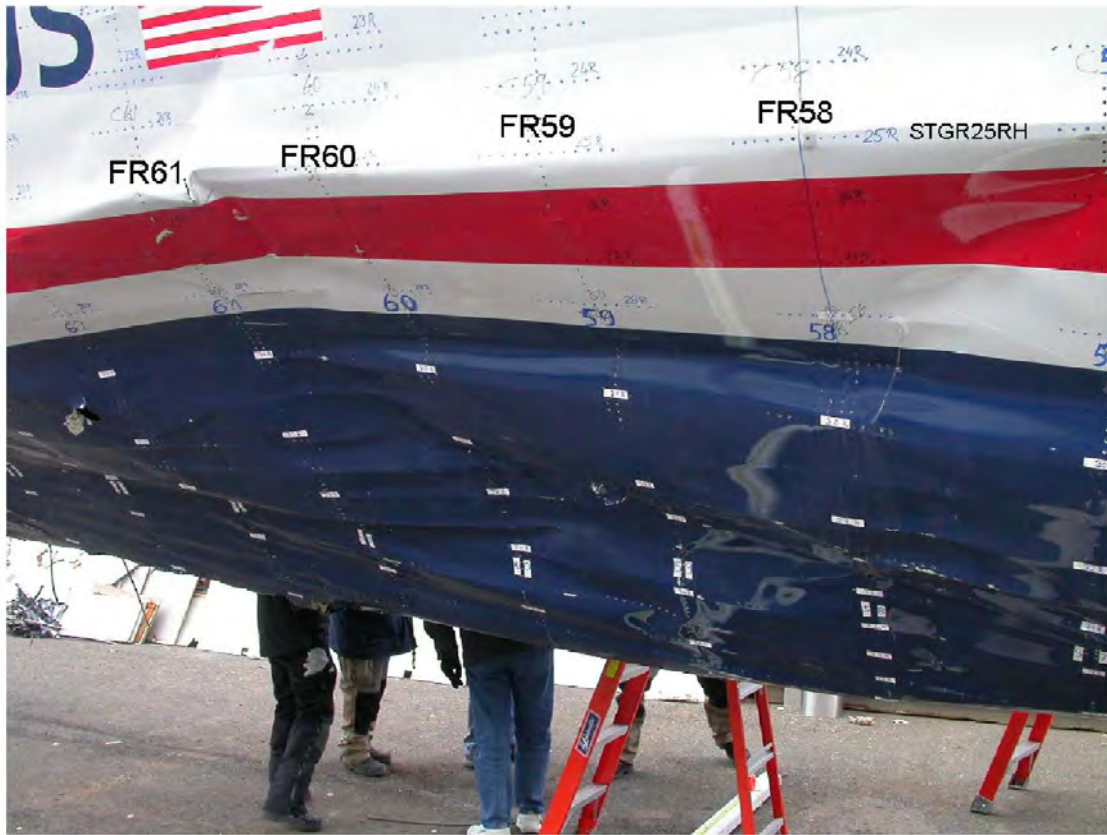
Photo 19

Description: RH FR57 to FR62.

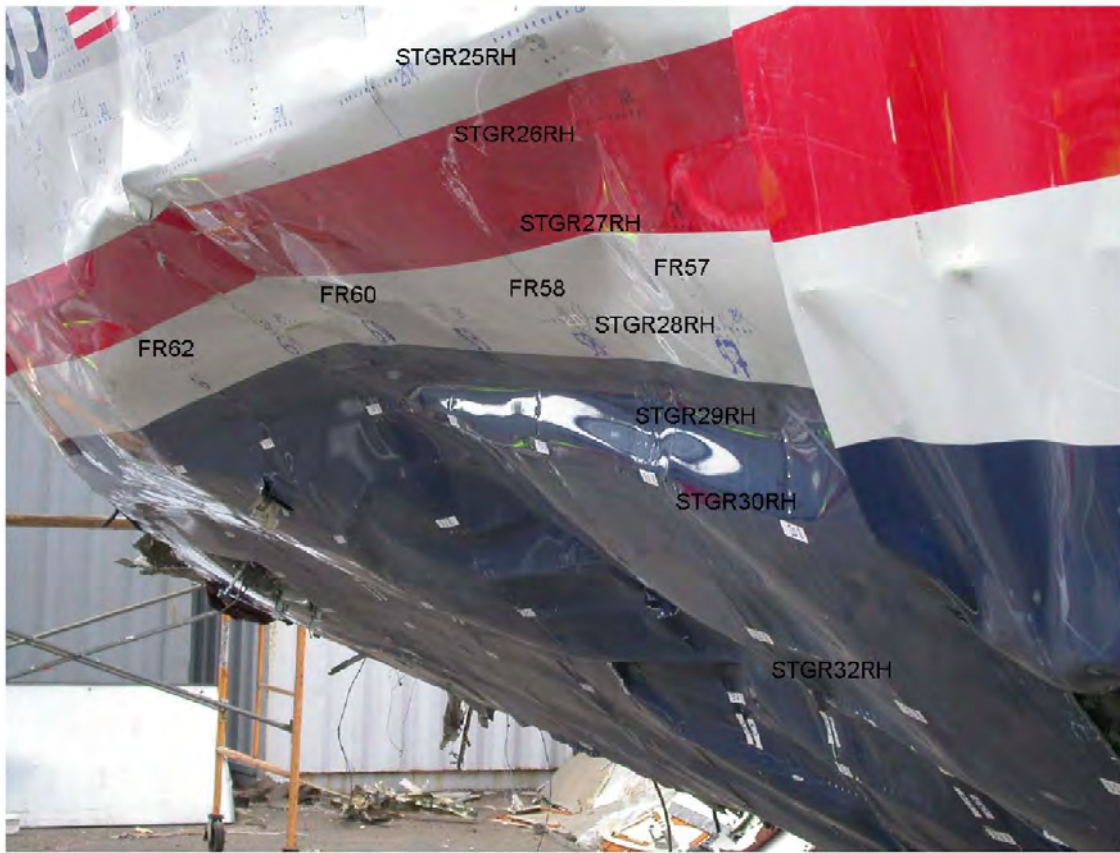
Photo 20

Description: RH FR57 to FR62.

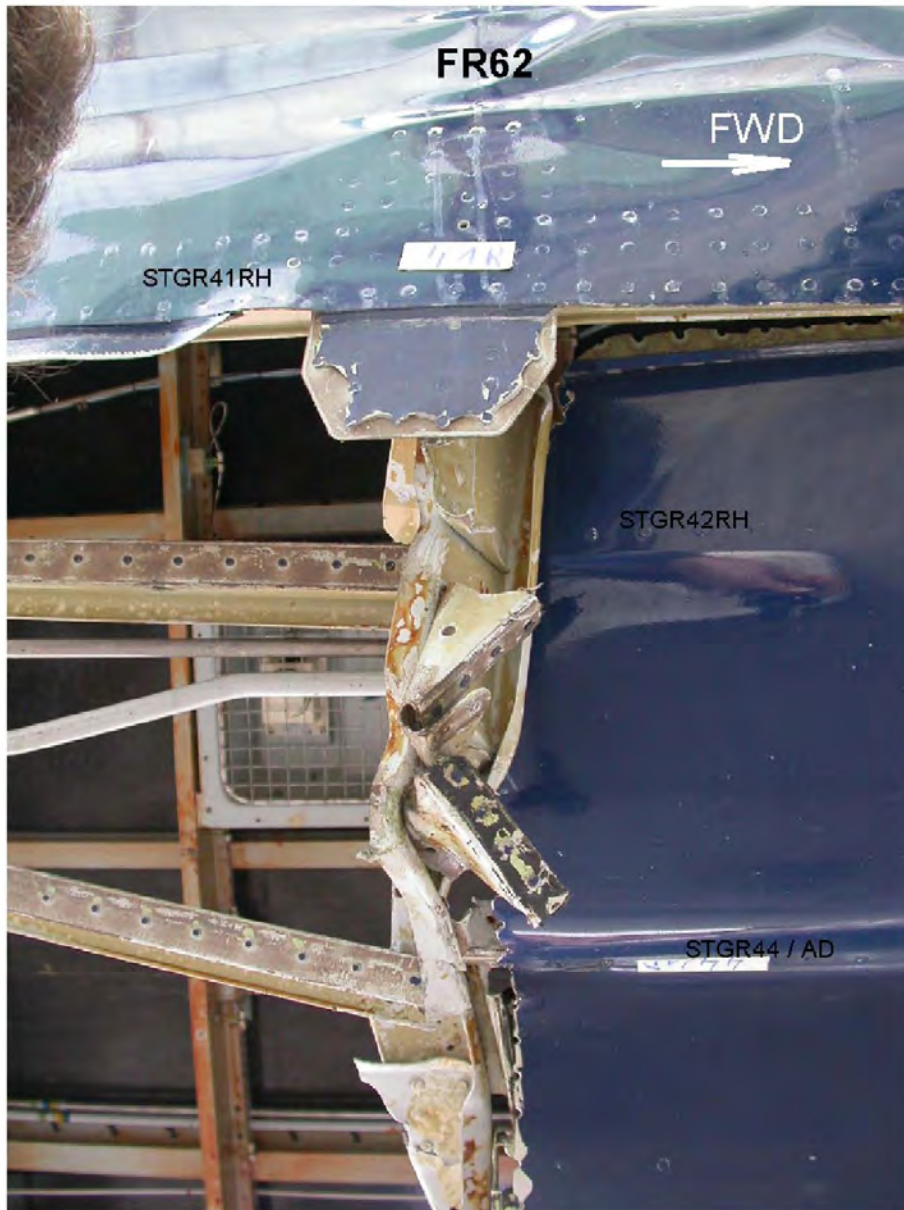
Photo 21

Description: RH FR62.

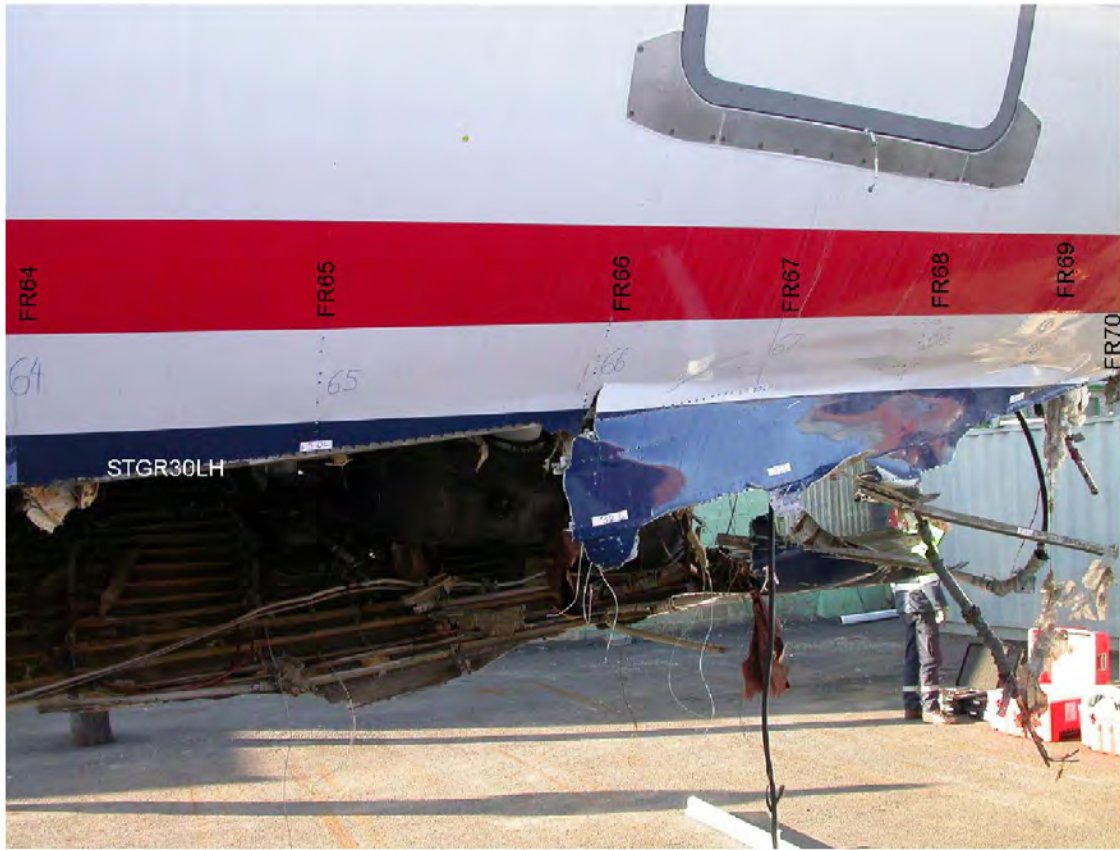
Photo 22

Description: LH FR64 to FR70.

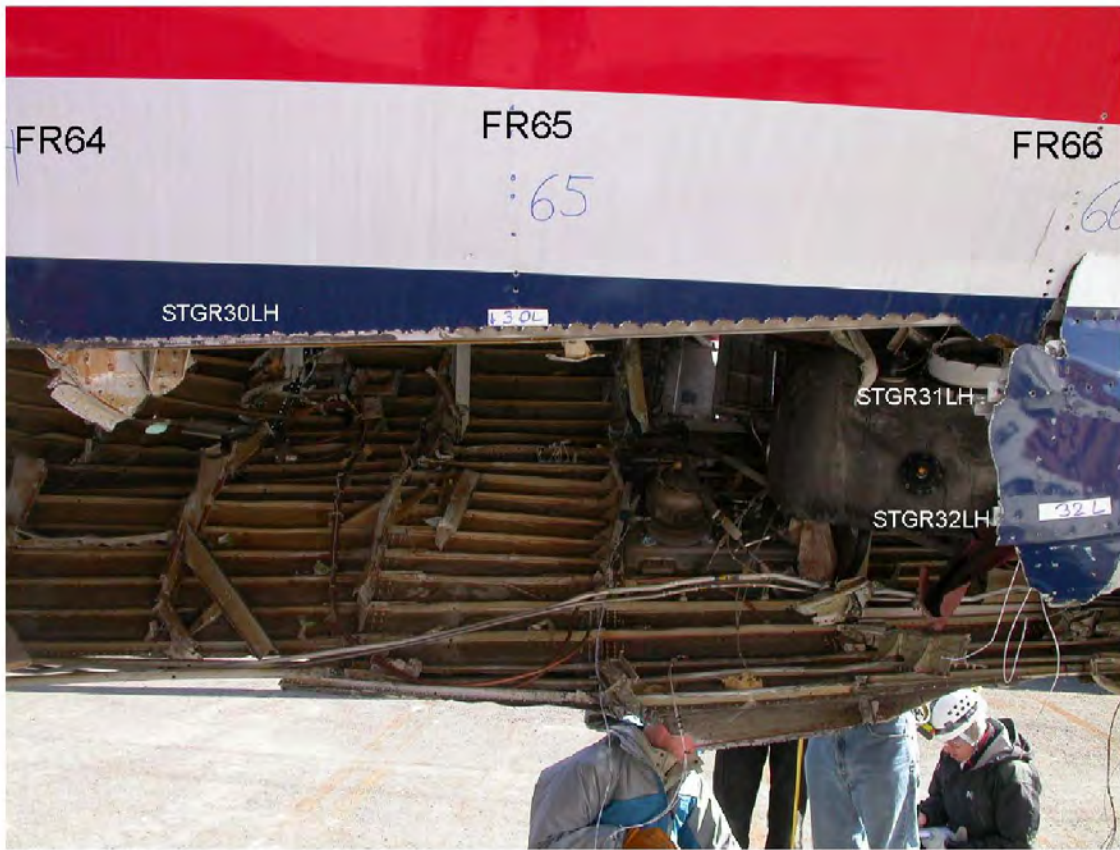
Photo 23

Description: LH FR64 to FR66.

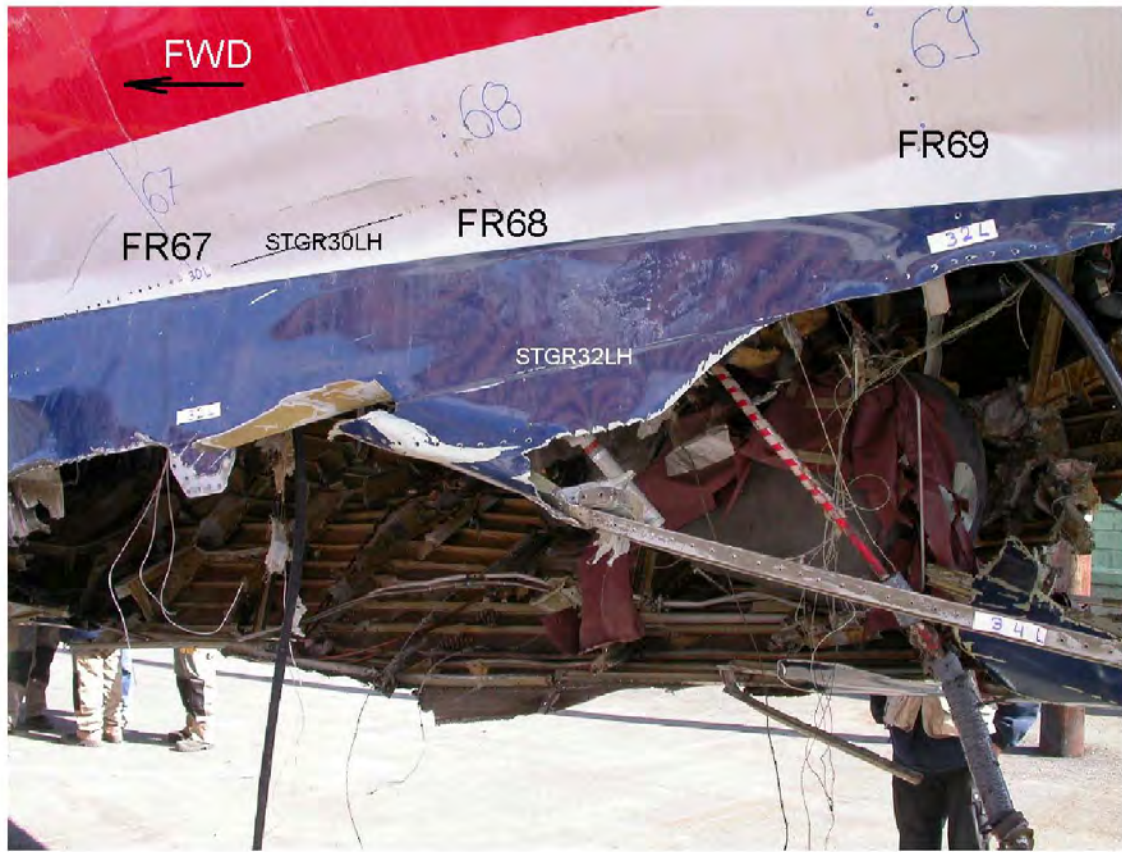
Photo 24

Description: LH FR67 to FR69.

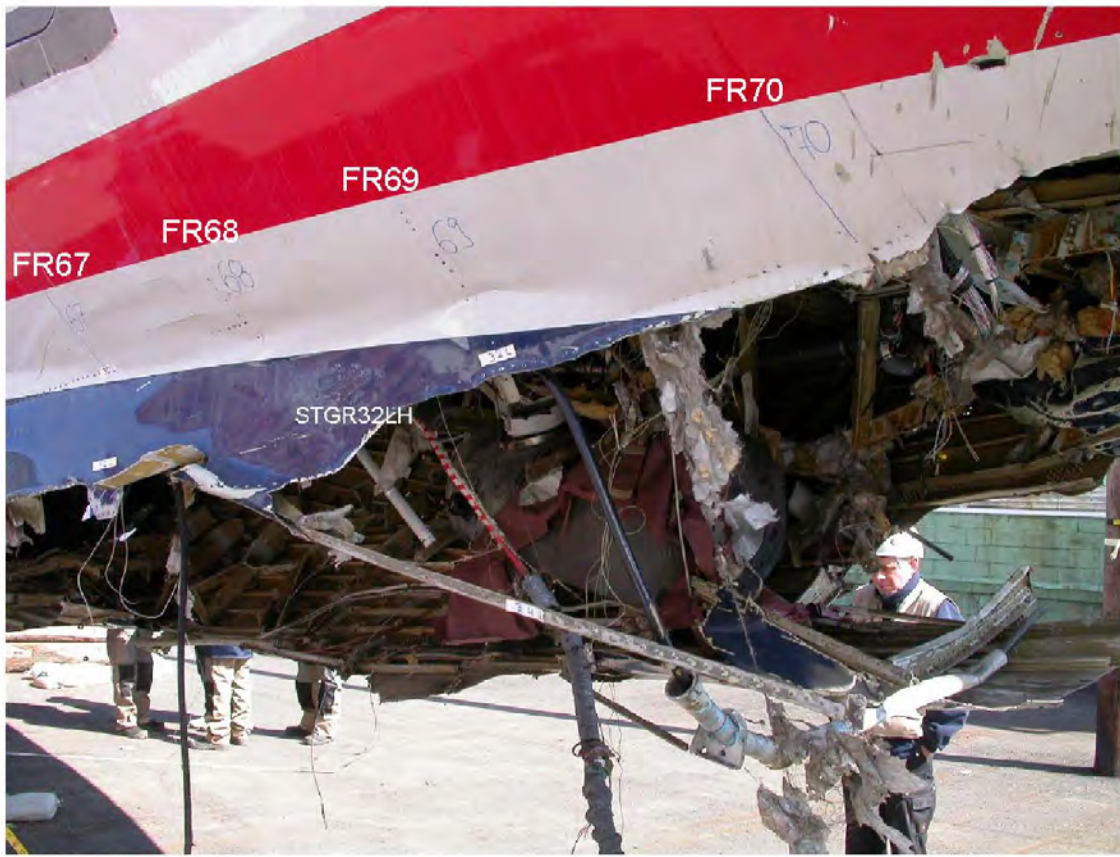
Photo 25

Description: LH FR67 to FR70.

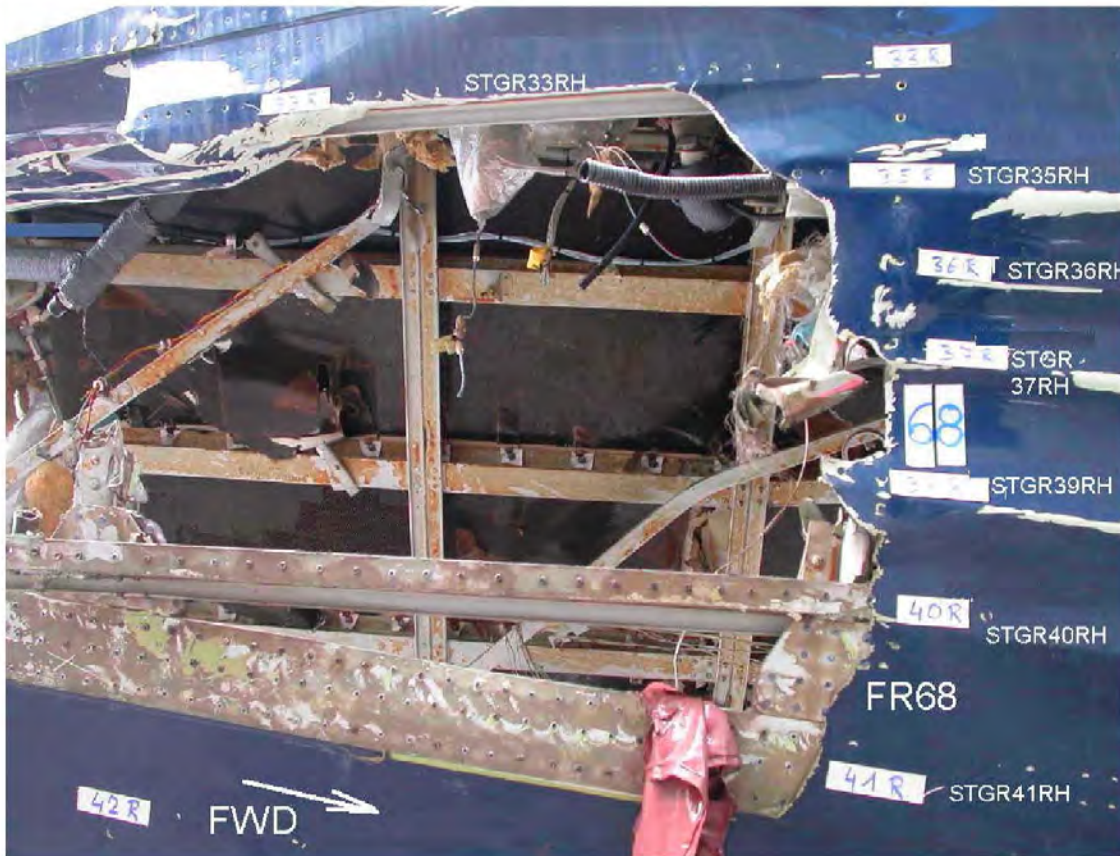
Photo 26

Description: RH Frame 68.
