**Docket No. SA-532**

Addendum 1  
Structures Group Chairman's  
Attachment 2 to the Factual Report  
Photos

### **STRUCTURES GROUP CHAIRMAN'S FACTUAL REPORT**

DCA09MA026  
May 26, 2009

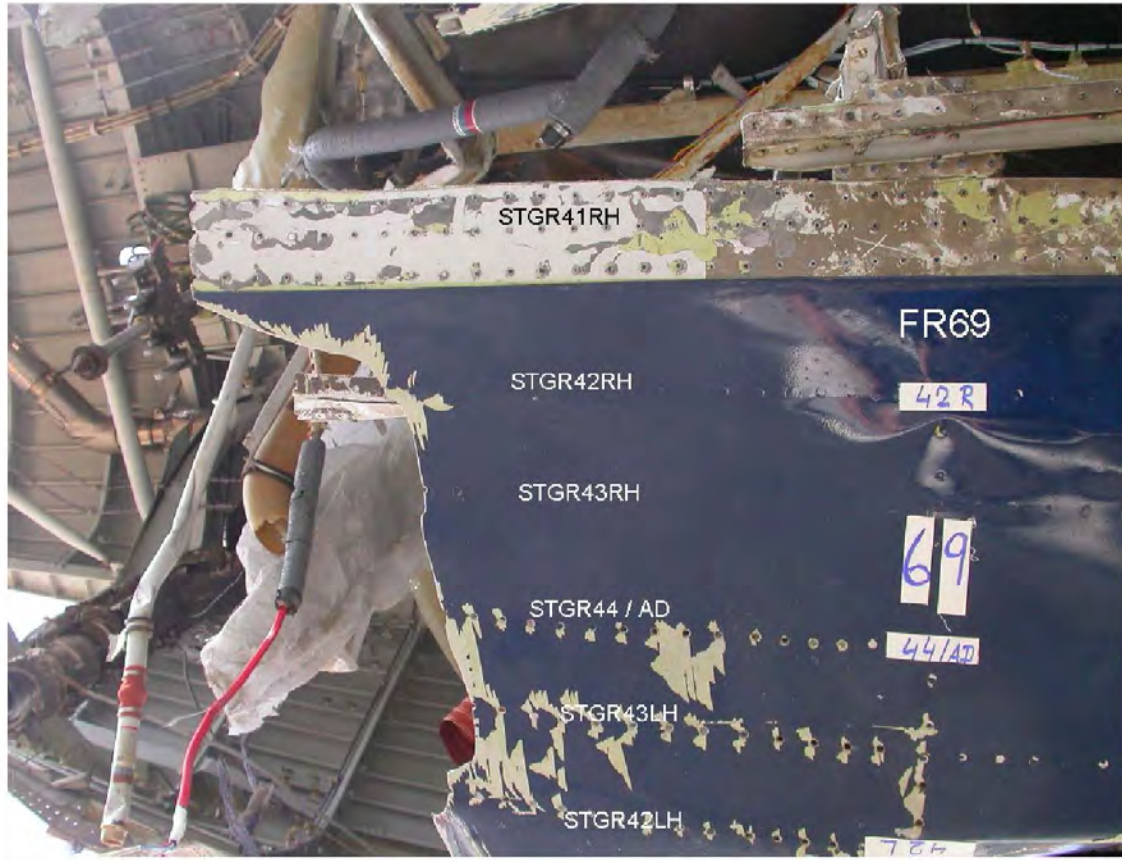
Photo 27

Description: RH Frame 69.

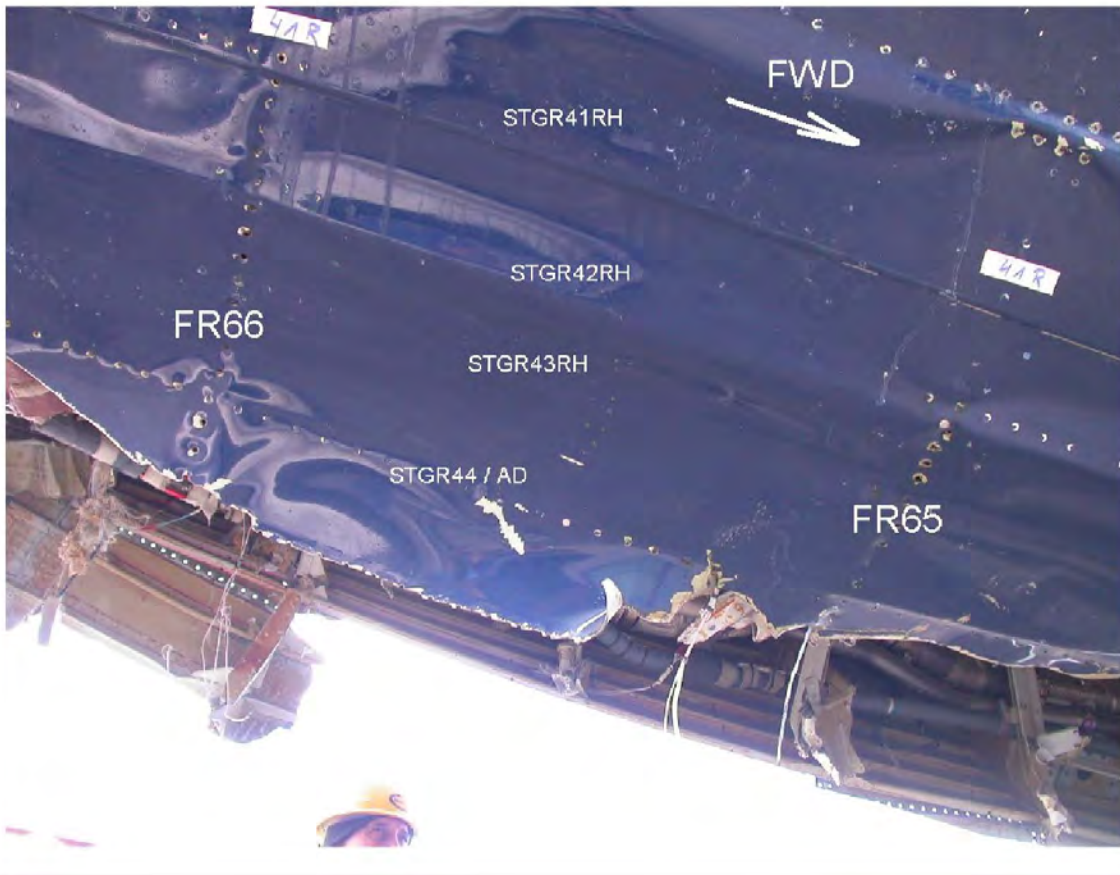
Description: RH FR65 to FR66.

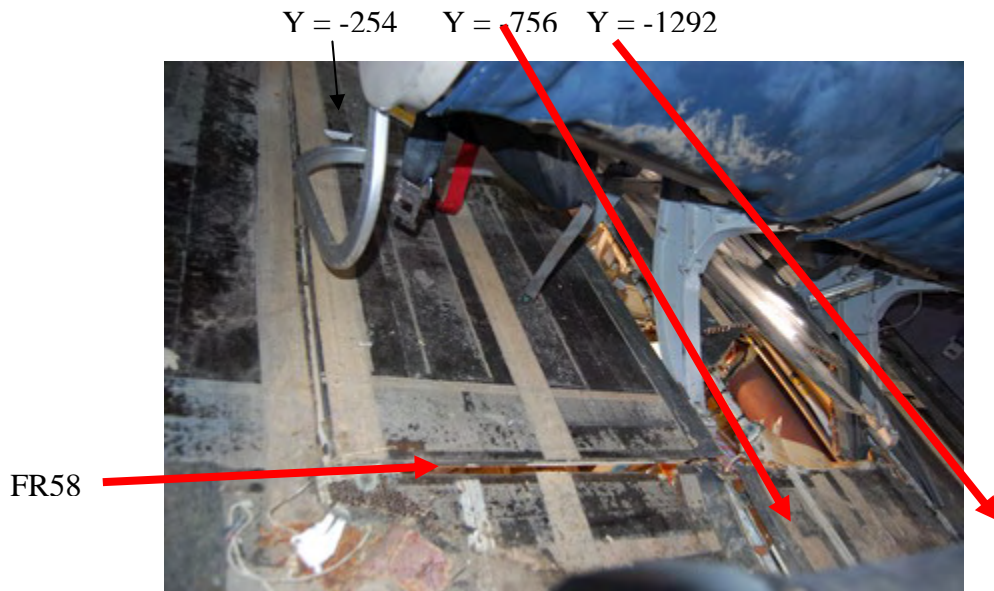
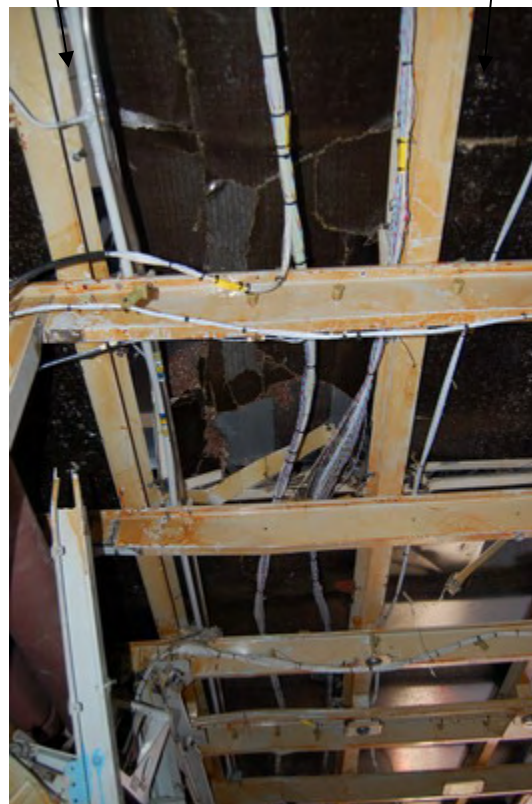
Description: Floor panels FR56  $y = -765$  to  $y = 1292$ .

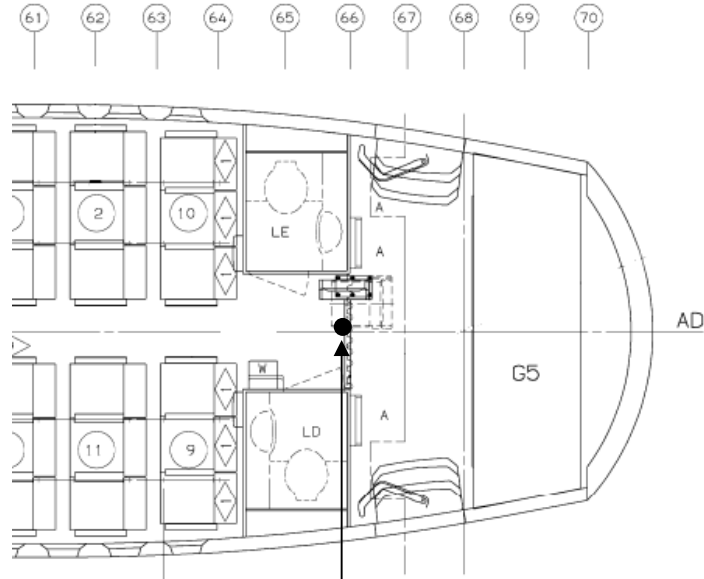
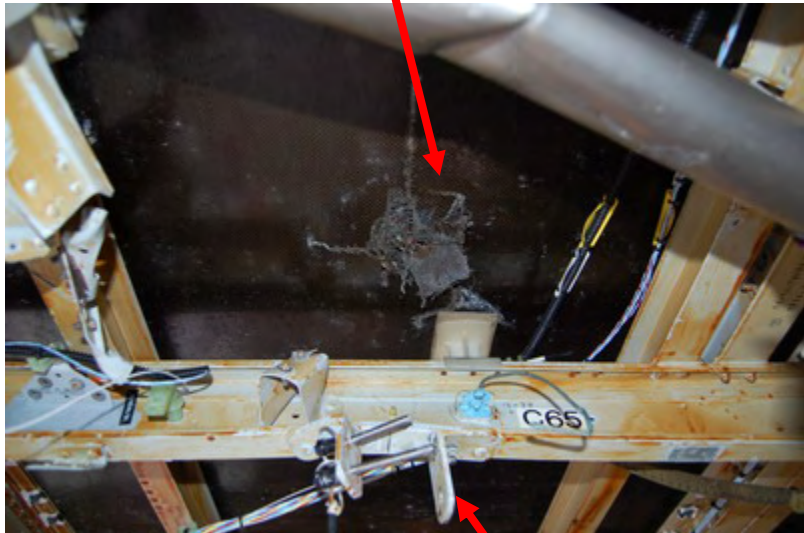
Description: FR65 floor panel perforation.

Floor panel perforation

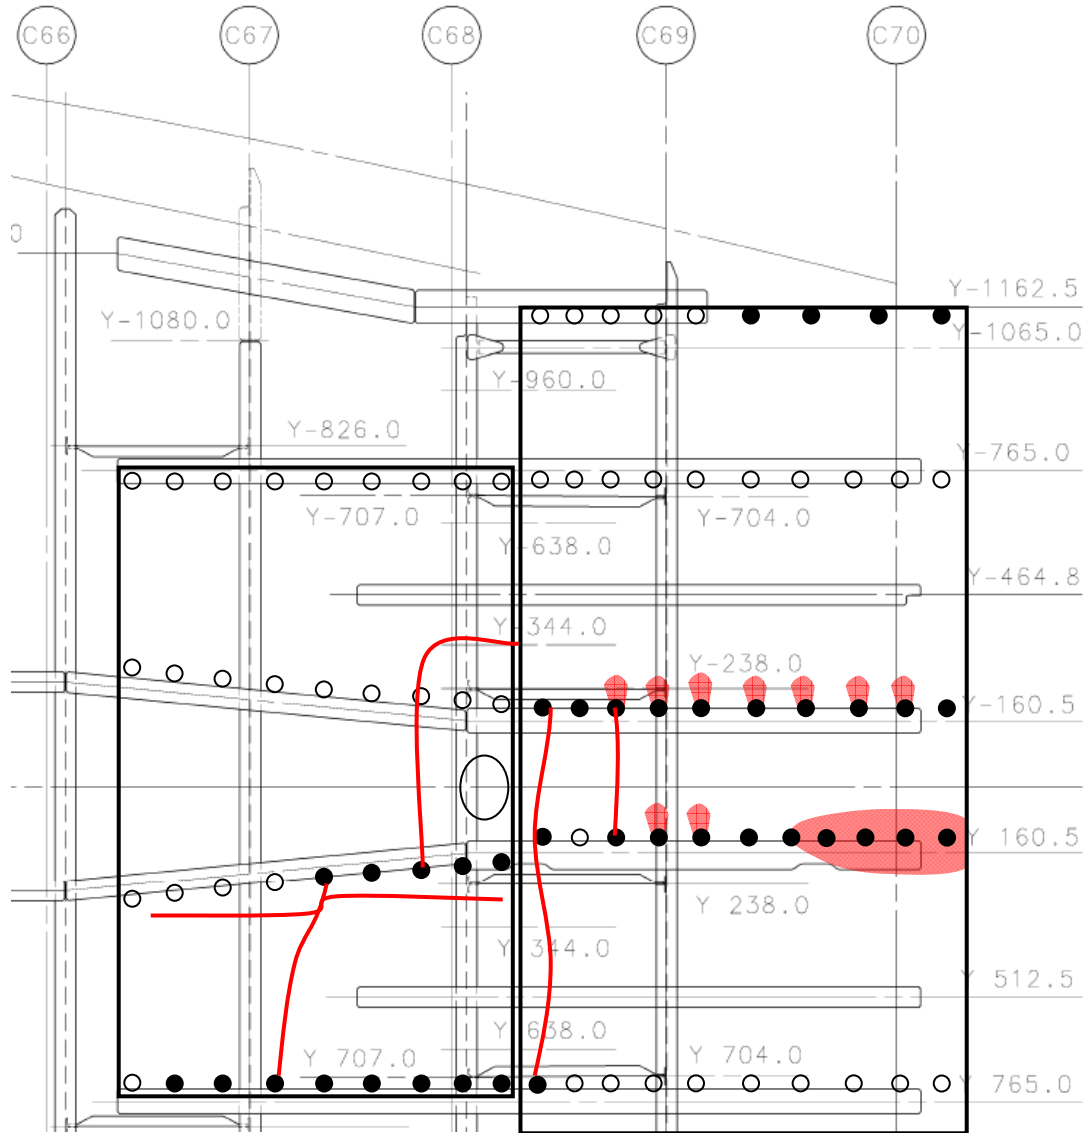
Description: Floor panel damages FR66 to FR70 (from bottom)

- Fastener insert not damaged
- Fastener insert damaged
- Lower plies of floor panel broken
- Lower plies area delaminated
- Contact point with lower frame part

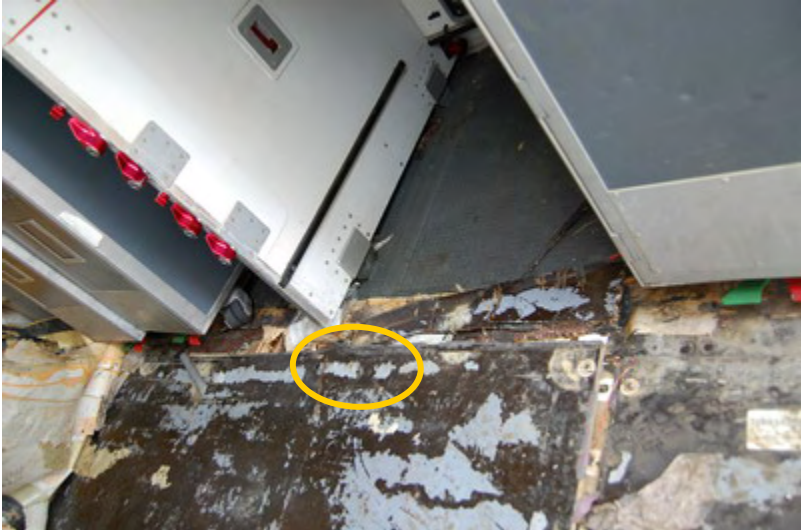
Accident #: DCA09MA026	N106US
Description: Floor panel damages FR66 to FR68 RH (from top)

Contact point with lower frame part
Photo 47

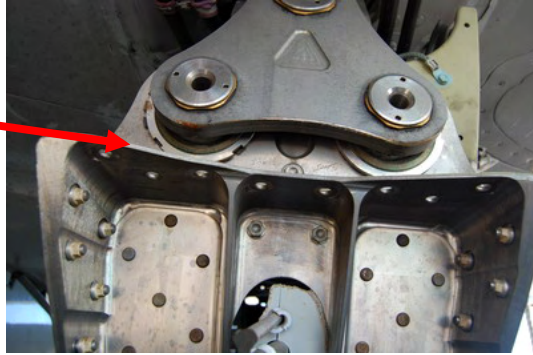
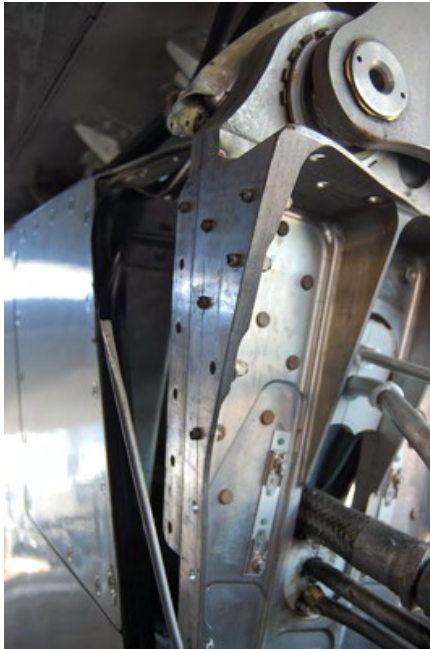
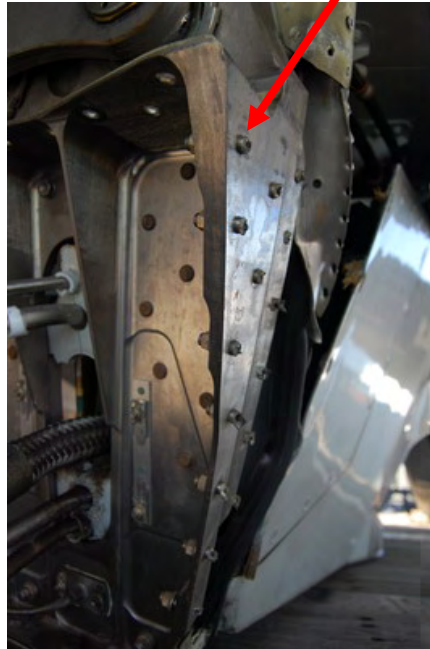
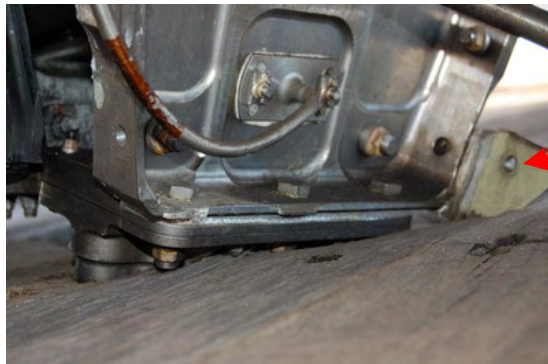
Description: LH pylon to wing attachments

Missing fasteners

Torn off fastener heads

Portion of lower spar

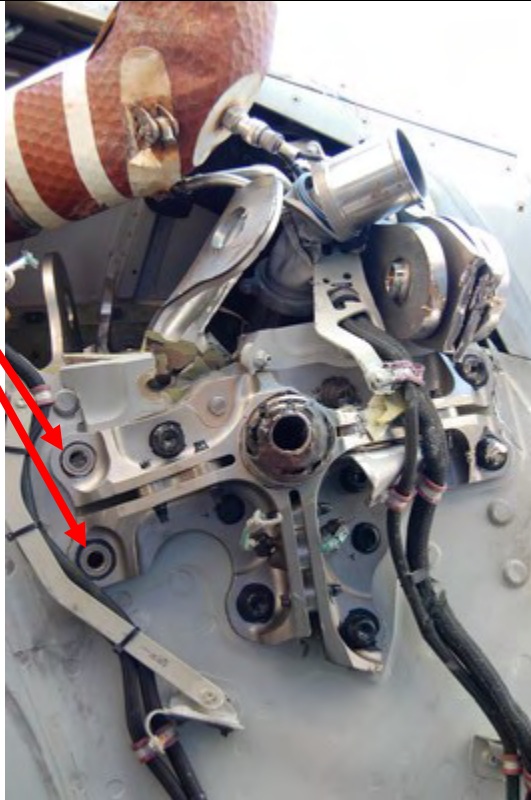
Description: LH pylon to wing spigot.

Missing fasteners
