National Transportation Safety Board
Office of Aviation Safety
Washington, D.C.

ADDENDUM TO THE STRUCTURES GROUP CHAIRMAN'S
FACTUAL REPORT OF INVESTIGATION

FLIGHT CREW SEAT TRACK DOCUMENTATION

A. ACCIDENT : DCA-94-MA-076

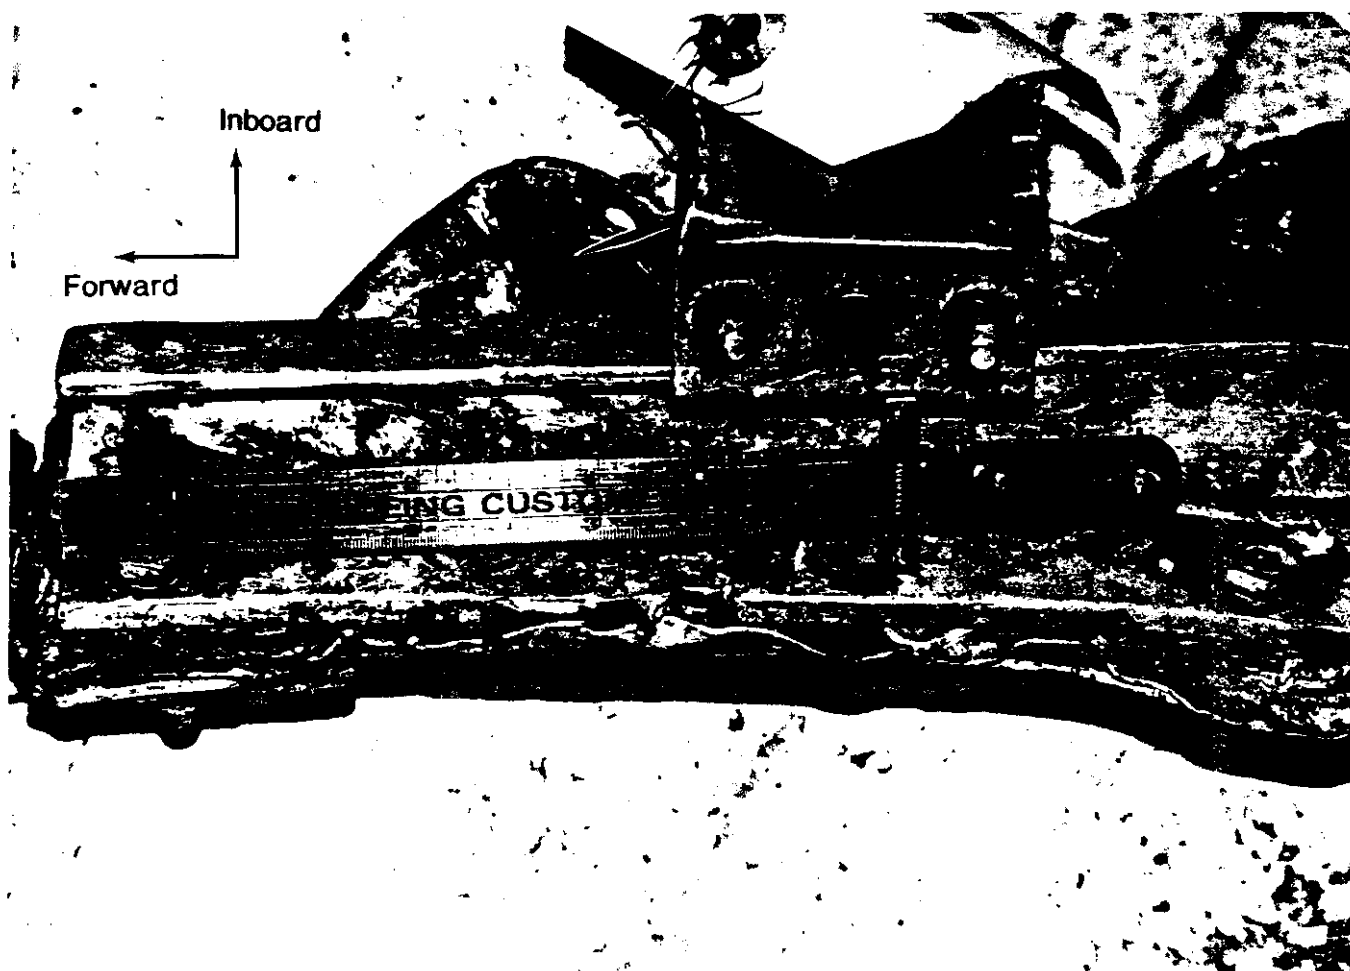
Both sections of seat tracks exhibited severe impact and fire damage. The floor structure normally attached to the periphery of the seat tracks was fractured and missing from both segments of track, and only the forward outboard boggie for the captains seat attachment remained attached to the seat tracks. The examination of the recovered sections of seat track revealed no evidence of indentations or scoring corresponding to the position of the seat boggies at impact.

1. View of boggie and forward outboard section of Captain's seat track
Note: No evidence was observed of indentations or scoring
corresponding to the position of the boggie at impact.

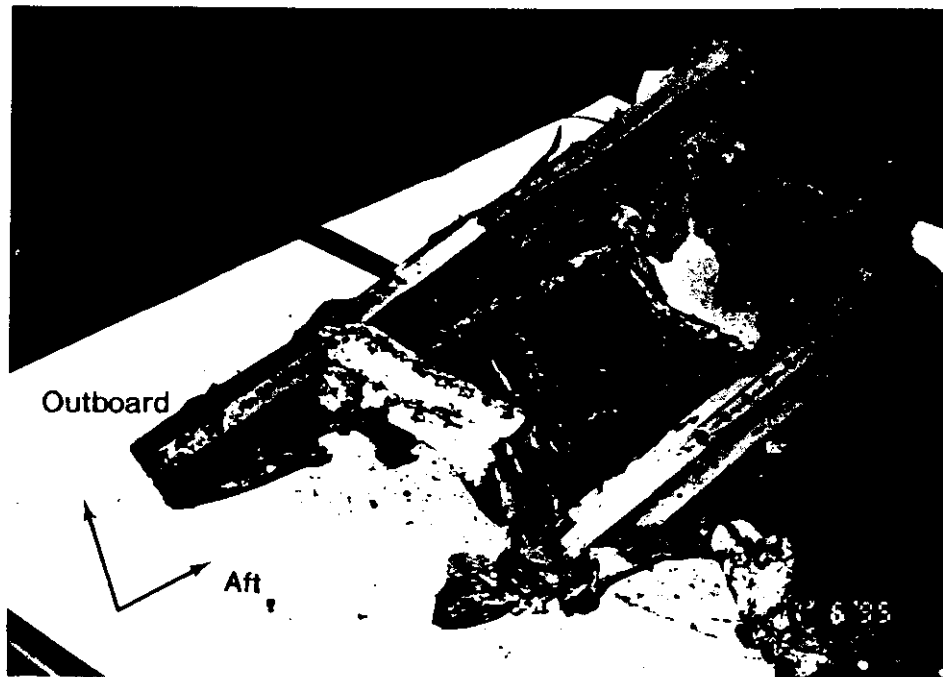
Both the outboard and inboard segments of the First Officer's seat track upper flanges were cracked at the forward locking hole and exhibited wear between the locking holes on the upper flange. Examination of the inboard seat track revealed that 4.0 inches of the aft track was fractured from the lower flange and 6.5 inches of the forward track was fractured and missing.

3. View of the First Officer's seat track.
Note: cracking of the first forward locking holes
and distortion of the forward outboard seat track.

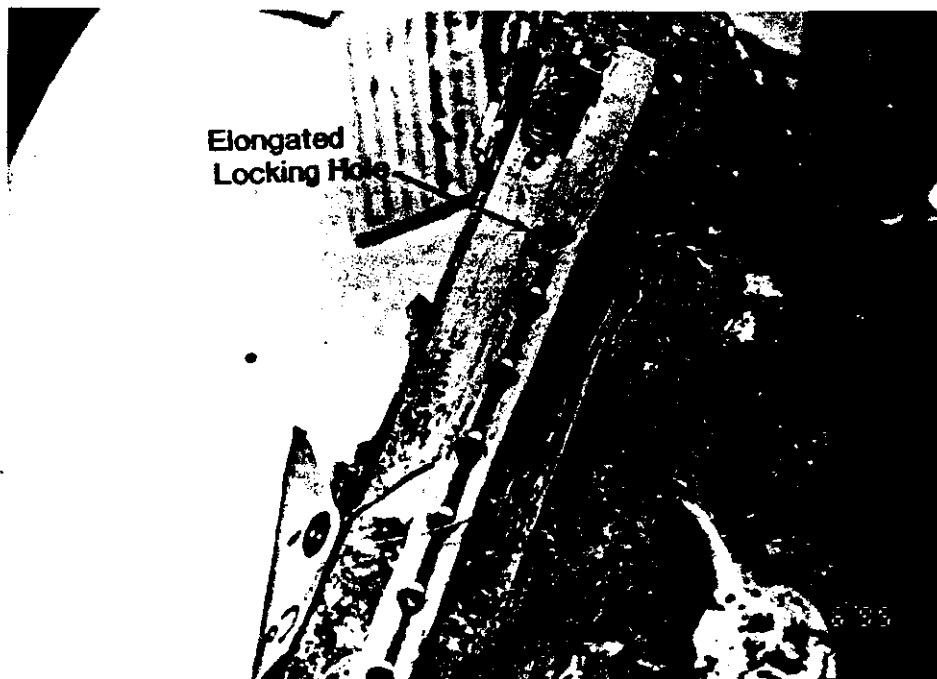
The outboard forward seat track was distorted 8 inches from the forward end of the track and cracked through the web 3.50 inches forward of the fractured area. The last locking hole on the outboard seat track's upper flange, parallel to the 4.0-inch section of the aft inboard track, was found elongated in the forward direction (equivalent to STA 241.4).

4. View of the outboard aft upper seat track flange.
Note: elongation of the last locking hole
