NATIONAL TRANSPORTATION SAFETY BOARD

Group Chairman's Factual Report

DCA15MA019

**Appendix A – Figures
(11 pages)**

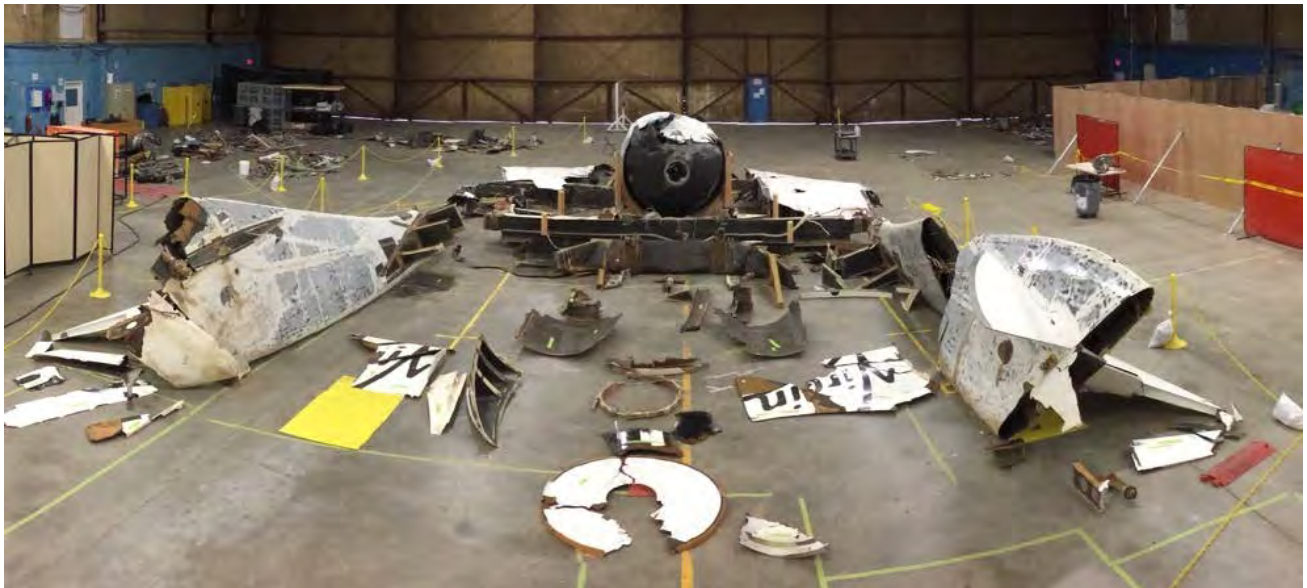
Figure 6 – Wreckage layout

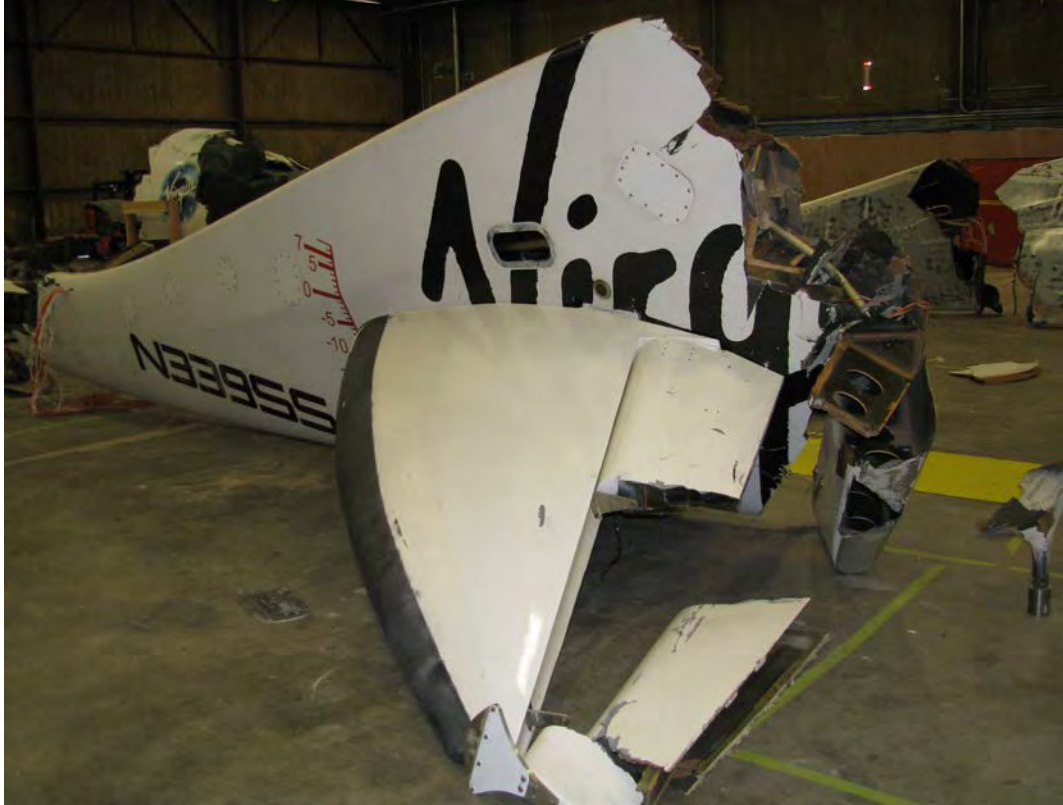
Figure 7 – Left boom wreckage

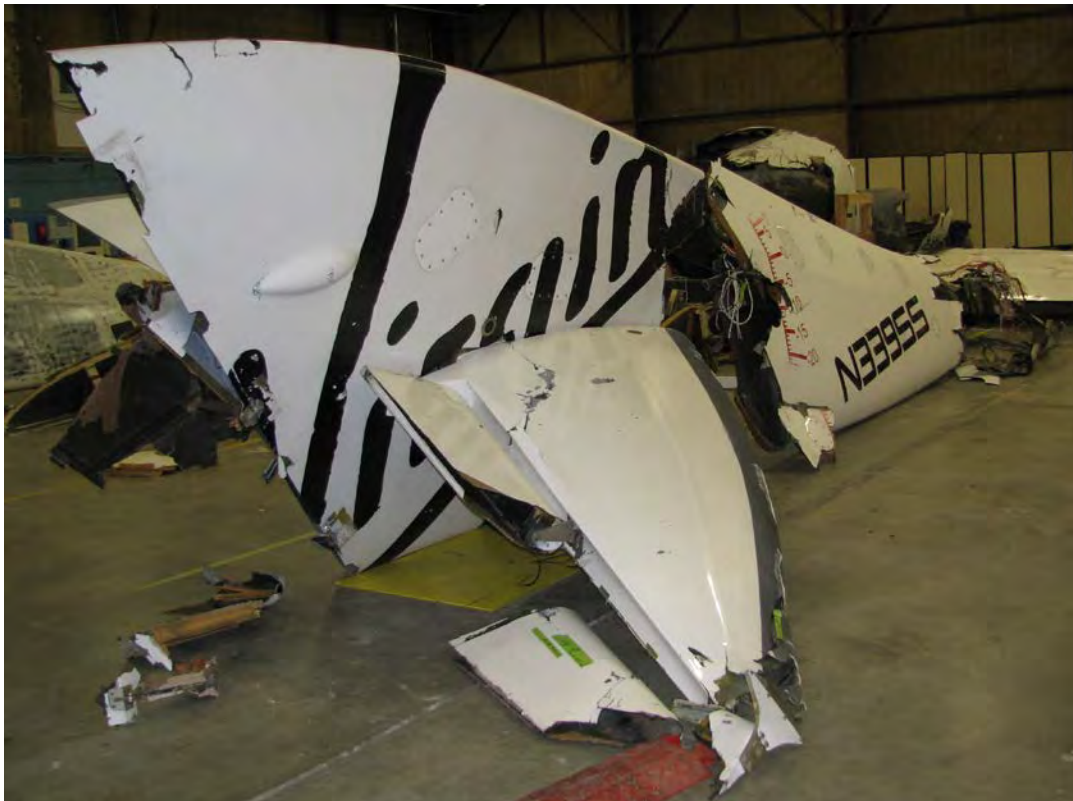
Figure 8 – Right boom wreckage

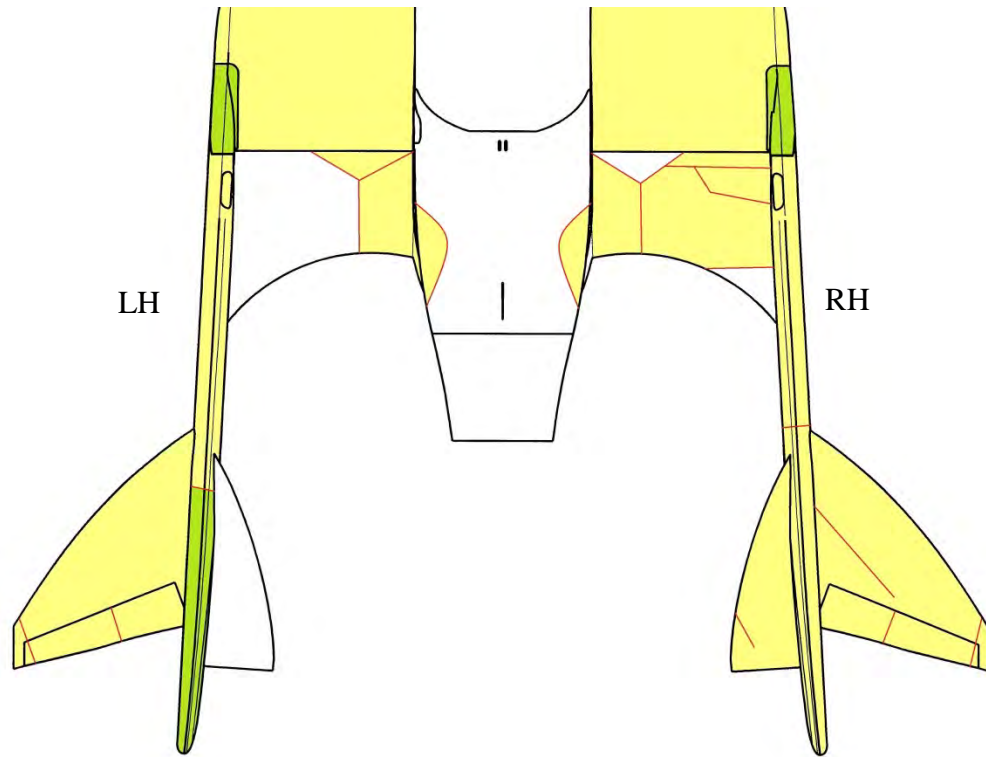
Figure 9 – Top view of recovered and identified structure from aft end of vehicle

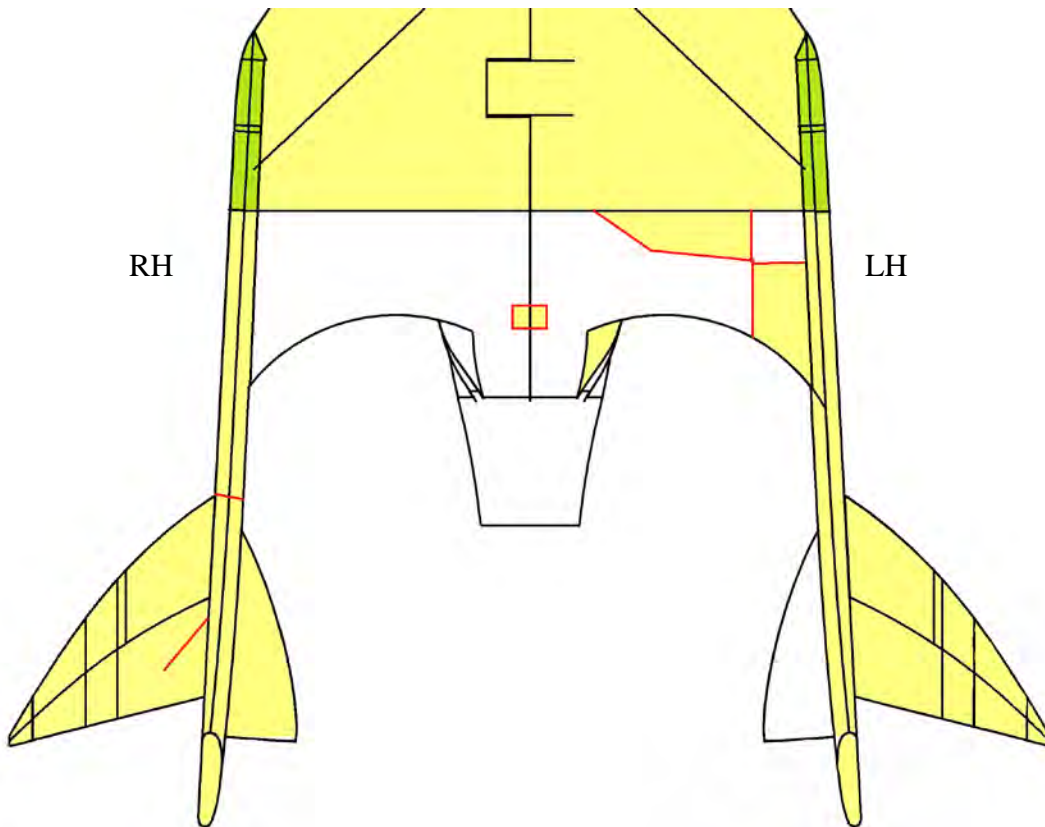
Figure 10 – Bottom view of recovered and identified structure from aft end of vehicle

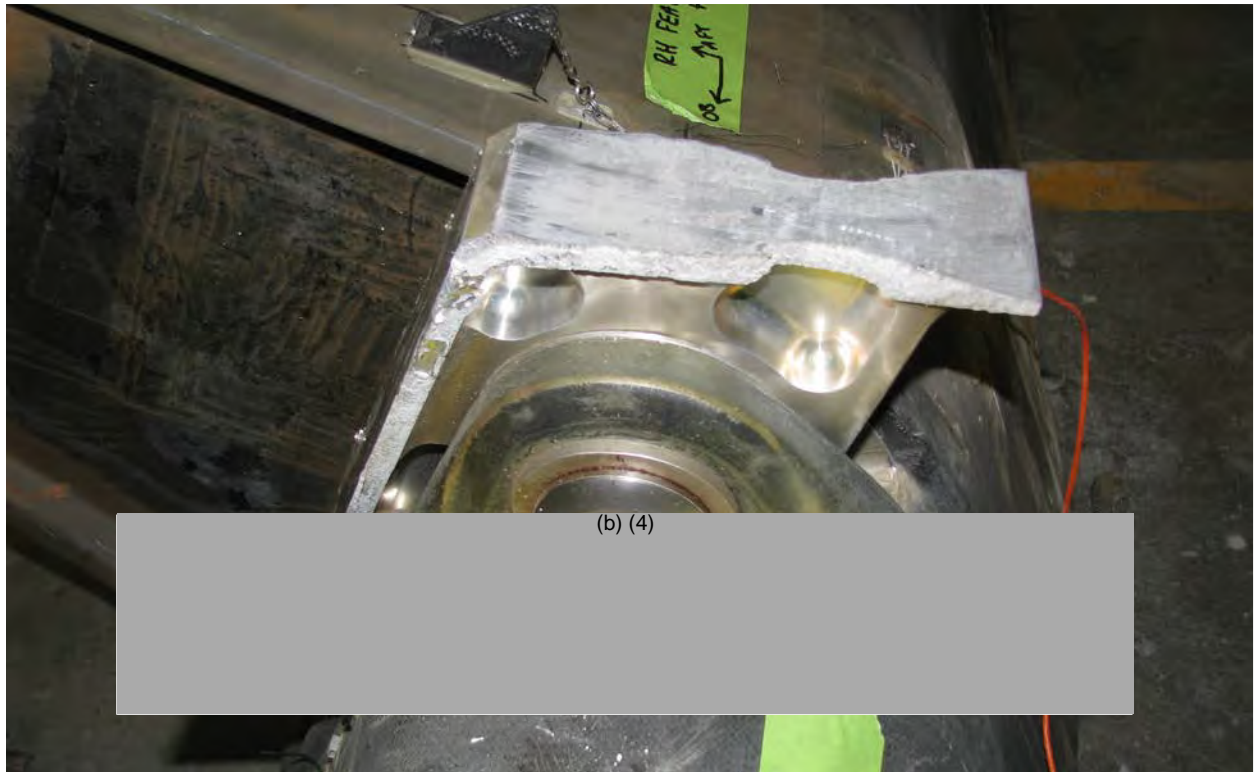
Figure 14 – Right inboard feather flap hinge

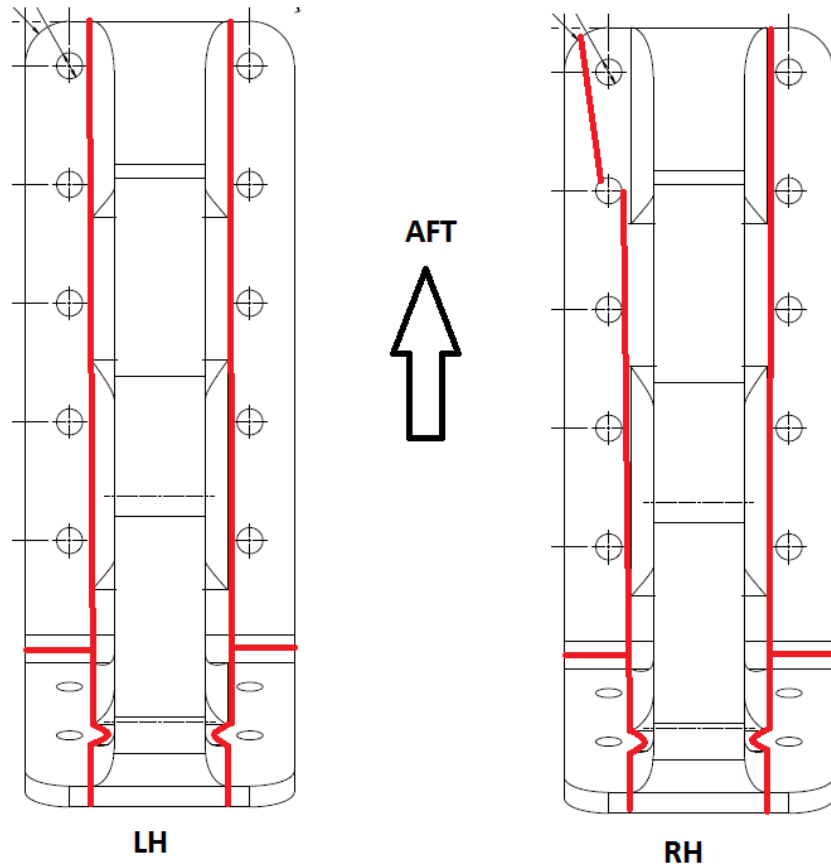
Figure 16 – Inboard Feather Flap Hinge fitting fractures (viewed looking up as installed)
