# NATIONAL TRANSPORTATION SAFETY BOARD

## Structures Group Factual Report of Group Chairman

**A. ACCIDENT:** DCA15MA029  
Location: Gaithersburg, MD  
Date: December 8, 2014, 10:41 am EST  
Aircraft: Embraer EMB-500, Phenom Model 100, N100EQ

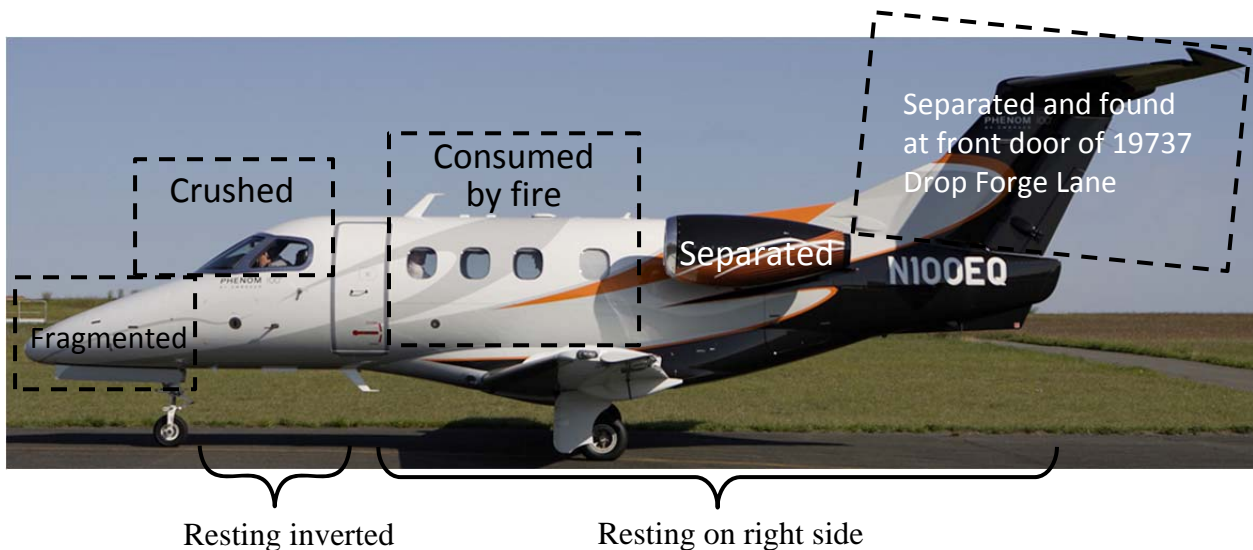
The airplane wreckage contained a mixture of impact and fire damage. (See Figure 3)

Figure 3. Generalized diagram of major damage areas to fuselage. The right side is approximately similar to this image of the left side. The top of the main cabin door was displaced aft. For reference, the original aircraft length was 42' 2" and the height was 14' 4". The remaining length of fuselage from tailcone to the front of the remaining nose was 33' 5".

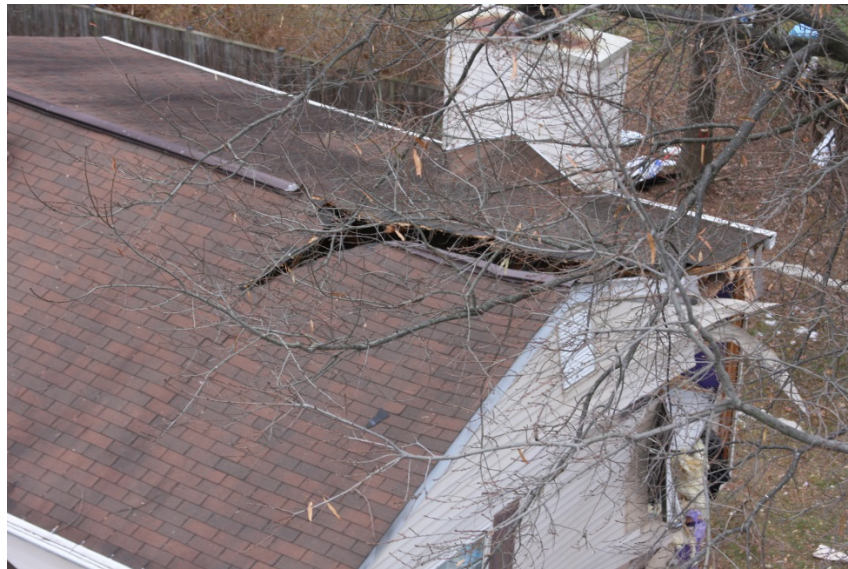
The initial impact was to the roof of a house at 19740 Drop Forge Lane. (See Figures 7 through 9) The contact point to the house on Google Earth was at 39.180155°, -77.180665°  
Inputting into Google Earth the following location from a hand-held GPS device viewing 17 satellites showed a location in the back yard of the 19740 house. The hand-held GPS coordinates were N39°, 10.815', W 77° 10.840'

Figure 7. Cut in roof of 19740 Drop Forge Lane.

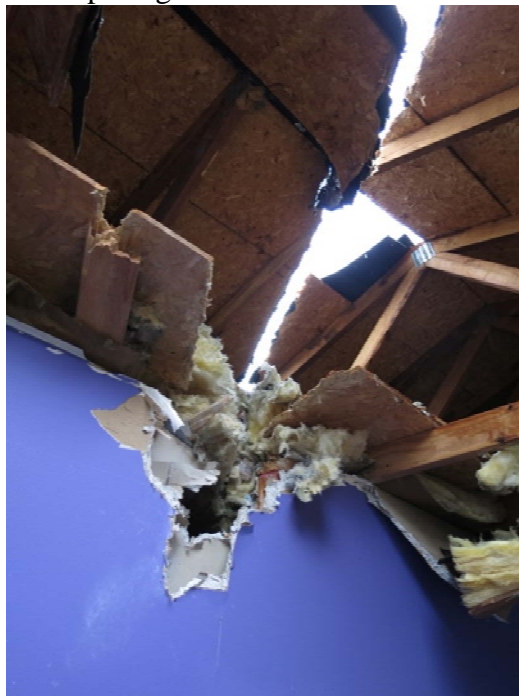
Figure 8. Initial contact of roof and interior bedroom wall inside 19740 Drop Forge Lane. This view is back toward the flight approaching the house, aligning the two contact points.

Utilizing an optical inclinometer, the cut from roof to interior bedroom wall had a pitch angle of  $-36^\circ$ . The angle from a cut in the interior wall to where the left wingtip contacted the ground was at a pitch angle of  $-26.5^\circ$ .

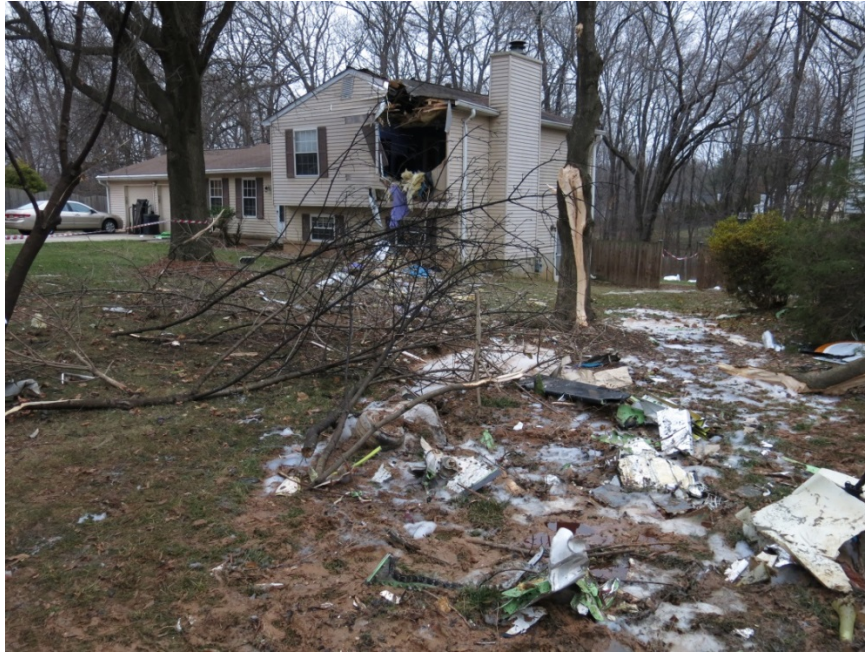
Figure 9. View back from nose of fuselage toward house at 19740 Drop Forge Lane, with debris trail leading to fuselage. The impact point is to the left of the heavily damaged tree in the debris trail.

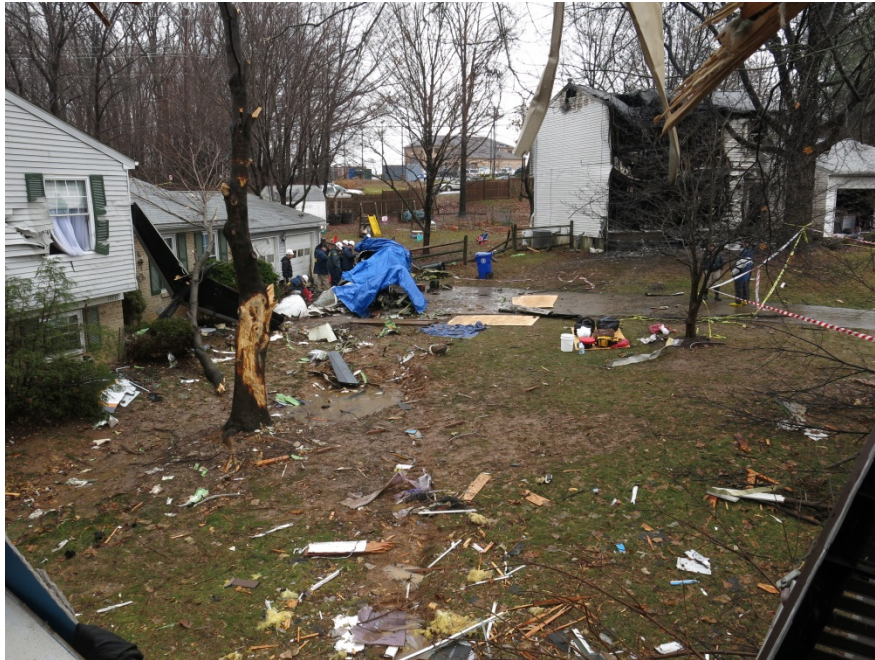
The magnetic bearing from cut interior wall to airplane was  $107^\circ$  magnetic. The fuselage heading was twisted and bent, generally on the reciprocal heading of  $287^\circ$  magnetic. (See Figure 10)

Figure 10. From the bedroom of 19740 Drop Forge Lane, view of debris trail, showing 19737 at left and 19733 at right. The impact hole with a diameter of about that of the fuselage is to the right of the base of the heavily damaged tree in the yard of 19737 and the fuselage is in

the driveway, covered by a blue tarp. The airplane tail is at the front door of 19737 and the left elevator is at the far side of the impact hole.

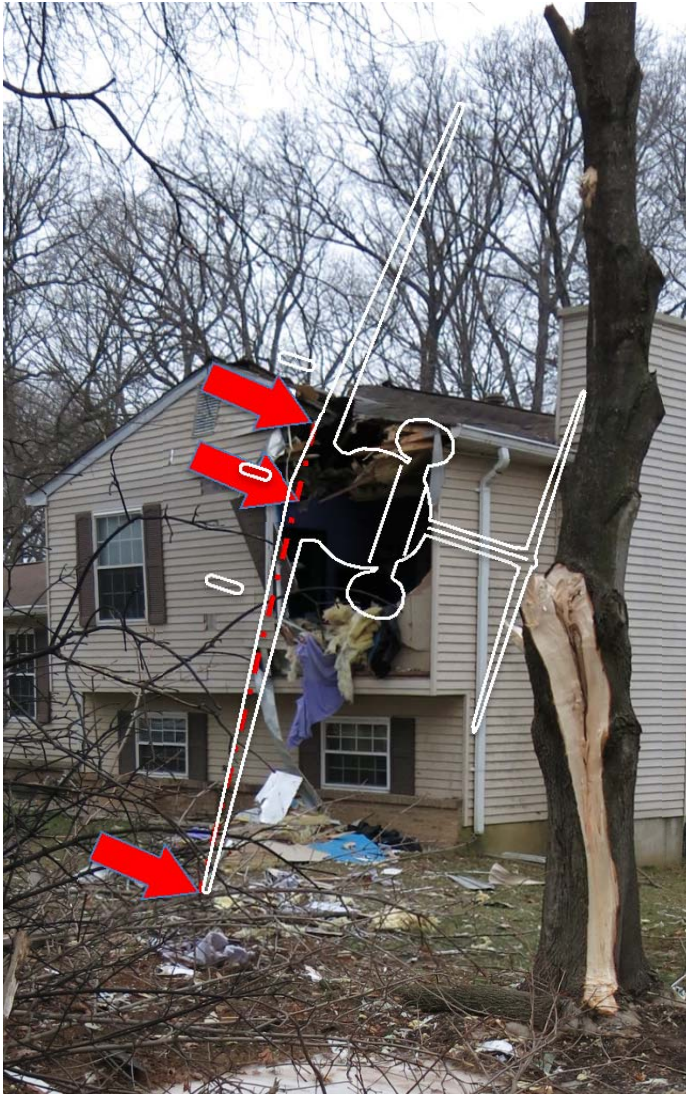
Alignment of three points in the path of left wing tip cut through the roof and wall of the 19740 provided a roll attitude of  $108^\circ$  left wing down. (The third point was the wing tip contact hole in the front yard.) (See Figure 11) Broken tree branches above the house were at the approximate height corresponding to the path of the right wing and a line connecting the broken branches and cut in the roof was  $113^\circ$  left wing down. (See Figure 12) The Embraer frontal illustration of the airplane shows  $5^\circ$  dihedral and adding this to the above data results in the fuselage at a roll attitude at impact of  $113^\circ$  based in the left wing damage to the roof and  $108^\circ$  for the right wing damage to the trees. (approximate average of  $-110.5^\circ$ )

Figure 11. Aligning three points in path of left wing tip are the initial hole in the roof, the hole in the bedroom interior wall, and the hole in the yard. The dashed red line is along the wing leading edge and the airplane is shown only for rotational orientation. (The scale with respect to size is only correct for one point along the path toward the viewer.) At the bottom of the photo is a hole filled with water and the diameter of the hole is about that of the fuselage.

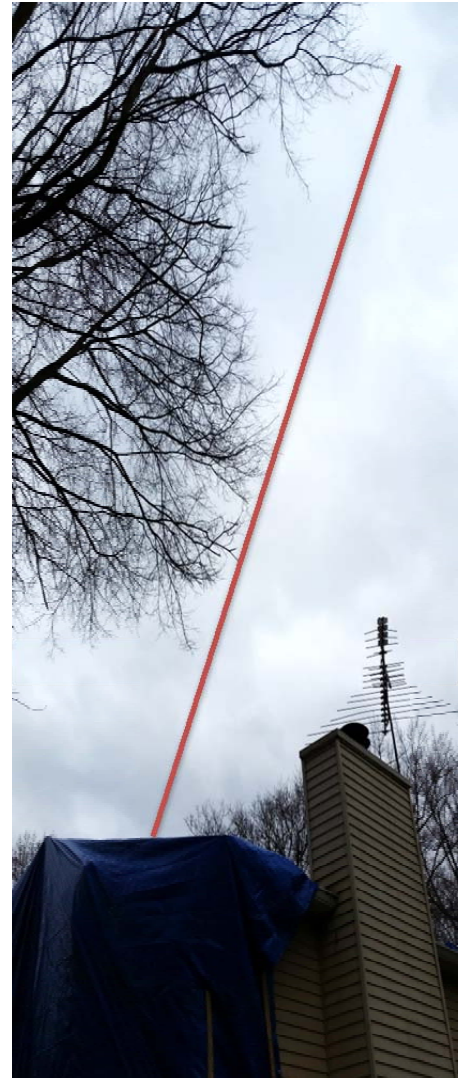
Figure 12. View is from the impact hole toward the broken branches above the house. A line connects the broken branches and cut in the roof.

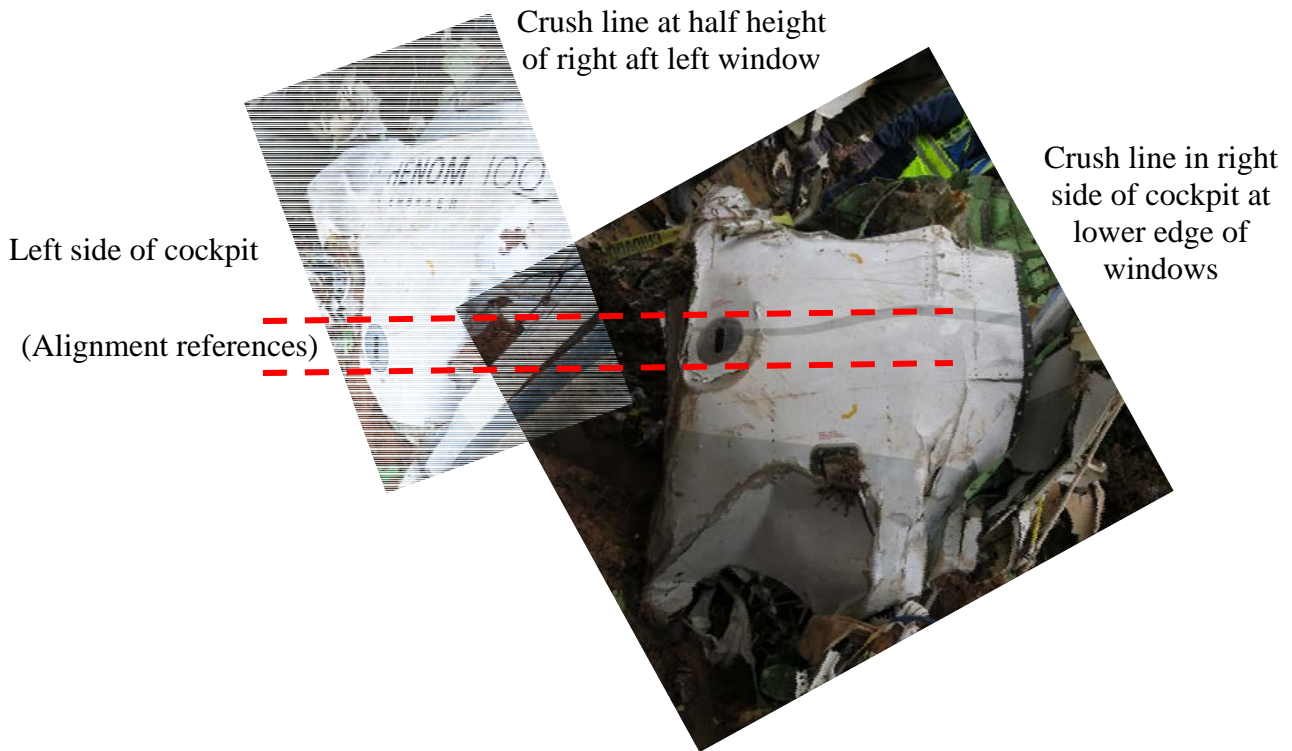
Fragments of the windshield frame and glareshield were found at the tree and embedded in it, immediately uptrack of the hole in the 19737 front yard. Crush lines correspond to windshield strike marks on the tree and the difference in heights of damage were at about 121 degree left down in roll attitude. (See Figures 13A and 13B) This is a reference and imprecise value which incorporates an unknown amount of error, due to the irregular curvature at the base of the tree which is visible in Figure 11.

Figures 13A and 13B. Sides of cockpit, rotated to a common top-up orientation.

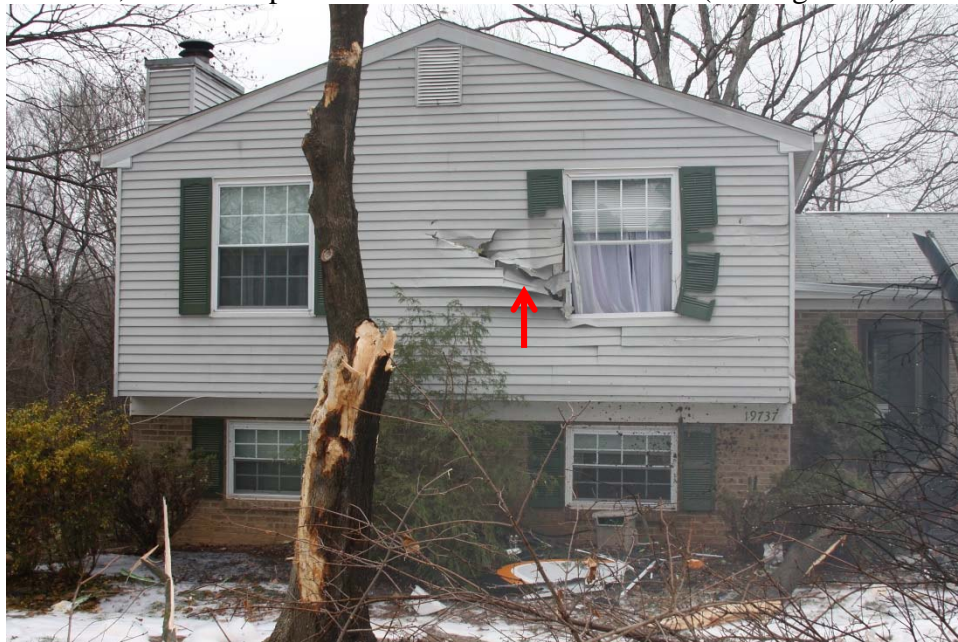
A cut and broad impact mark was found in the front wall and bedroom window of the 19737 house. (See Figures 14 and 15) A carbon composite fragment approximately one foot long from the outboard end of the left elevator was found caught inside the wall to the uptrack side of the damaged window in the front of the house. The torn edge of the fragment matched the left elevator. (See Figure 16) The top outboard portion of the left elevator had smears of color which matched the color of the house aluminum siding.

In shrubbery beneath the struck bedroom window of the 19737 house were the lower rudder, rudder trim actuator, and lower portions of the vertical stabilizer. (See Figure 15)

Figure 15. Exterior cut and damage to front of 10737 Drop Forge Lane at bedroom window. The airplane tail is at the right edge of the photo, partially blocking the front door. The arrow points to the carbon elevator fragment shown in the next photograph, from the trailing edge.

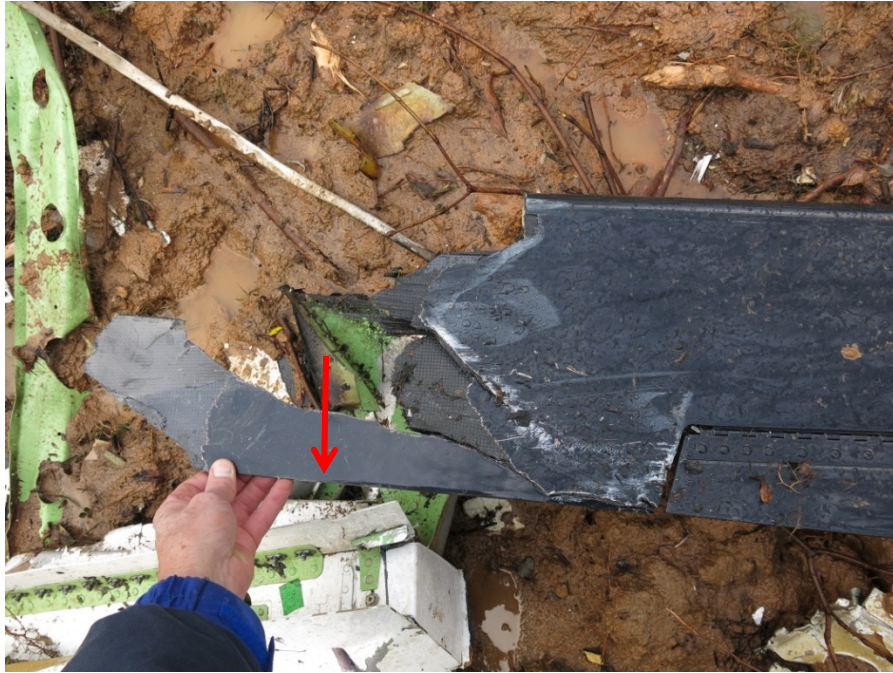
Figure 16. Carbon fiber trailing edge of elevator, found in wall of 19737 house.

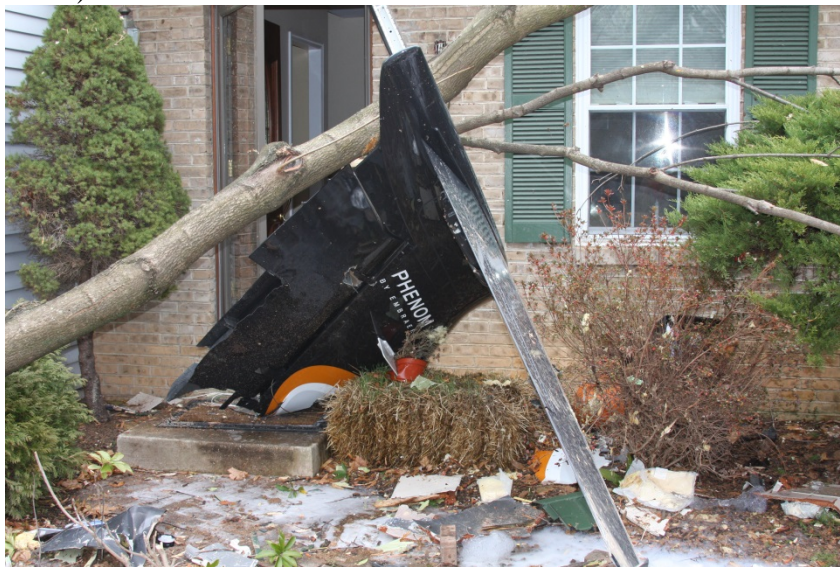
Caught in and beneath the shrubbery to the driveway side of the 19737 front door were the standby attitude indicator, glareshield fragments, cockpit documentation, and other cockpit items. (See Figure 17)

Figure 17. Tail resting at 19737 front door and cockpit materials in shrubbery.

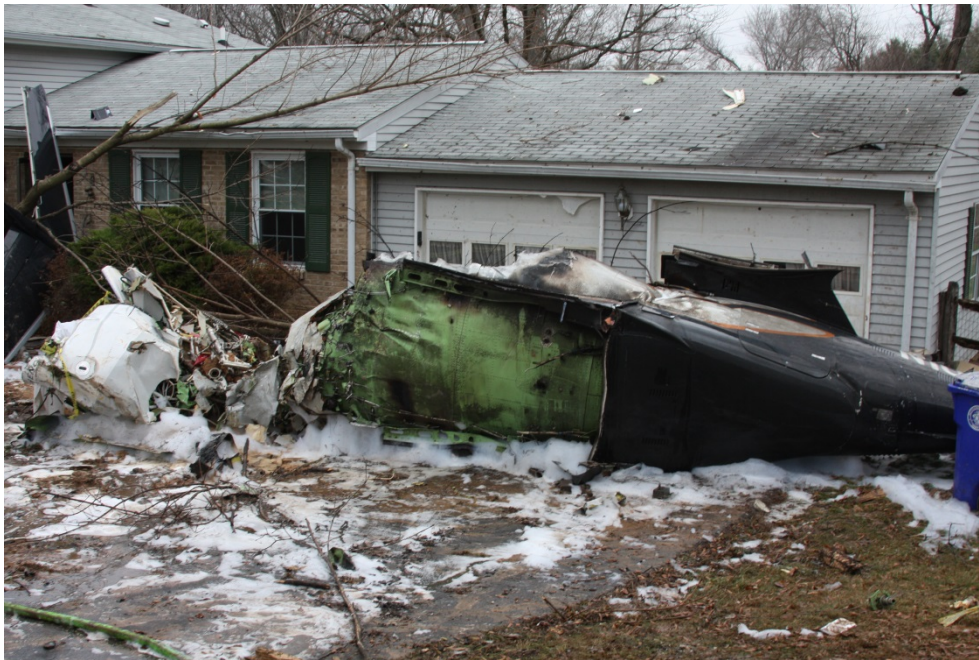
The fuselage came to rest on the driveway of the 19737 house and from approximately the cabin door aft was laying on the right side. The cockpit portion came to rest inverted, with extreme damage to the upper half.

Figure 18. Fuselage in driveway of 19737 Drop Forge Lane. The belly of the fuselage folds upward forward of the green area, which had been above the wing.

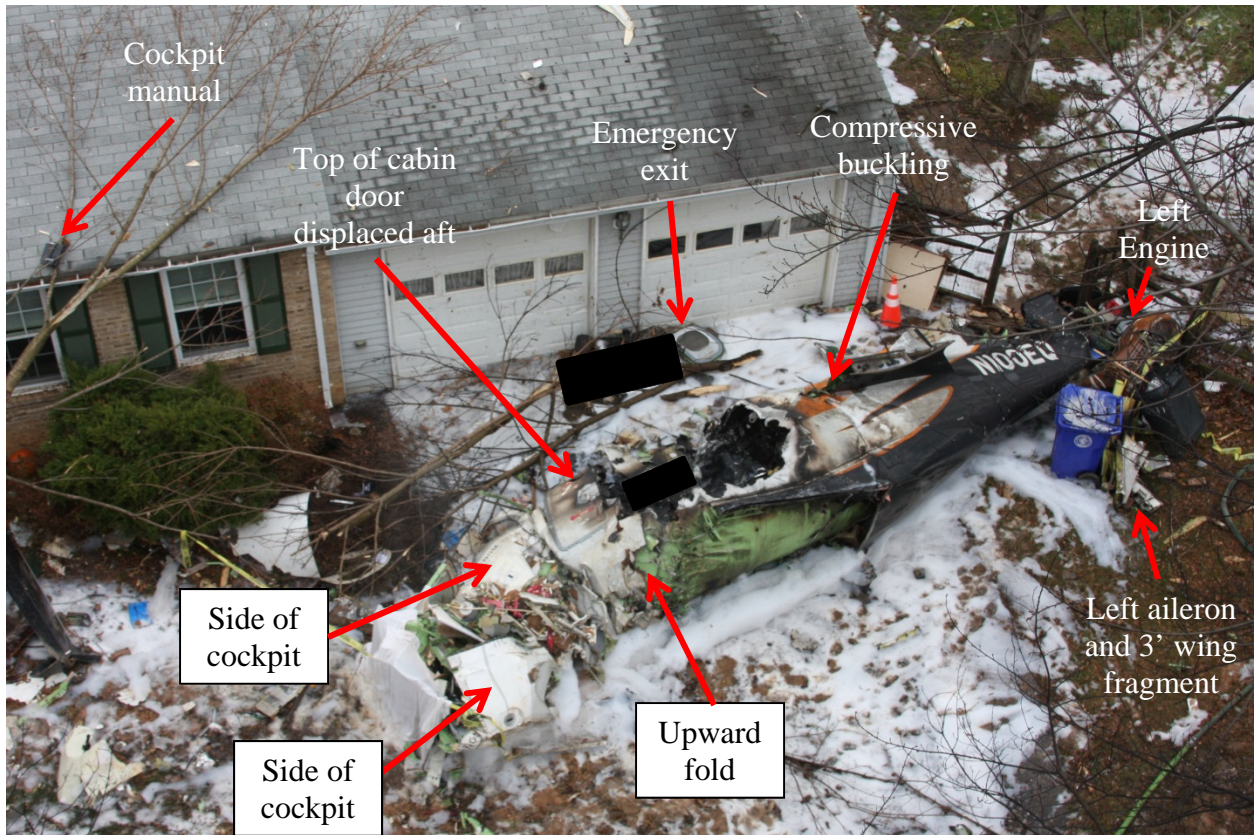
Figure 19. Fuselage as seen from above before fire fighting foam had cleared. As a dimensional reference, the width of the driveway at the garage was 19' 7".

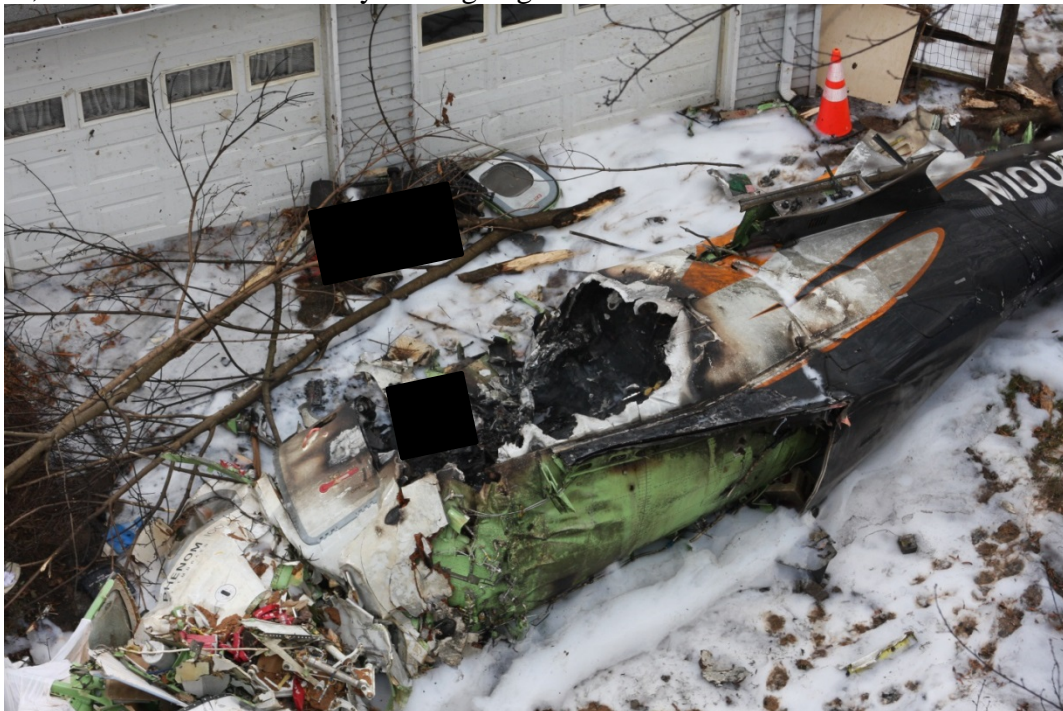
Figure 20. Close up of fuselage from above.

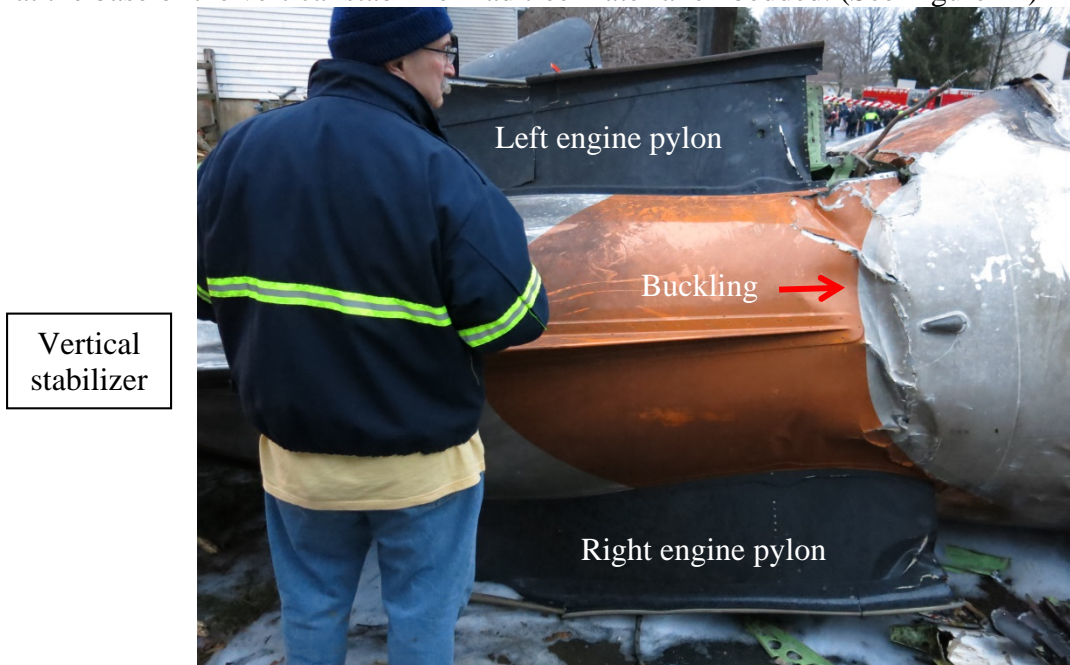
The crown of the fuselage had fore/aft compressive damage in a torsional orientation of the tail, with a displacement toward forward left. (See Figure 21) The interior right carbon fiber material at the base of the vertical stabilizer had tree material embedded. (See Figure 24)

Figure 21. Compressive buckling in crown skin. This view looks down on the top of the crown.

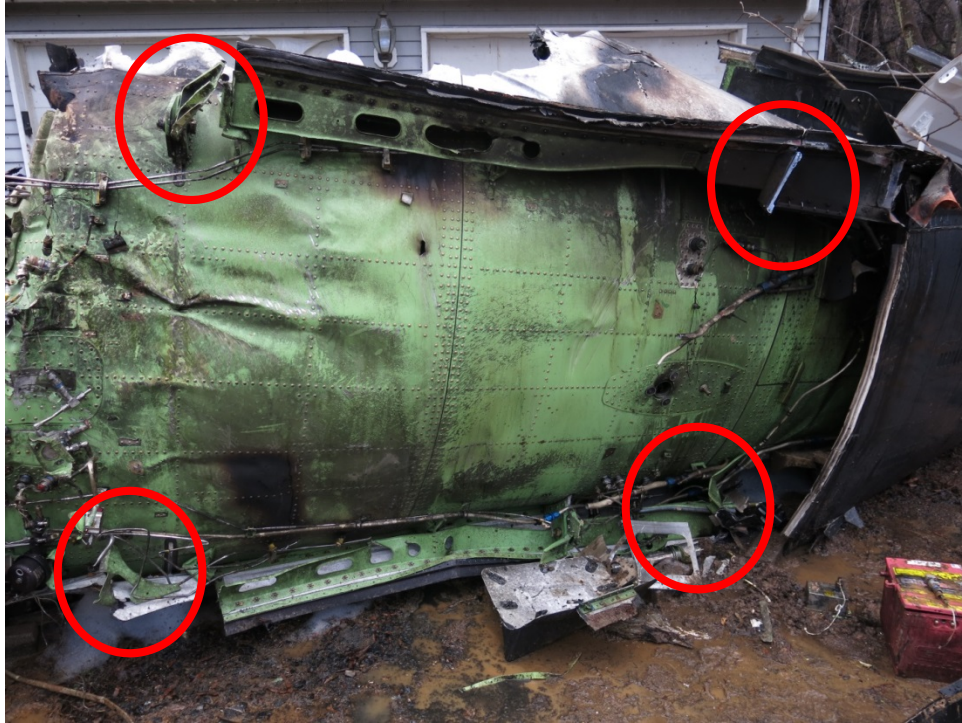
The bottom of the fuselage was bent upward at the approximate location of the wingbox leading edge. The wing attach fittings were bent and broken with both left fittings displaced aft and the right fittings displaced forward. (See Figure 22) The corresponding wing center section found at the 19733 house fire had been consumed. The downward displacement of the wing from the fuselage had been far enough that the systems components on the bottom of the fuselage remained in approximately the original locations. The components did have some impact-related damage.

Figure 22. Center section of fuselage with wing attach fittings circled.

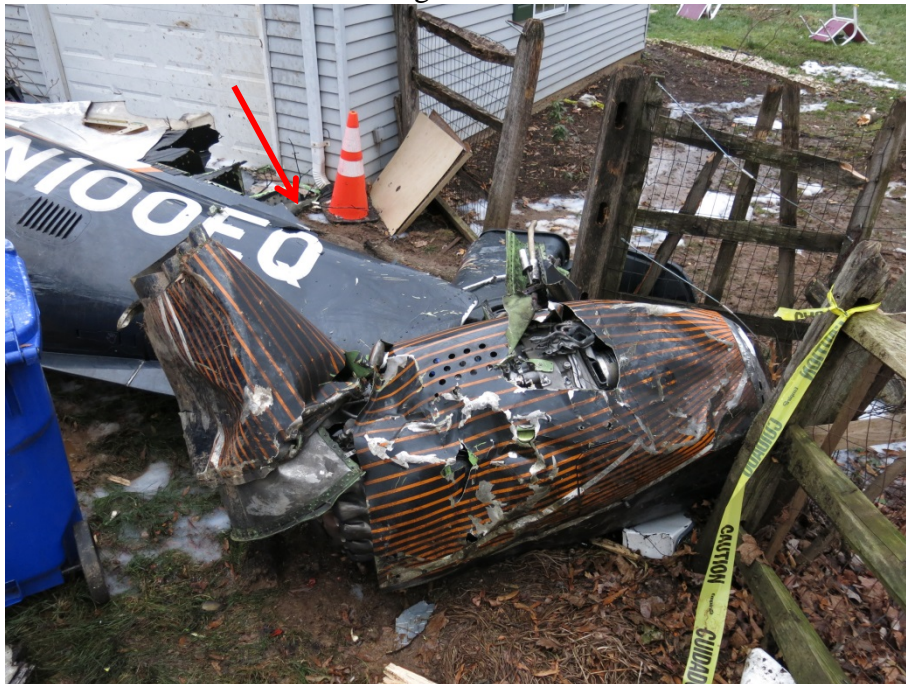
Figure 23. Tail cone and inverted left engine. The arrow orients where wood was embedded into carbon fibers at base of vertical stabilizer, as shown in Figure 24.

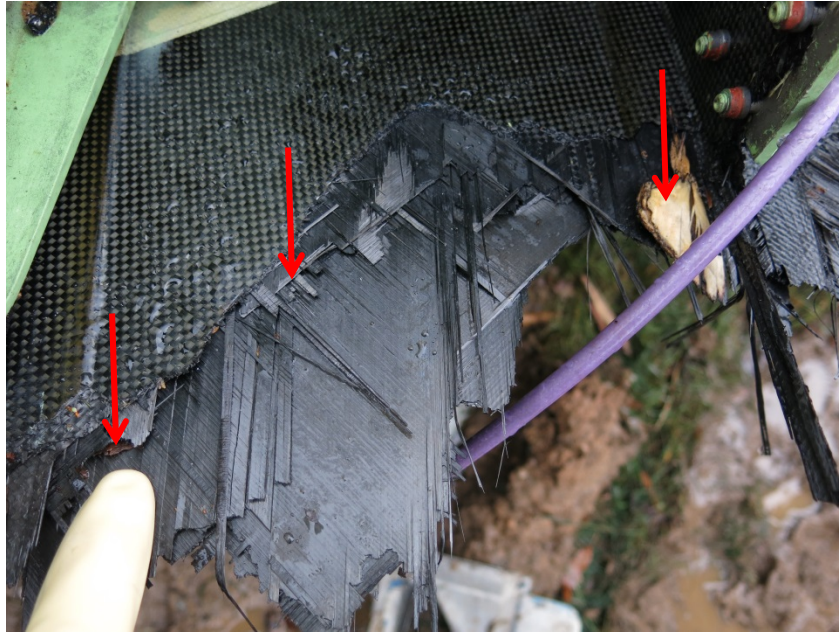
Figure 24. Embedded into the carbon fibers at the base of the vertical stabilizer were fragments of wood.

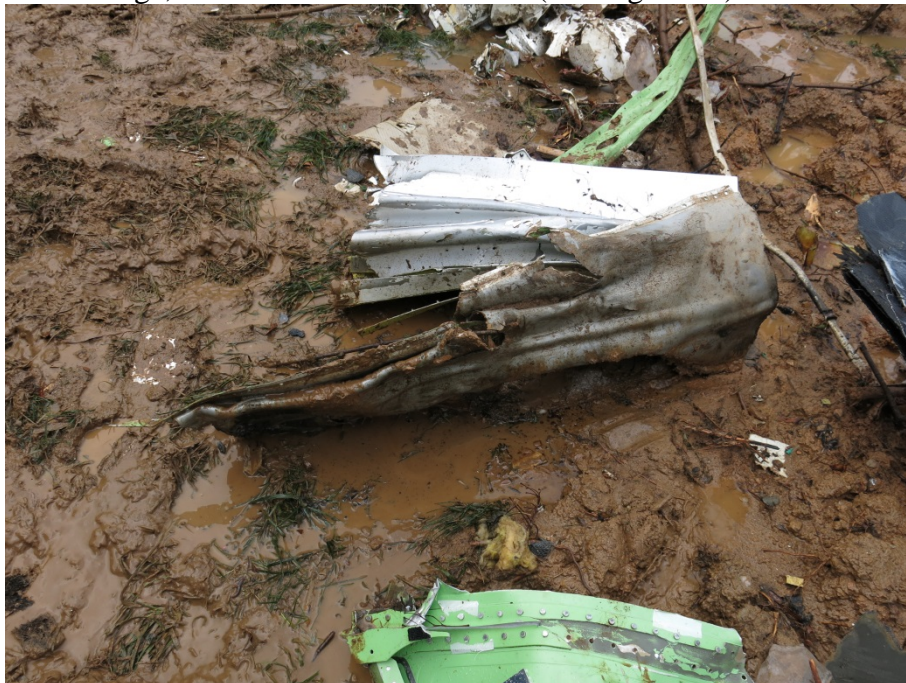
Three feet of left aileron with trim actuator and wing structure material was located near the bottom of the aft fuselage, near a household trash can. (See Figure 25)

Figure 25. Three feet of left wing structure and aileron.

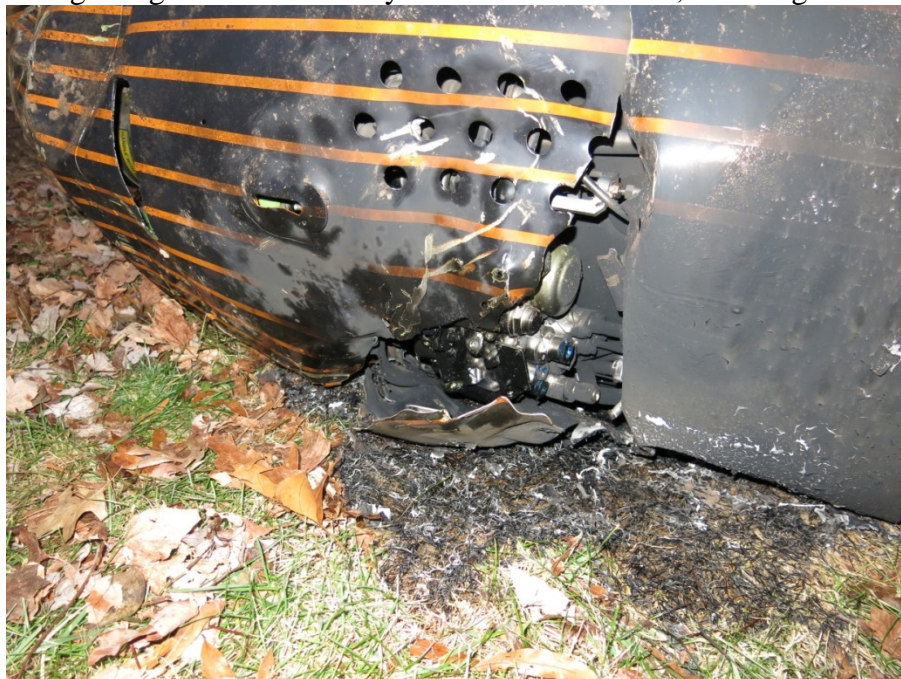
The right engine was found in the back yard of the 19733 house and a fuel burn was in the wet grass at the engine. (See Figures 26 and 27)

Figure 27. Fuel burn in grass at right engine.

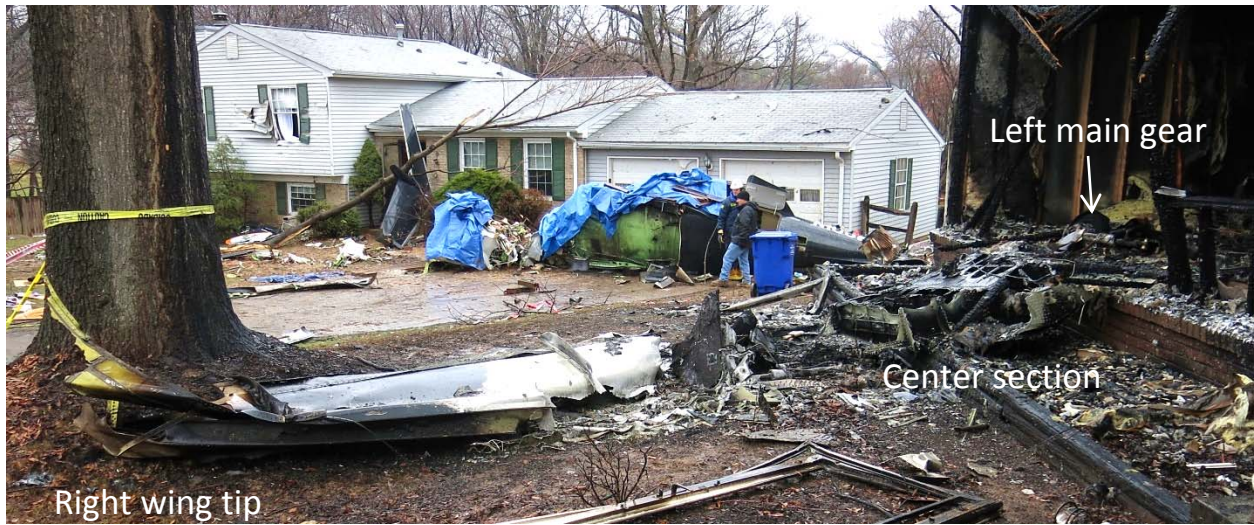
Most of the wing was found at and within the front of the 19733 house, with both main landing gear extended. (See Figures 29-33) The left wing tip in Google Earth was at 39.179984°, -77.180292°. The right wing tip in front yard of the 19733 house in Google Earth was at 39.179955°, -77.180359°

Figure 30. The remnants of the wing are shown in this photograph, which faces the leading edge. The house in the background is 19737 Drop Forge Lane and the fuselage is in front of the garage doors.

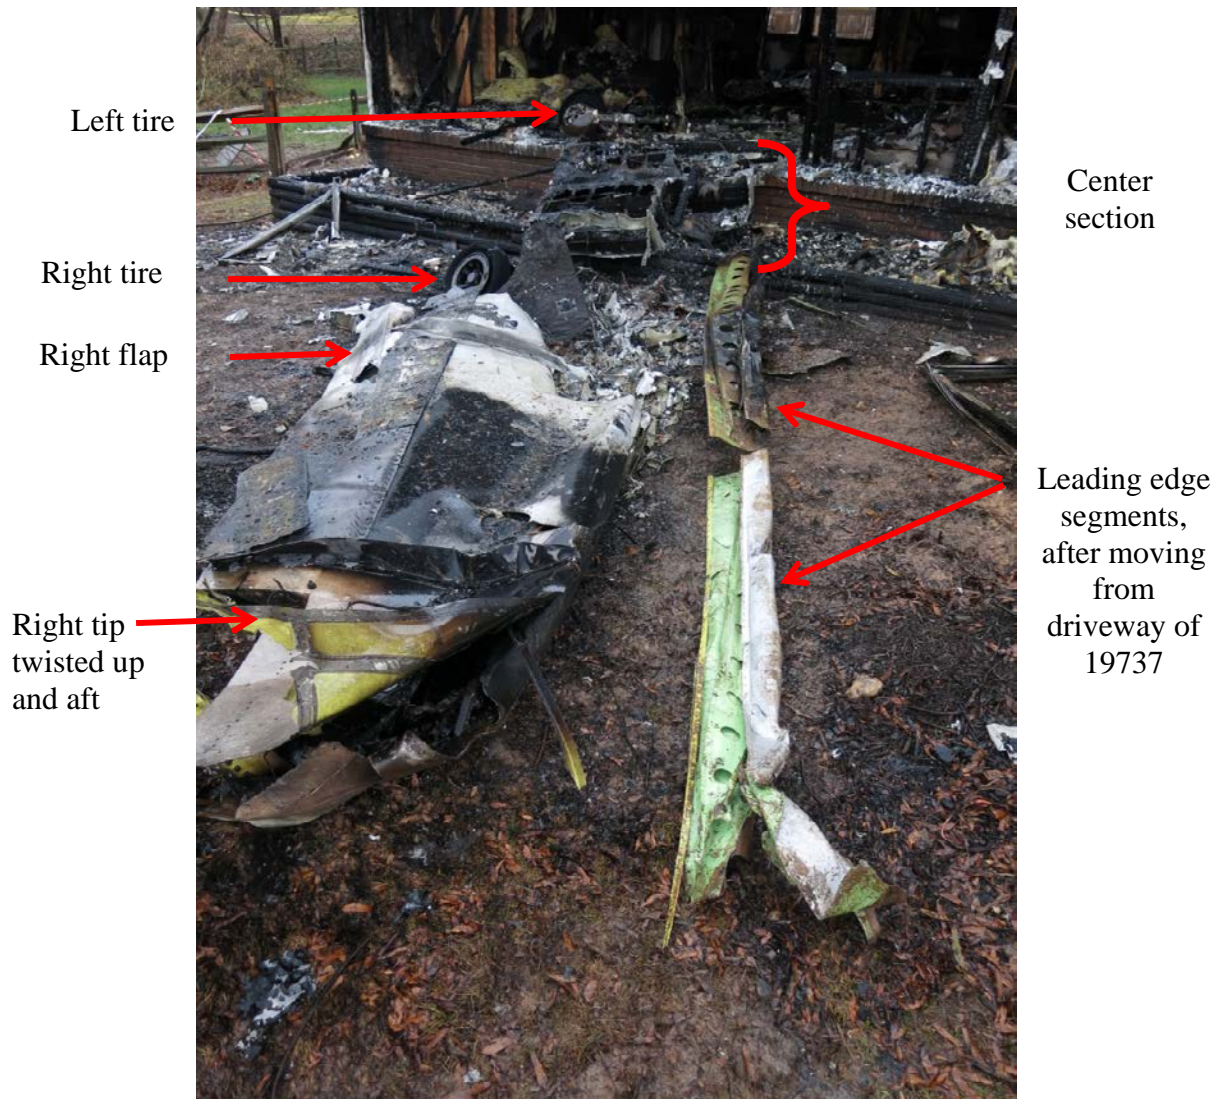
Figure 31. Wing at 19733 Drop Forge Lane, with captions added to show major features.

The remaining tip of the right end of the wing was next to a large tree in the front yard of the house. The right end of the wing included the inboard 2'5" of the aileron cut-out, with no aileron. The leading edge of the right wing structure was bent upward and was matched to the two sections of leading edge which had been brought from the driveway of the 19737 house. From the aircraft centerline, the end of the right wing measured 18 feet in span, and the two sections of leading edge matched this remaining length. The complete right flap was attached to the wing structure.

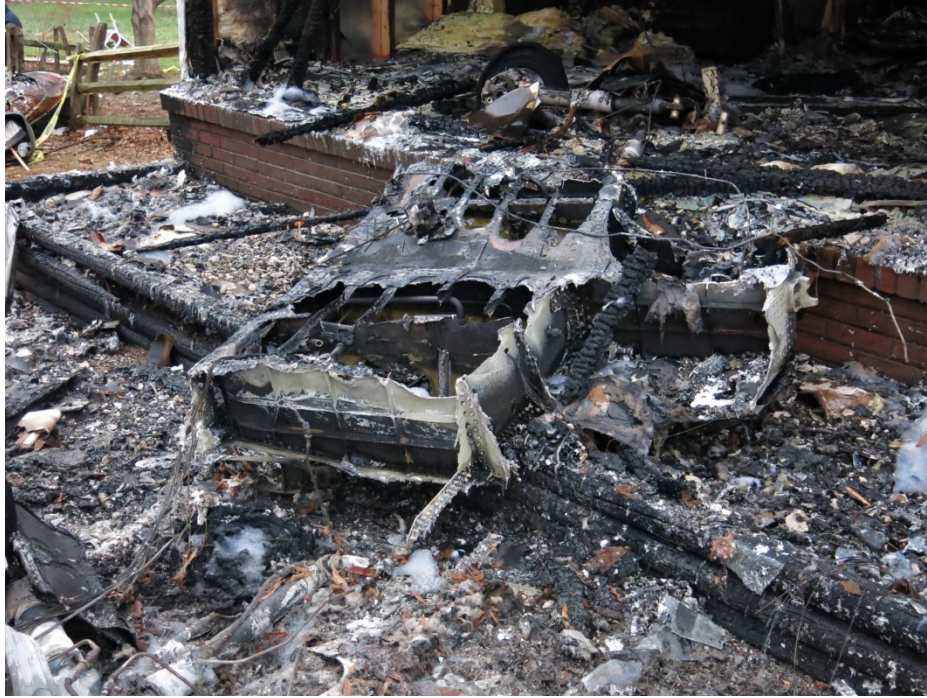
Figure 32. Wing center section, with left main landing gear inside of 19733 Drop Forge Lane.

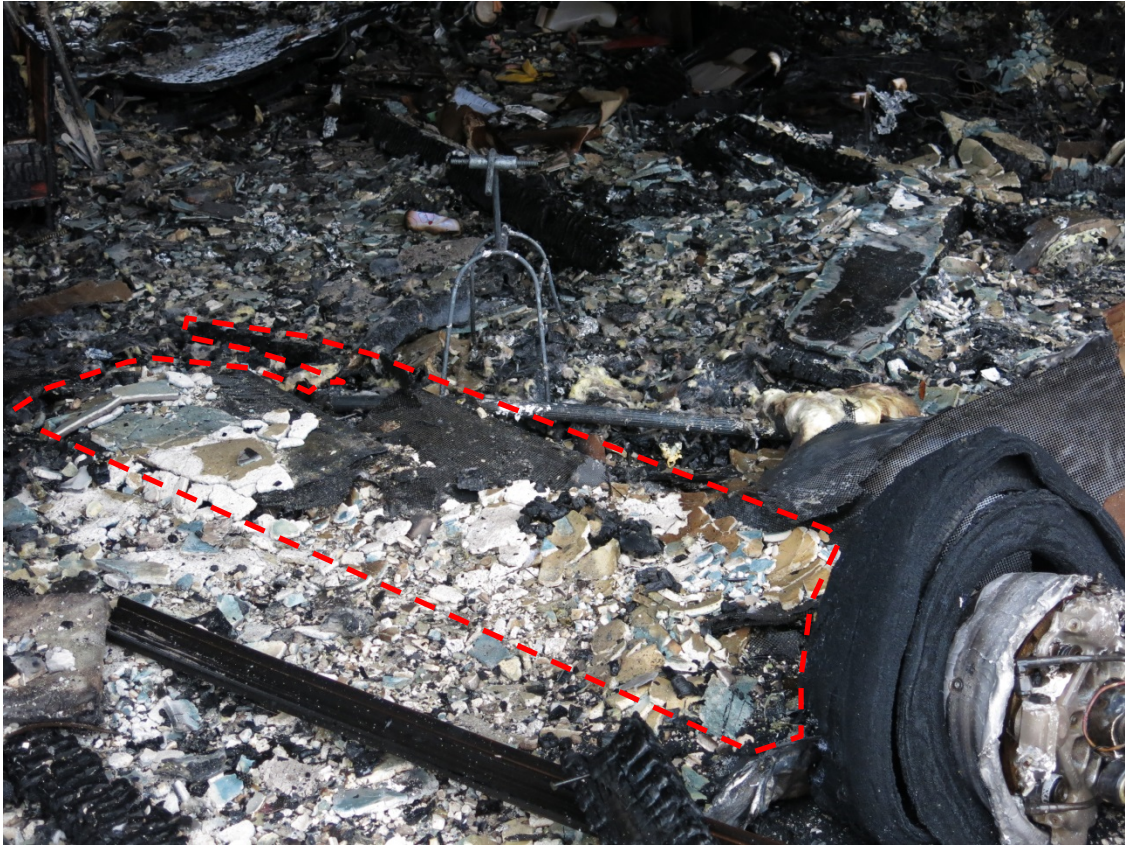
Extending straight beyond the landing gear were remnants of composite material from above the left flap track and nine feet of control cable. (See Figure 33) Because of the instability hazard associated with the 19733 house, the three leading edge segments (3', 5', 5'9") from the yards of the 19740 and 19737 houses were not laid in front of the remnants of structure. A fragment of the left flap from the front yard of 19737 and the inboard flap track which had been near the bottom of the fuselage also were not brought to the 19740 house.

Figure 33. Dashed outline of the carbon fiber panel edges within the 19733 house, which are outboard of the visible left main landing gear tire. These left wing panels were similar to the accessible right wing panels which were above and ahead of the right wing flap.
