National Transportation Safety Board

STRUCTURES EXAM FACTUAL REPORT FIELD NOTES

CEN15FA034

Location: Wichita, KS Mid-Continent Airport
Date: October 30, 2014
Time: 0948 CDT
Vehicle: Raytheon Super King Air 200, BB1686, N52SZ,
Engine: Pratt Whitney PT-6A-42, 850 SHP
Propeller: Hartzell Propeller, Inc.

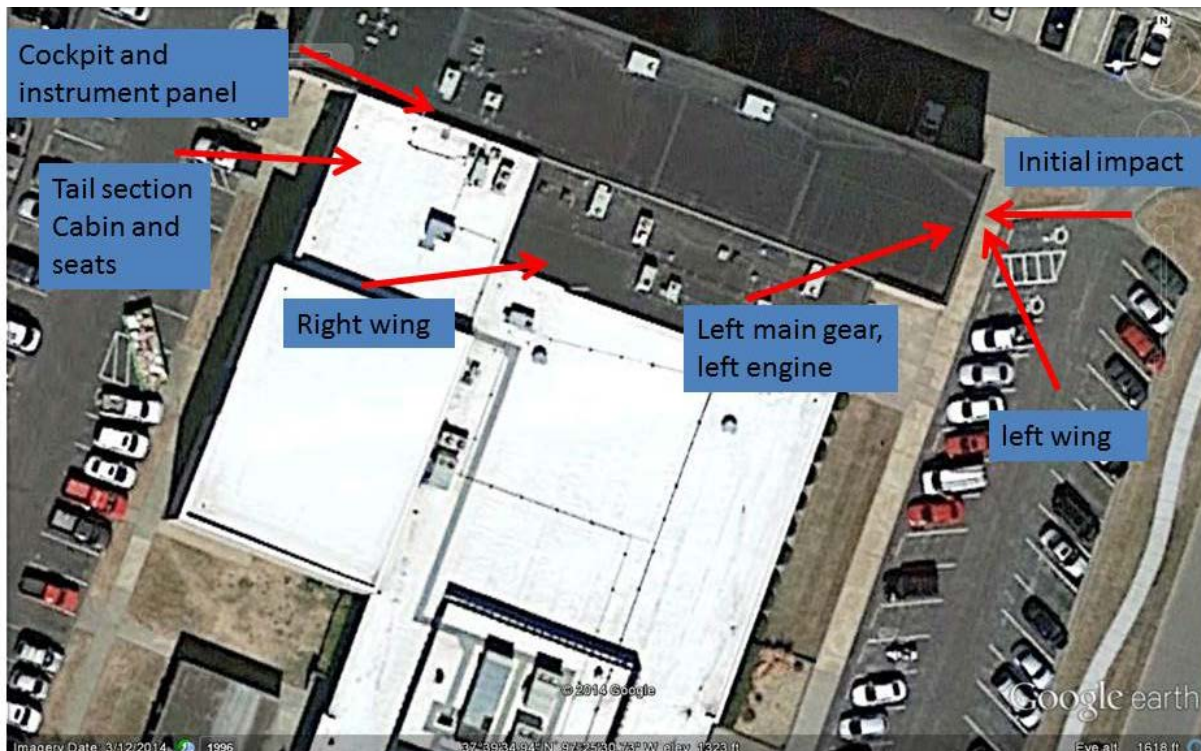
Photo 1 – Overview of wreckage scatter

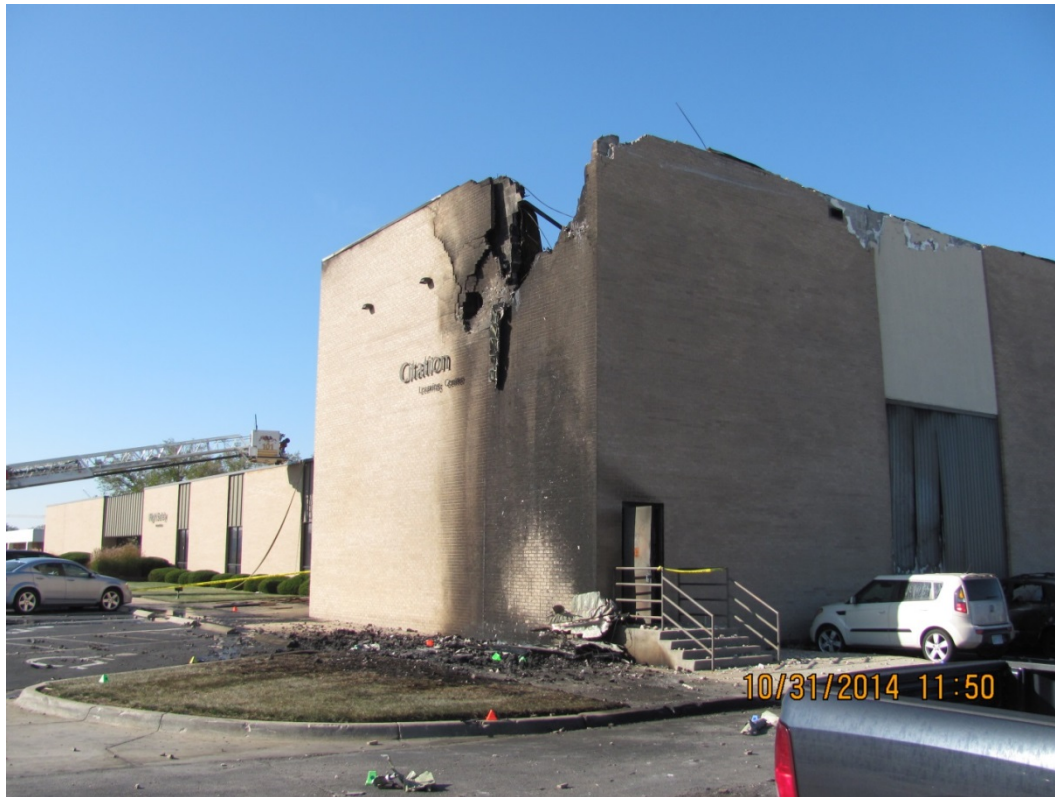
The airplane struck the northeast corner of the building, impacting the east wall and roof of the north simulator bay. The simulator room is two stories high and is about 198 feet (east-west) by 42 feet (north-south).

Photo 2 – Northeast corner of simulator bay

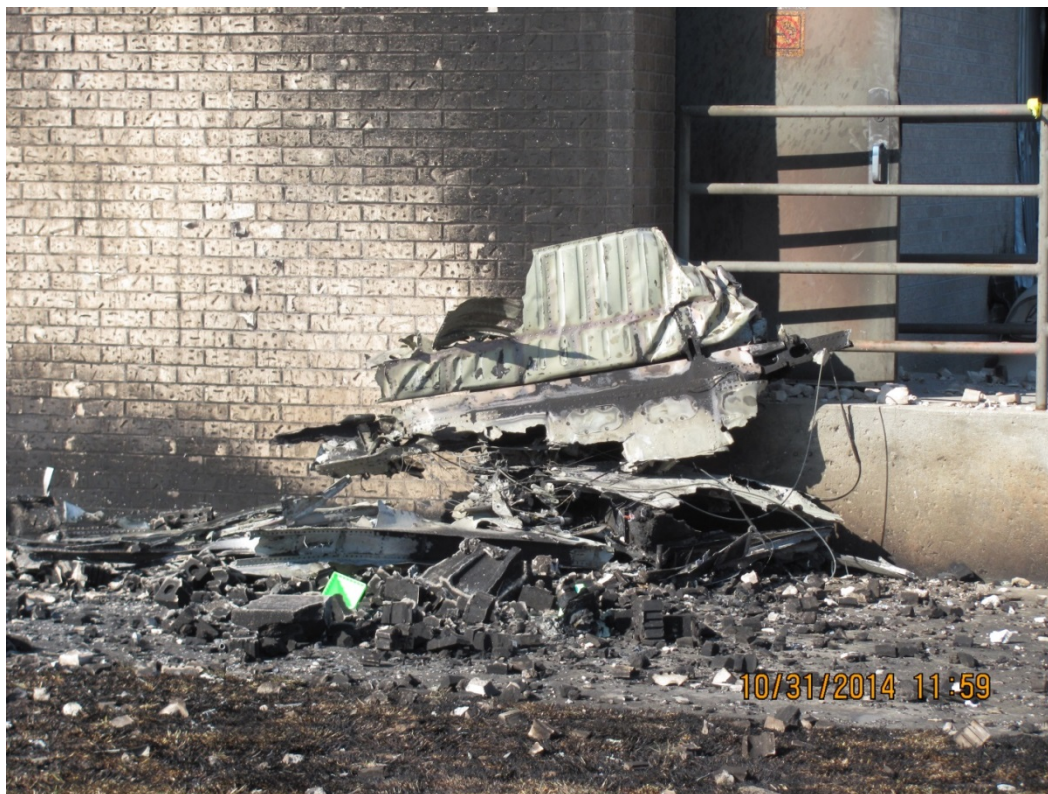
Most of the airplane sustained severe fire damage. A majority of the left outboard wing, flap and aileron were found at the foot of the exterior east wall. The left engine, propeller and left main landing gear were found on the floor just inside the building. The fuselage, tail section, cockpit, right engine, right main landing gear travelled across the top of the building. The cockpit, instrument panels, right engine and right gear strut traveled about 160 feet to the south wall. The right engine and propeller came to rest next to the cockpit area. The cabin area of the fuselage, portions of the wing center section and all of the tail section crossed the south wall and fell on the roof of the attached building. The right wing had separated and crossed the south wall, and came to rest on the roof of an attached building about 120 feet from the initial impact point. A portion of a propeller blade from the left propeller was near the right wing. A separated propeller blade tip was found about 150 feet northeast from the initial impact point.

Photo 3 – Portion of left wing and flap at northeast corner

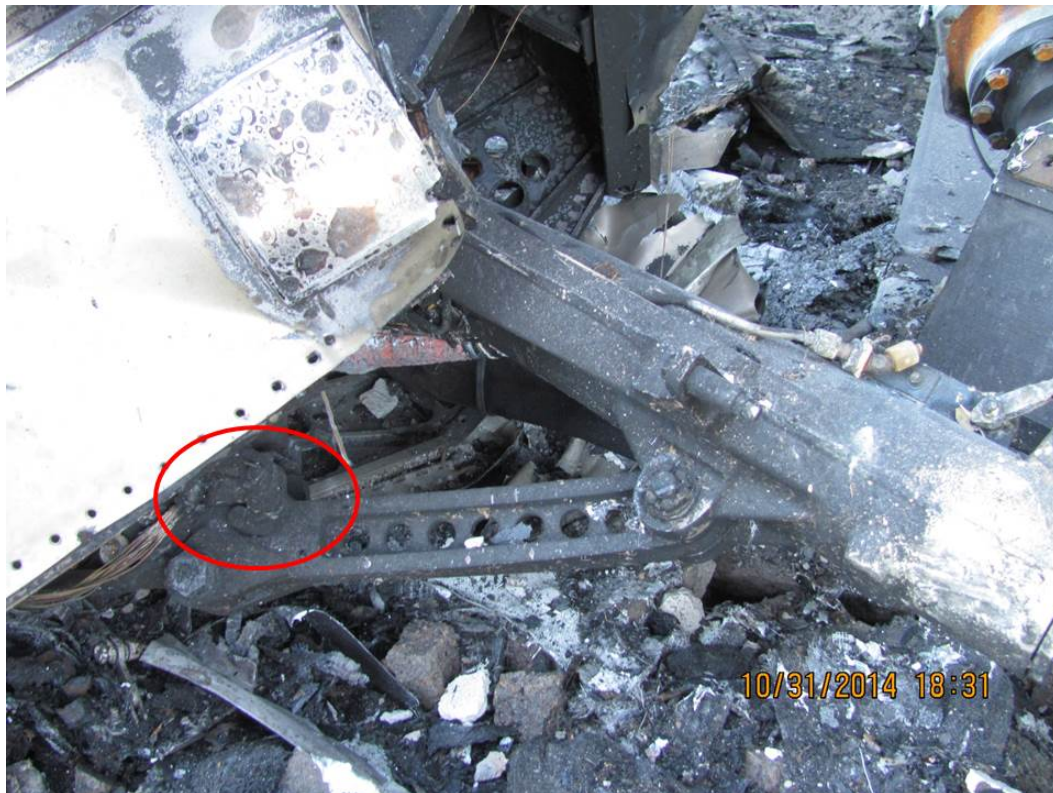
The left main landing gear structure was found in the extended position with the down lock latched in place. The structure of the right main landing gear was not intact. Only the strut, wheel and tire of the nose gear assembly were found on the ground outside the building. Witness and video evidence show that the three gears were extended at impact.

Photo 4 – Left main landing gear and lock in place

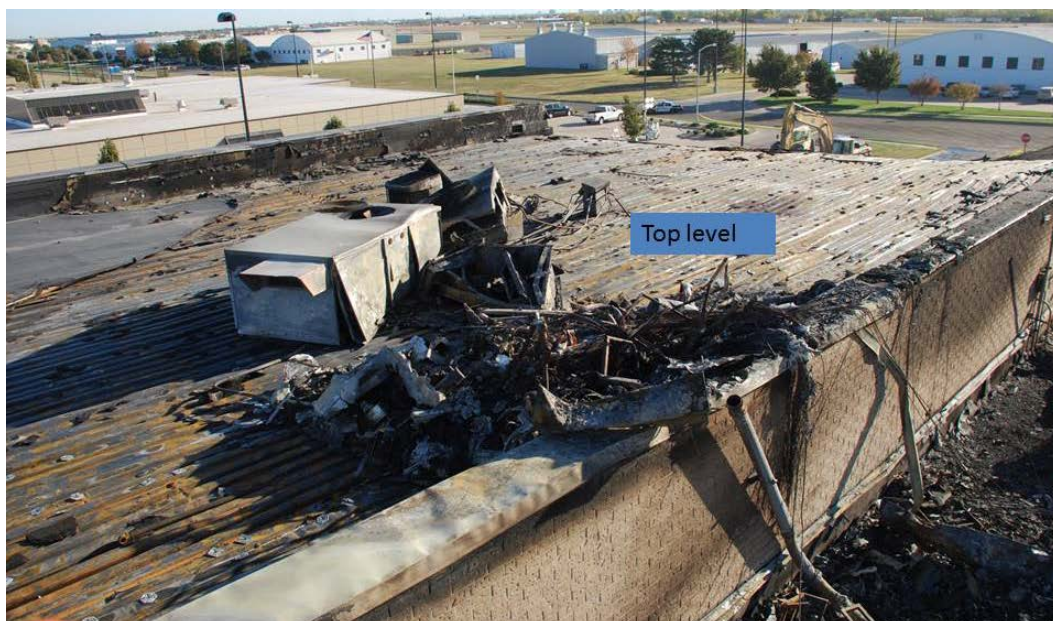
The cockpit area came to rest on the upper, north roof.

Photo 5 – Area of fuselage and instrument panel on top roof level. The initial impact area is at the top of the photo.

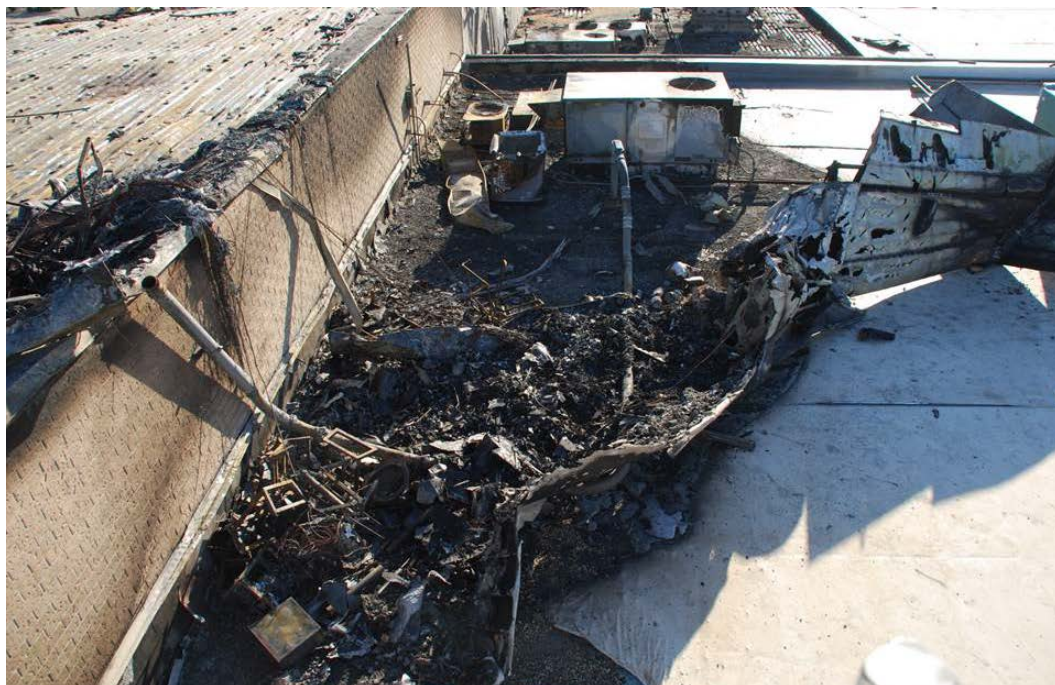
The cabin area of the fuselage and empennage came to rest inverted on the lower, west roof. The cabin area was substantially consumed by post impact fire. The empennage was thermally damaged by post impact fire. The horizontal stabilizers remained attached to the vertical stabilizer with the elevators attached. The elevator trim tabs remained attached to their respective elevator. One elevator trim tab exhibited slight trailing edge up when visually compared to its corresponding elevator trailing edge. The vertical stabilizer remained attached to the aft fuselage with the rudder attached. The rudder trim tab remained attached to the rudder.

Photo 6 – Cabin top is inverted, vertical tail and rudder to the right on 2nd roof level

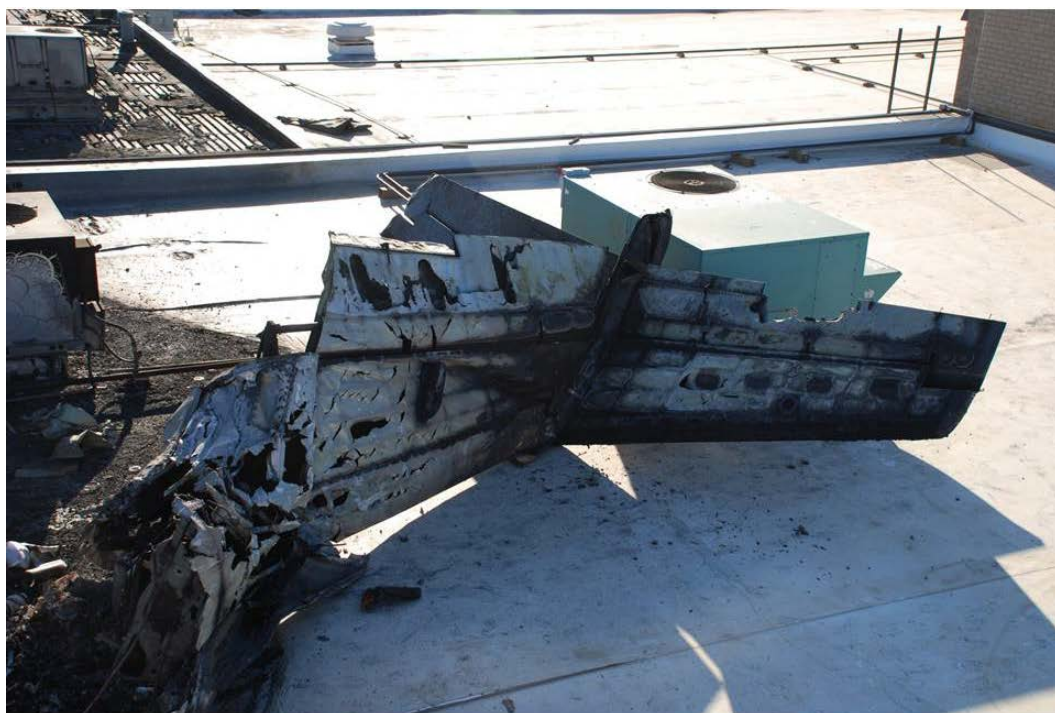
Photo 7 – Vertical and Horizontal surfaces on 2nd roof level

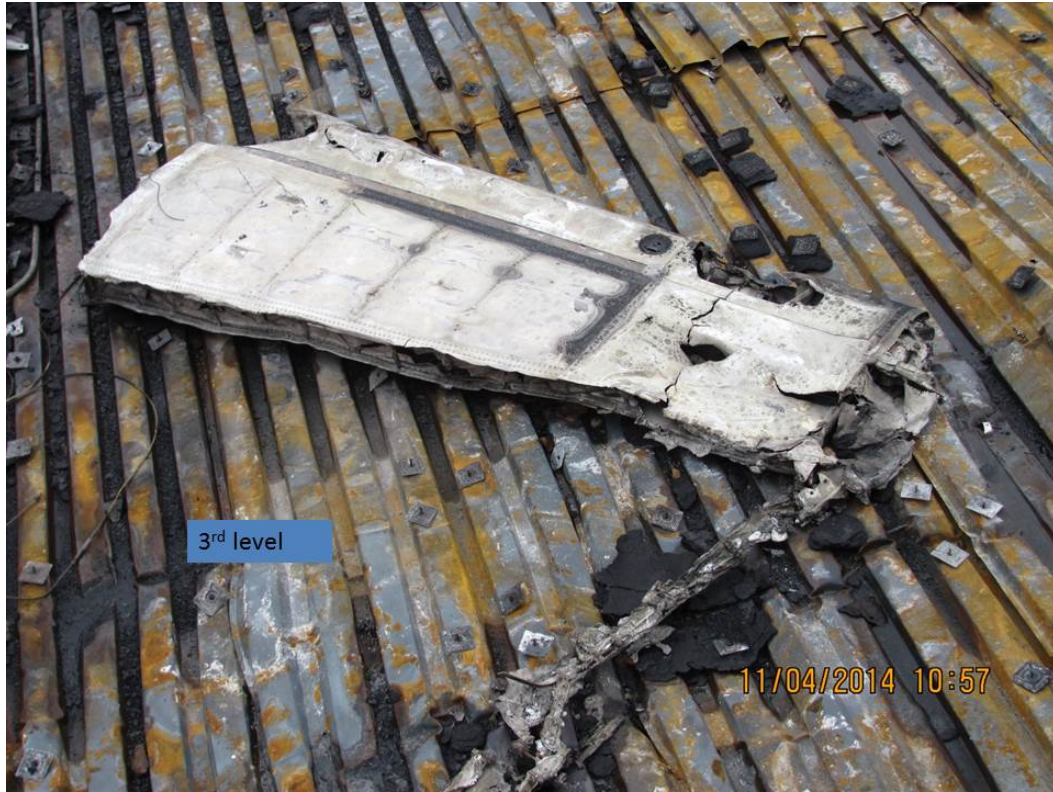
Photo 8 – Right wing on 3rd roof level
