NATIONAL TRANSPORTATION SAFETY BOARD

STRUCTURES

Group Chairman's Factual Report

ERA18FA120

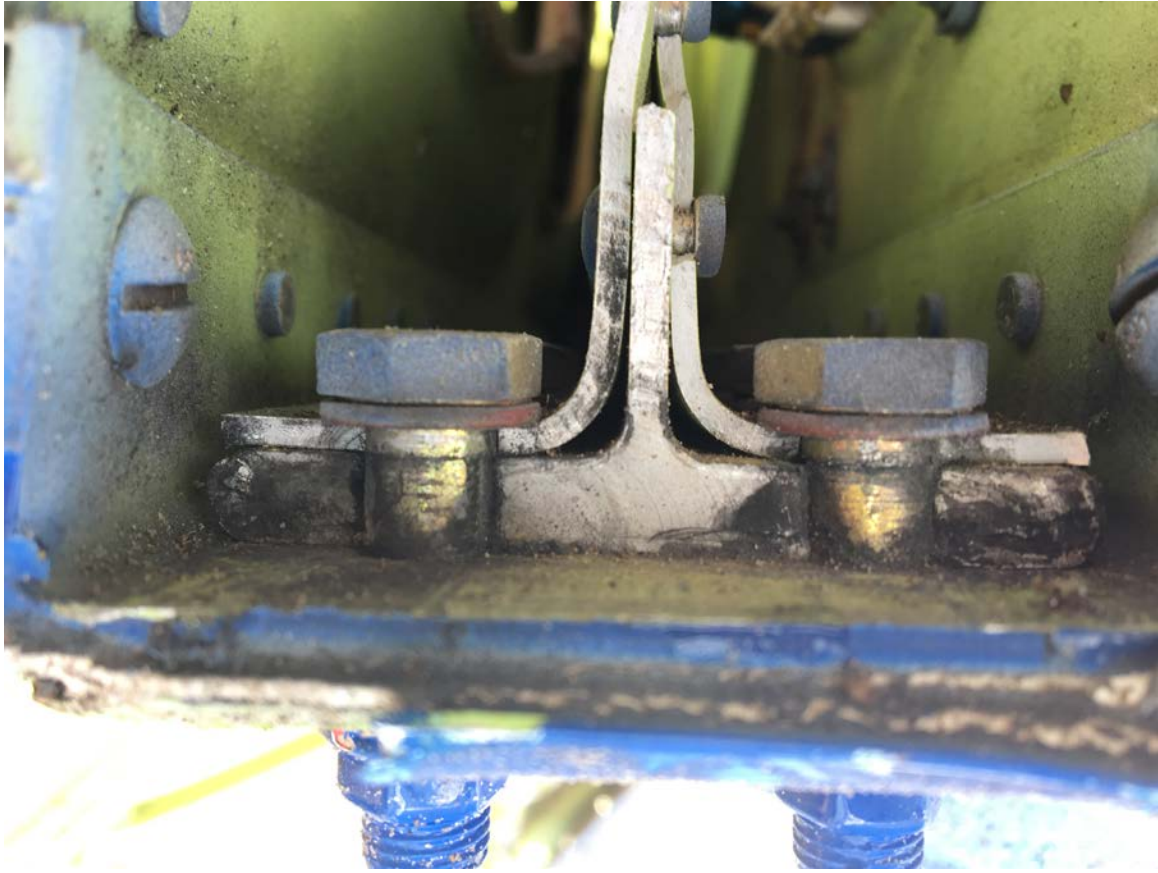
Figure 4 – N106ER Left wing lower spar cap fracture face, looking inboard

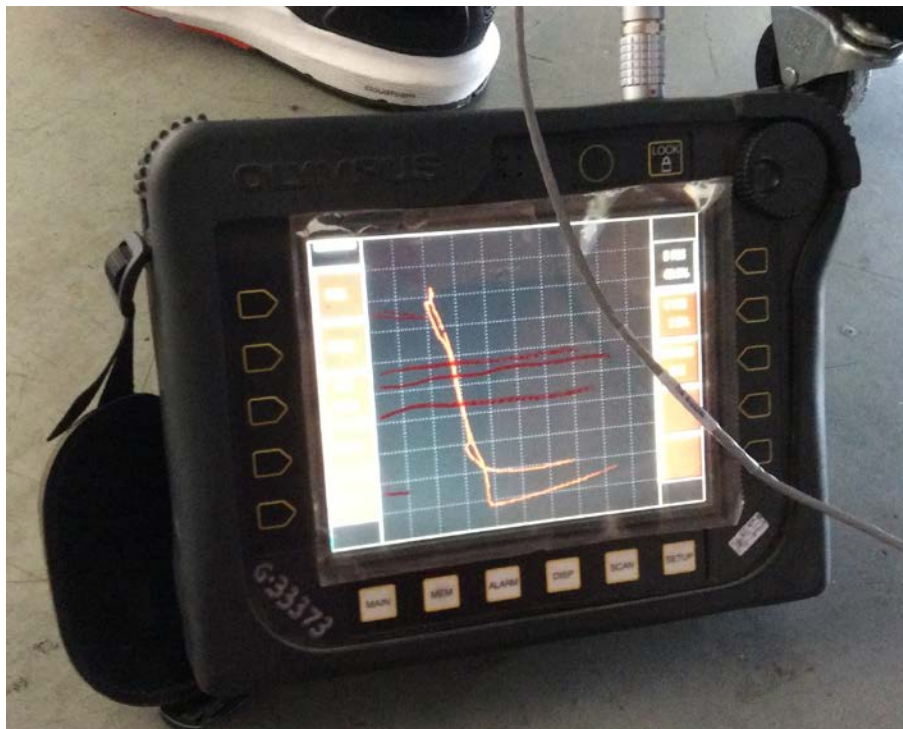
Figure 5 – N104ER Eddy Current indication in hole LC-1
