NATIONAL TRANSPORTATION SAFETY BOARD

Group Chairman's Factual Report

DCA15MA019

Operator: Scaled Composites, LLC
Location: Koehn Dry Lake, California
Date: October 31, 2014
Time: 1007 Pacific Daylight Time
Vehicle: Model 339 SpaceShipTwo
Registration Number: N339SS

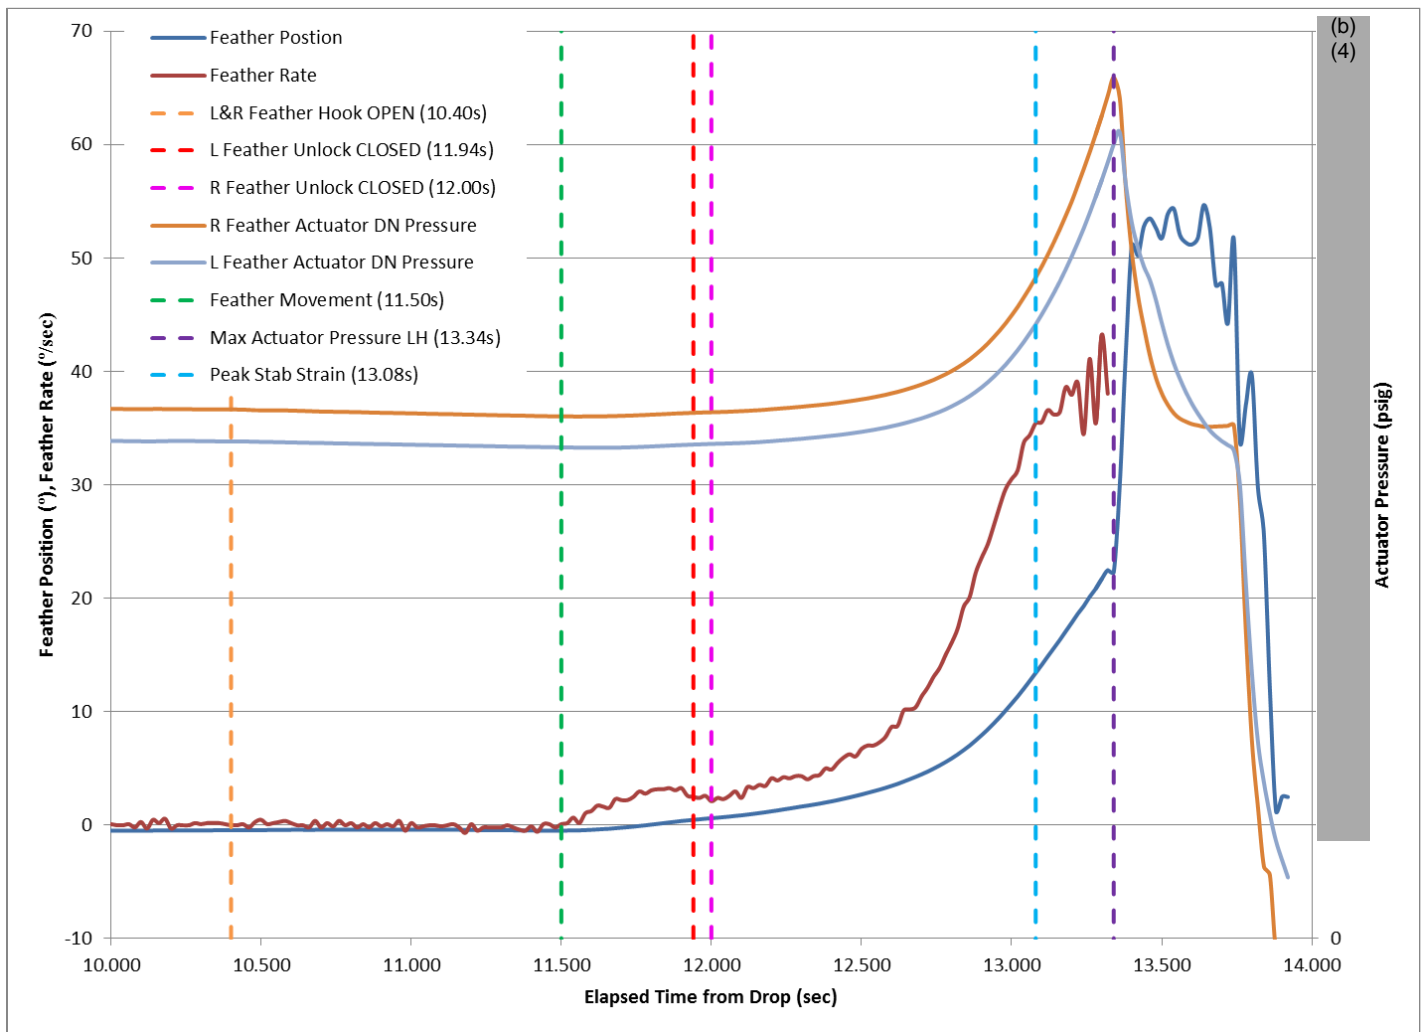
- Max Actuator Pressure – This time was selected based on the recorded feather actuator pressures and represents the time when the right feather actuator pressure peaked 13.34 seconds after the separation (10:07:32.44 PDT). The left feather actuator pressure peaked 20 milliseconds later.

Plot 1 shows the feather actuator pressures, feather position, and feather rate for the period between 10.00 and 14.00 seconds after the separation with relevant discrete time events.

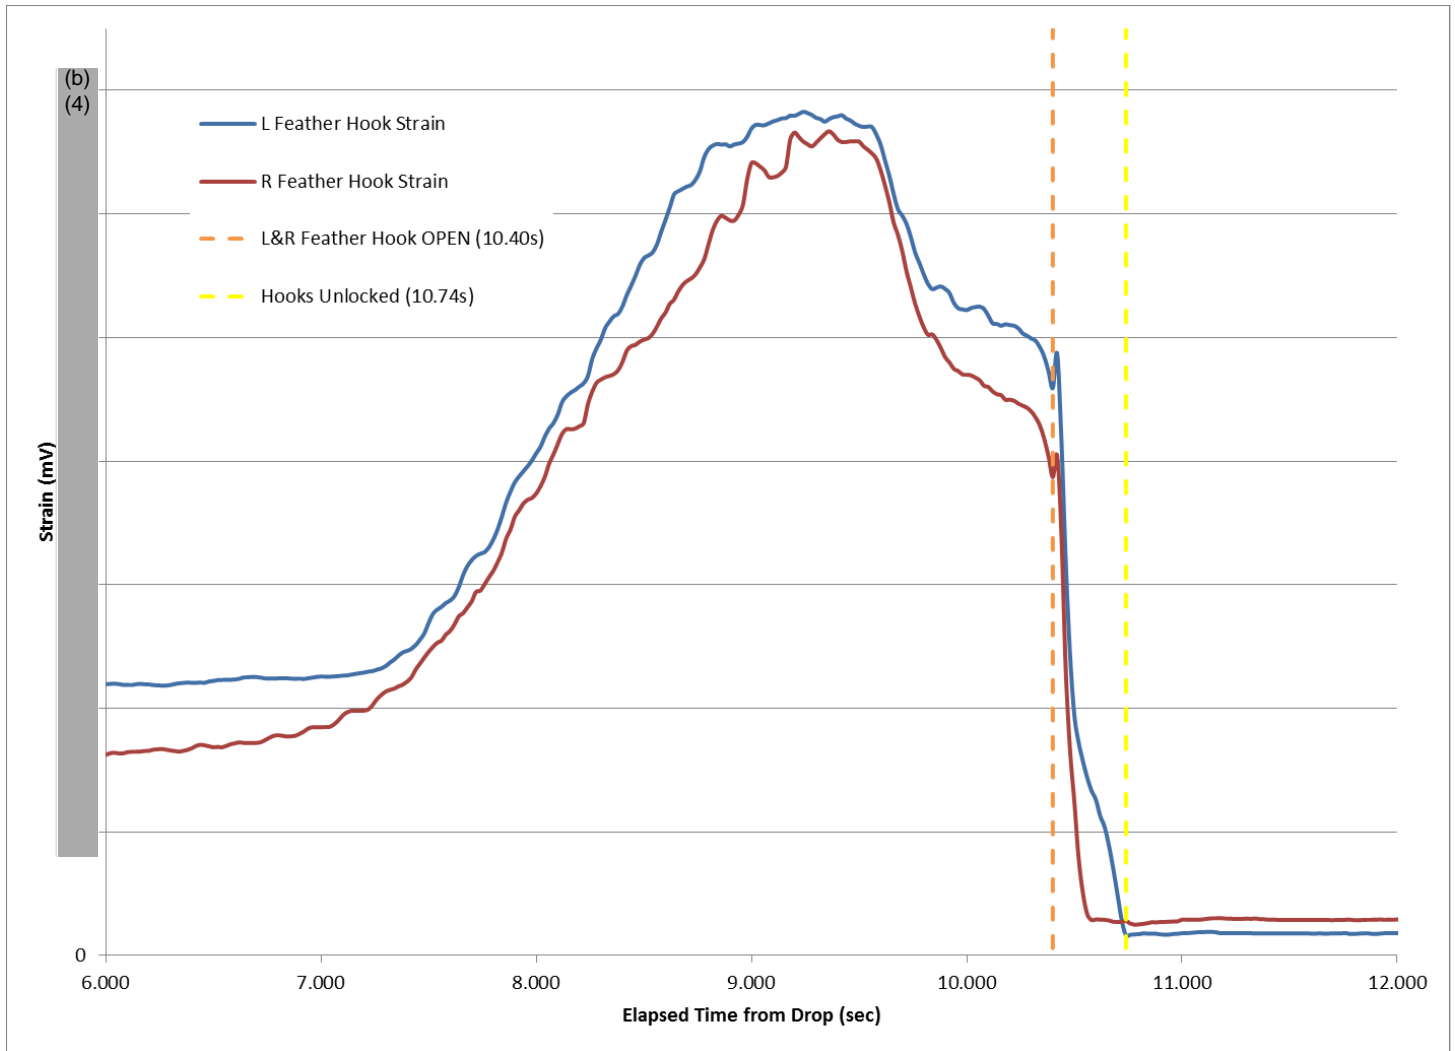
Plot 2 shows the strain in the feather lock hooks for the period between 6.00 and 12.00 seconds after the separation with the discrete times when the feather locks began opening and when both hooks had unlocked.

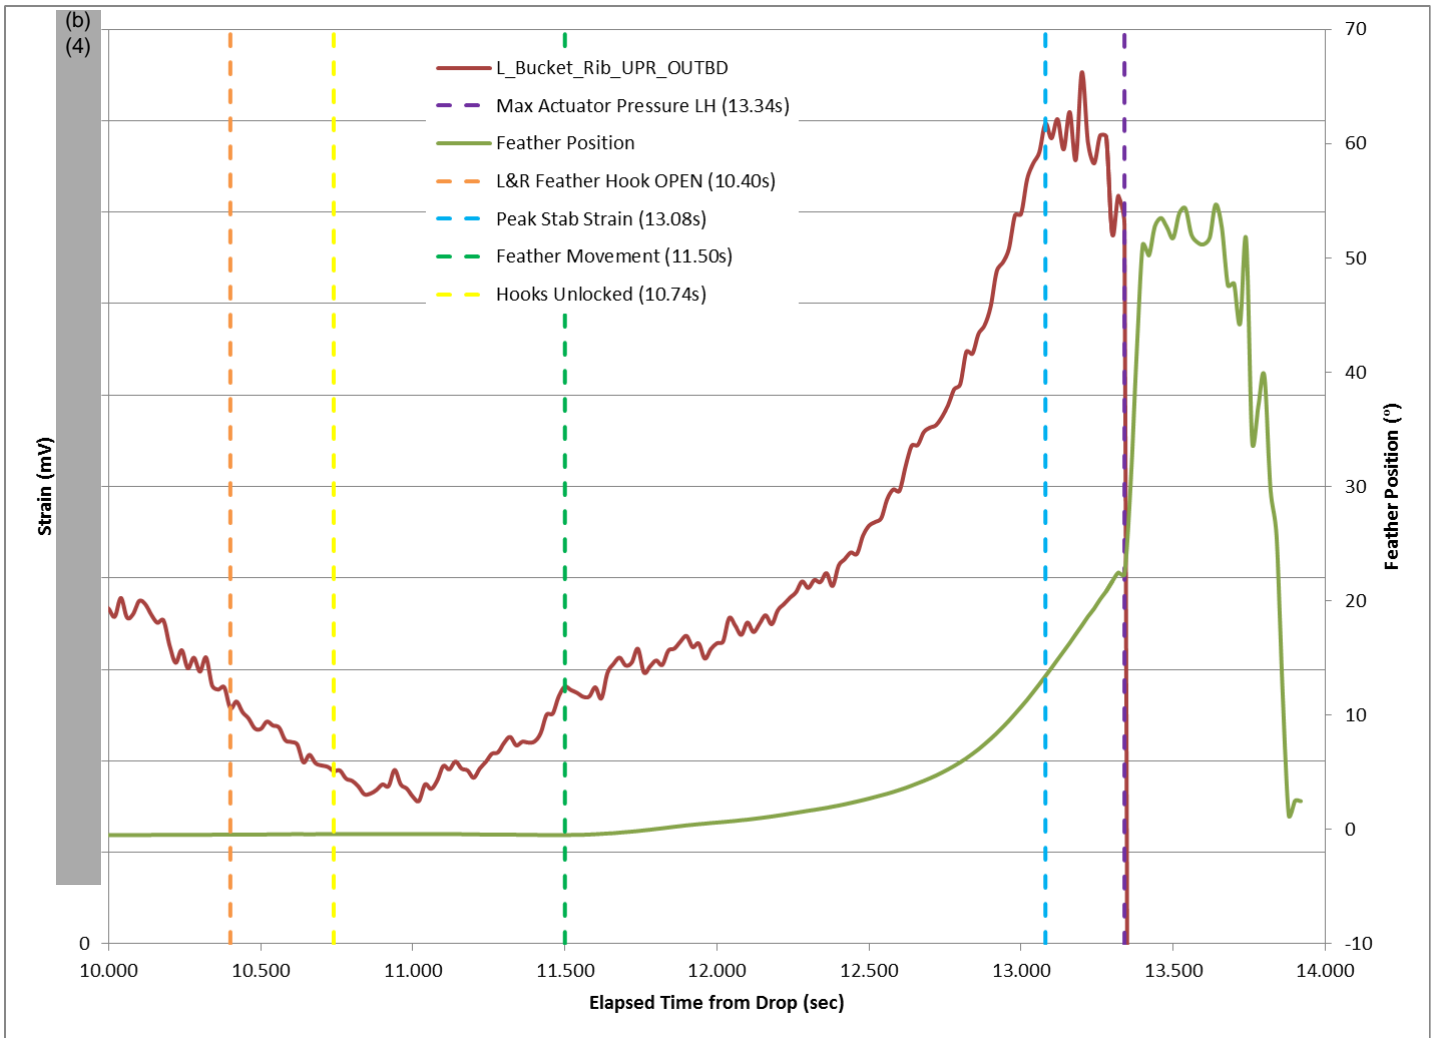
- Peak Stab Strain – This time was selected based on the recorded bucket rib strain and represents the peak strain value recorded before the signal levels off and begins oscillating. The peak stab strain occurred 13.08 seconds after the separation (10:07:32.18 PDT).

Plot 3 shows the bucket rib strain and feather position for the period between 10.00 and 14.00 seconds after separation with relevant discrete time events.

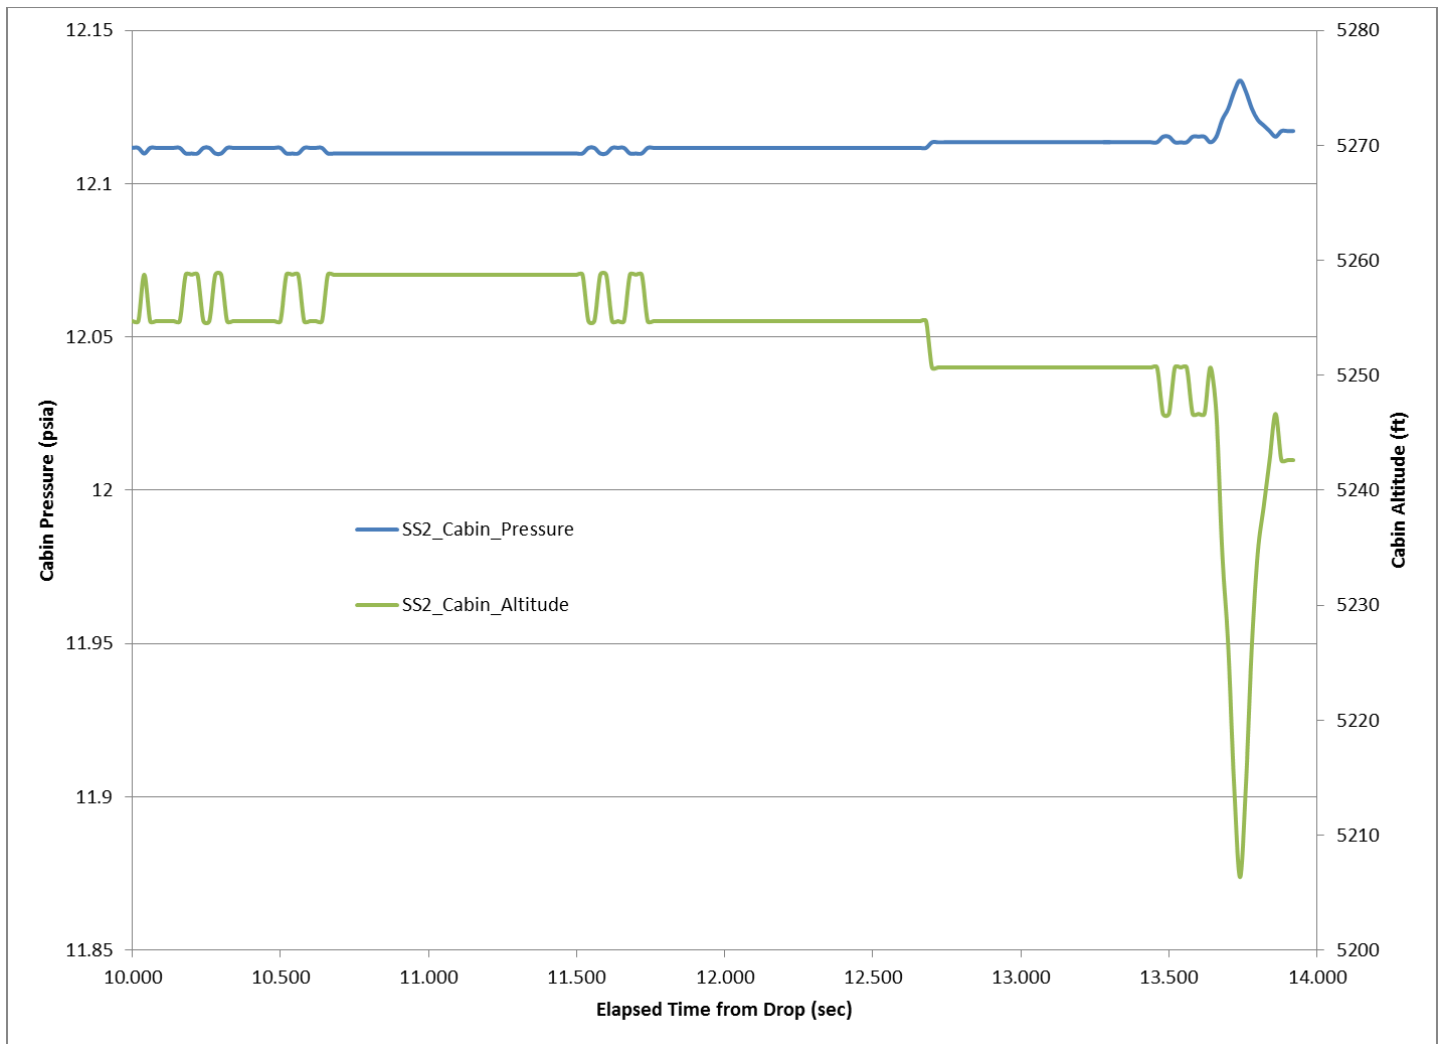
Plot 4 shows the cabin pressure and altitude for the period between 10.00 and 14.00 seconds after the separation. The last data point was recorded 13.92 seconds after the separation. These parameters were plotted for correlation with some of the information from the recovered videos.

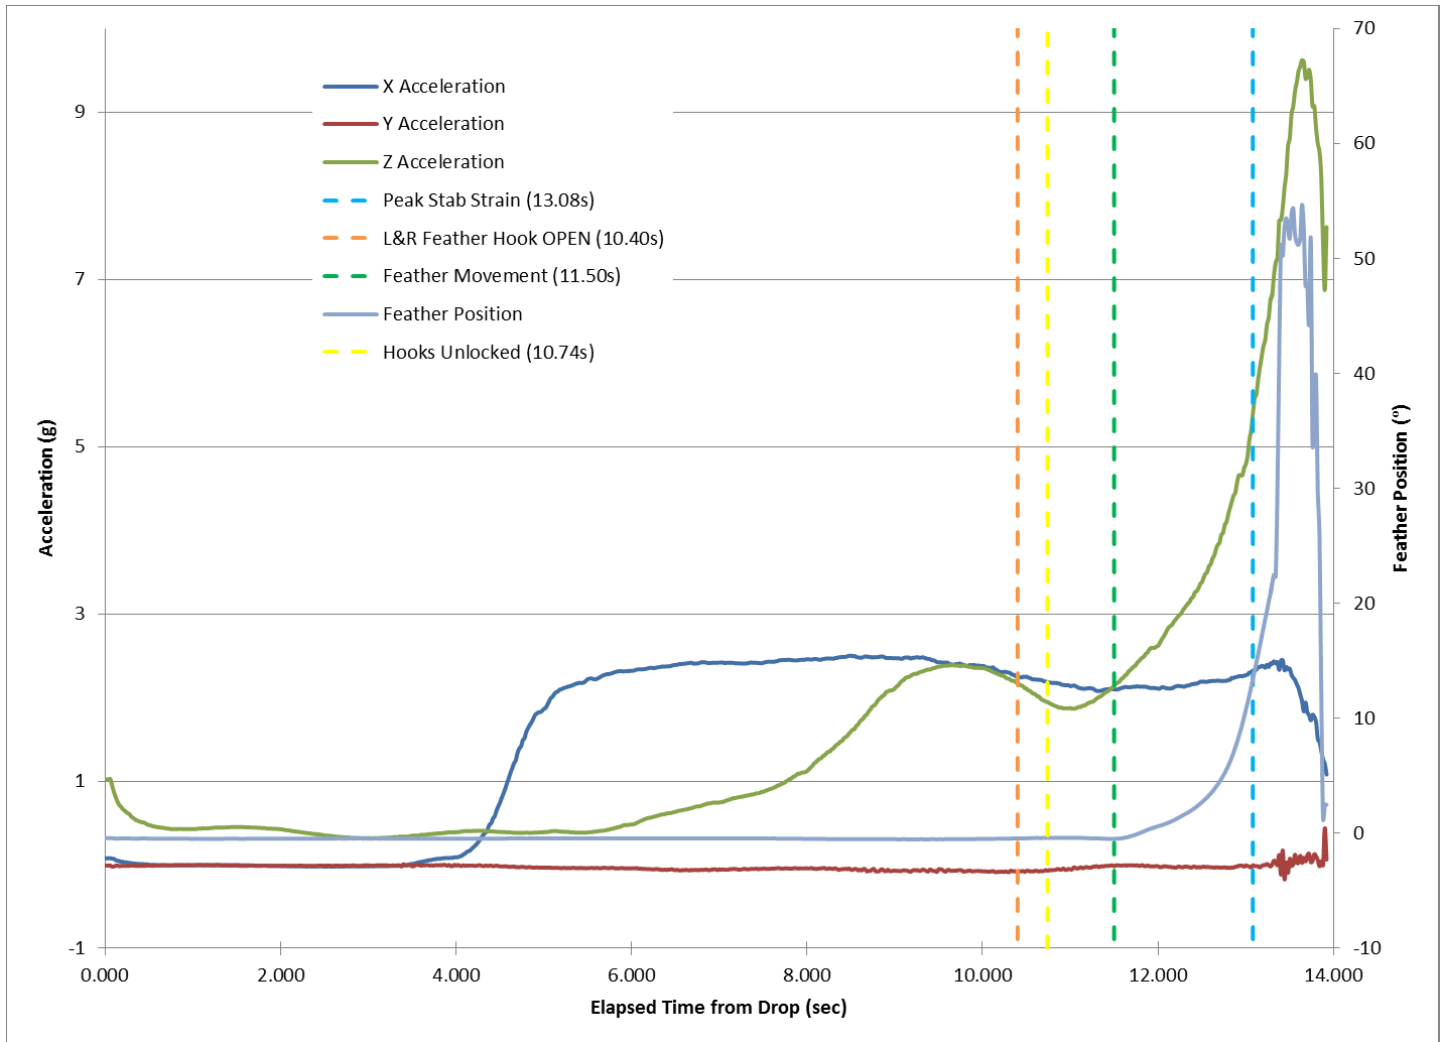
Plot 5 shows the acceleration in the x, y, and z directions and the feather position for the period between 0.00 and 14.00 seconds after the separation with relevant discrete time events.

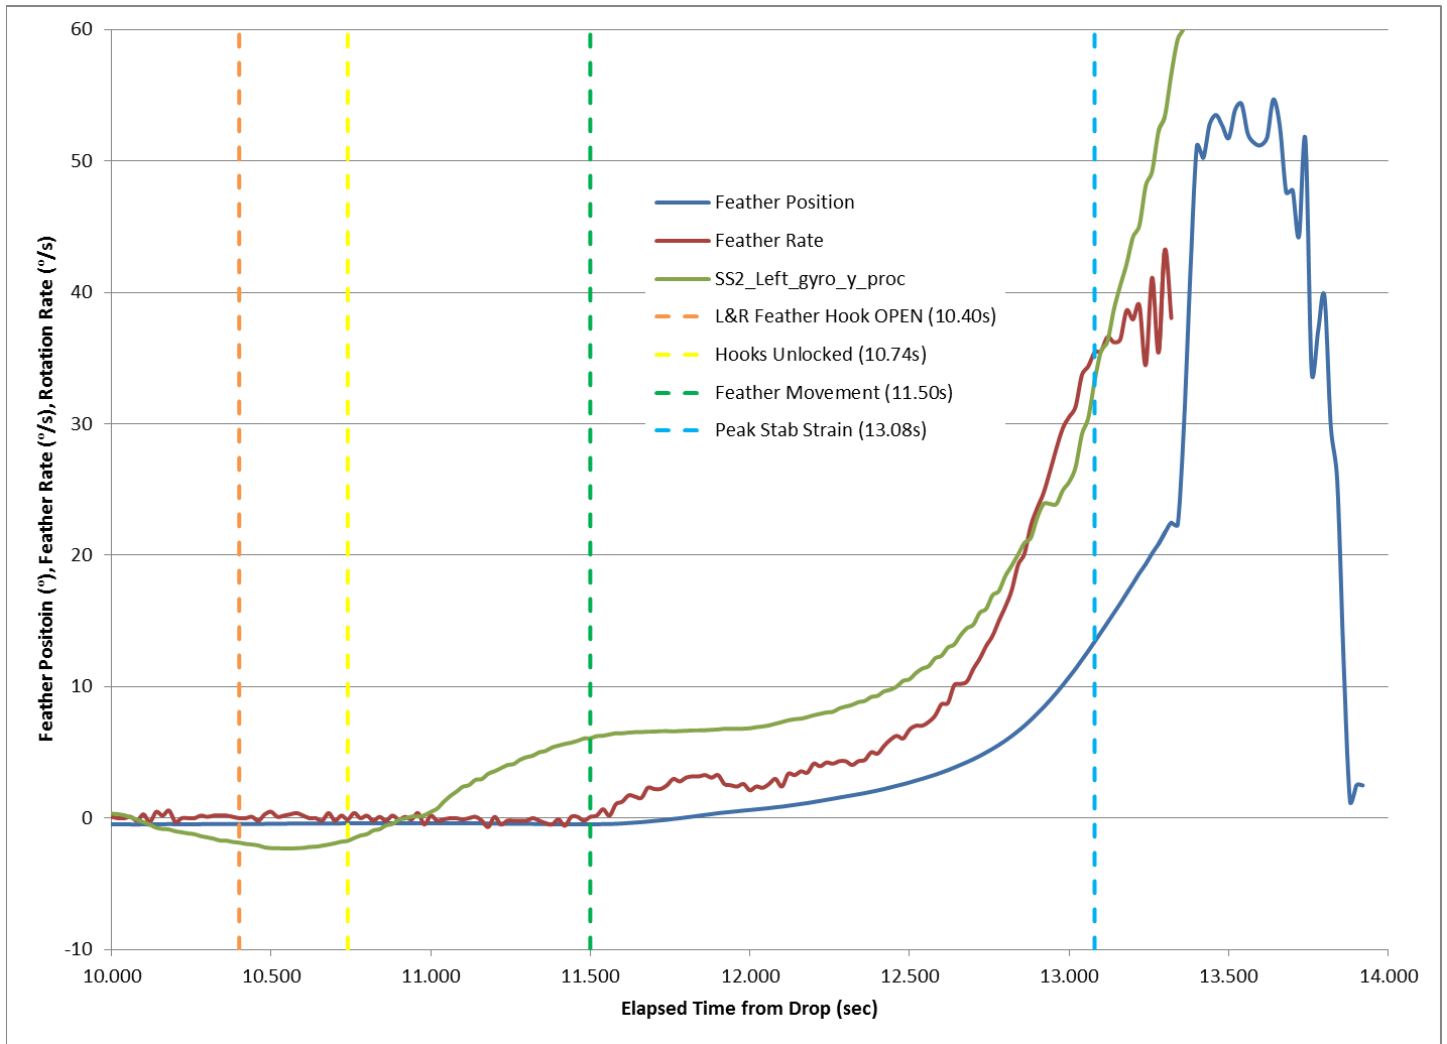
Plot 6 shows the feather position, feather rate, and vehicle pitch rate for the period between 10.00 and 14.00 seconds after the separation with relevant discrete time events.
