NATIONAL TRANSPORTATION SAFETY BOARD
Office of Aviation Safety
Washington, D.C. 20594
January 30, 2015

Group Chairman's Factual Report

STRUCTURES

DCA13MA081

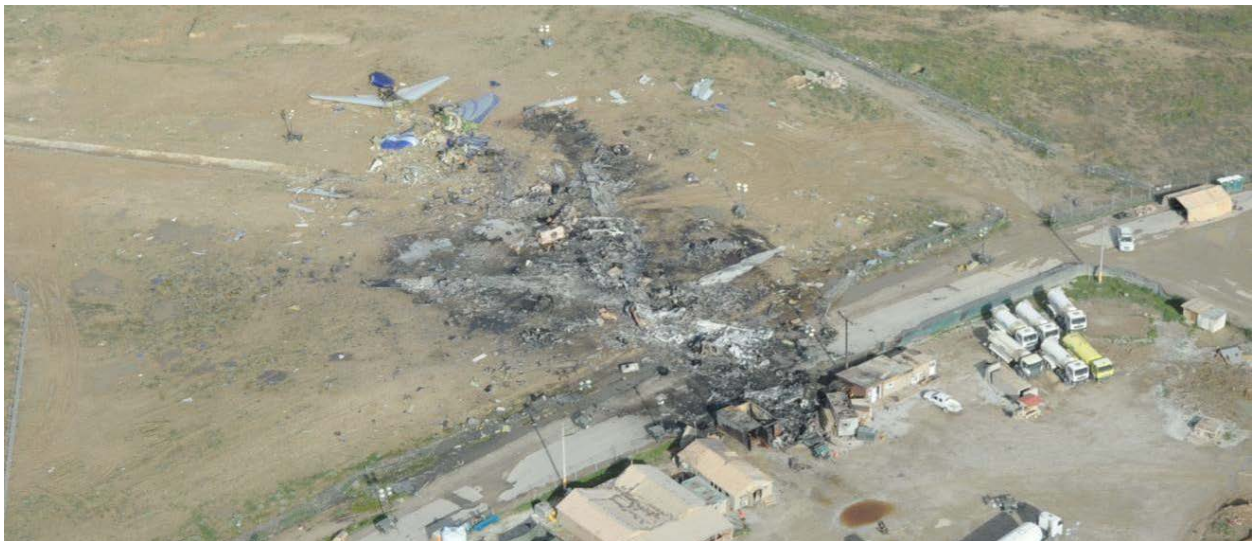
Figure 2 – N949CA Crash Site Aerial View

All of the structure forward of about STA 2060 was consumed by fire (Figures 2 & 3). This includes the wings, fuselage sections 41, 42, 44, and section 46 forward of about STA 2060.

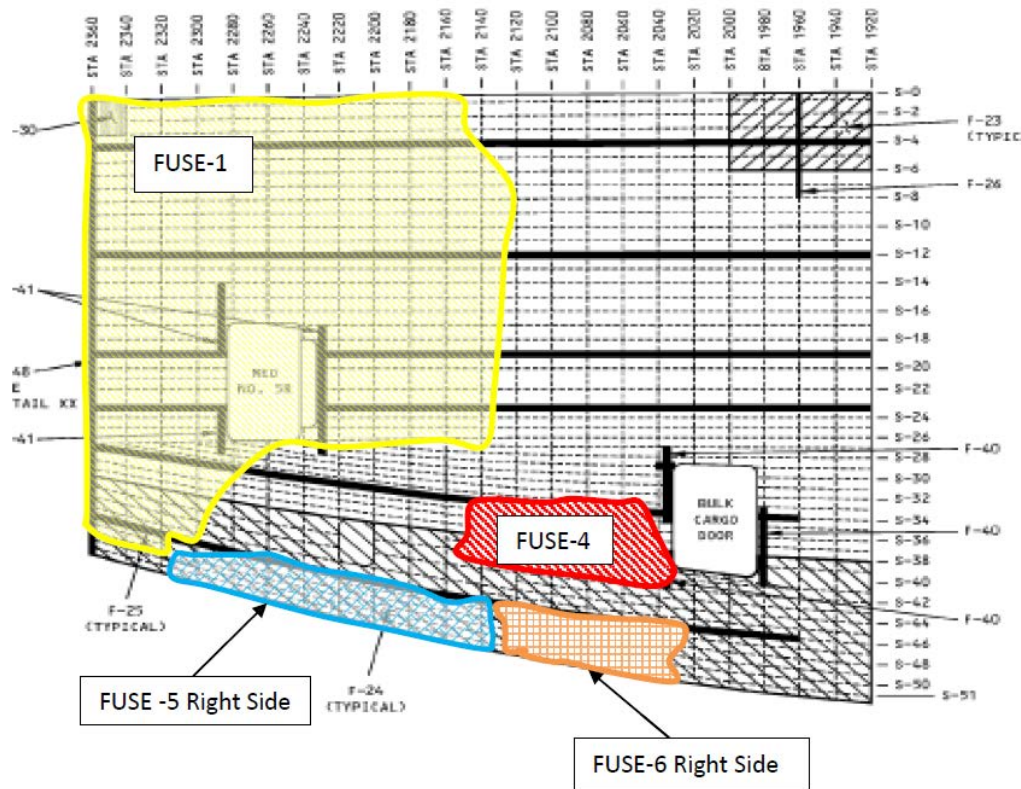
Figure 5 - Right Hand Major Skin Panel Sections FUSE-1, -4, -5, and -6

FUSE-1 includes a deactivated and intact R5 door (Figures 5 & 7). The skin panel section also contained a section of the APB.

FUSE-4 and FUSE-5 were found next to and partially on top of each other near the bottom of the large impact crater that was approximately 30 feet in front of the horizontal stabilizer. The stringer stiffeners and frames common to these skin sections were flattened and had a smeared appearance (Figures 5 & 6).

FUSE-6 (Figures 5 & 6) was also found at the bottom of the large impact crater. This section of skin exhibited evidence of buckling, but did not have the flattened appearance of FUSE-4 and FUSE-5 (Figures 5 & 6).

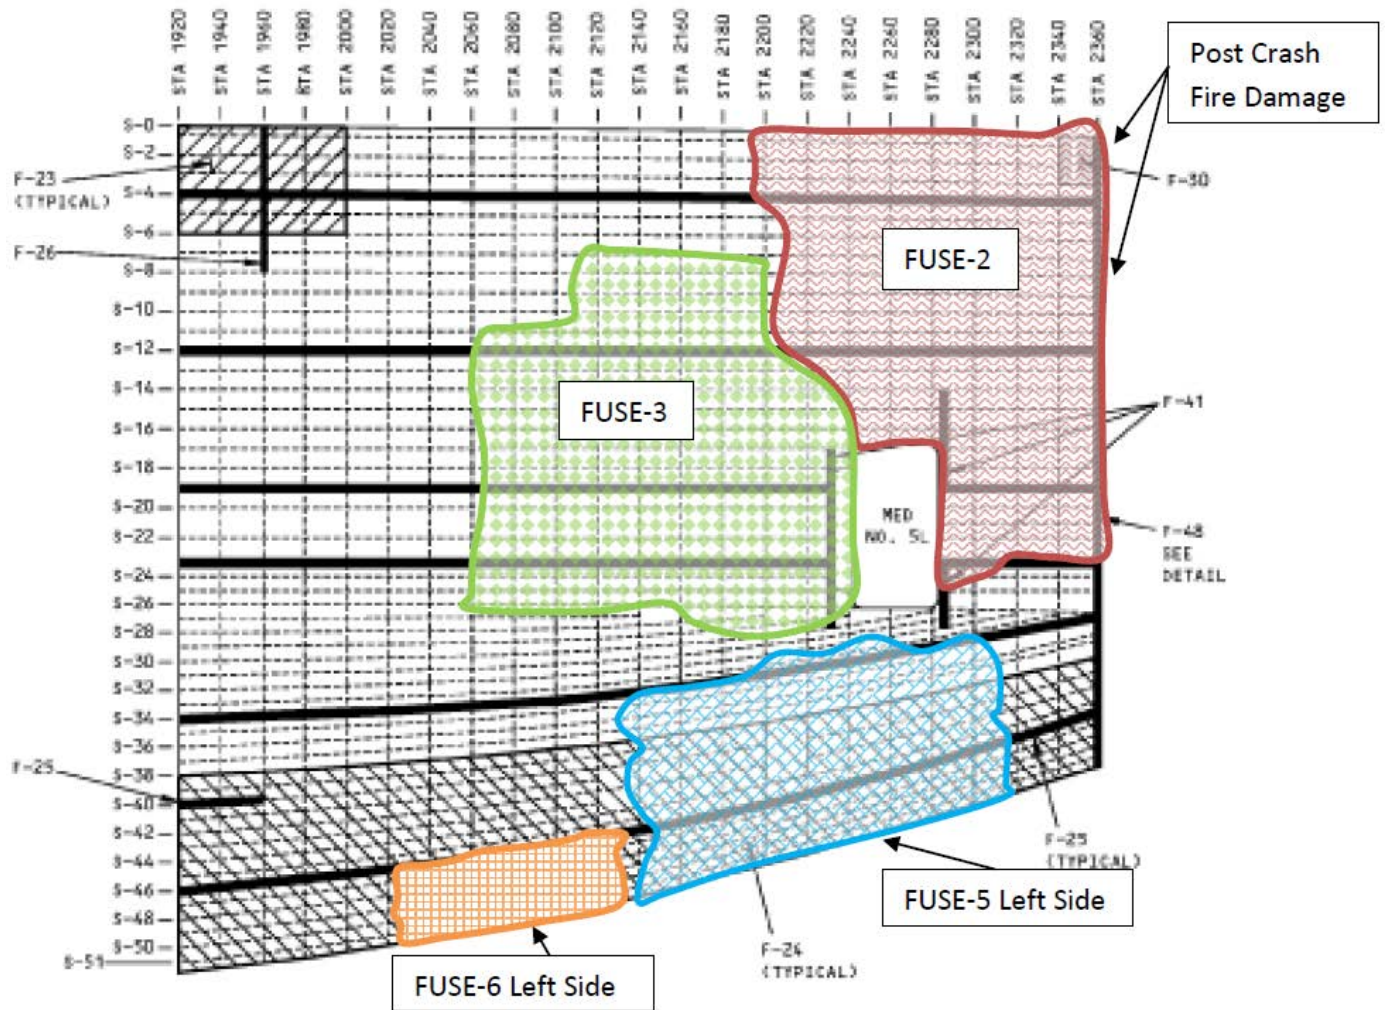
Figure 6 - Left Hand Major Skin Panel Sections FUSE-2, -3, -5, and -6

The FUSE-2 skin panel also contained a portion of the APB and exhibited fire damage (Figures 6 & 8). The fire damage was from about stringer 22L to about stringer 1 between STA 2320 and STA 2360. The FUSE-2 skin contained the E-8 rack that housed the FDR and CVR.

The FUSE-3 skin panel section was impaled on the left side of the aft most MRAP⁴ (Figure 6).

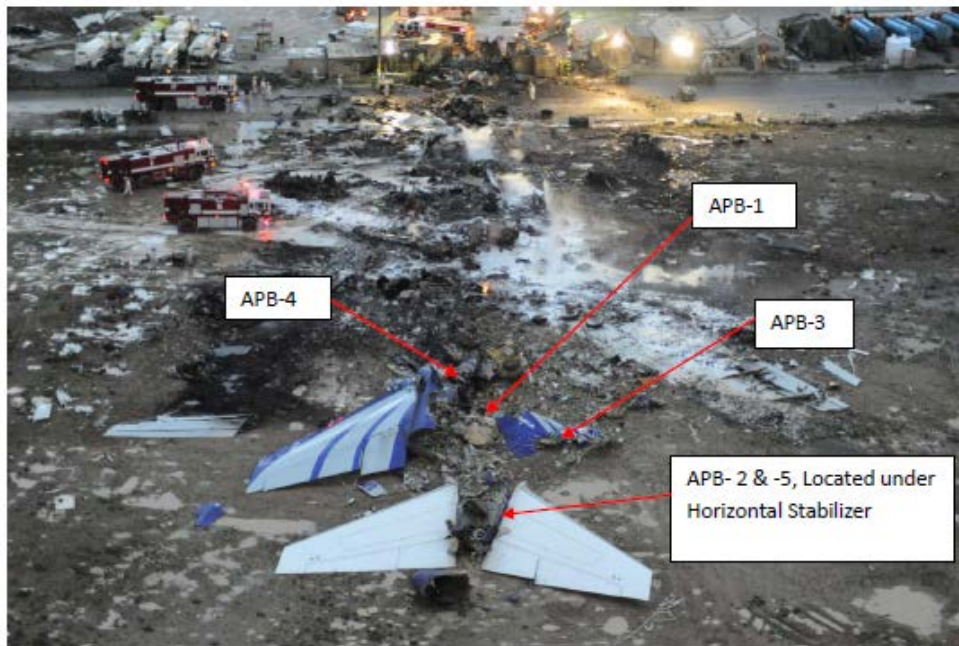
Figure 9 – Five APB sections

Five sections of the APB were identified at the accident site (Figures 9 & 10). The aft pressure bulkhead is dome shaped and curved aft. Three of these sections, APB-3, -4 & -5, were still attached to the faceplate “Y” chord and section 46 outer skin panels. APB-1 & -2 were found not connected to any fuselage structure.

The 5 major sections of the APB were recovered as depicted in Figure 9.

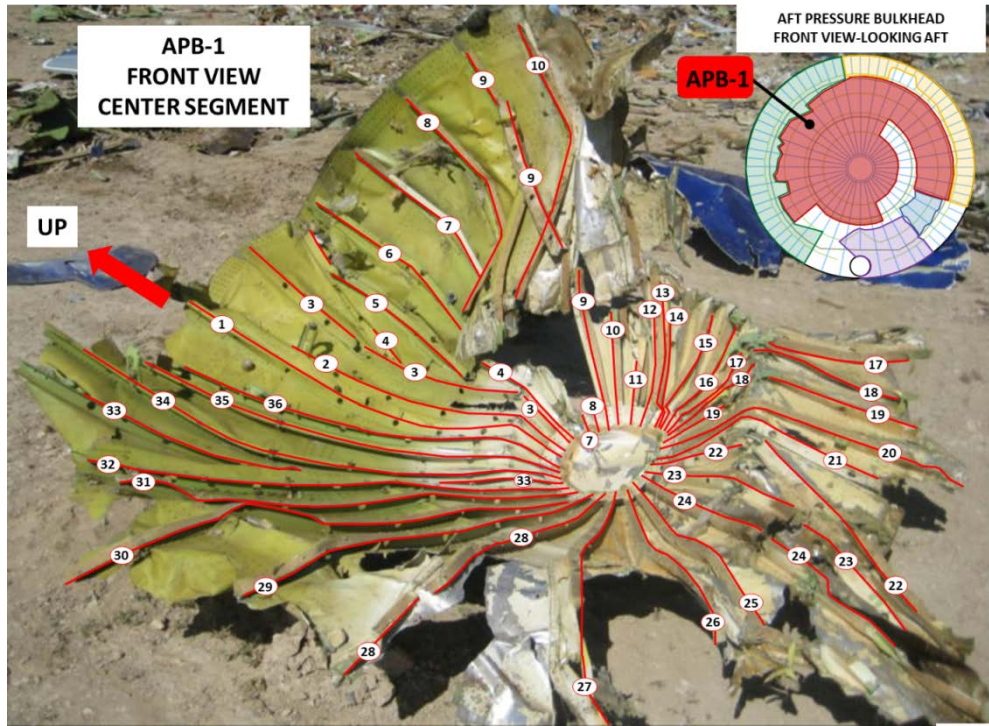
Figure 11 - APB-1, View Looking Aft

Section APB-1 was found on top of a pile of section 46 wreckage that was in an impact crater located approximately 30 feet forward of the horizontal stabilizer (Figure 11). APB-1 had a large crease just below the center dome. The upper half, above the center of the APB, was deformed aft. APB-2 was found under the horizontal stabilizer with the stiffeners deformed flat. APB-3, -4 and -5 were still attached to their respective STA 2360 Y chord and section 46 fuselage skins. APB-3 was attached to a large section of the right hand section 46 skin panel (Figure 12). APB-3 was deformed forward. The forward deformation was greater at the lower waterline levels and less pronounced near the crown.

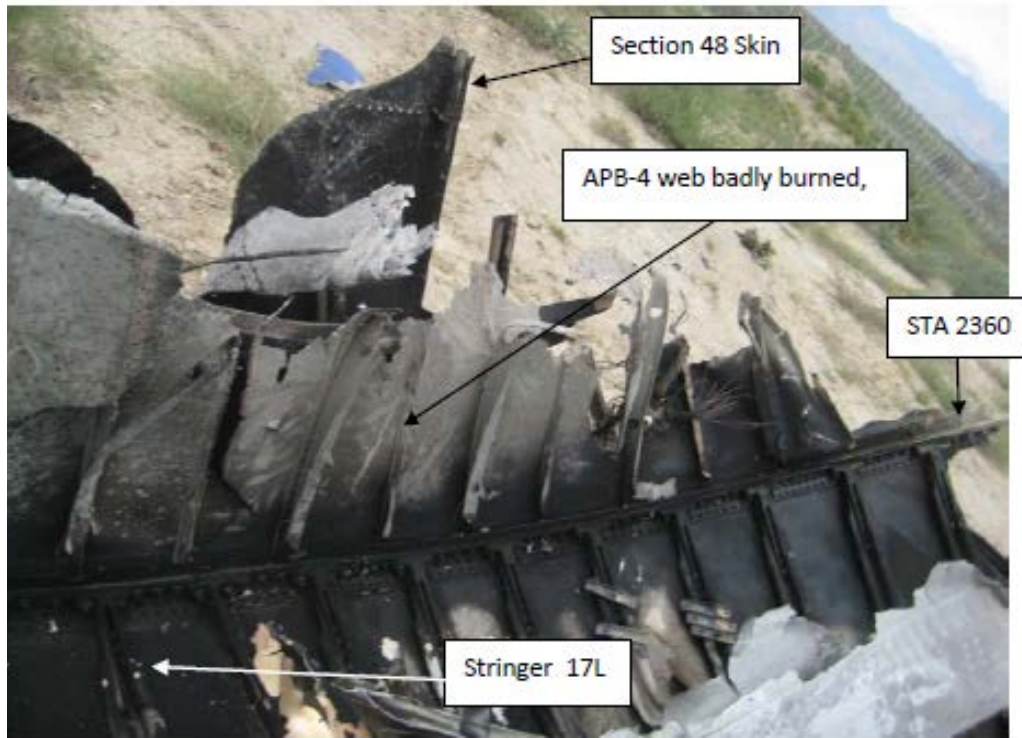
Figure 13 - APB-4 View Looking Aft and Outboard

APB-4 was attached to a portion of the left hand section 46 skin panel (Figure 13). It was also deformed forward similar to APB-3. APB-5 was bent aft from the skin panel to about the top of the APU cutout and the remainder of the section was bent forward (Figure 14). APB-5 was located under the horizontal stabilizer near APB-2.

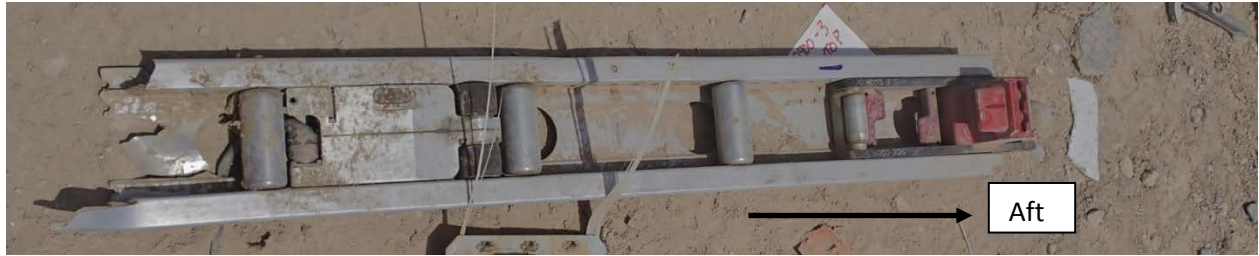
Figure 17 – N949CA Fixed End Stop (1) (part number 289100-3)

The fixed end stop and black housing in position 1 were recovered still mounted and secured to about a 40 inch section of silver aluminum roller tray (Figures 15 & 17). The roller tray was fractured about 40 inches forward of the aft end and about 5 inches forward of the power drive unit (PDU). The fixed end stop located in position 2 was recovered still mounted to the black housing and was no longer mounted to a silver aluminum roller tray (Figures 15 & 18). The fixed end stop located in position 3 was recovered separated from the black housing and the housing was no longer attached to the silver aluminum roller tray (Figures 15, 16 & 19). The housing fractured on the right hand side where the fixed end stop attaches to the black housing.

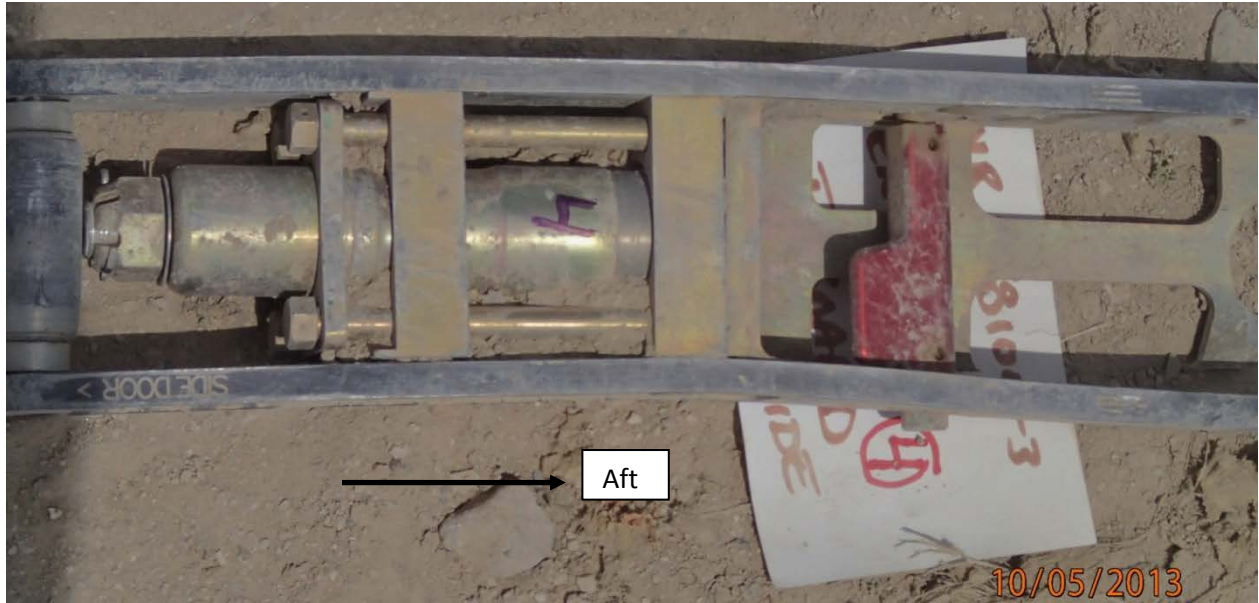
Figure 20 – N949CA Retractable End Stop Tray (4) with Missing End Stop (part number 288100-3)

The black housing of the retractable end stop in position 4 was recovered fractured at the aft end with no retractable end stop attached to the housing (Figures 15, 16 & 20). The

retractable end stop was not recovered in the wreckage debris. In position 5 the retractable red end stop was recovered in the down position attached to the black housing (Figures 15 & 21). The assembly was not attached to the silver aluminum roller tray. In position 6 the retractable red end stop was recovered in the up position and secured to the black housing (Figures 15 & 22). The assembly was attached to about 20 inches of the silver aluminum roller tray. The roller tray was fractured at the forward end.

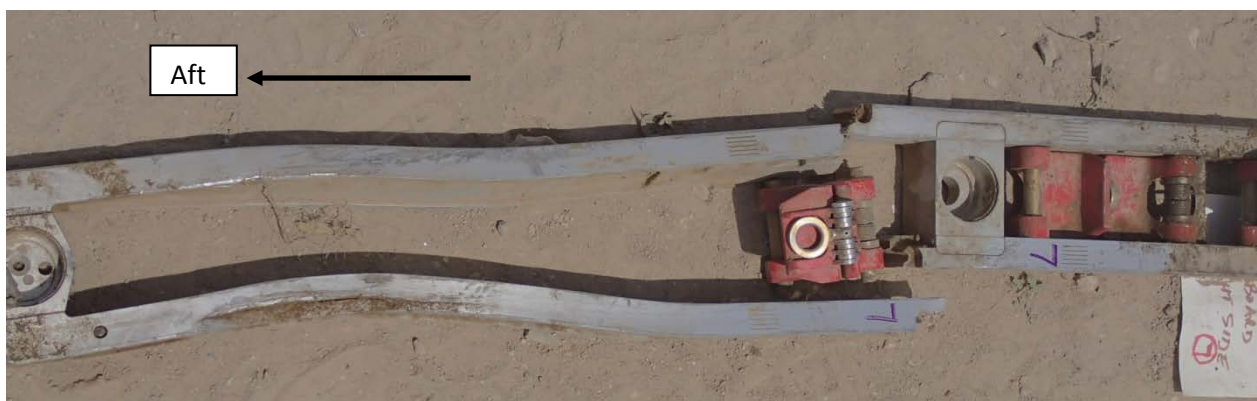
Figure 23 - P29 Forward Lock Tray (7) retractable end stops (part number 279100)

In position 7 the silver aluminum lock tray was fractured about 22 inches from the forward end in the location of the aft retractable end stop (Figures 15 & 23). The forward retractable end stop was in the up position, the middle was in the down position and the position of the aft retractable end stop could not be determined due to it being separated from the silver aluminum lock tray. In position 8 the entire assembly comprised of the silver aluminum lock tray and the 3 retractable end stops was recovered intact. The aft retractable end stop was in the up position and the middle and forward stops were in the down position (Figures 15 & 24). The assemblies in positions 7 and 8 are interchangeable and a determination of which was located on the left versus right hand sides of the airplane was not possible (Figures 15, 23 & 24).

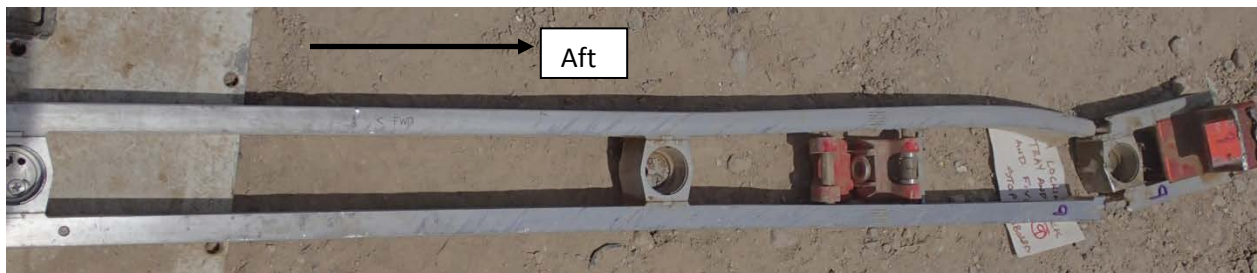
Figure 25 - P29 Aft Lock Tray (9) fixed and retractable end stops

In position 9 (Figures 15 & 25) the entire assembly was recovered with the forward retractable end stop in the down position (Figure 25). The silver aluminum lock tray was fractured about 44 inches from the forward end or about 7 inches from the aft end in the location of the aft roller. Material from the upper forward edge of the fixed end stop where the single stud and double stud attachment points are located was ground away. The upper surface of the silver aluminum lock tray also had diagonal scratches going from right to left on a 45 degree angle when viewed from the front looking aft. In position 10 the entire assembly was recovered with the retractable end stop in the up position and the fixed end stop attached and in place (Figures 15 & 26). The silver aluminum lock tray was fractured on the right hand side when viewed looking aft about 6 and ½ inches forward of the aft end of the tray. In position 9 the entire assembly was recovered with the forward retractable end stop in the down position. The assemblies in positions 9 and 10 are interchangeable and a determination of which was located on the left versus right hand sides of the airplane was not possible.

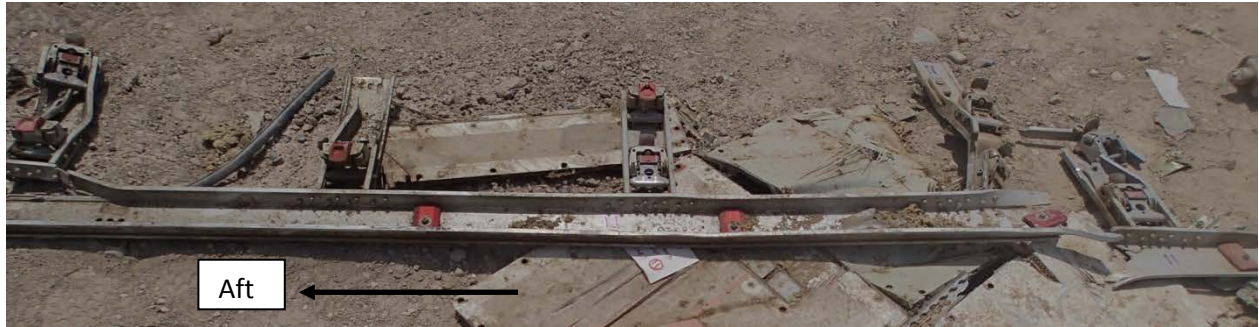
Figure 28 - N949CA P29 LH Side Guide Rail (11)

The P29 side guide and latch assembly was recovered in the wreckage with 9 out of the 10 lateral and vertical restraints in place. The forward end of the side rail was fractured about 12 inches aft of the forward end. The restraints have been numbered 1A and 1B in the forward location to 5A and 5B in the aft position for the purposes of this report. The A position is the inboard restraint and B position is the outboard restraint. In position 1, the retractable restraint 1A was in the down position and in position 1B the restraint had separated from the track assembly. The track in position 2 separated from the side rail assembly and both stops 2A and 2B were in the down position. In position 3 restraint 3A was in the down position and 3B was in the up position. In position 4 restraint 4A was in the up position and stop 4B was missing. In position 5 the track was separated from the side rail assembly and restraint 5A was in the up position and 5B was in the down position.

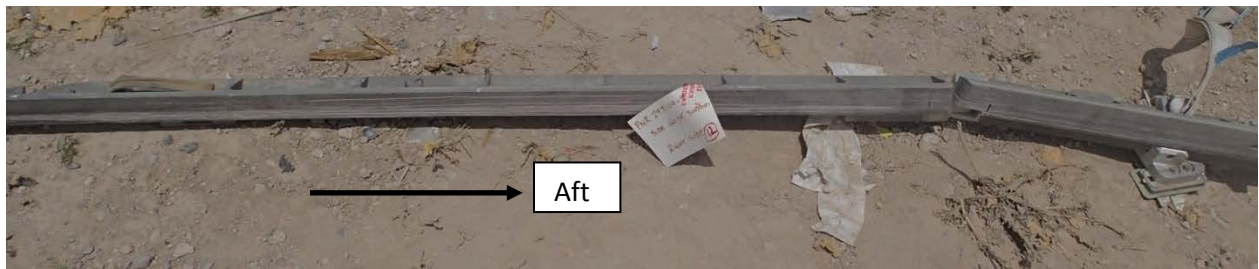
Figure 29 - N949CA P29 RH Transition Side Guide Rail (12)

The RH side P29 side guide rail movable arm, item 12 (Figures 27 & 29), remained attached to the forward end of the fixed side guide rail item 13 (Figures 27 & 30). The lug used for attaching the movable section of the side guide rail to the fixed forward side rail via a quick connect pin was fractured on the movable guide rail side. The aft fixed side guide rail was fractured 57 and ½ inches from the forward end creating items 13 and 14 (Figures 27, 30 & 31).

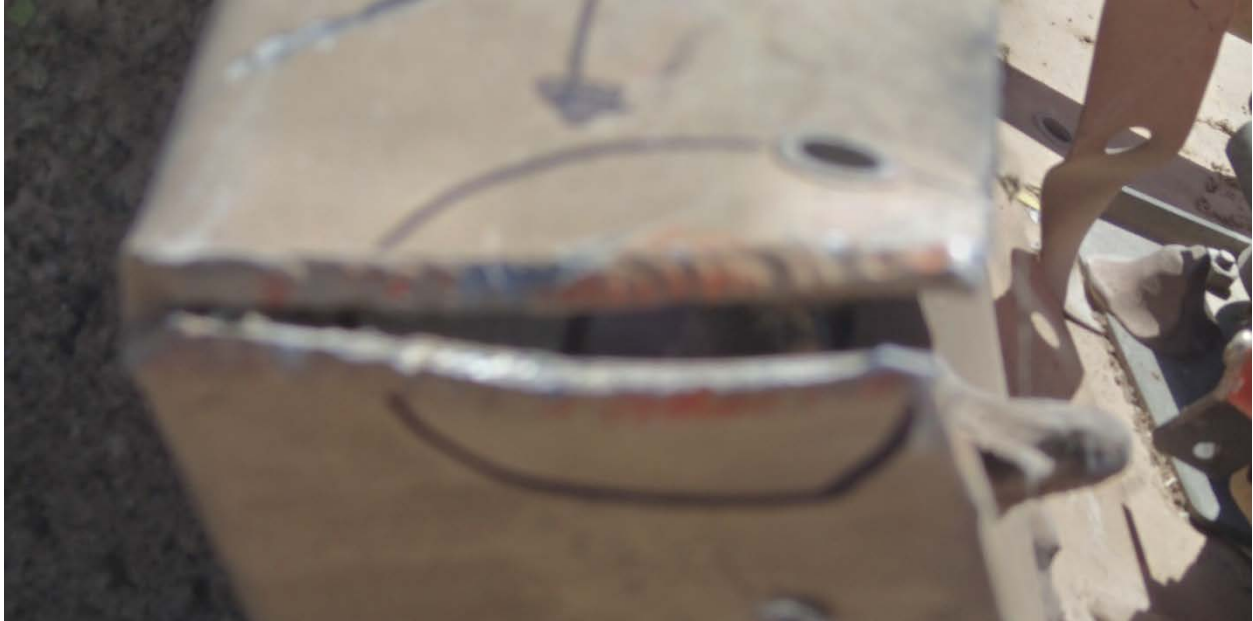
Figure 41 - Orange Paint Transfer (2) to M-ATV

The aft M-ATV was located from B.A. 1973 to 2211. The M-ATV was substantially damaged but was not consumed by fire. Pieces of the main deck interior panels were recovered from inside the M-ATV and orange and green paint transfers consistent with the orange paint on the CVR and the FDR cases and the green primer used on unpainted airplane structure were identified on the rear portion of the aft M-ATV. The paint transfer marks are consistent with airplane structure located aft of the M-ATV's tie down position (Figures 39 thru 42).

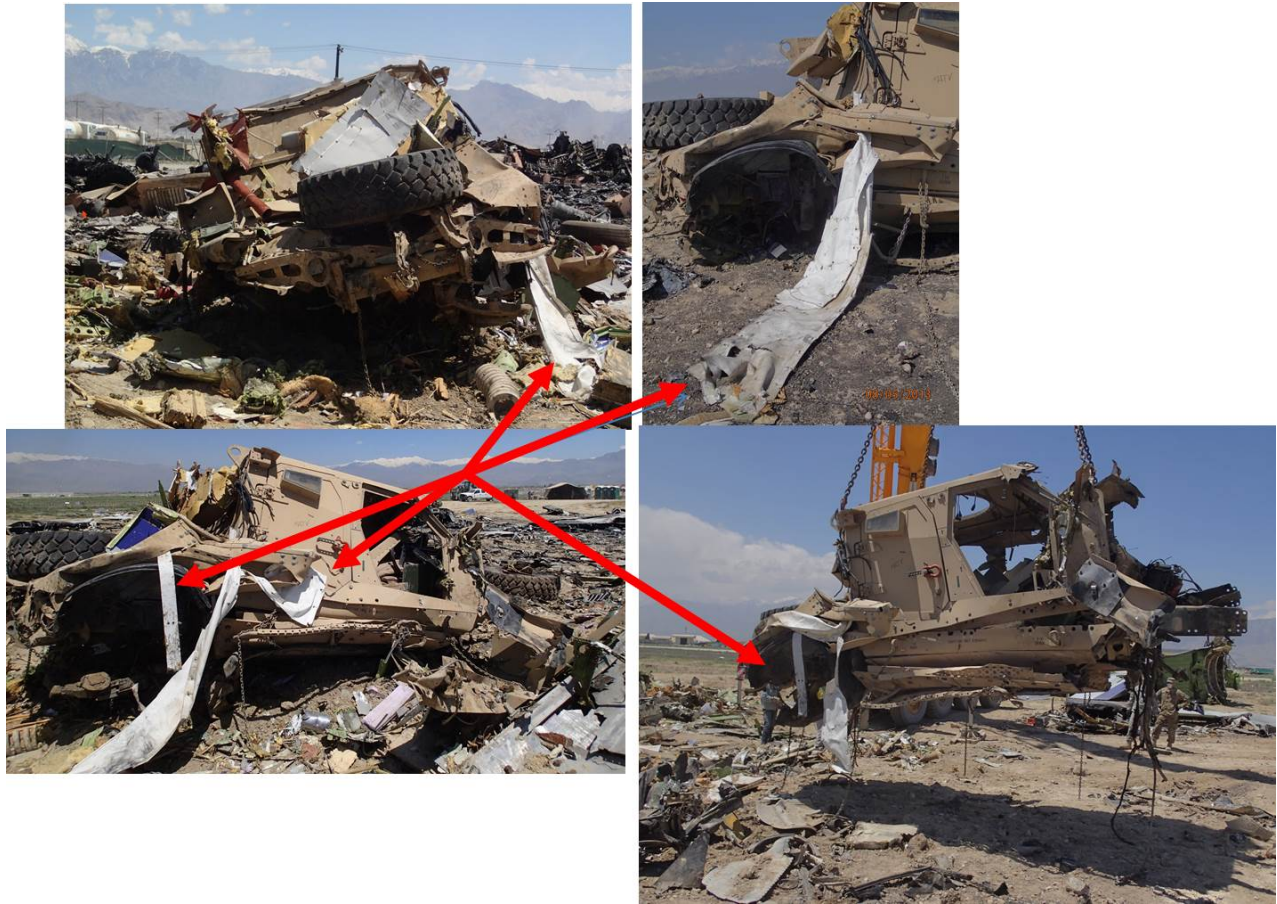
Figure 43 - Trapped APB Liner Material (1)

The right (first officers side) interior liner between the APB and airplane side of body interior lining and the lower APB cargo liner splice strap were found on the right hand side of the aft M-ATV trapped underneath the collapsed M-ATV structure(Figures 43 thru 45).

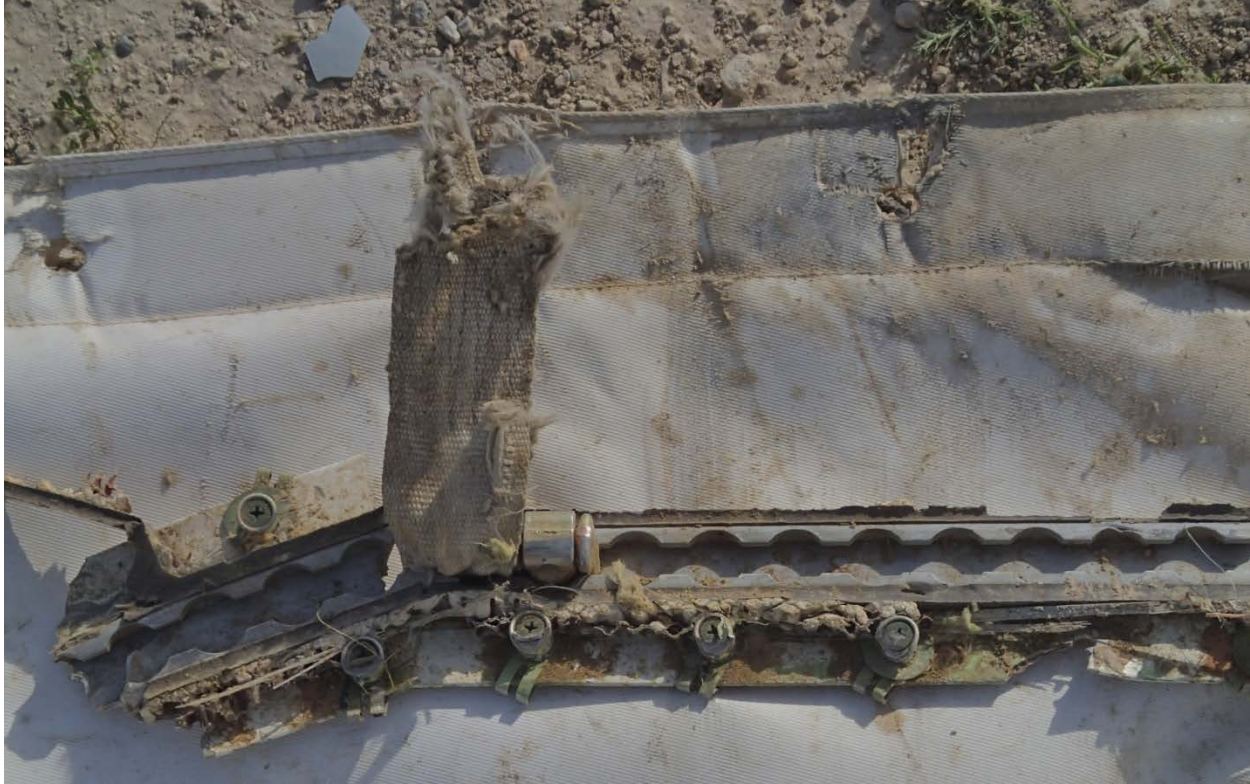
Figure 49 - Seat Track with attached Strap

70 total sections of strapping were recovered aft of the last M-ATV and were torn at varying lengths. Twelve 5,000 LB straps of varying length were found attached to 6 sections of the cargo system side guide rail. The straps were submitted to the NTSB Material's Laboratory for examination.¹⁹ Four straps (Figures 46, 47, 48 & 49) were found attached to seat tracks. The double stud fitting shown in Figure 46 was installed in the right butt line (RBL) 75.9 seat track, between STA 1920 and STA 1940. There are no seat track allowables²⁰ for this track at this location per the Boeing Weight and Balance Control and Loading Manual. Figure 47 shows a part consistent with floor panel 814B6554-100. This would place the tie down location shown in Figure 43 on RBL 89.67 at approximately STA 2220. In Figure 48, the T/SL mark is a pallet mark on the left sidewall at the aft end of the side by side pallets (approximately STA 2218). The seat track appears to be the left butt line (LBL) 89.67 seat track at this location. There are seat track allowables²¹ for these tracks at these locations per the Boeing Weight and Balance Control and Loading Manual. It was not possible to determine the location of the fourth seat track and strap combination (Figure 49).

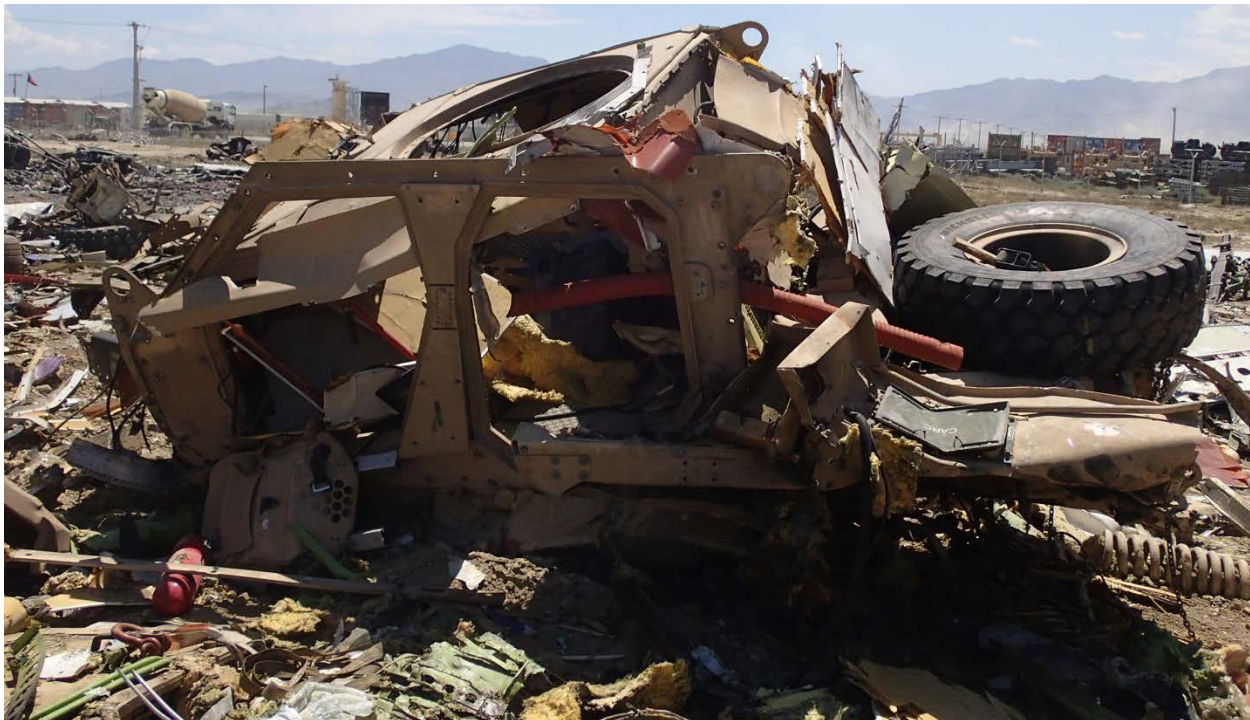
Figure 59 - M-ATV tire rotated 90 degrees forward

M-ATV was rotated about 90 degrees from its original position parallel to the ground and no longer in its upright vertical position (Figure 59).

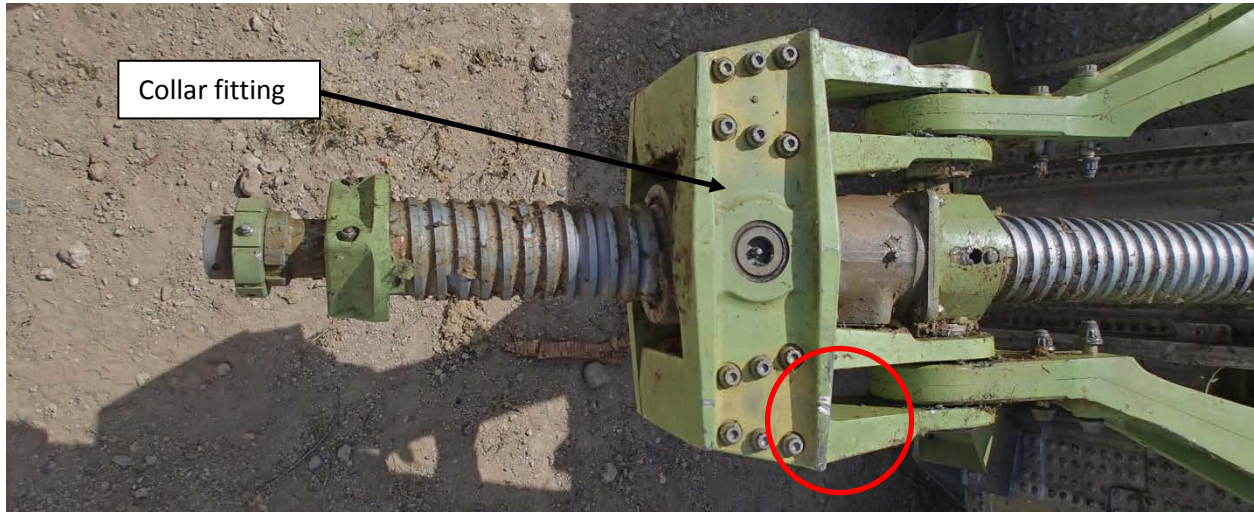
Figure 70 - Jack Screw Collar Fitting Witness Mark

The upper collar fitting of the jack screw assembly had a longitudinal witness mark and material smearing exposing the bare aluminum under the green primer (Figures 70, 71 and 72). The jack screw is located aft of the APB and attached to the fuselage structure about 3 feet above the main cargo floor and the fitting was positioned about 8 feet above the main cargo deck floor (Figures 73, 74 and 75). The aft side of the M-ATV was about 8 feet 8 inches (104 inches) tall (Figures 39, 73 and 7571).

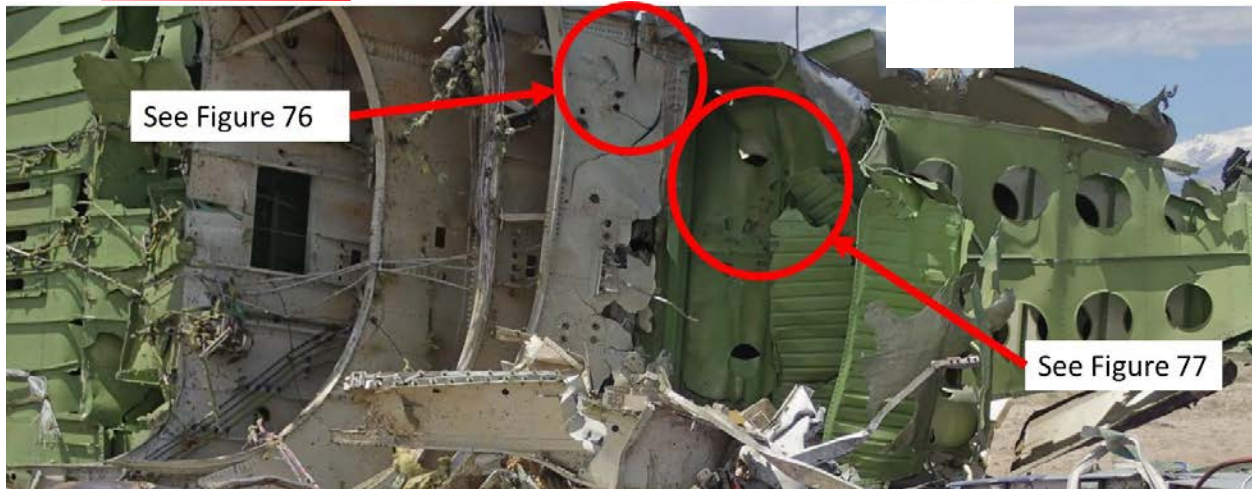
Figure 76 - Lower Side of the VTP Structure with Black Tire Transfer Marks at STA 2412

The aft edge of the aft M-ATV was located at about STA 2218. The APB ties into the fuselage structure at STA 2360. Black tire transfer marks were located at STA 2412, aft of the original starting location and aft of the APB located at STA 2360 and the green dorsal fairing support structure just forward of the frame at STA 2412 (Figures 76, 77 and 78).
