NATIONAL TRANSPORTATION SAFETY BOARD

STRUCTURES GROUP

Factual Report ERA17FA066

Appendix A – Figures (8 pages)

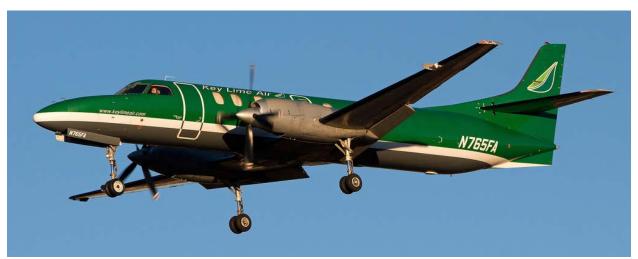
Figure 2 – Accident airplane, N765FA

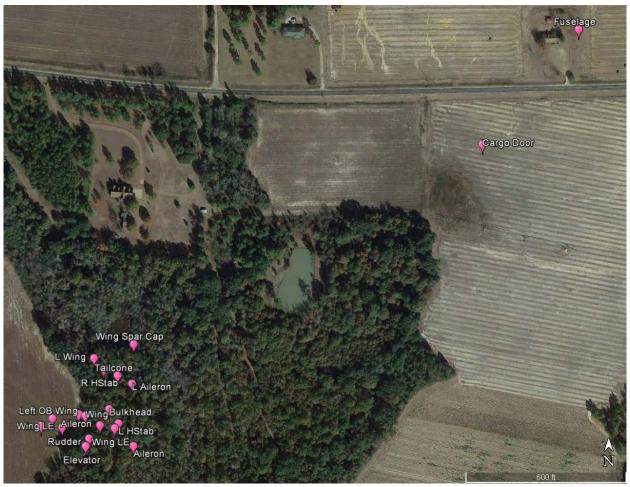
Figure 8 – Wreckage map, N765FA

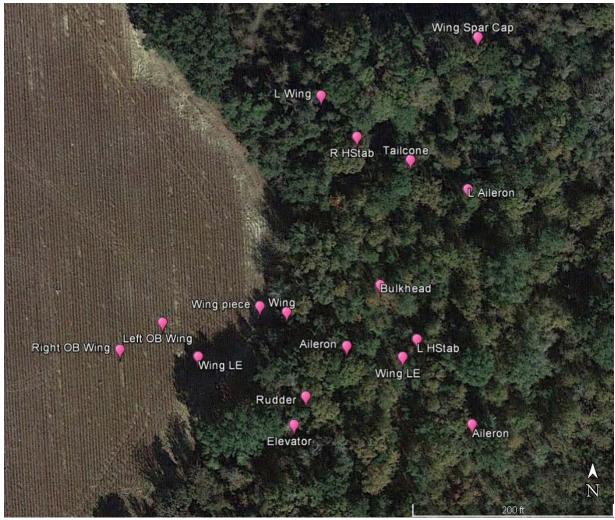
Figure 9 – Concentrated area of wreckage, N765FA

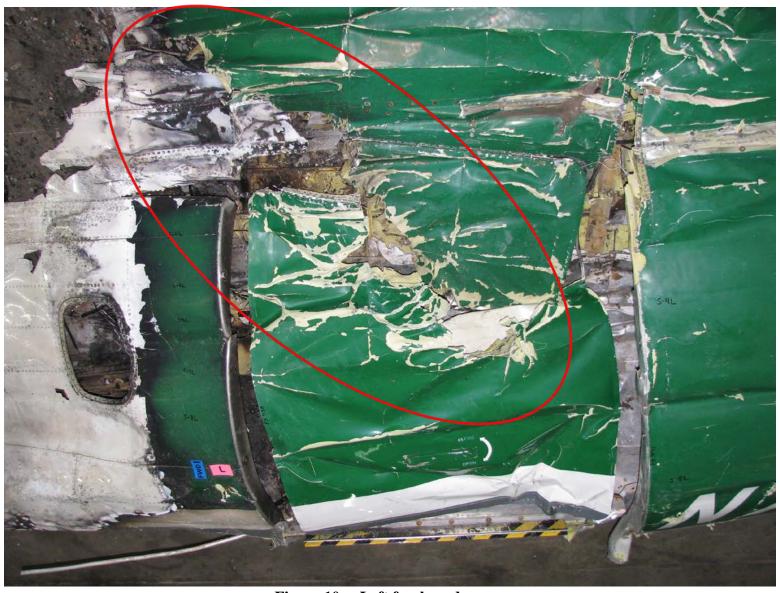
Figure 10 – Left fuselage damage

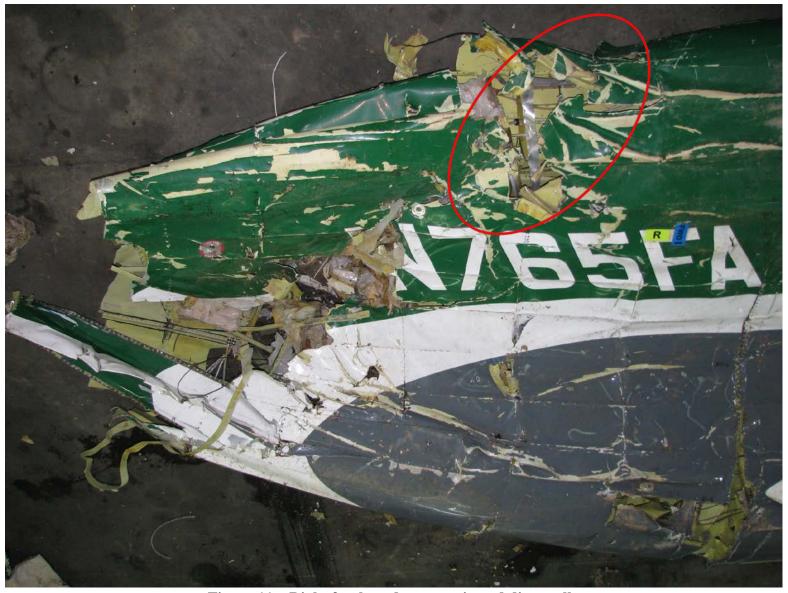
Figure 11 – Right fuselage damage oriented diagonally

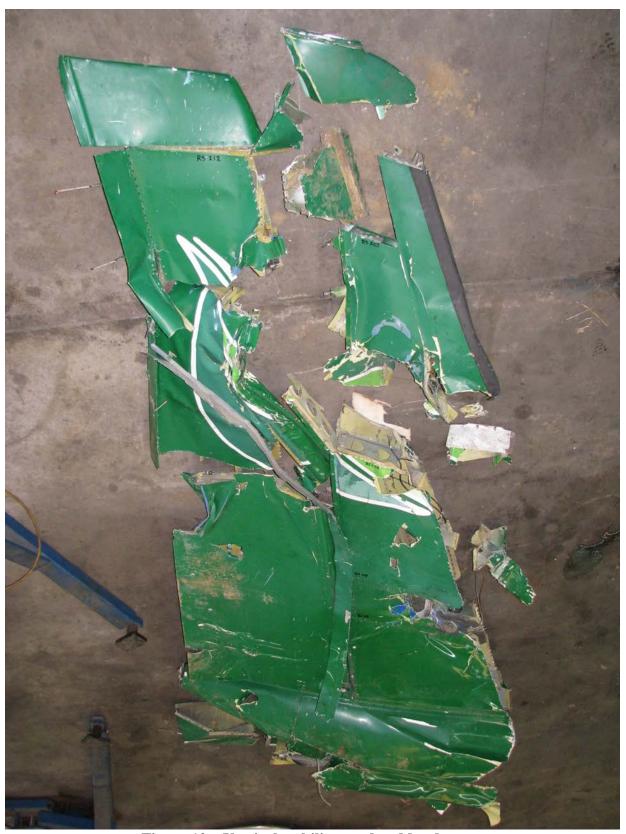
Figure 12 – Vertical stabilizer and rudder damage
