NATIONAL TRANSPORTATION SAFETY BOARD

STRUCTURES STUDY 30 imbedded photographs

Location: Johnstown, NY
Date: May 24, 2013
Time: 2110 GMT,
Aircraft: Piper PA34-200T, N31743
NTSB: ERA13FA253
IIC: A Diaz

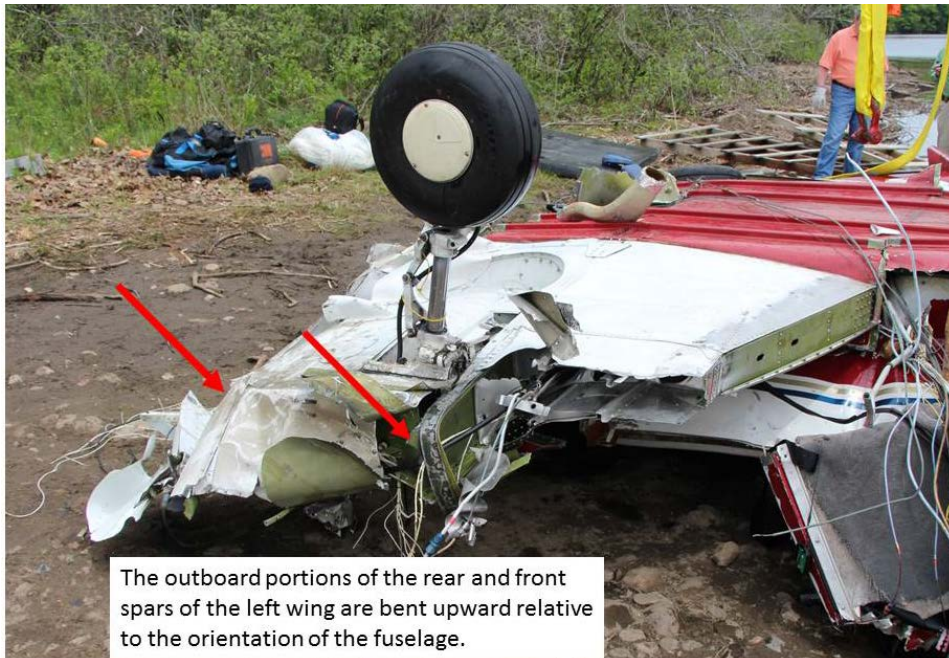
Photo 1 - The front and rear lower spar caps of the left wing are bent in an upward direction. The fuselage and right wing (still attached) impacted the water inverted.

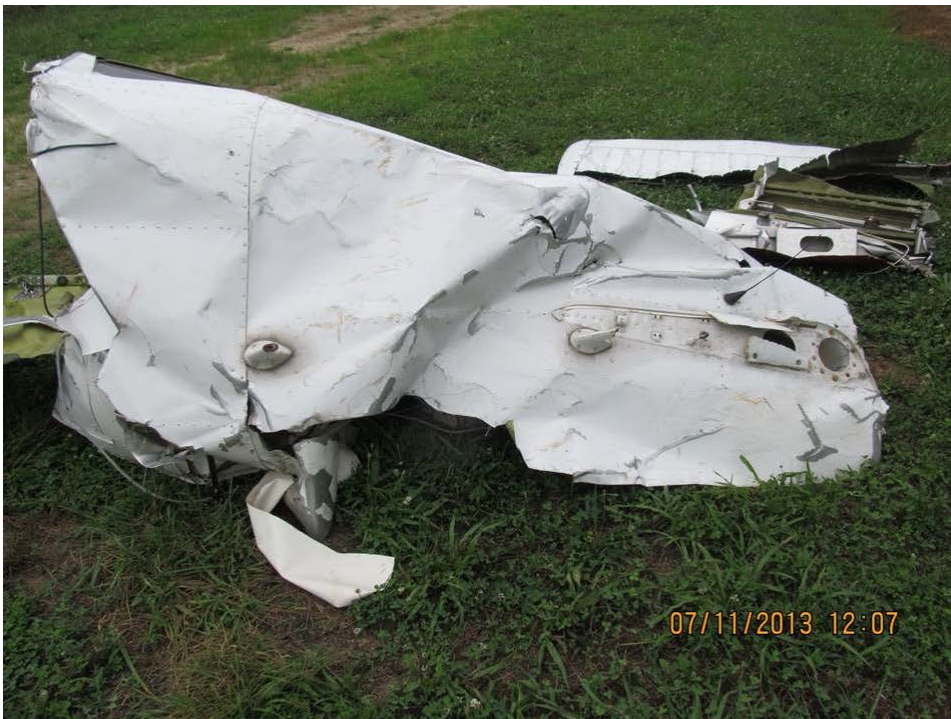
Photo 2 - Top, aft skin of fuselage.

upper wing skins consistent similar to the damage to the upper portion of the fuselage, consistent with water impact. There was compression damage on the lower spar caps of rear spar. The damage could be consistent with either downward aerodynamic loading of the wing or downward hydrodynamic loading of the wing due to the inverted impact with the water.

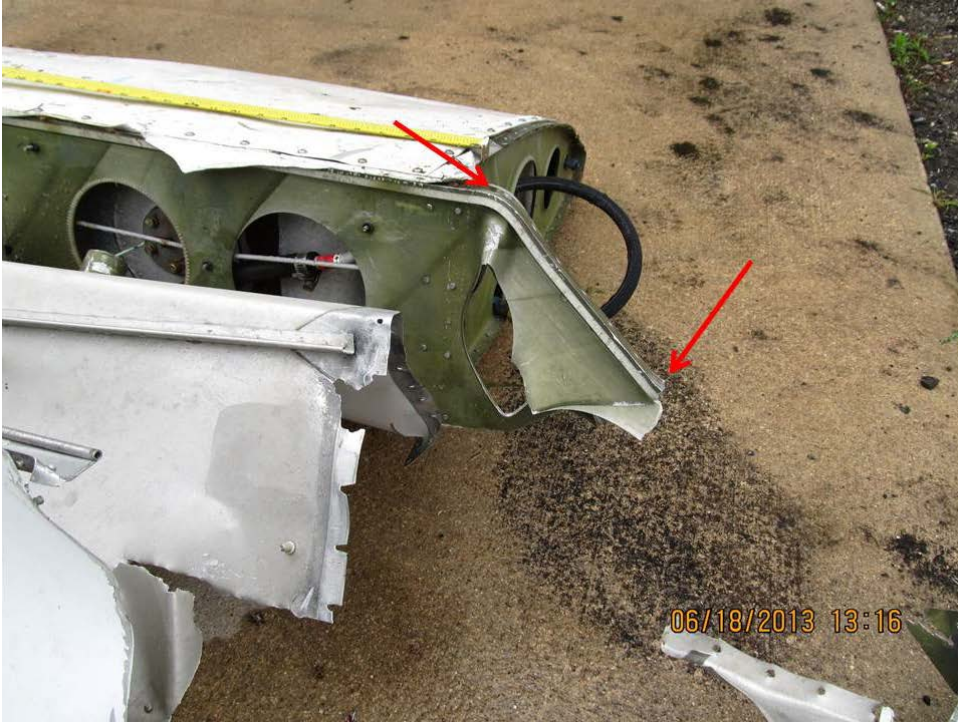
Photo 5 - The upper spar cap is bent downward. The downward bend and the reflex bend at the end of the upper spar cap are consistent with compression buckling of the top spar cap.

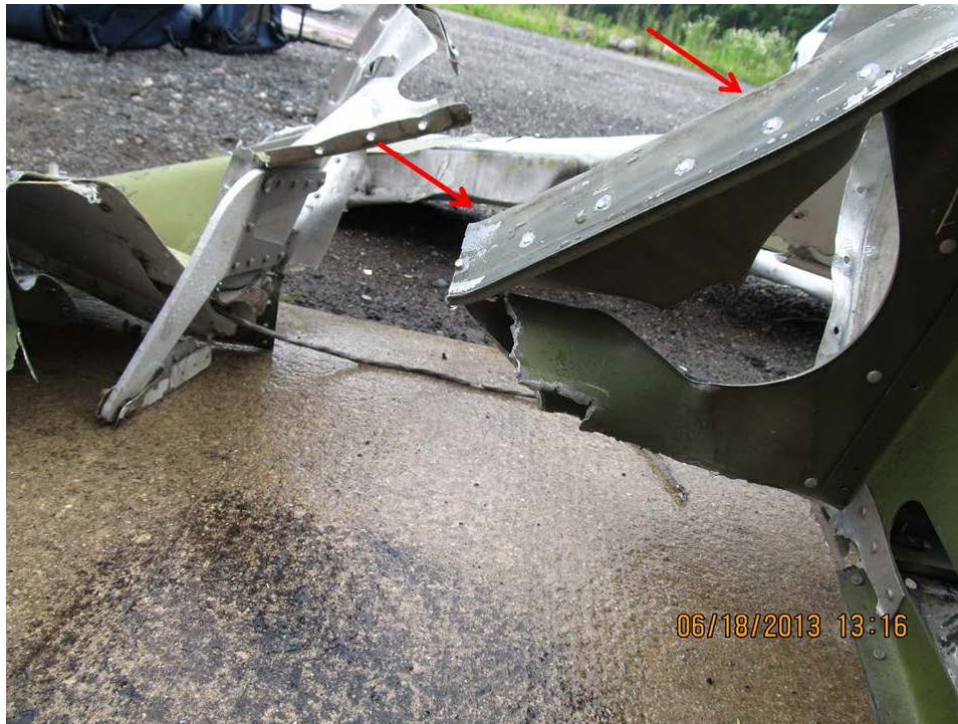
Photo 6 - Reflex bend of upper spar cap.

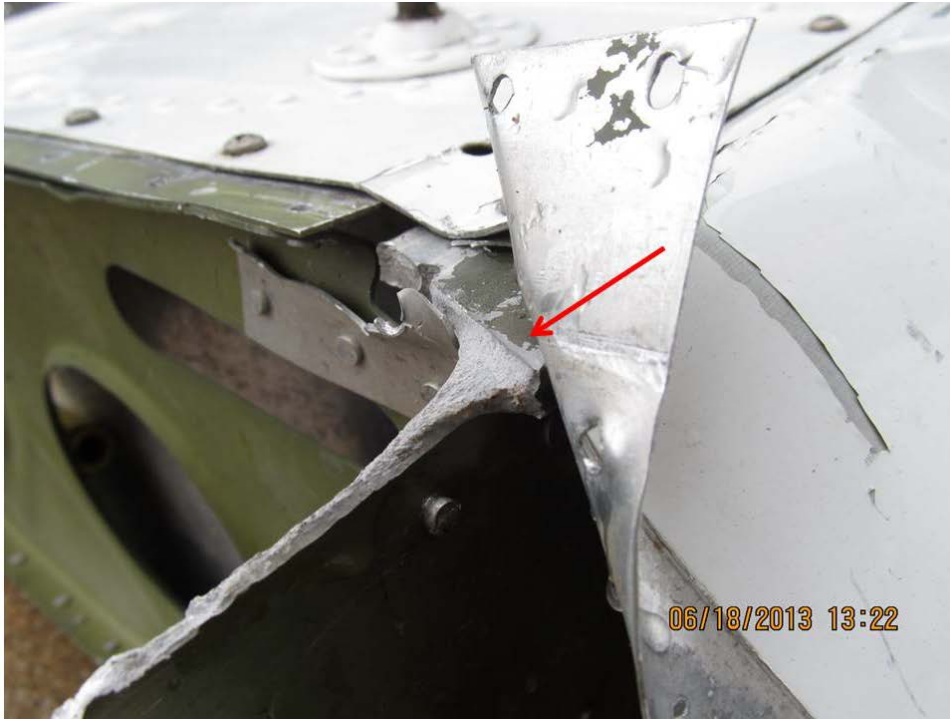
Photo 7 - The lower spar cap exhibits characteristics of tension overload.

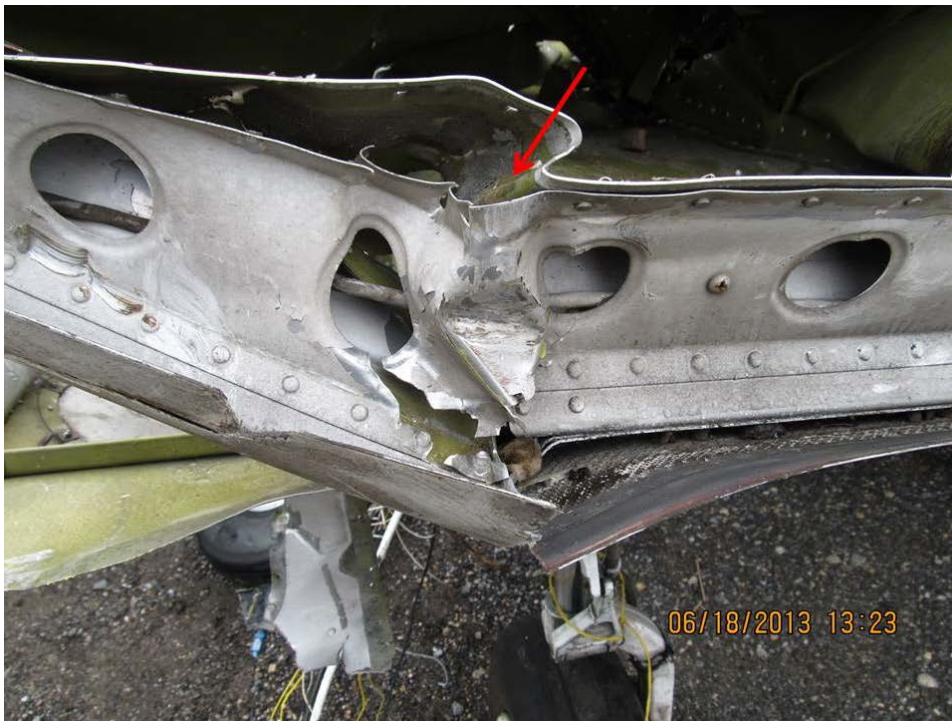
Photo 8 - The section of the rear spar is buckled at the top.

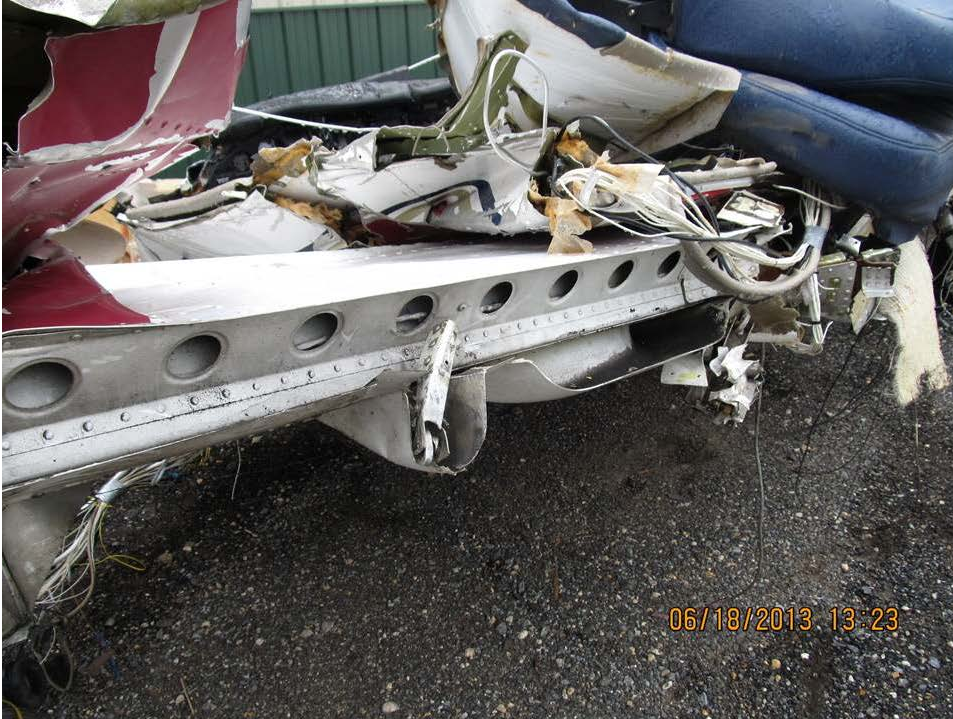
Photo 9 - A large portion of the rear spar is relatively free from distortion.

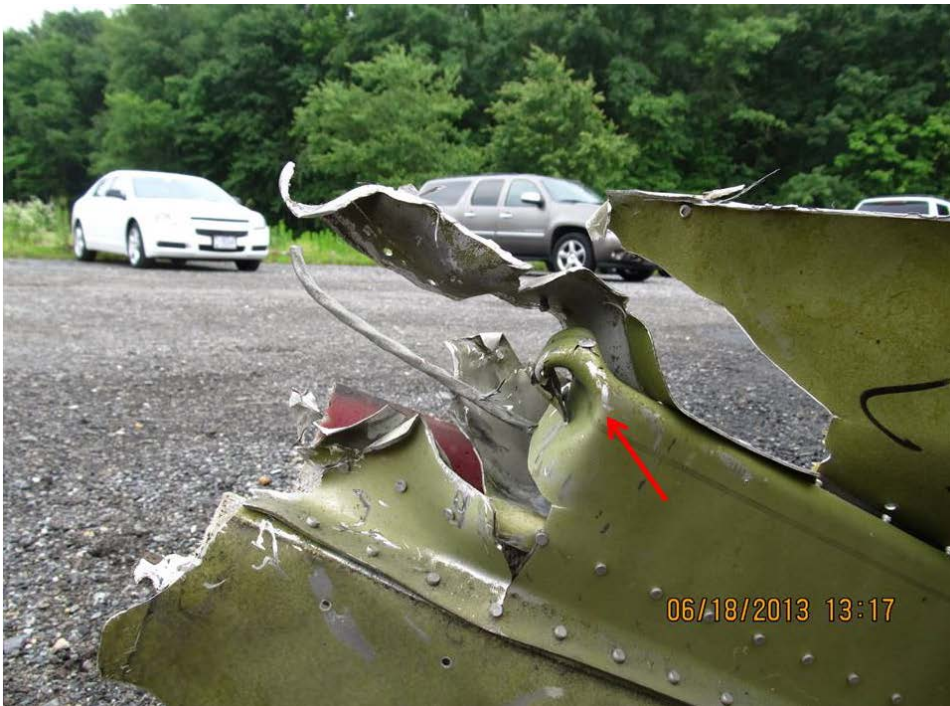
Photo 10 - Top cap of rear spar buckled in compression.

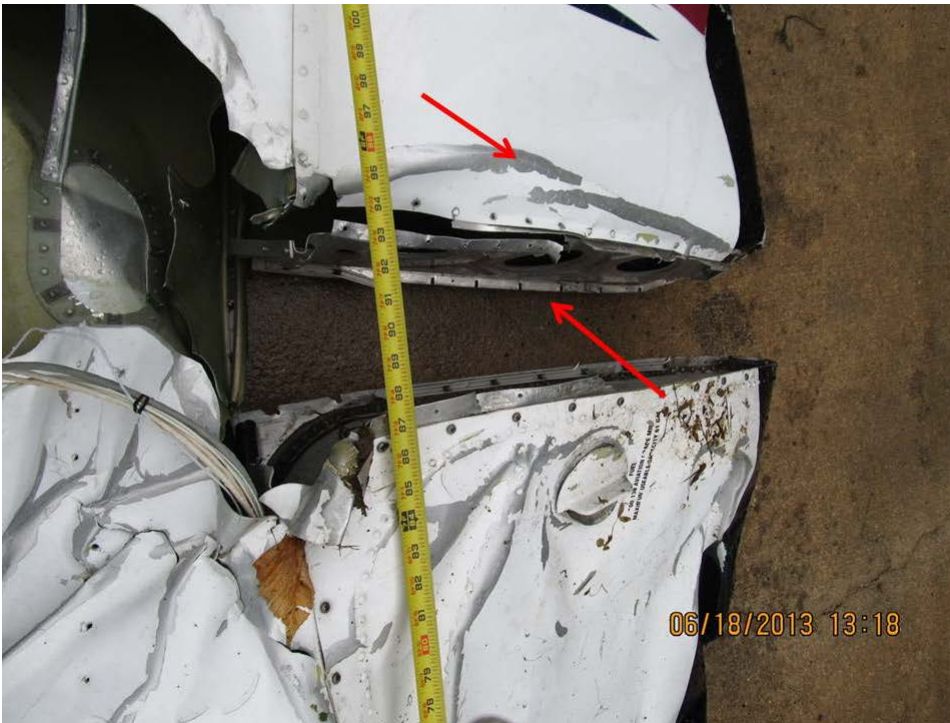
Photo 12 – An arrow highlight the compression wrinkles on the top skin of the left wingtip. The other arrow highlights the tension tears at the rivet holes on the bottom skin.

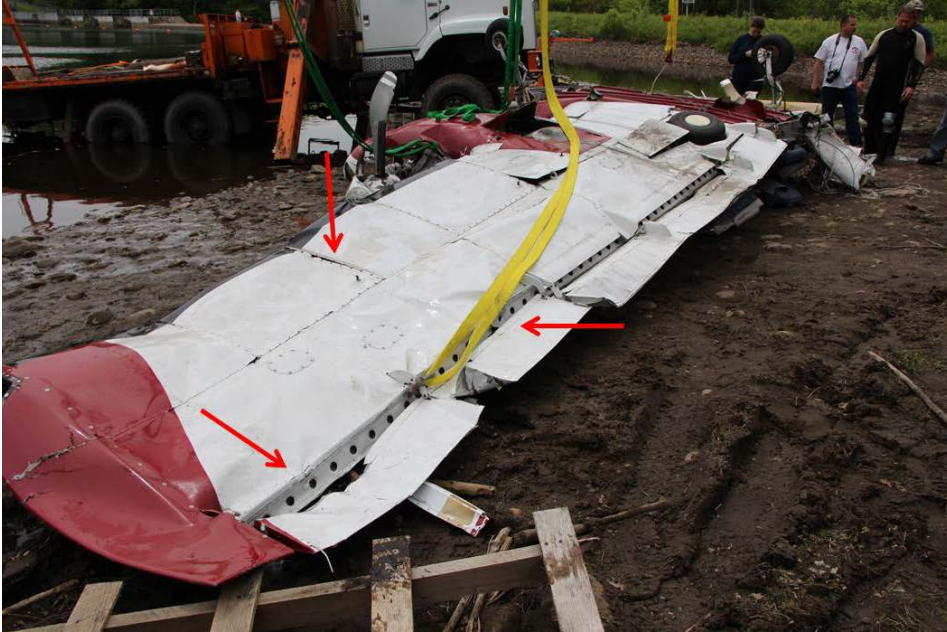
Photo 13 - The right wing is inverted. The arrows pointing to the aft spar highlight points of compression damage to the bottom of the aft spar (r) and the top of the aft spar (l).

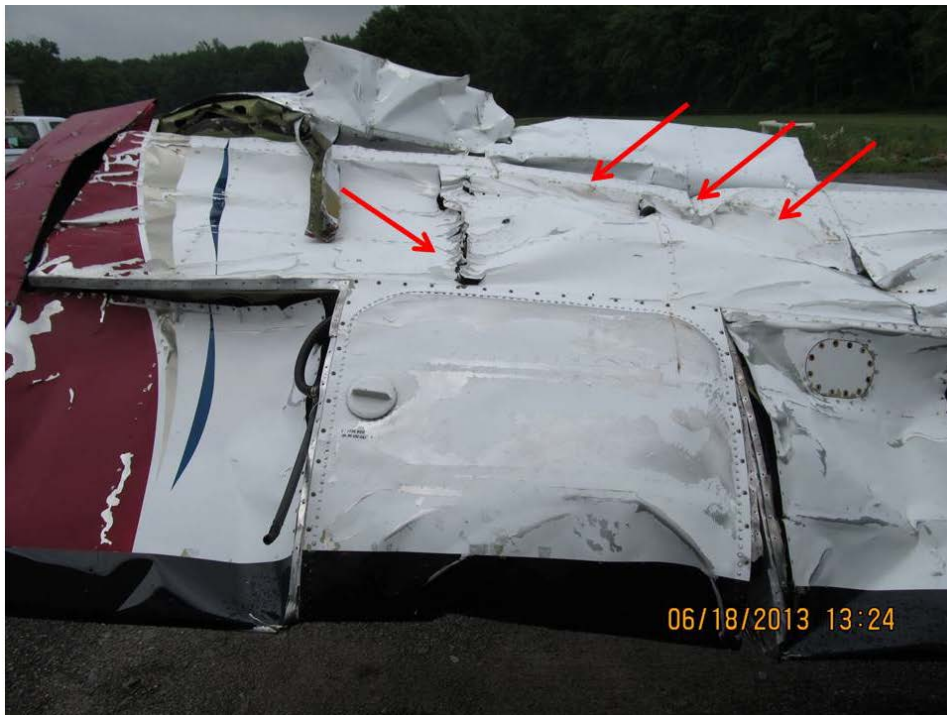
Photo 14 - Outboard portion of right wing. The left arrow shows an area of compression damage to the upper service of the right wing. The series of arrows highlight a diagonal wrinkle across the top of the right wing. The wing skins on each side of the tank are compressed downward. The tank wing skin is compressed downward around the stringers.

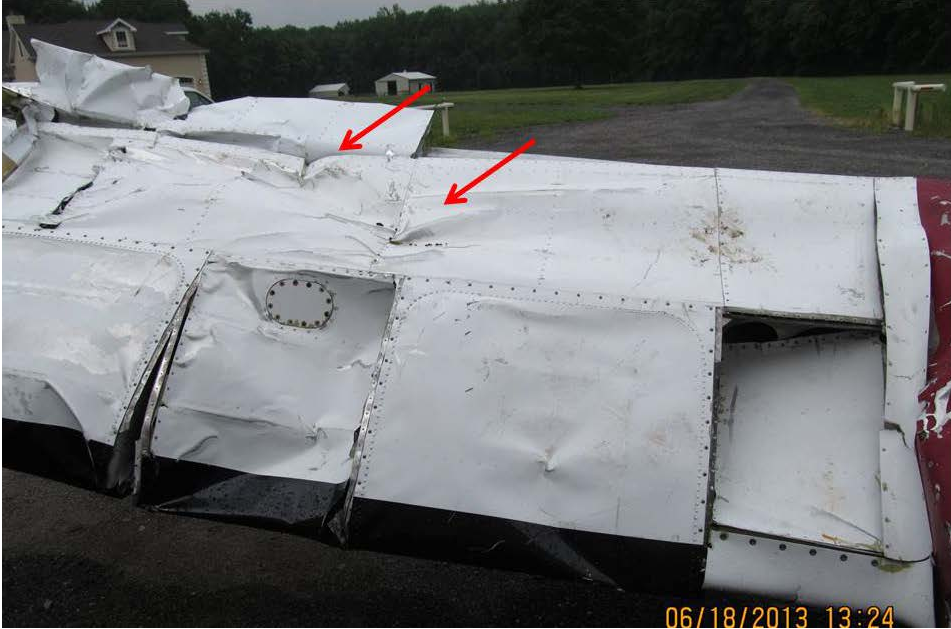
Photo 15 - One arrow highlights compression damage on the upper cap of the rear spar. The other arrow highlights a major wrinkle across the top of the right wing.

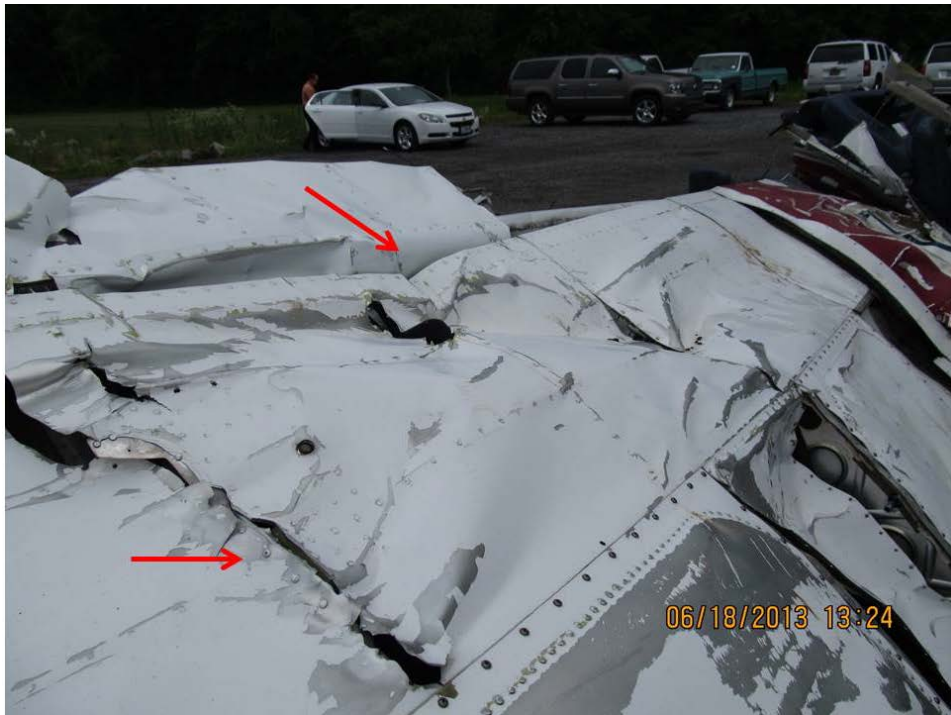
Photo 16 - The arrows highlight compression damage on the upper surface of the right wing. The diagonal wrinkle is also visible.

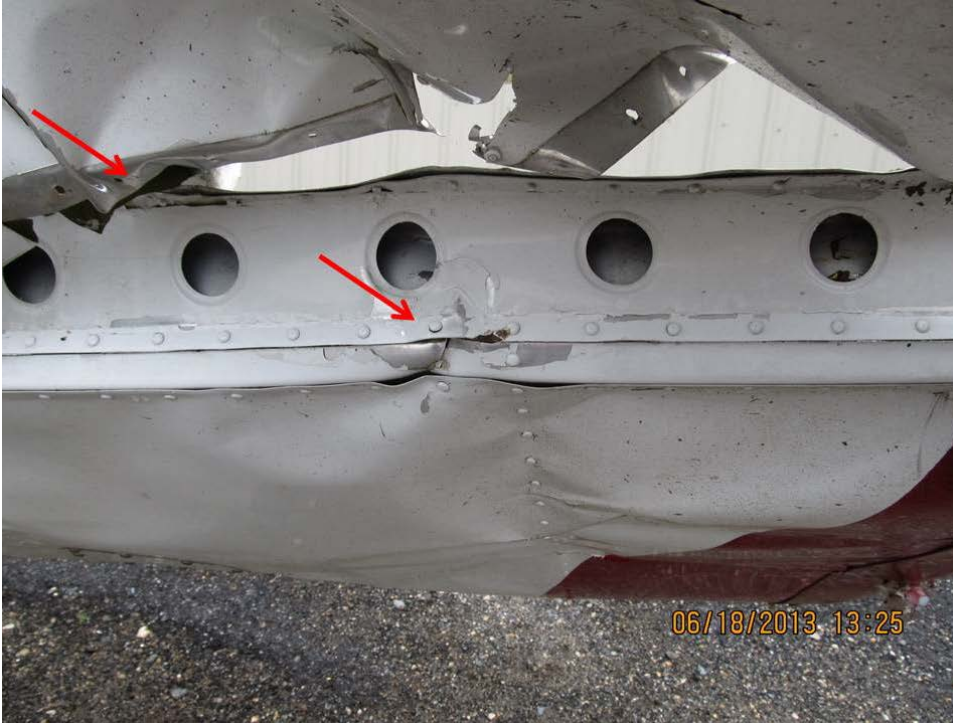
Photo 17 - The outboard section of the rear spar has compression damage on the top and bottom rear spar cap.

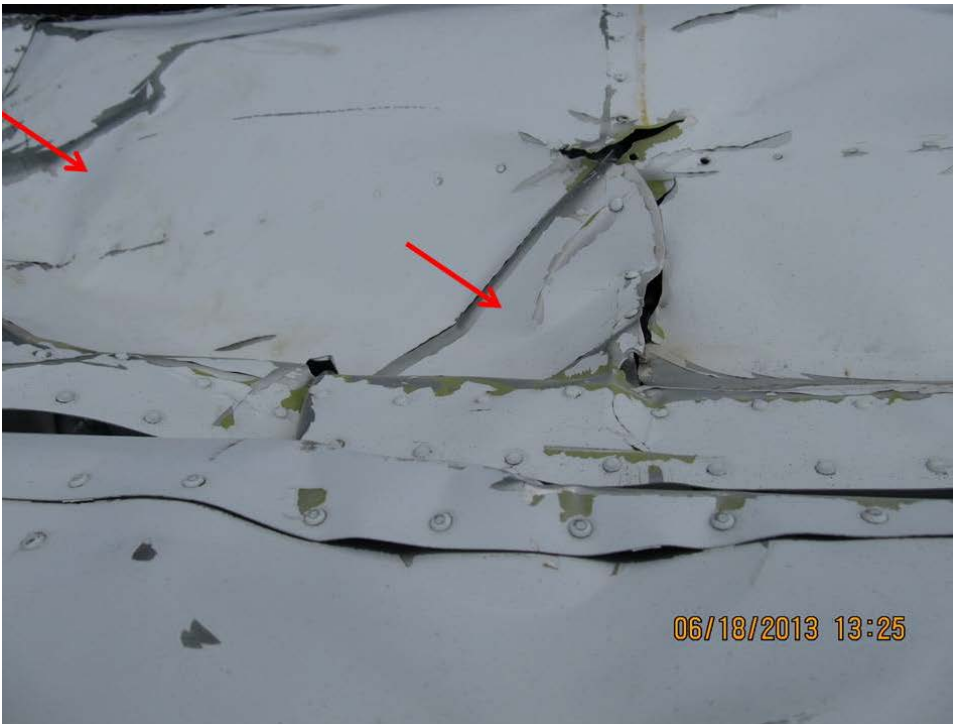
Photo 18 - Diagonal wrinkles and compression damage to the top of the right wing.

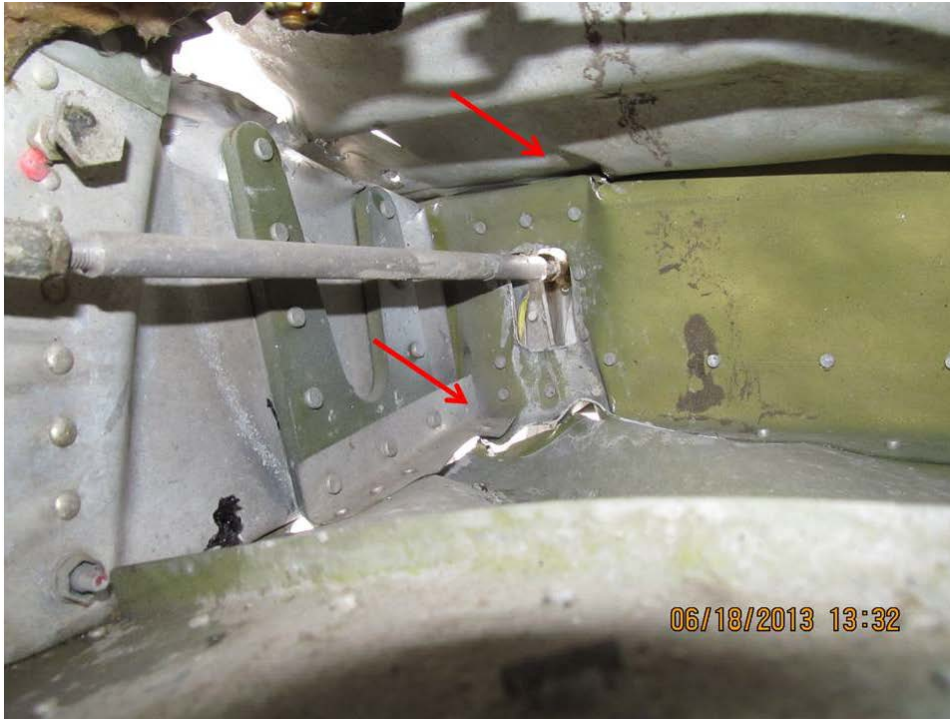
Photo 19 - Compression damage to top and bottom rear spar caps.

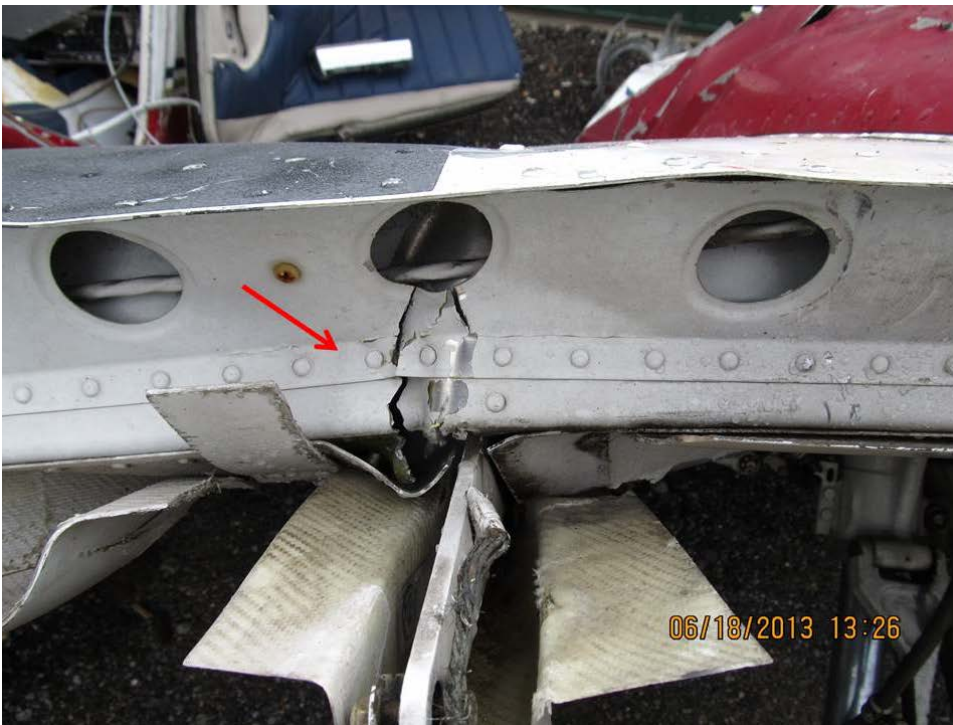
Photo 20 - Compression damage to lower cap of rear spar.

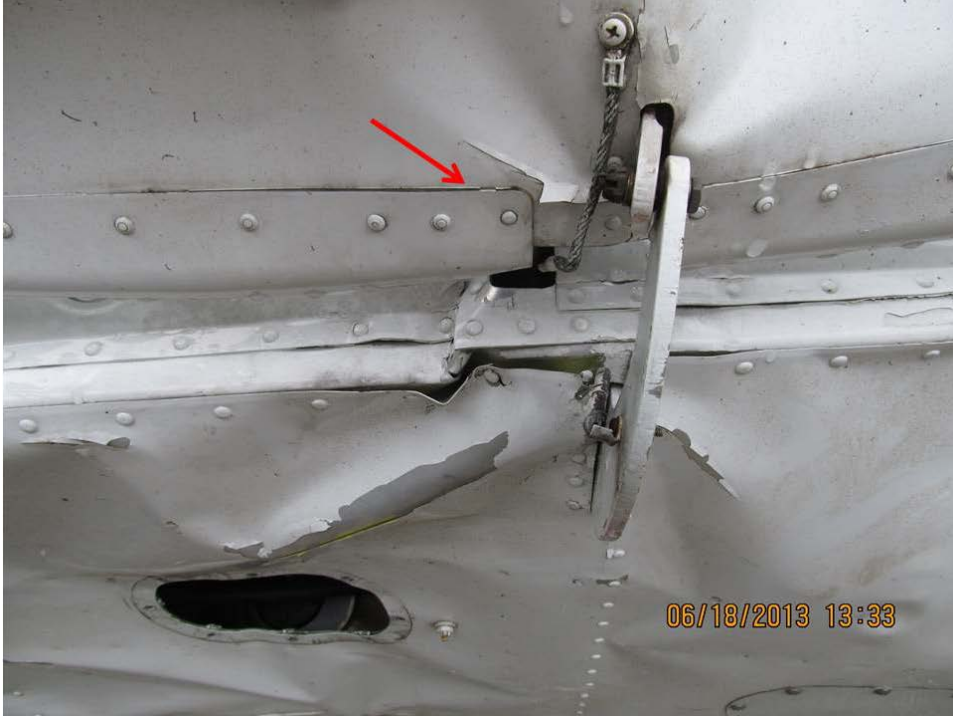
Photo 21 - Compression damage at lower cap of rear spar.

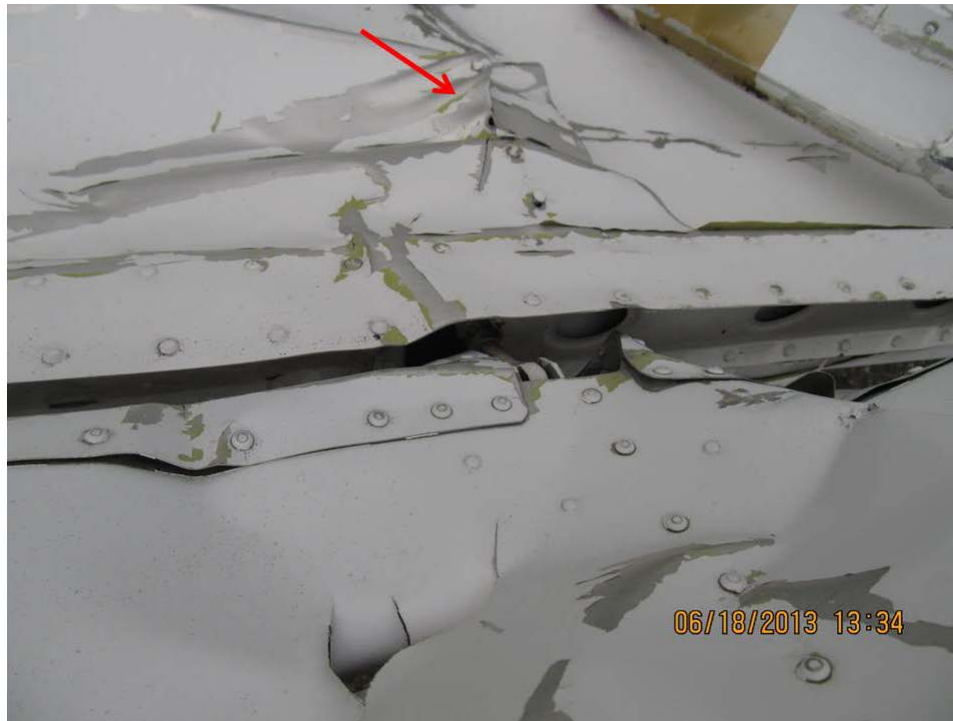
Photo 22 - Compression damage of upper cap of rear spar.

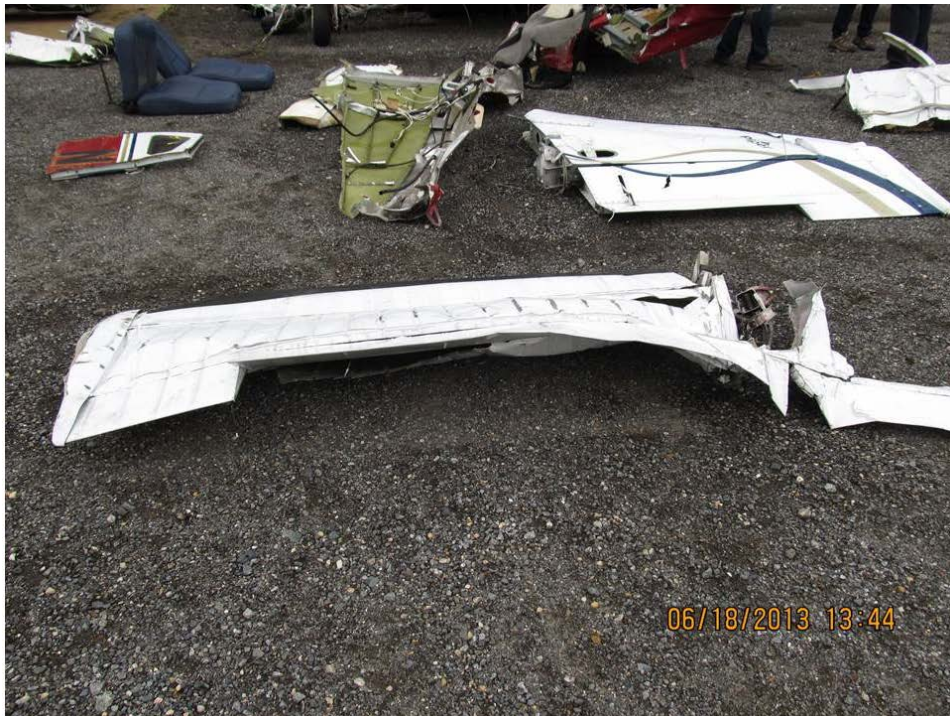
The left horizontal stabilator bending, fracture and compression damage were consistent with downward loading.

Photo 23 - The left stabilator exhibits a downward bend.

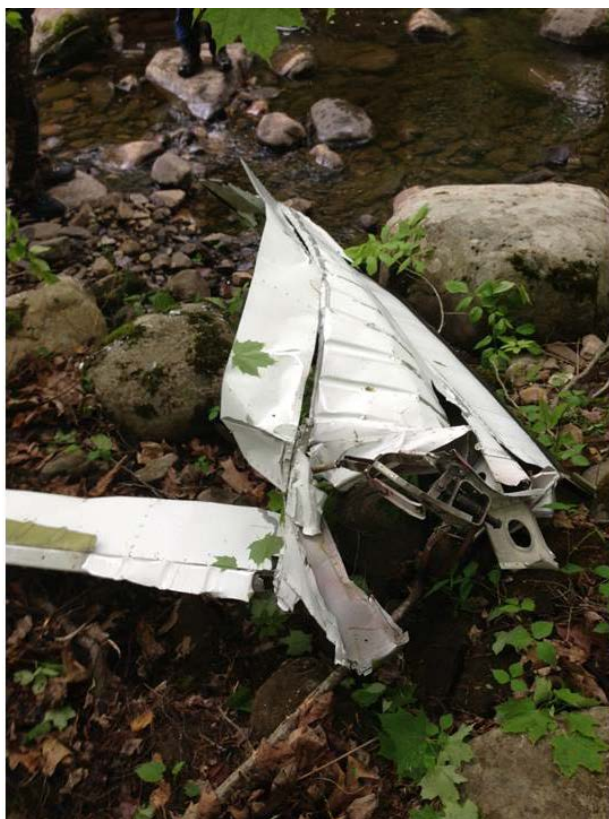
Photo 24 - Another view of the left stabilator displaying the downward bend.

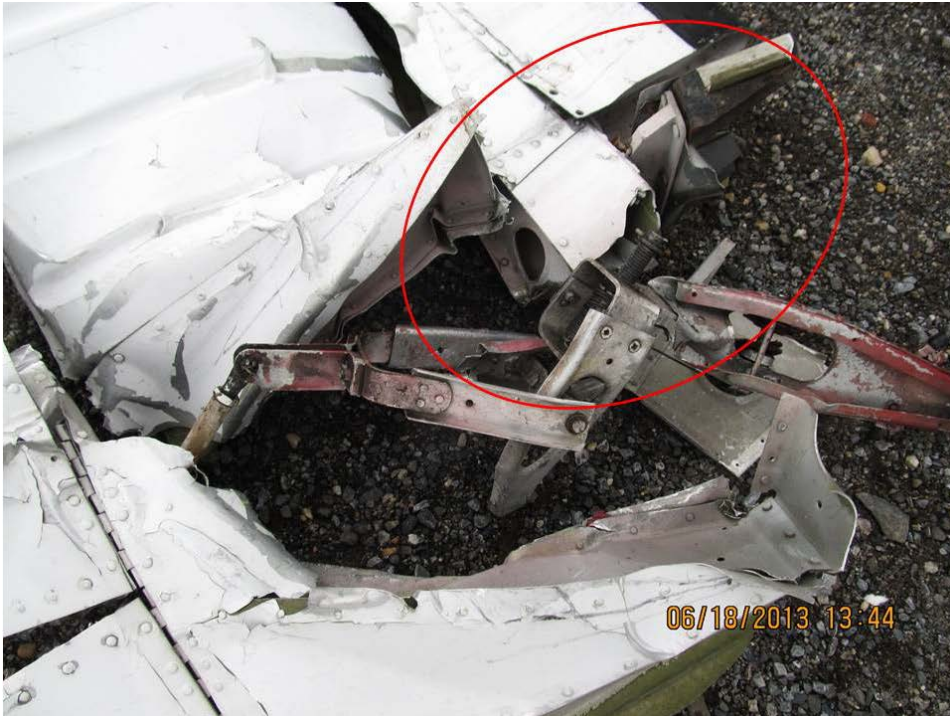
Photo 25 - The highlighted area shows the main spar of the stabilator.

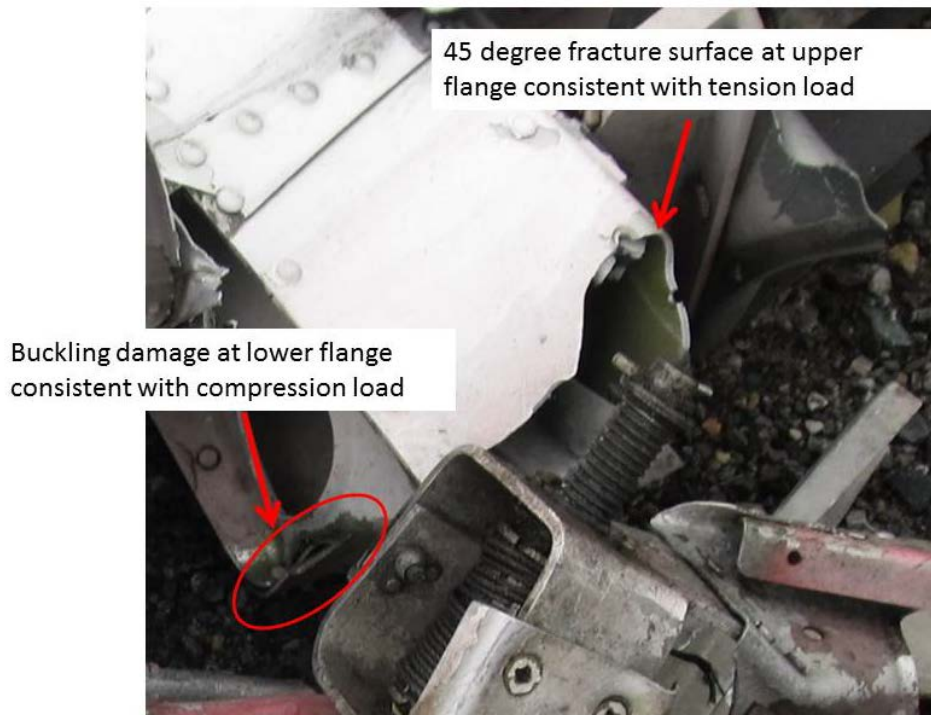
Photo 26 - The upper portions of the stabilator spar exhibit 45 degree fracture surfaces. The lower surfaces are buckled.

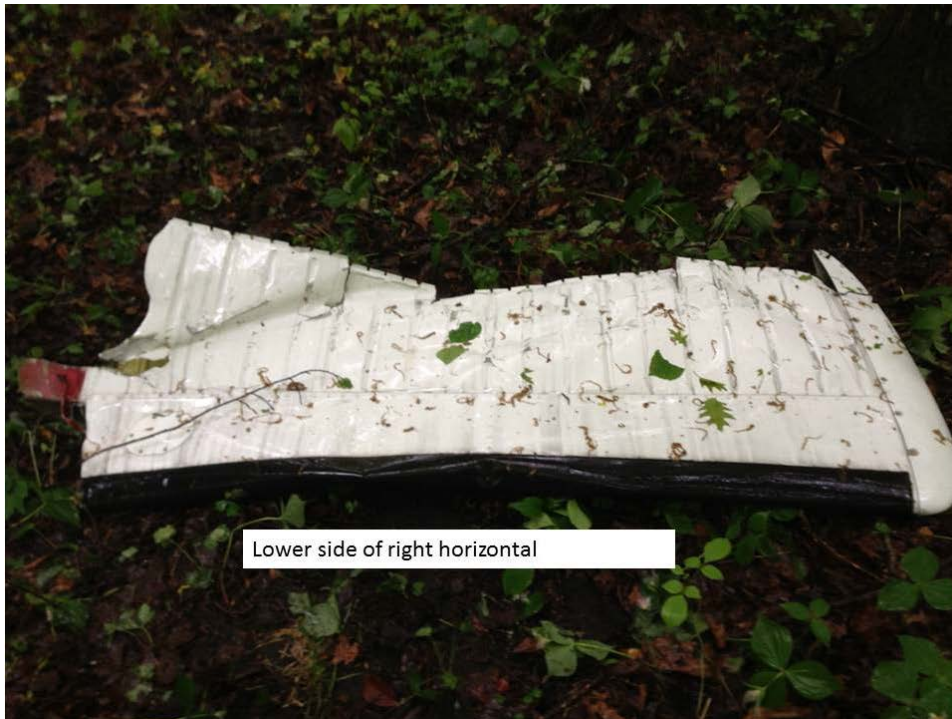
The right horizontal stabilator bending, fracture and compression damage were consistent with both upward and downward loading.

Photo 27 - The right stabilator displays diagonal wrinkles and down bending of the main spar.

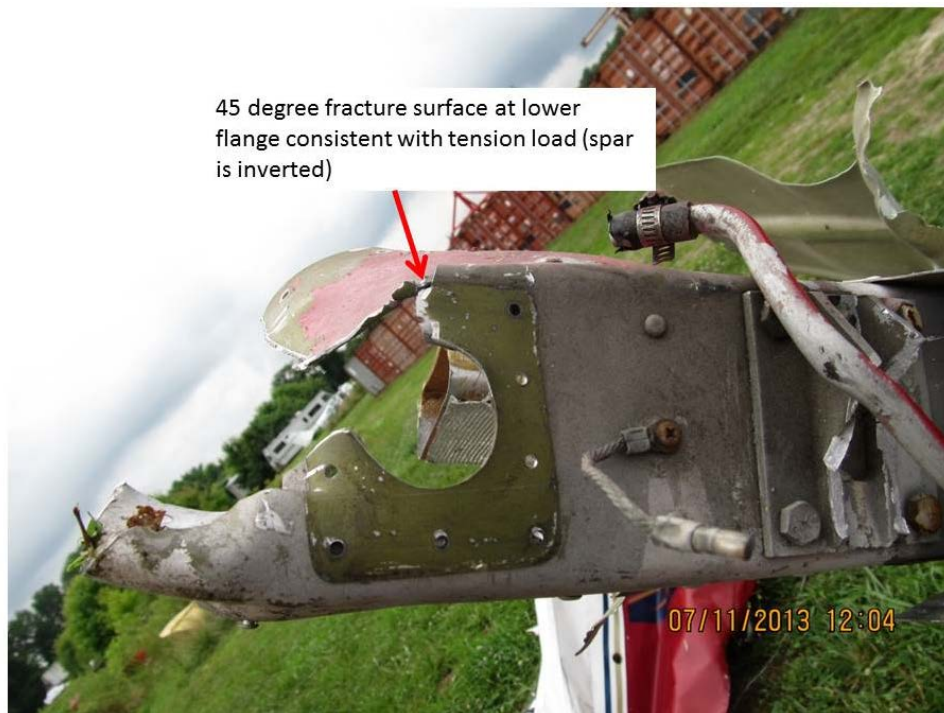
Photo 28 - The lower spar surface of the right stabilator spar exhibits 45 degree surfaces consistent with tension overload.

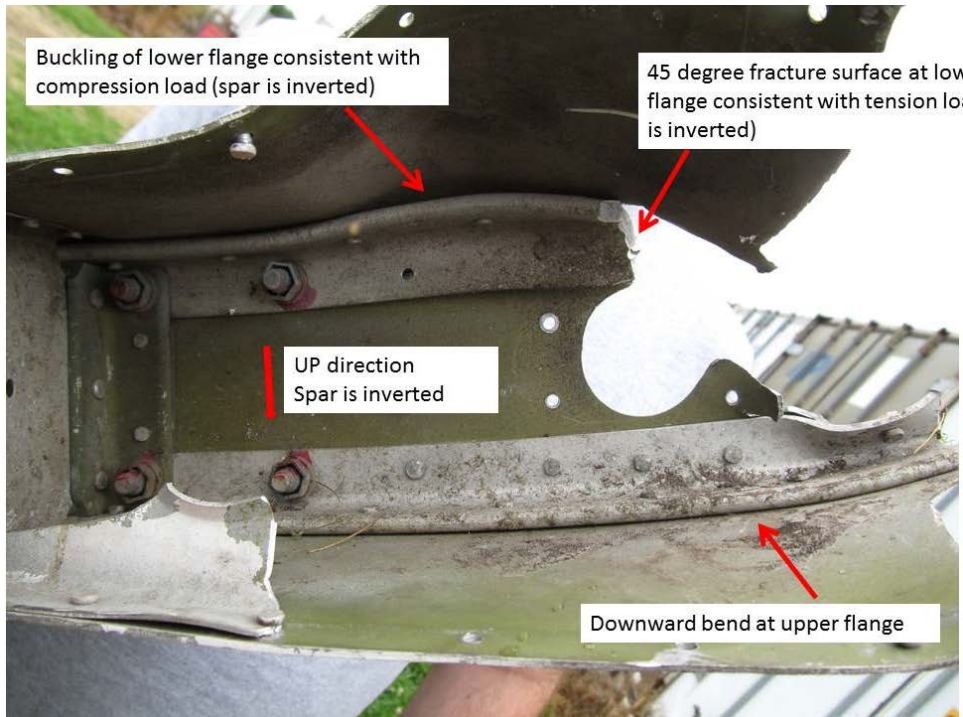
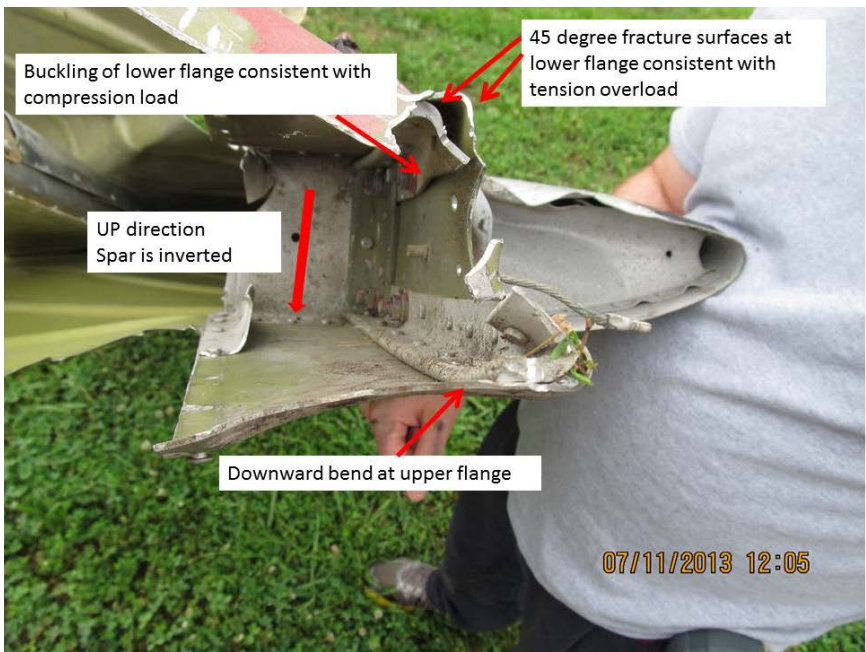
Photo 29 – Structure is inverted. The lower spar of the right stabilator (upper part of photo) exhibits compression buckling and a 45 degree fracture surface. The upper spar cap exhibits a bend consistent with downward motion of the stabilator.

Photo 30 - Same as previous photo.
