**NATIONAL TRANSPORTATION SAFETY BOARD
OFFICE OF RESEARCH AND ENGINEERING
WASHINGTON, D.C. 20594**

Vehicle Dynamics and Visualization Study

Vehicle: 1999 Prevost H3-45 56- Passenger Motorcoach

NTSB # : HWY-11-MH-005

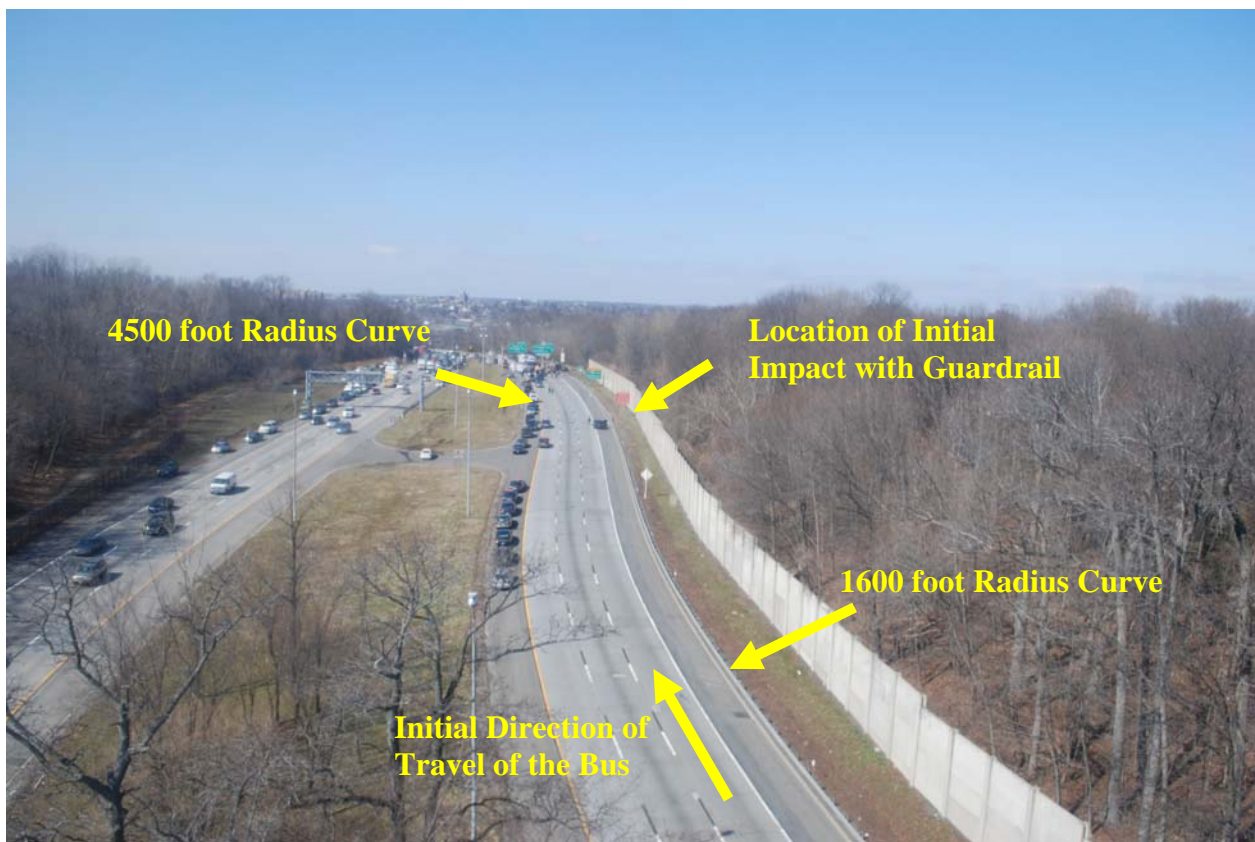
The geometry of the section of roadway where the accident occurred is shown in figure 1 below. According to information contained in the Highway Group Chairman's Factual Report the horizontal curvature on the southbound lanes of I-95 just prior to the accident consisted of a 1,600 foot radius curve that turned to the right in the direction of travel. The 1,600 foot radius horizontal curve ended approximately 770 feet prior to the accident location. The horizontal curvature transitioned to a 4,500 foot radius curve that turned to the left in the direction of travel. The accident location was within the 4,500 foot radius curve

Figure 1 – Aerial view of roadway looking southbound.

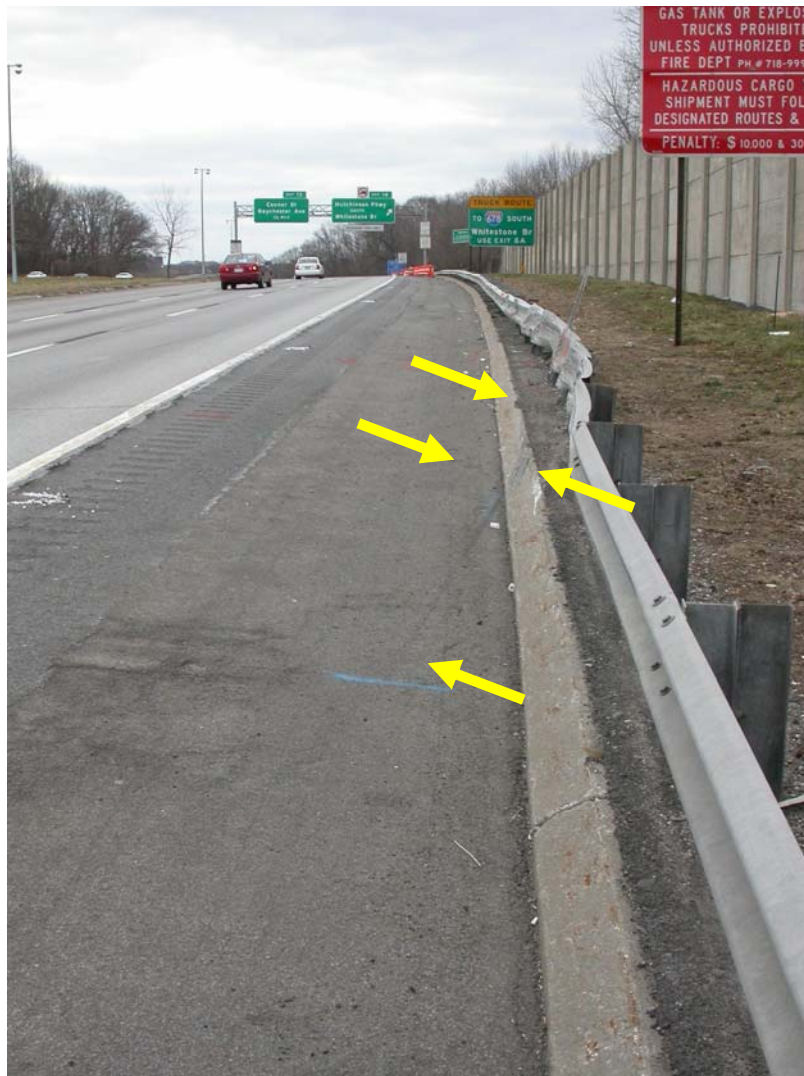
Figure 2 – Guardrail damage caused by the initial impact of the bus with the guardrail. Arrows point to tiremarks and scrapmarks indicating the path of the accident vehicle as it traveled across the 10 foot shoulder and impacted the guardrail. It could not be determined if the bus made contact with the red sign in the foreground. (Unless indicated by an arrow, tiremarks and scrapmarks shown in the photograph are not associated with this accident.)

⁴ It could not be determined from the physical evidence if the bus contacted the red sign next to the guardrail during the first collision with the guardrail (see figure 2). In the video it is not depicted as touching the sign.

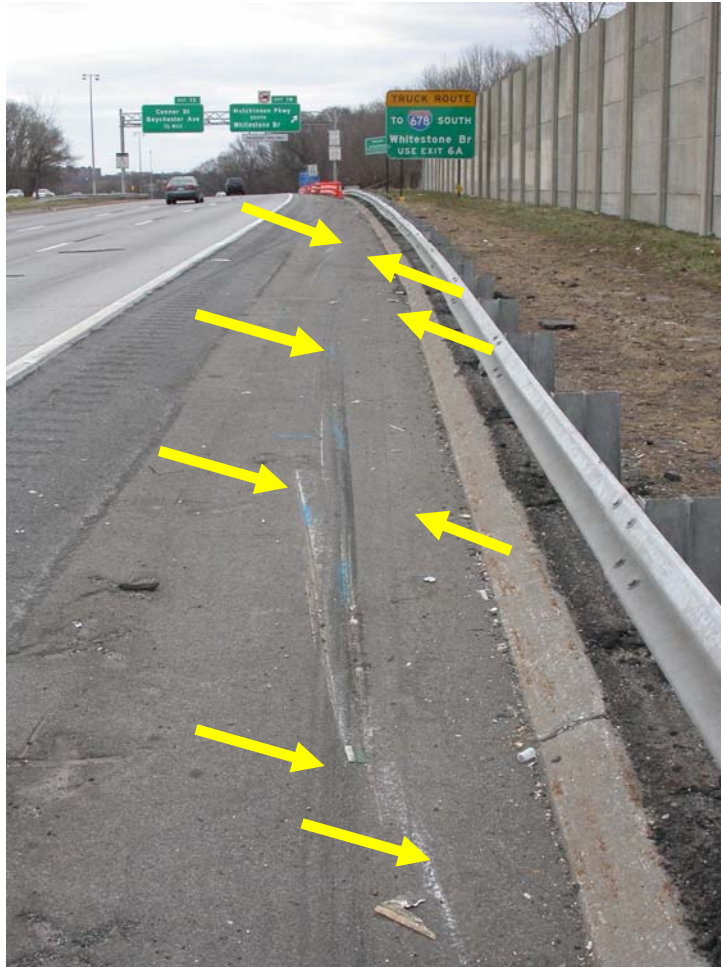
Figure 3 – After initially striking the guardrail the bus veered away from the guardrail and lost contact the guard rail for short distance. The arrows shown in the photograph indicate evidence of the path of the bus during the time it lost contact with the guardrail. Note that there is no evidence of contact damage from the bus visible on the guardrail. (Unless indicated by an arrow, tiremarks and scrapemarks shown in the photograph are not associated with this accident.)

After initially striking the guardrail in the video, the bus veers away from the guardrail along the marks shown in figure 3. (These marks are depicted as black lines in the video.) The maximum roll angle orientation of the bus along its longitudinal axis during the initial impact with the guardrail in the video was estimated from the location of the tiremarks on the roadway and the damages to the guardrail⁴. After veering away from the guardrail in the visualization, the bus veers back towards the guardrail along the marks shown in figure 4. (Again, the marks on the shoulder are depicted as black lines in the video.) After striking the guardrail the second time the simulated bus continues to travel forward while leaning on the guardrail for several hundred feet before overturning onto its right side. The roll angle orientation of the bus around its longitudinal axis during this portion of the video was calculated from the marks on the road, the damage to the guardrail, and the damage from the bus found on the two signs shown in figure 6. (Again, the marks on the shoulder are depicted by black lines.) After overturning onto its right

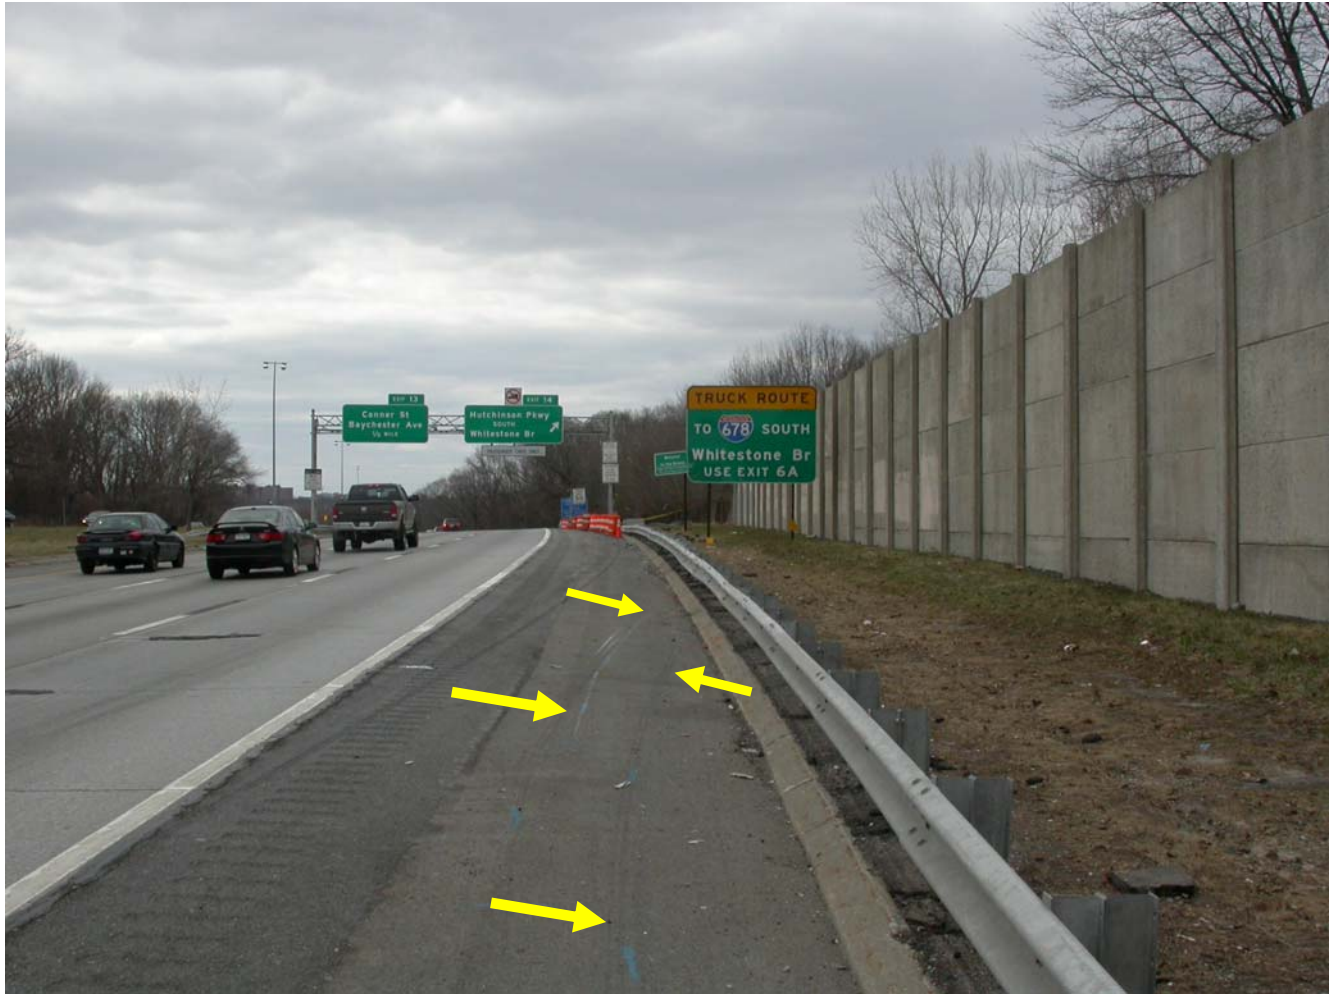
Figure 4 – Arrows highlight the physical evidence indicating the path of the bus as it veered back towards the guardrail and impacted the guardrail for a second time. (Unless indicated by an arrow, tiremarks and scrapemarks shown in the photograph are not associated with this accident.)

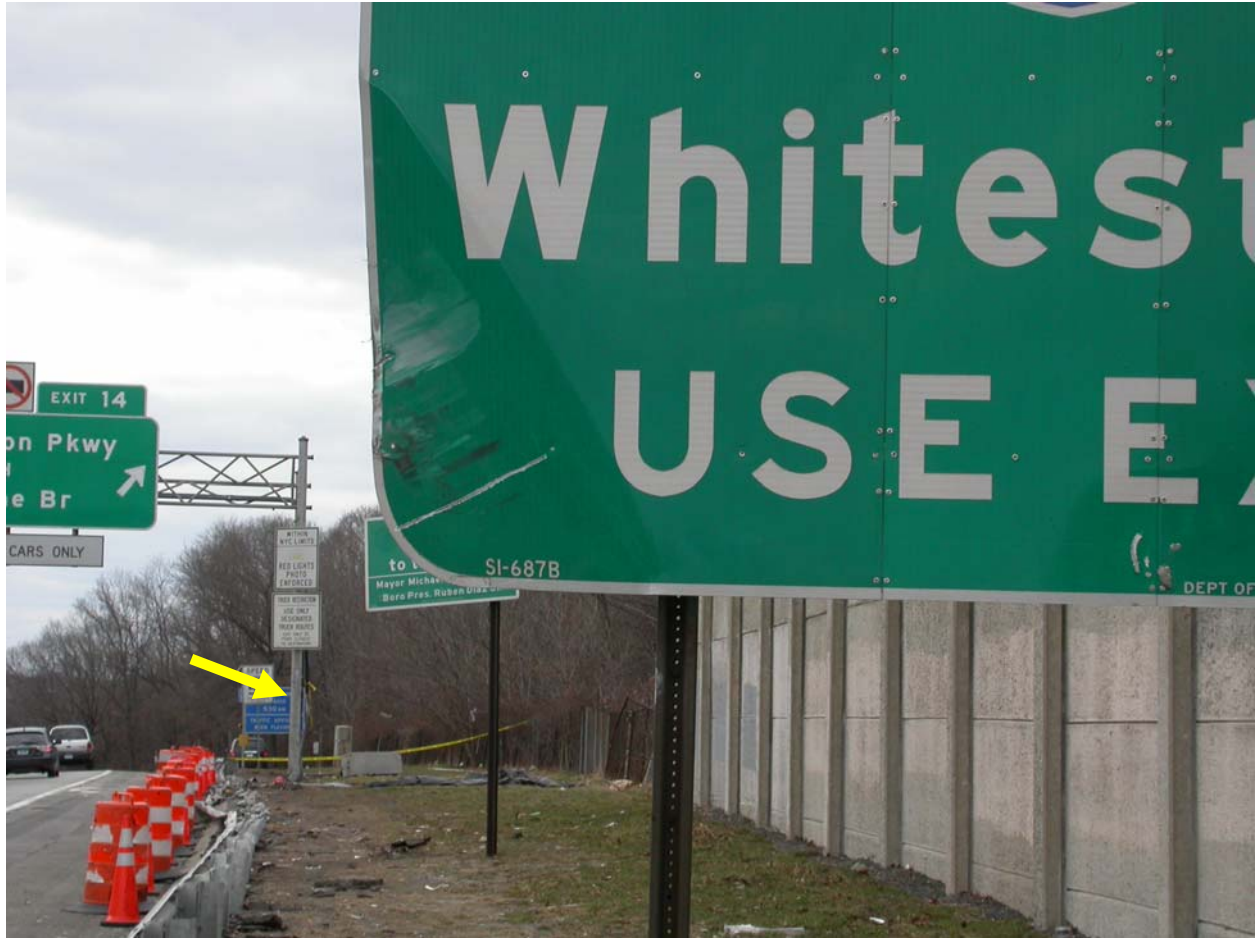
Figure 6 - Close up of contact damage from the bus found on the first sign shown in figure 5. The main damage to the second sign was to the left side support post which was destroyed by the impact with the bus. Arrow in the background highlights the overhead sign stanchion which the bus struck before coming to final rest. Note damage to guardrail just before the overhead sign stanchion. This damage suggests the bus was rolled approximately 90 degrees to the right at this point.

side, the simulated bus slides for several feet before striking the support pole for the overhead sign and coming to rest. The location of the rollover shown in the video was determined by damage to the guardrail indicating that the bus was on its side (figure 6). The location of the overhead sign stanchion was included in the survey information. The speed of the bus after striking the guardrail until final rest in the video is not uniquely determined by the information available; different choices for parameters used in the model could result in a different solution that also matches the physical evidence.

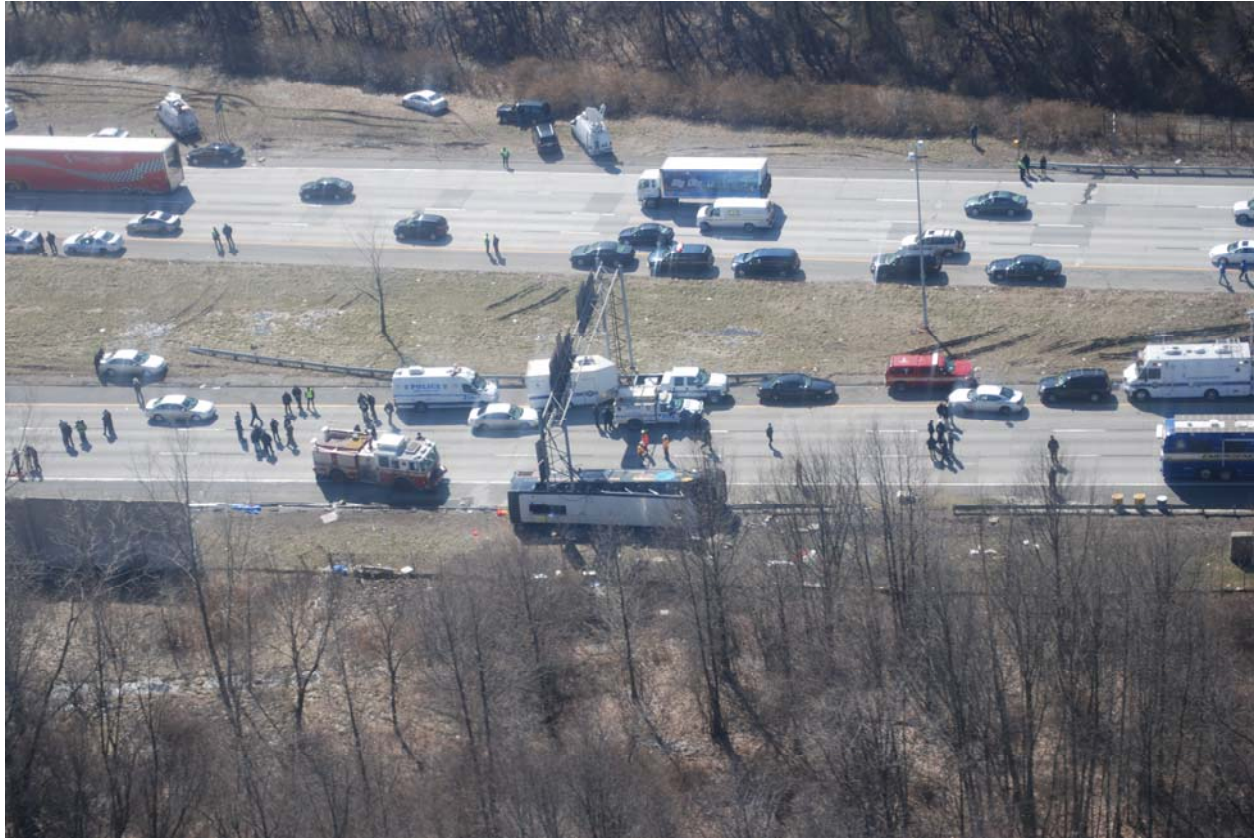
Figure 7 - Final rest position of the bus
